Re: Application 2016/6670/T

Planning Application No 2016/56670T

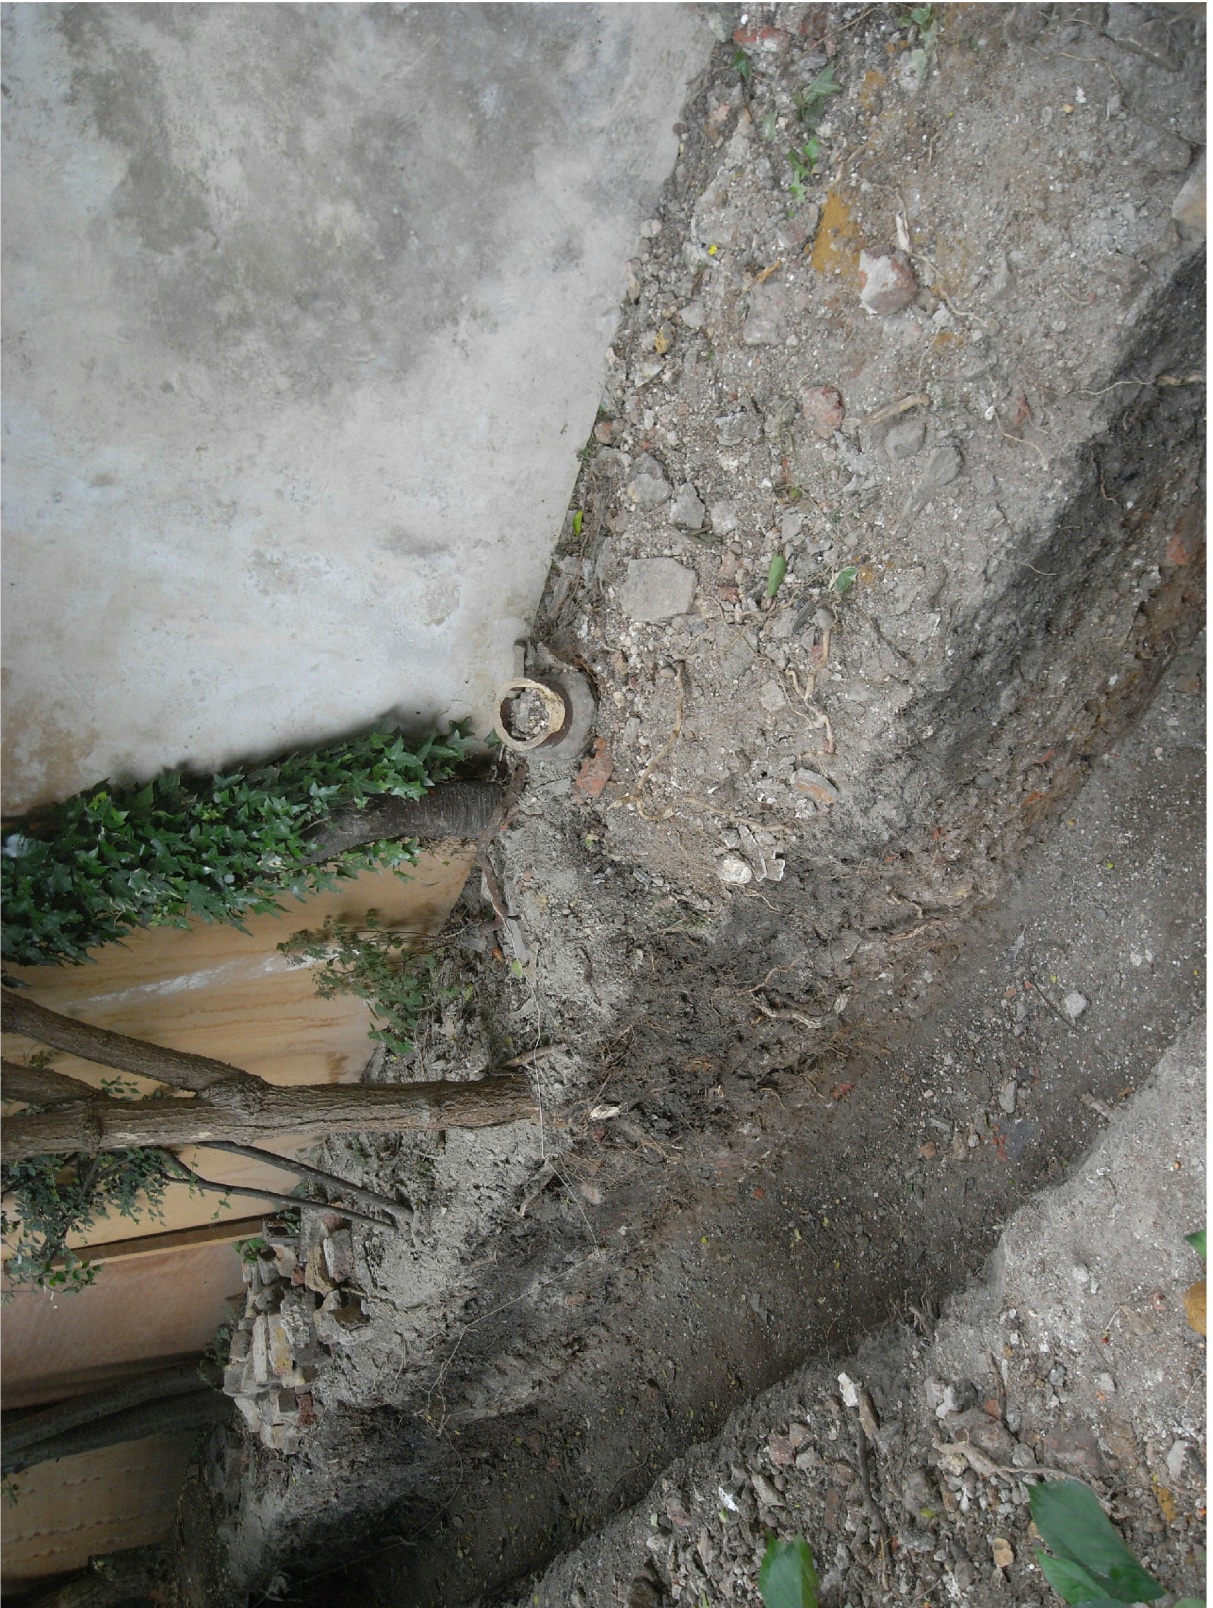
During the 2013 replacement of the original boundary wall between 22 and 20 Hilltop Rd, albeit with slightly less retained level, Genesis' surveyors had inaccurately alleged that the collapse had been caused "entirely" by roots from several adjacent trees in the garden of No 20. Evidence that this was complete nonsense can be seen in the attached photo of that wall's new foundation trench.

The wall between 20 and 22 had no foundation whatsoever.
