Re: Arboricultural Report – 11 Regents Park Road NW1

**ARBORICULTURAL
REPORT**

**INSURANCE
PURPOSES**

**11 Regents Park Road
London NW1**

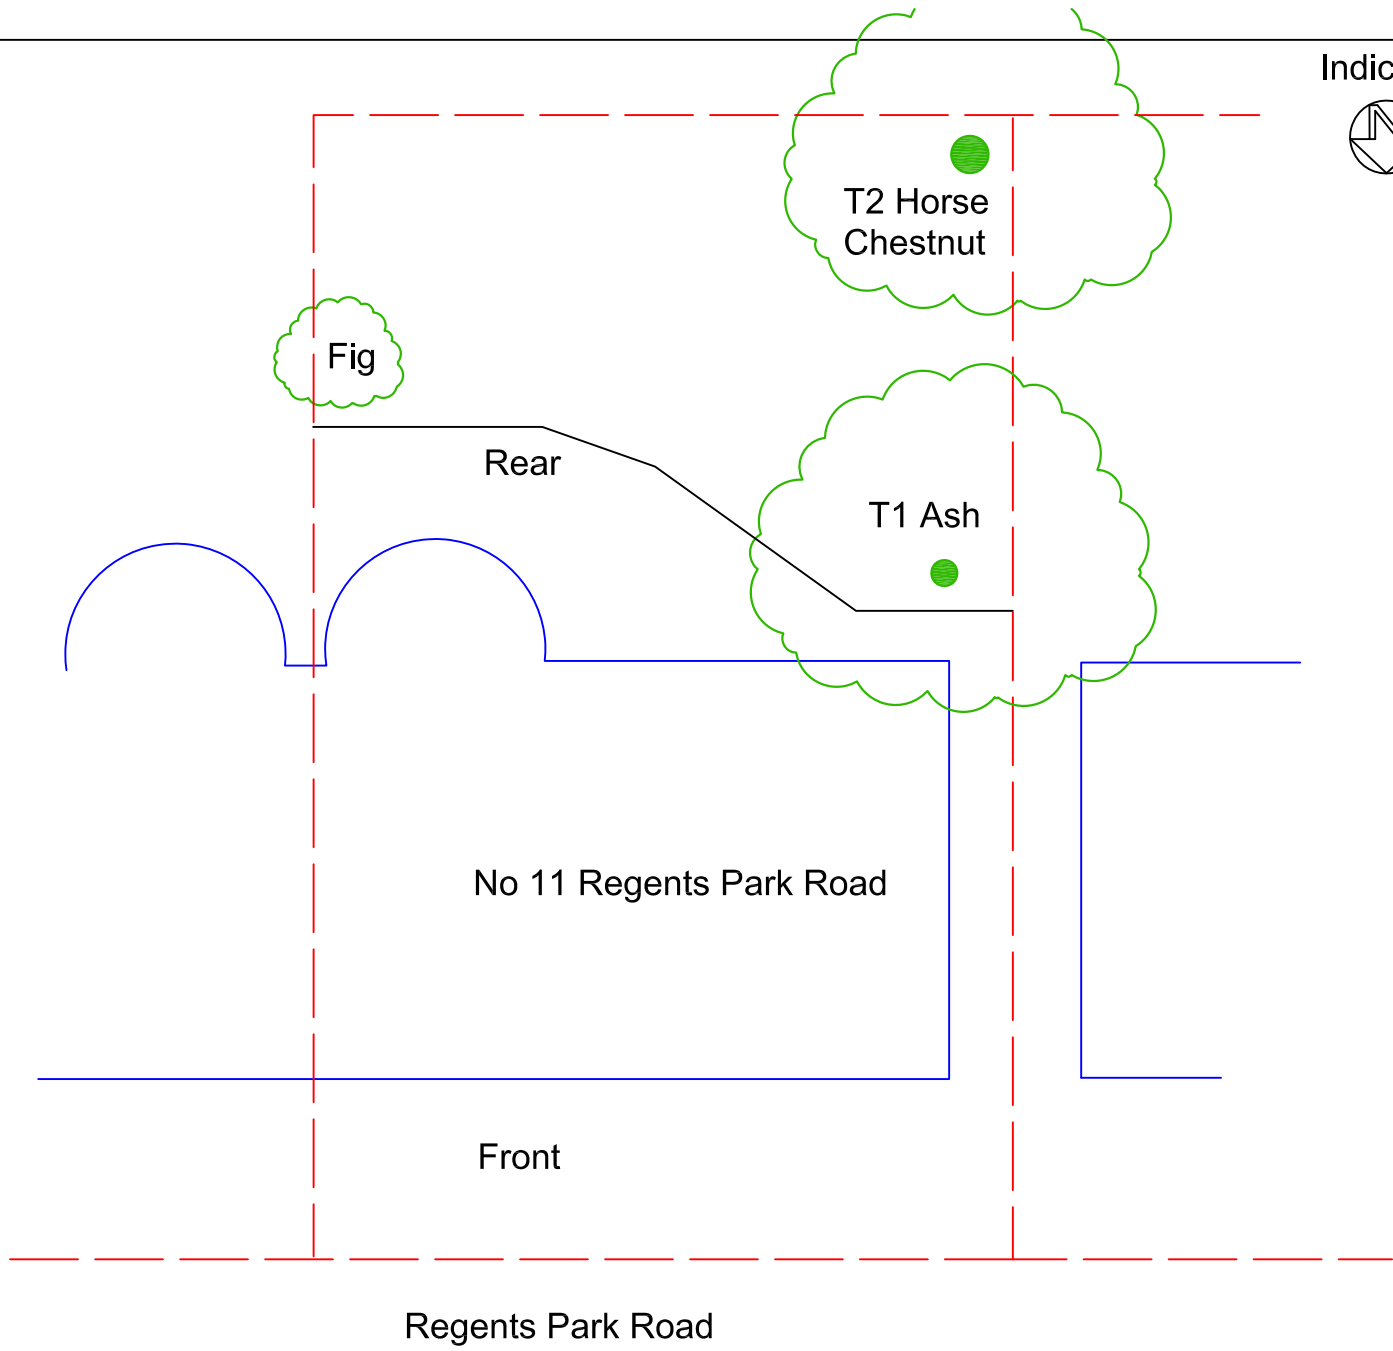
APPENDIX 1

| Tree Details | | | | | | | | |
|---|---|---|---|---|---|---|---|---|
| T1 Ash | 18m | 4m | 80cm | MV | M | LM | 3.5m | - |
| T2 Horse Chestnut | 17m | 5m | 60cm | Vig. | M | LH | 10m | - |

- 5.4 I note that the Ash T1 has been quite heavily reduced in size in the past and although re-growth has been vigorous, the tree canopy as a whole is sparse and appears moribund. There is evidence (old fruit bodies) of the wood-decay fungus *Inonotus hispidus*, common to Ash species having taken hold in the main branches and stems. This fungus can cause brittle fracture of branches or stems, which may have led to the heavy reduction work conducted in the past.

- 5.5 I note that some patio paving stones have lifted and, whilst I did not lift any slabs, it is highly likely that roots from the Ash tree have grown under the patio and dislodged the paving stones above. The roots will continue to cause this level of damage without directly removing roots or by removing the tree completely. The tree's trunk is very close to a low retaining wall and as the tree grows, pressure will be exerted laterally upon this wall. Pruning the canopy branches will have no remedial effect upon the tree's roots or the condition of the patio area or wall. Given the tree's proximity to the rear of the house and neighbouring property, the tree's suspect condition in terms of the decay fungus found and impact roots are likely to be having upon the lightly-loaded structures area, I recommend that this tree be removed completely.

- 5.6 The Horse Chestnut T2 is more remote from the rear of the house at 10m distance. However, I expect roots to have travelled this distance to absorb moisture from the soil surrounding the base of the rear elevation. The tree is mature and unlikely to increase significantly in height or spread in the future and so far as I am aware, there is no link between the tree and any structural defects within the property. There seems no reason to expect that this relationship will alter to the detriment of the building. It is reasonable, in spite of the low risk, to prune the tree in order to manage the tree comfortably into the typically modest rear garden space, which is currently significantly over-hung by the tree. I have set out my recommendations in Appendix 2.

| Tree No. | Tree Name (English) | Work Specification | Timescale/ Rotation | Cost Guide (where appropriate) |
|---|---|--|---|---|
| T1 | Ash | Fell to ground level | Within 12 months | Upper C |
| T2 | Horse Chestnut | Crown thin by 25%; Crown lift to 3.0m | Within 12 months | Mid B |
