Property Services - Estates,  
Royal Free London - NHS Foundation Trust,  
Pond Street,  
London,  
NW3 2QG

Date: 22 January 2017

My ref 16/103

### **Tree root damage to Fleet Road Boundary Wall**

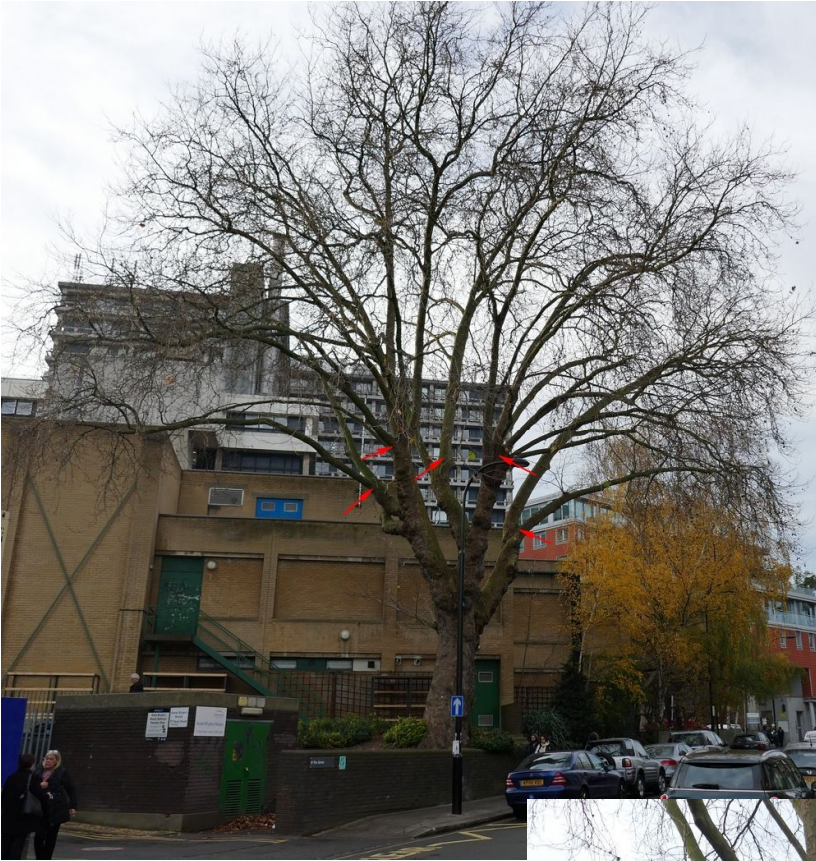
1) view from across Fleet Road. Red arrows indicate the earlier pollarding points

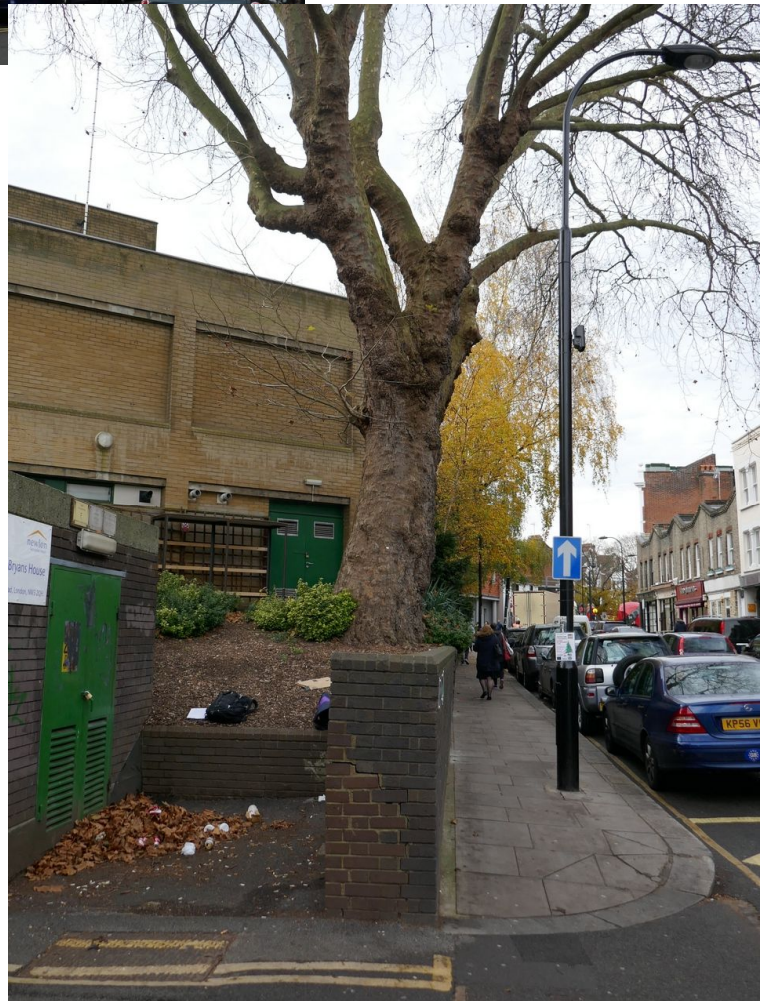
4. The wall forms the boundary between the hospital grounds and the highway and now leans out over the footway by 80 - 90mm at the top. Next to the tree it has a vertical crack about 40mm wide at the top where sides are offset by about 20mm. Mr Wareham's view is that the wall might not have been built to support the retained earth and tree and comments that it..... *"is currently in an unsafe condition and could collapse without warning which could result in serious injury to persons using the public footpath or vehicles on the highway."*

2) View along the wall showing lean in the wall and the tree's trunk and the crown overhang which would impede piling equipment.

24. Therefore the only viable option is to remove the tree. There would be a loss of public amenity, but there are other trees nearby that would mitigate the immediate effect and ample space farther back from the wall where a new tree would mature to make a comparable or better contribution to the street scene without the problems associated with this one.
