# Middlesex Hospital Annex

## Historic Building Structural Engineering Report

Document name	Ref	Prepared for	Prepared by	Date	Reviewed by
Historic Building Structural Engineering Report	MHA-ACM-00-REP-S-0001	UCLH Charity	Daniel Wallington	13/09/16	Jack Brunton

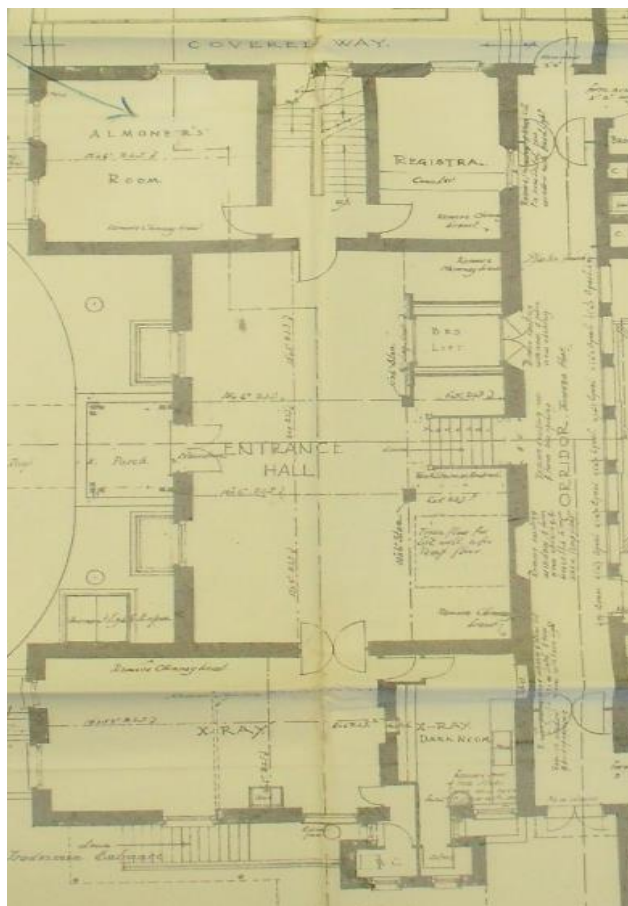
**Historic Record Drawing**

Extract from record ground floor drawing, dated May 1924

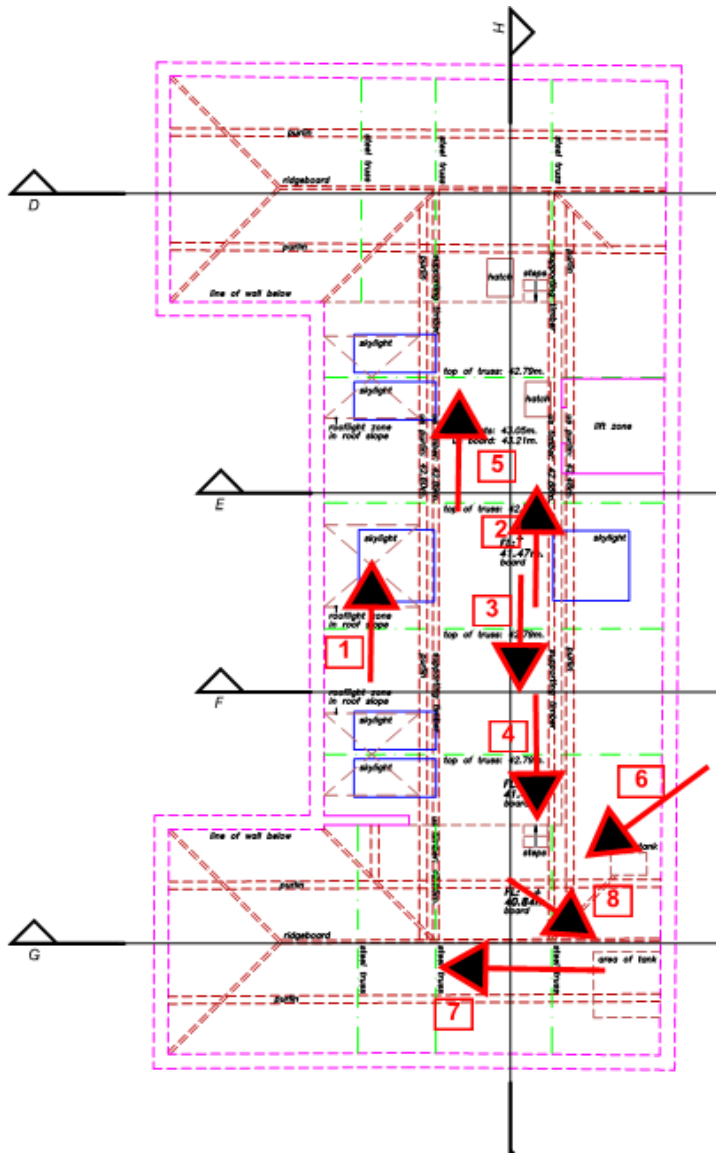
*Roof Void Plan.*

Extract from Greenhatch Group Survey drawing  
 13514b\_06\_P dated 23.9.16 showing the key to photographs

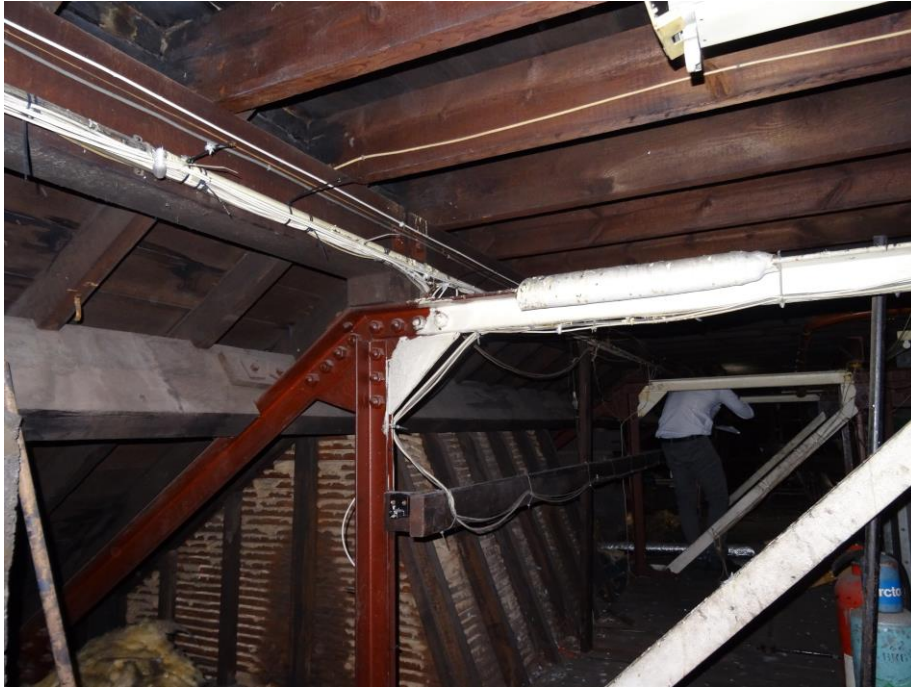
Photo 1

The roof trusses and timbers appeared dry and in sound condition.
