Design Access Statement

61 Neal St

34012/L/001/SH/lw

RE: STRUCTURAL INSPECTION OF TIMBER STAIRCASE AT 61 NEALE ST, LONDON, WC2H 9PJ

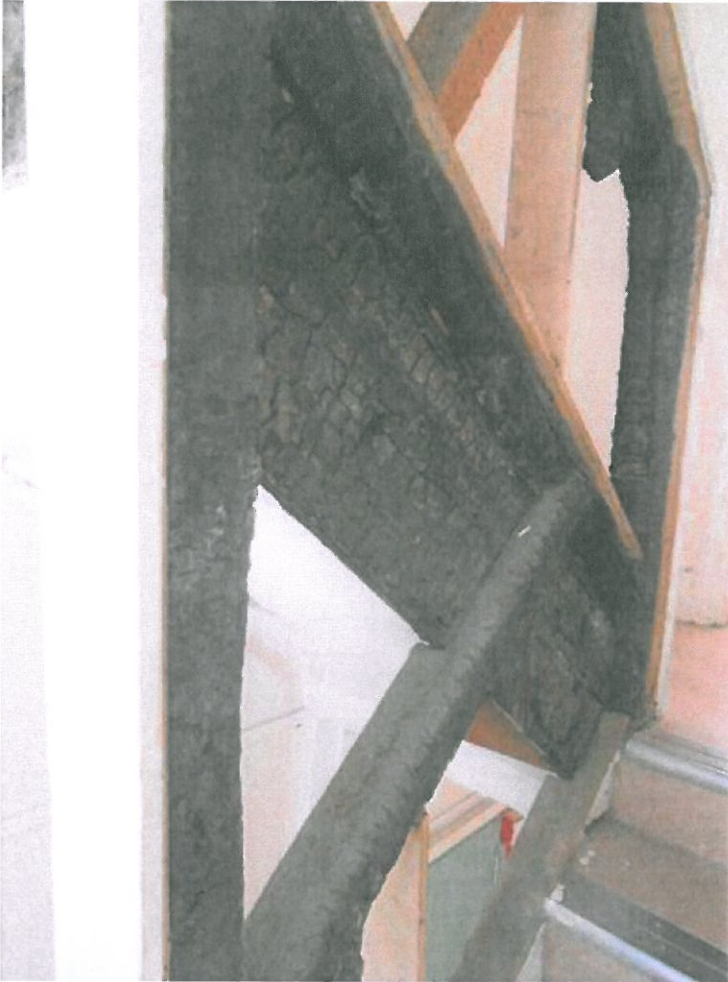
Charred Stringers and newel post

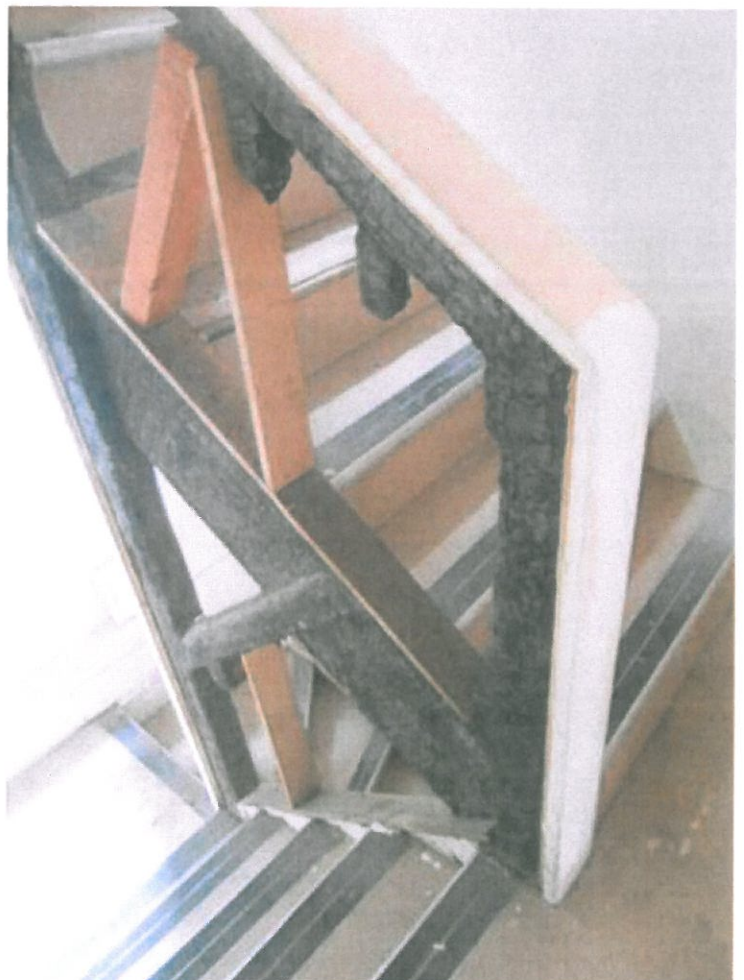
Loss of stair spindles where they have burnt out and a loss of cross section of the hand rail.

Upper stair flight showing burnt oak stair spindles
and charred newel post and stringer

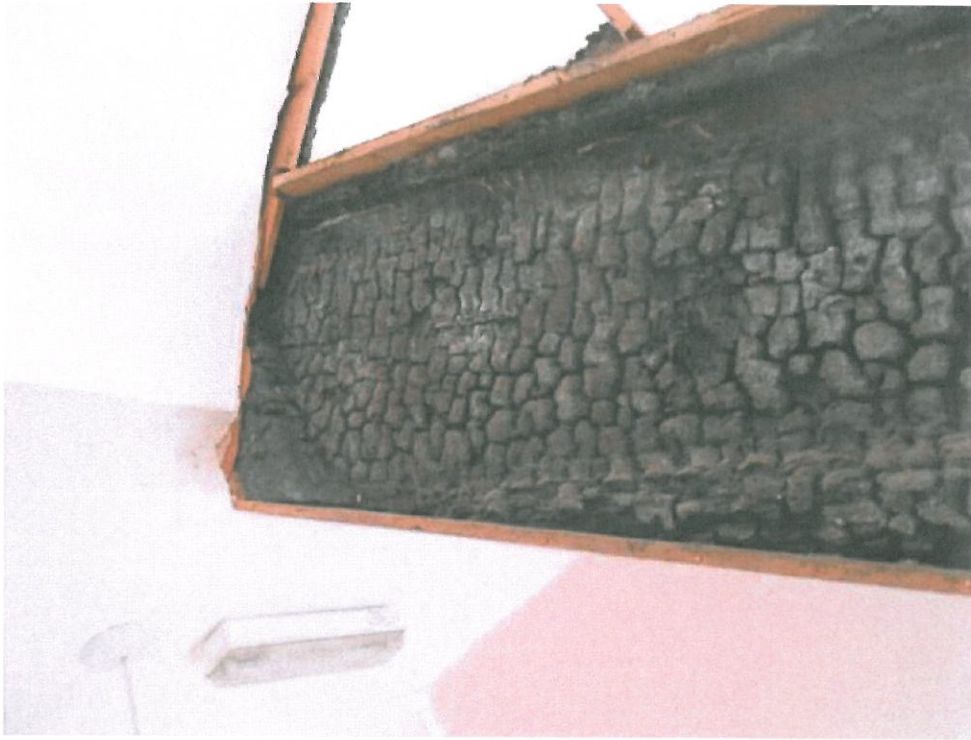
Extensive charring of internal stringer

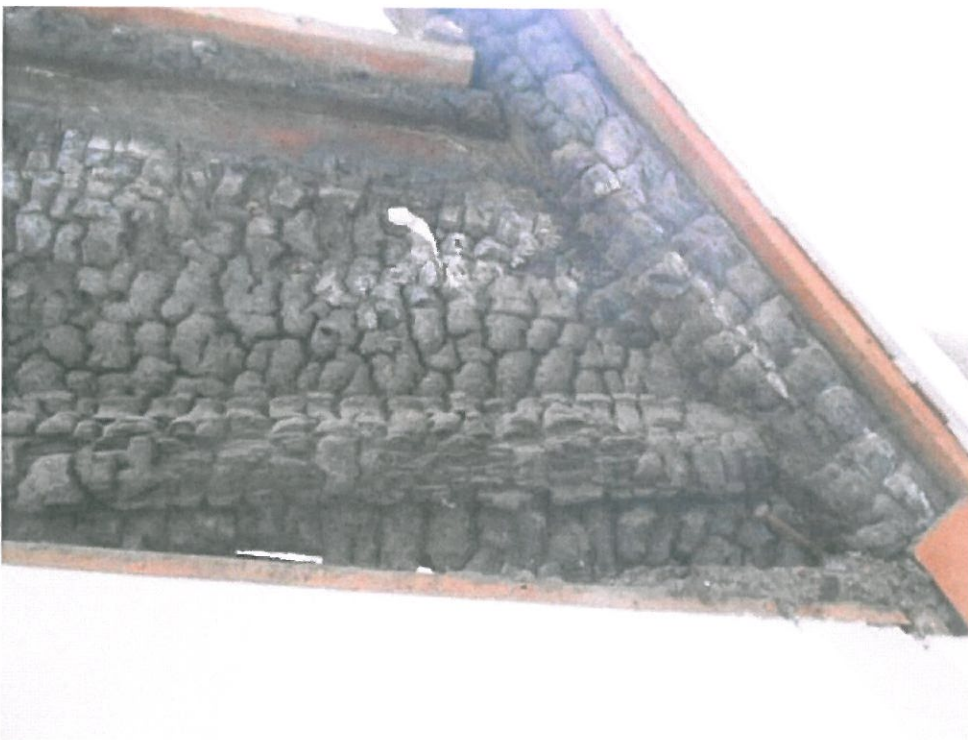
Extensive charring at stringer to newell post junction

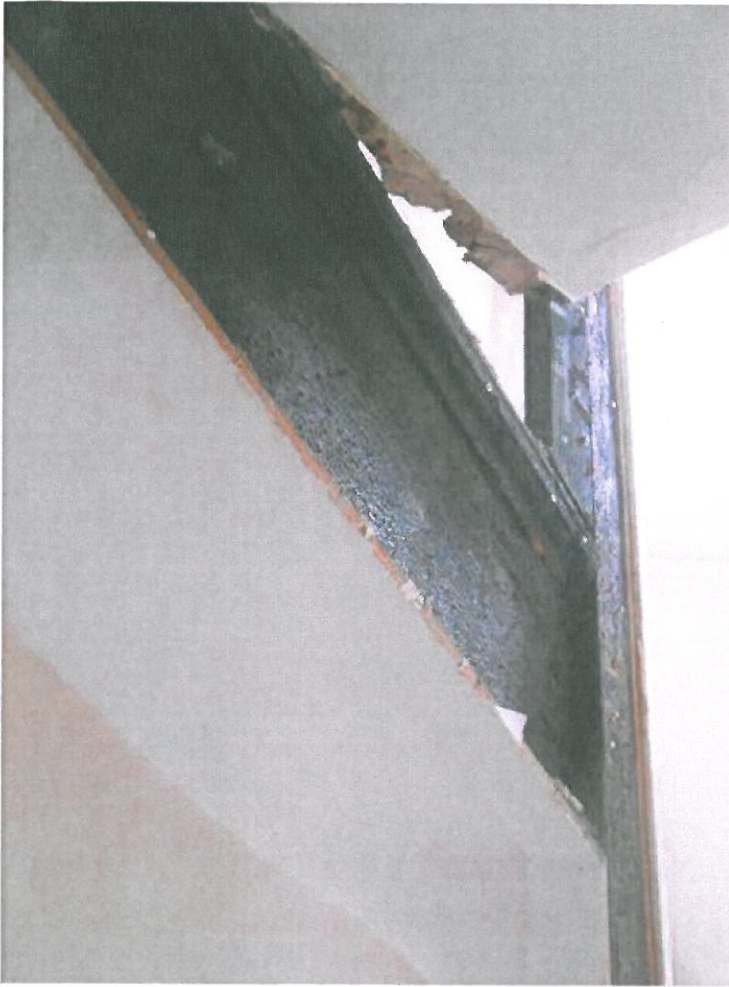
Upper stringer and newell post with light
surface charring
