## SJ Stephens Associates

3<sup>rd</sup> November 2016

### **Re: Beech tree by tennis court**

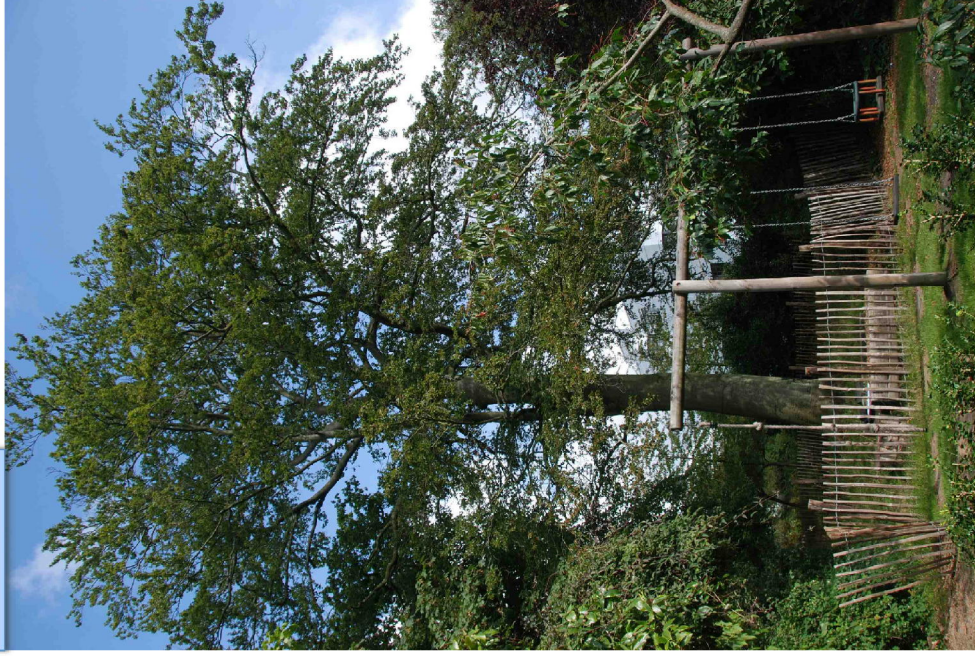
10-09-2014

The vigour of the tree has significantly deteriorated since my previous inspections in September 2014 and October 2015. Some photos are attached to aid comparison. The change is most evident in the photos taken from the lawn in 2015 and 2016, only a few days apart. The 2015 photo was taken after the crown reduction had been completed earlier in 2015. The decrease in crown density is marked and the average leaf size is much smaller than, for example, the mature beech growing in the adjacent site the other side of West Hill Court. This is almost certainly caused by a factor affecting the ability of the roots to take up nutrients and moisture. Disfunctional roots, as well as affecting nutrient uptake, are also likely to affect the stability of the tree.

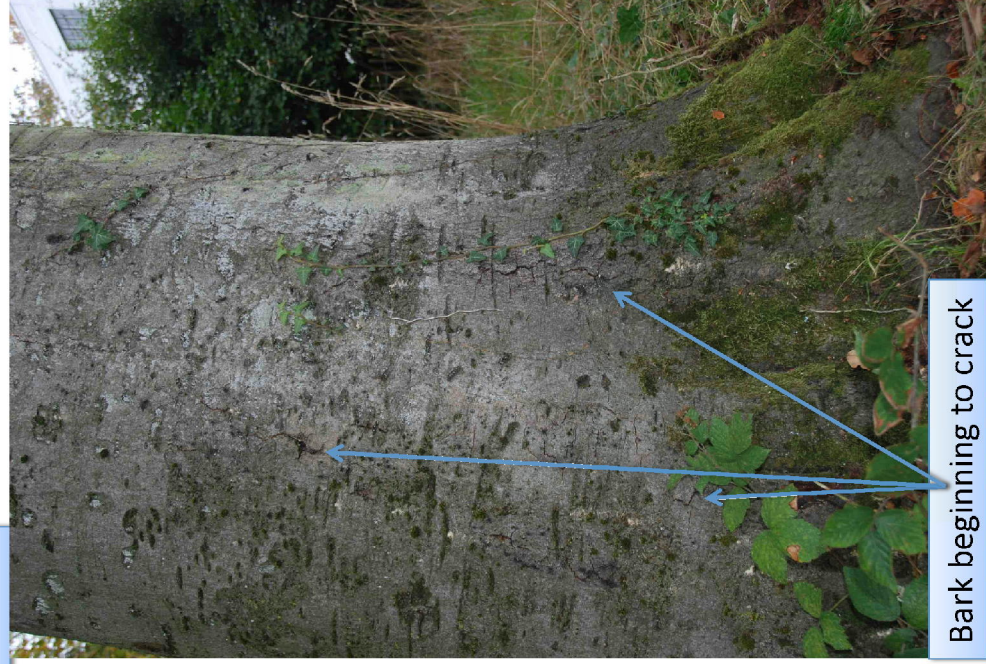
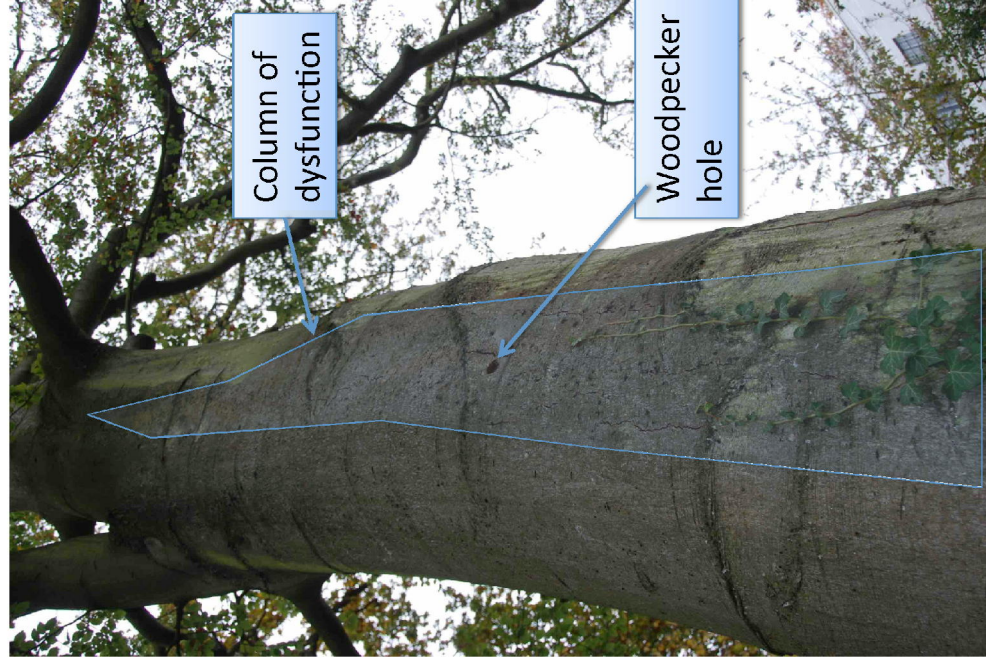
01-11-2016

Some bark cracking was observed around approximately 15% of the basal circumference to the south-east, tapering up to approximately 3.5m. This is shown in the photos attached.

Although this tree has been a prominent landscape feature in the locality, its amenity value is reducing as its vigour deteriorates. I suggest that the time has come to remove the tree and plant a replacement. To do otherwise is to put off the inevitable and subject residents to an unnecessary risk.
