# Cooper Associates

CA3559.01

**1 Marquis Road - 22a Canteloves Road, London NW1.**

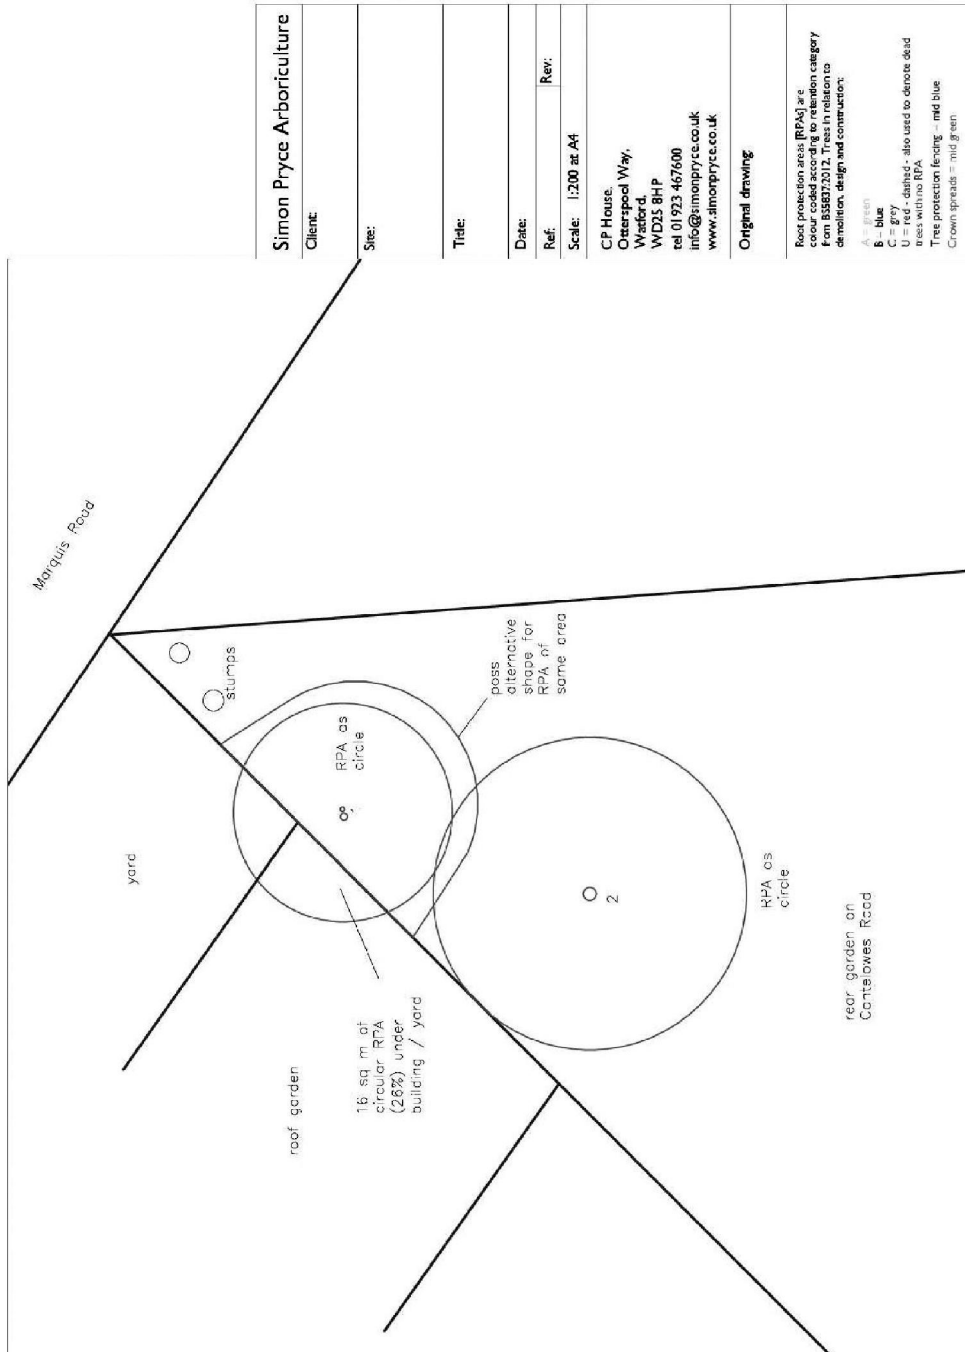
These are shown on your Arboriculturalist's site plan, which we attach at our fig one. We estimate the two sycamore trees to be 1.8 m and 6.4 m away from your single story building and that they are both in excess of 15 m high.

**Fig 1:**  
**Basic plan layout showing your property and the adjacent trees.**

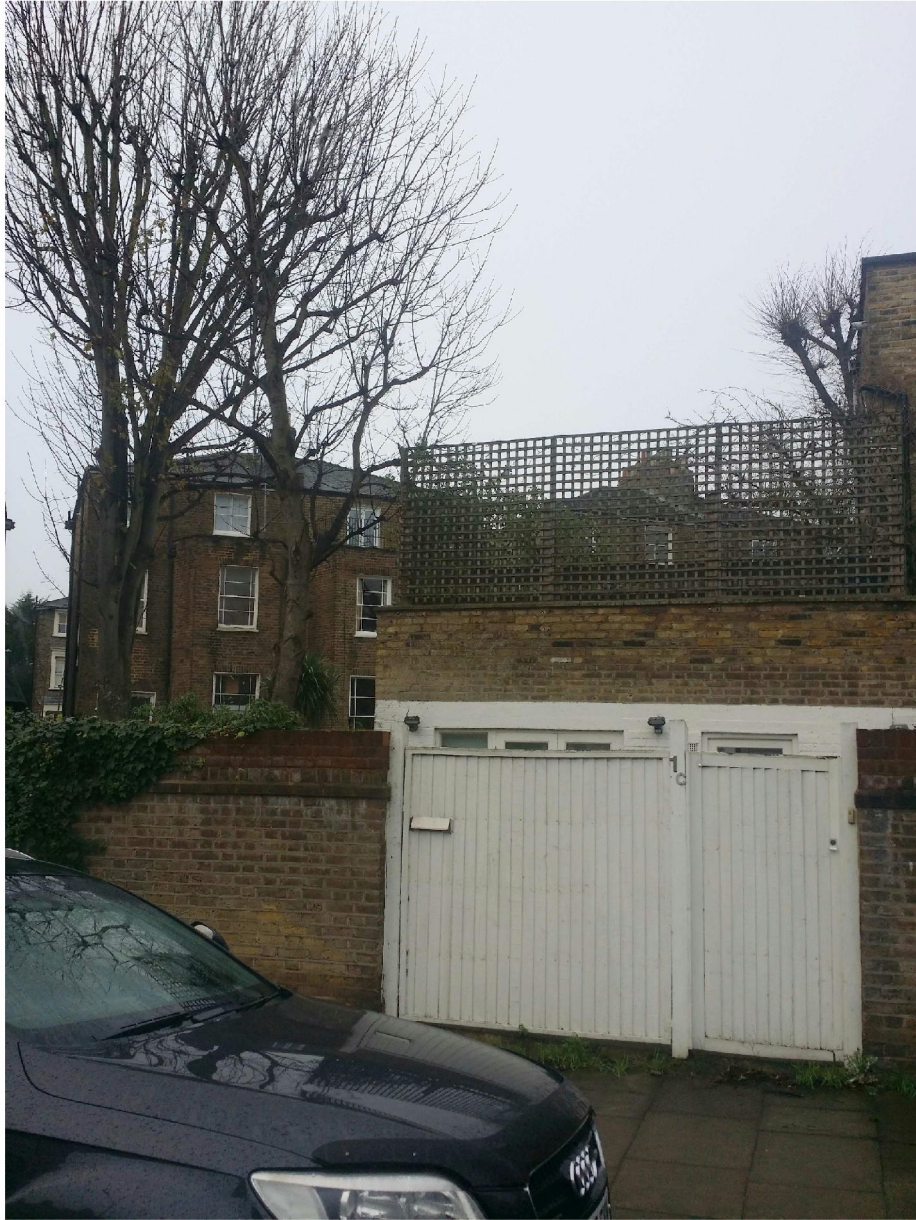
**Photo one: shows property from the road, with trees to the left.**

In order to reduce this problem, we recommend that you have only the tree nearest your property taken down, thus limiting the risk of clay heave to your property.

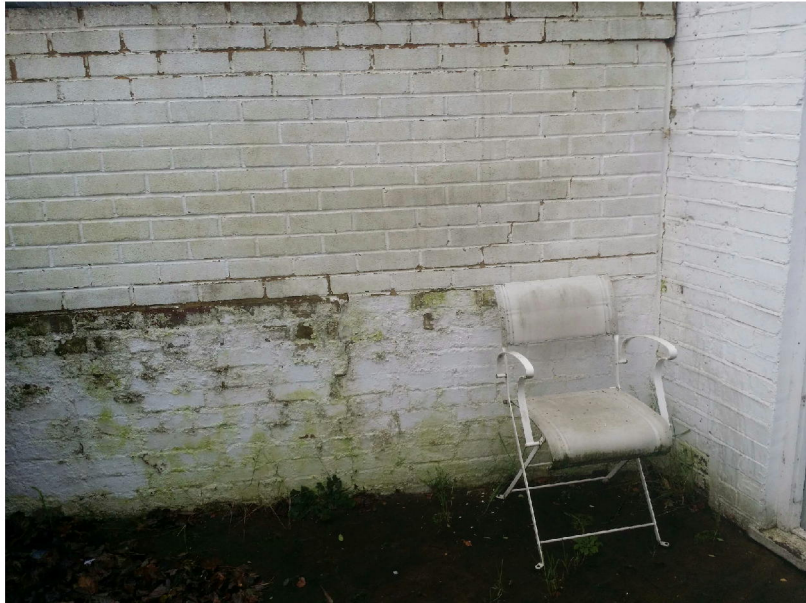
Although the boundary wall is 225 mm wide, below the neighbours ground level (approximately 800 millimetres higher than your front ground level), it is only a half brick or 100 mm wide above the higher ground level. This brickwork is badly cracked in places and is potentially unsafe, in particular if lent against.

**Photo two: shows left hand boundary wall with cracking. Lower section is 225 mm thick brickwork; the upper more modern section is 100 mm thick.**

We recommend that the long-term solution would be to have the nearest tree taken down and the old tree stump that is pushing on the boundary wall, removed; however this action could in itself cause damage.

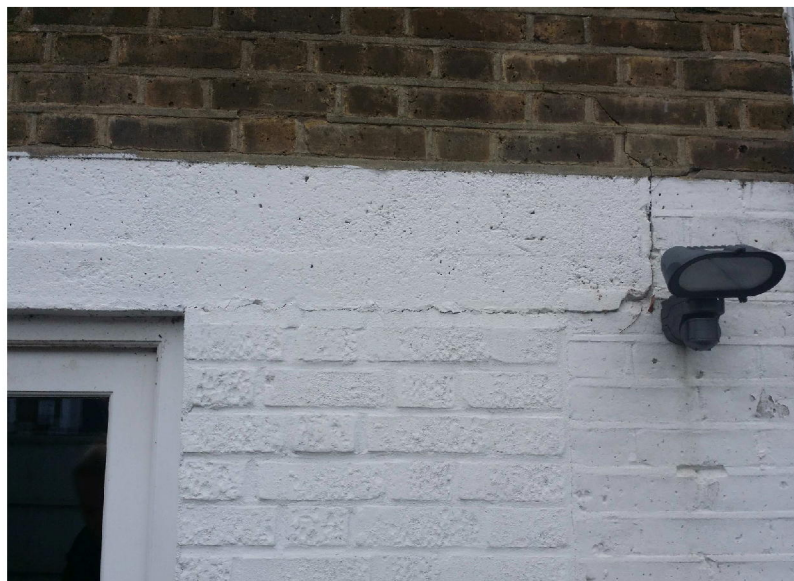
As the various photos attached to this report show, the front elevation of the building has suffered from foundation movement. Cracking can be seen around the concrete lintel over the wide opening, which would originally have been the entrance to the garage. The boundary garden wall between the two properties has movement cracks.

**Photo three: shows cracking around the right-hand bearing of the main lintel.**

Should you become aware that either of these problems is occurring, you should have the cracking made good, either by

injecting a sealant or by injecting an epoxy resin into the crack, to tie the brickwork together.

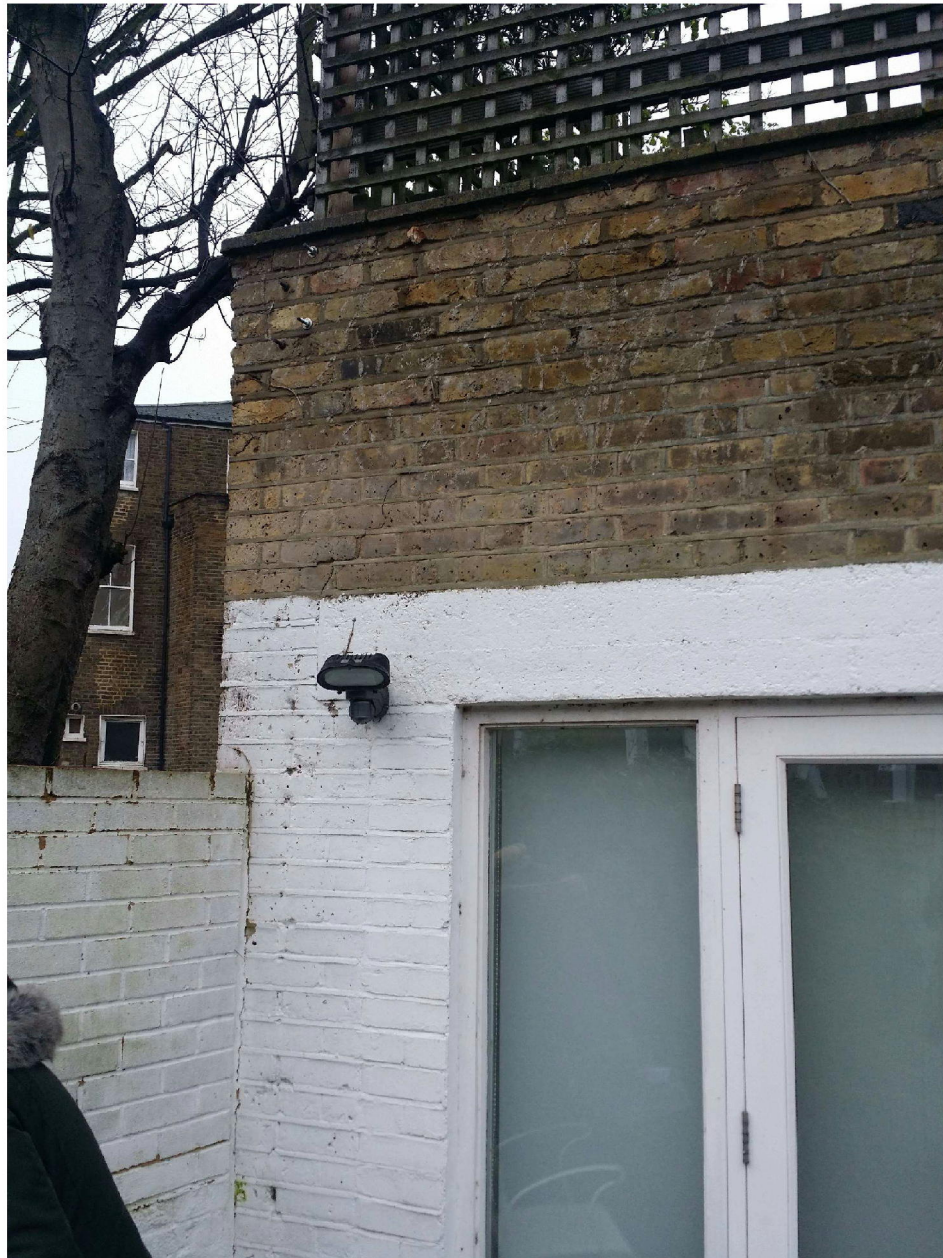
**Photo four, shows diagonal cracking above the left-hand bearing of the lintel.**
