**STATEMENT OF HERITAGE SIGNIFICANCE
10 REGENT'S PARK TERRACE, LONDON NW1**

**For
Mr Godeau & Ms Gastaldo
December 2016**

G R Bennett BA MA DipTP IHBC

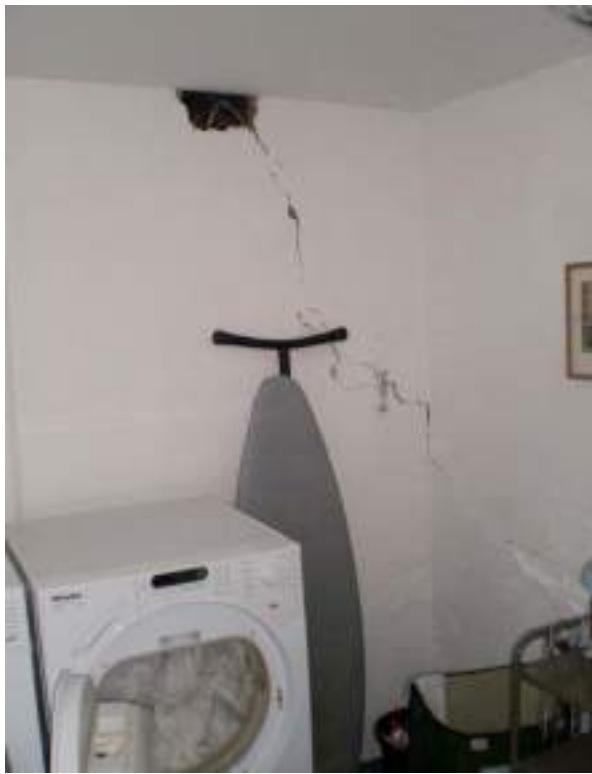
Rear wing, basement. Crack in rear and south wall.

- 7.1 A condition survey or structural survey have not been carried out by Studio Astragal Ltd and what follows does not purport to be these and we do not accept any liability for any errors or omissions. In carrying out the study of the building’s architectural and historic character and the assessment of its heritage significance it was noted that whilst the property appears to be generally well-maintained and good condition, some defects were observed. Structural cracks were noted in several places in the rear wing at basement level, ground level and in the stone coping beneath the first floor conservatory. These may already have been the subject of further investigations and a report by a structural surveyor to identify the causes and to propose suitable remedies. However, if this has not been done, we consider it advisable that this is carried out as soon as possible by a suitably qualified and experienced structural surveyor.

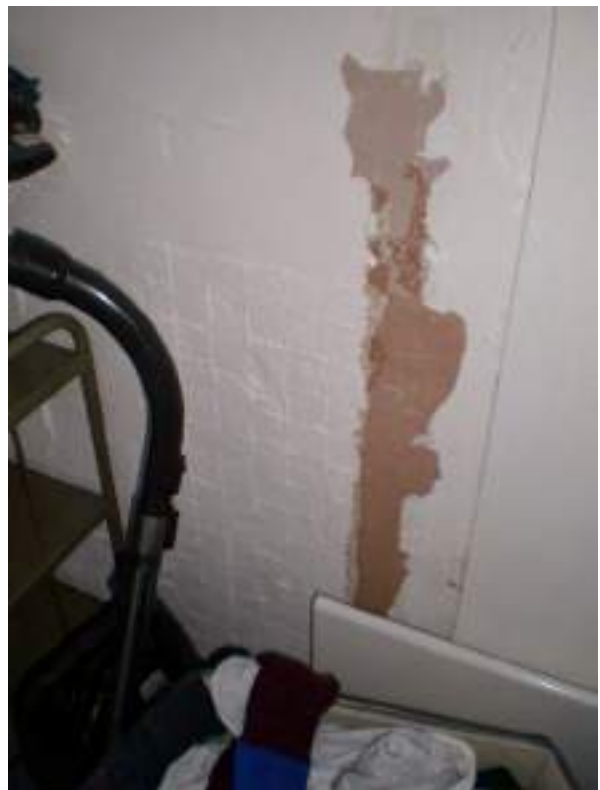
Rear wing, basement level. Defect in plaster.

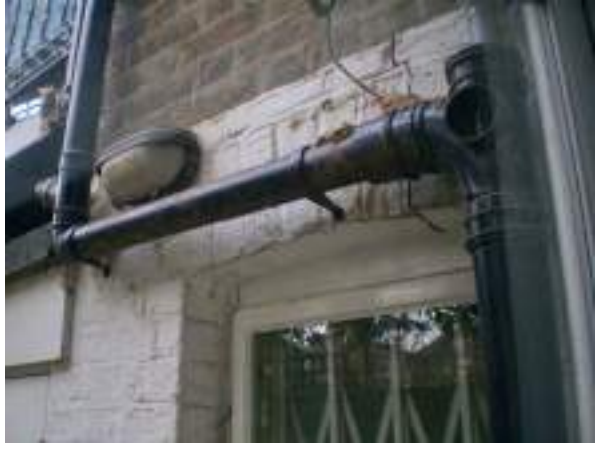
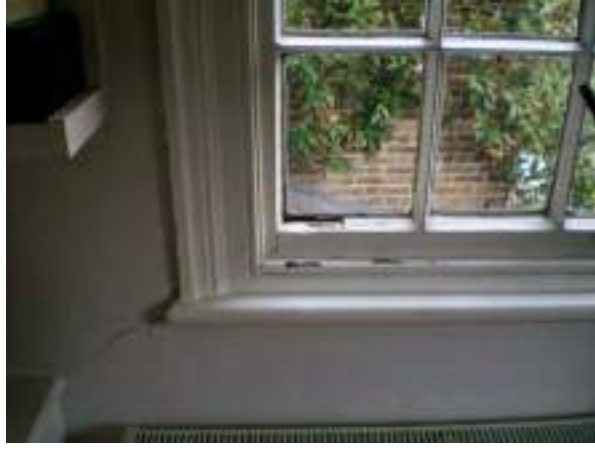
<p>Rear wing, basement level. Crack in north wall above window.</p>	<p>Rear wing, ground floor level. Crack in north wall.</p>

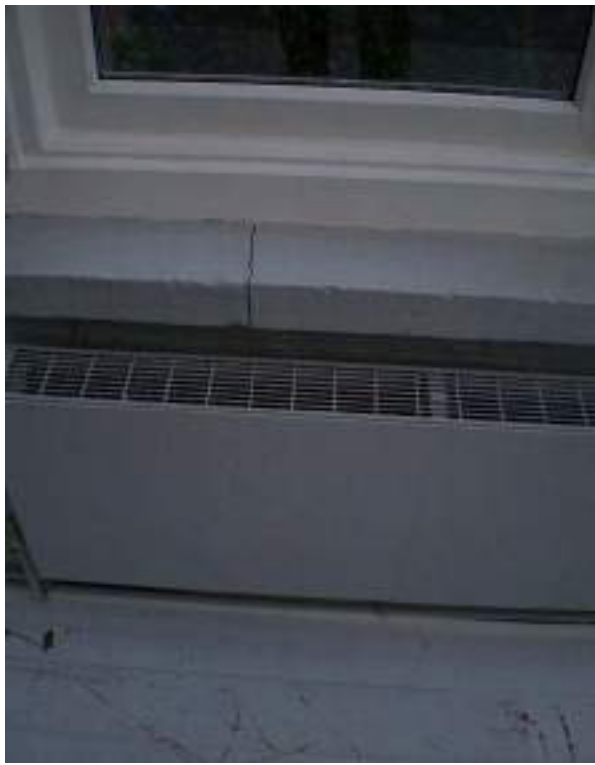
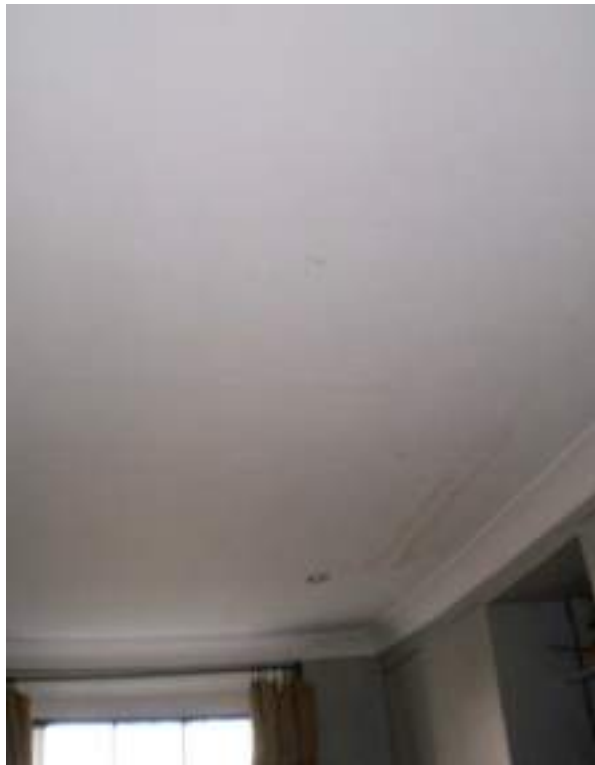
- 7.3 Water stains were also observed on the ceiling of the third floor north rear room and it is recommended that this also be investigated by a suitably qualified and experienced surveyor.

<p>Rear wing Conservatory at first floor half - landing level. Crack in coping stone below conservatory timber framing on north wall.</p>	<p>Third floor rear north room. Water stain on ceiling.</p>

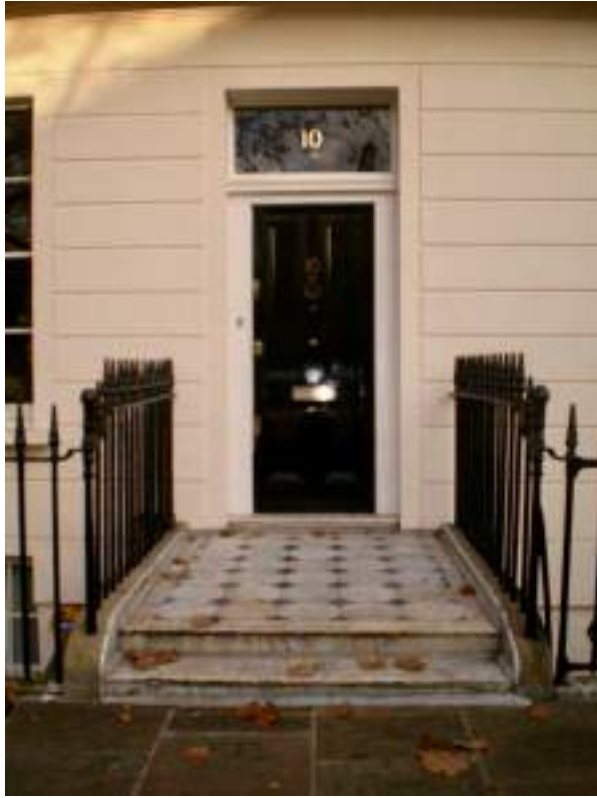
No. 10 Four-panelled door with ogee bolection mouldings - High Significance. Steps and landing clad in marble & marble tiles - No Significance. Harmful modern alteration.

- On the pavement vaults' wall, rerun the white plastic plume pipe and the condensate pipes internally to reduce their visual impact and paint their outlets to match the wall.
- Remove the marble cladding and tiling from the front entrance steps and landing and reinstate the steps in Portland stone and the landing in York stone using large slabs to the original design.
- Remove the basement build-out of the kitchen area under the front entrance bridge and reinstate the wall in line with the bridge. Replace the front basement entrance door with an appropriately detailed four-panelled door with flush panels with butt and beaded edges externally and flat recessed panels with no mouldings internally.

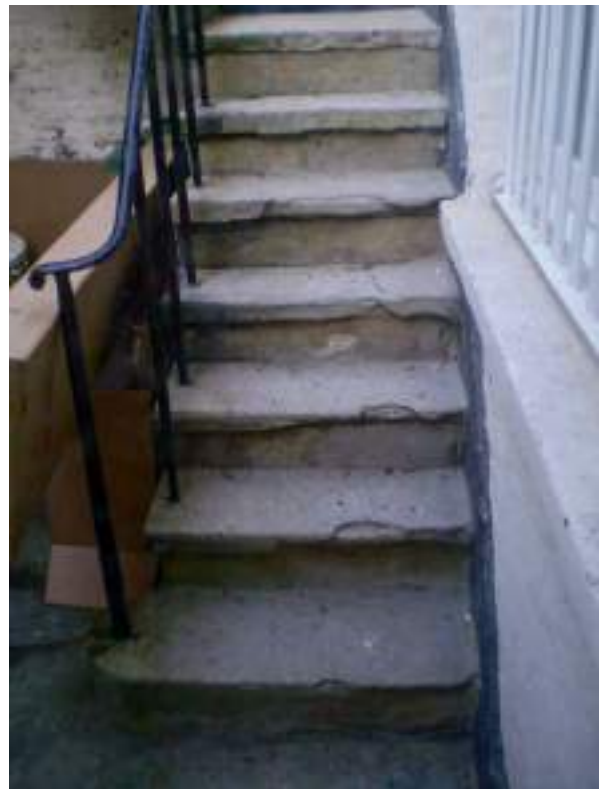
- 5.12 The steps down into the basement front lightwell are of York stone, but have been patch repaired in cement. They have plain cast iron bannisters and handrails.

Front Basement lightwell. Original York stone steps and railings, steps patched with cement. High Significance.

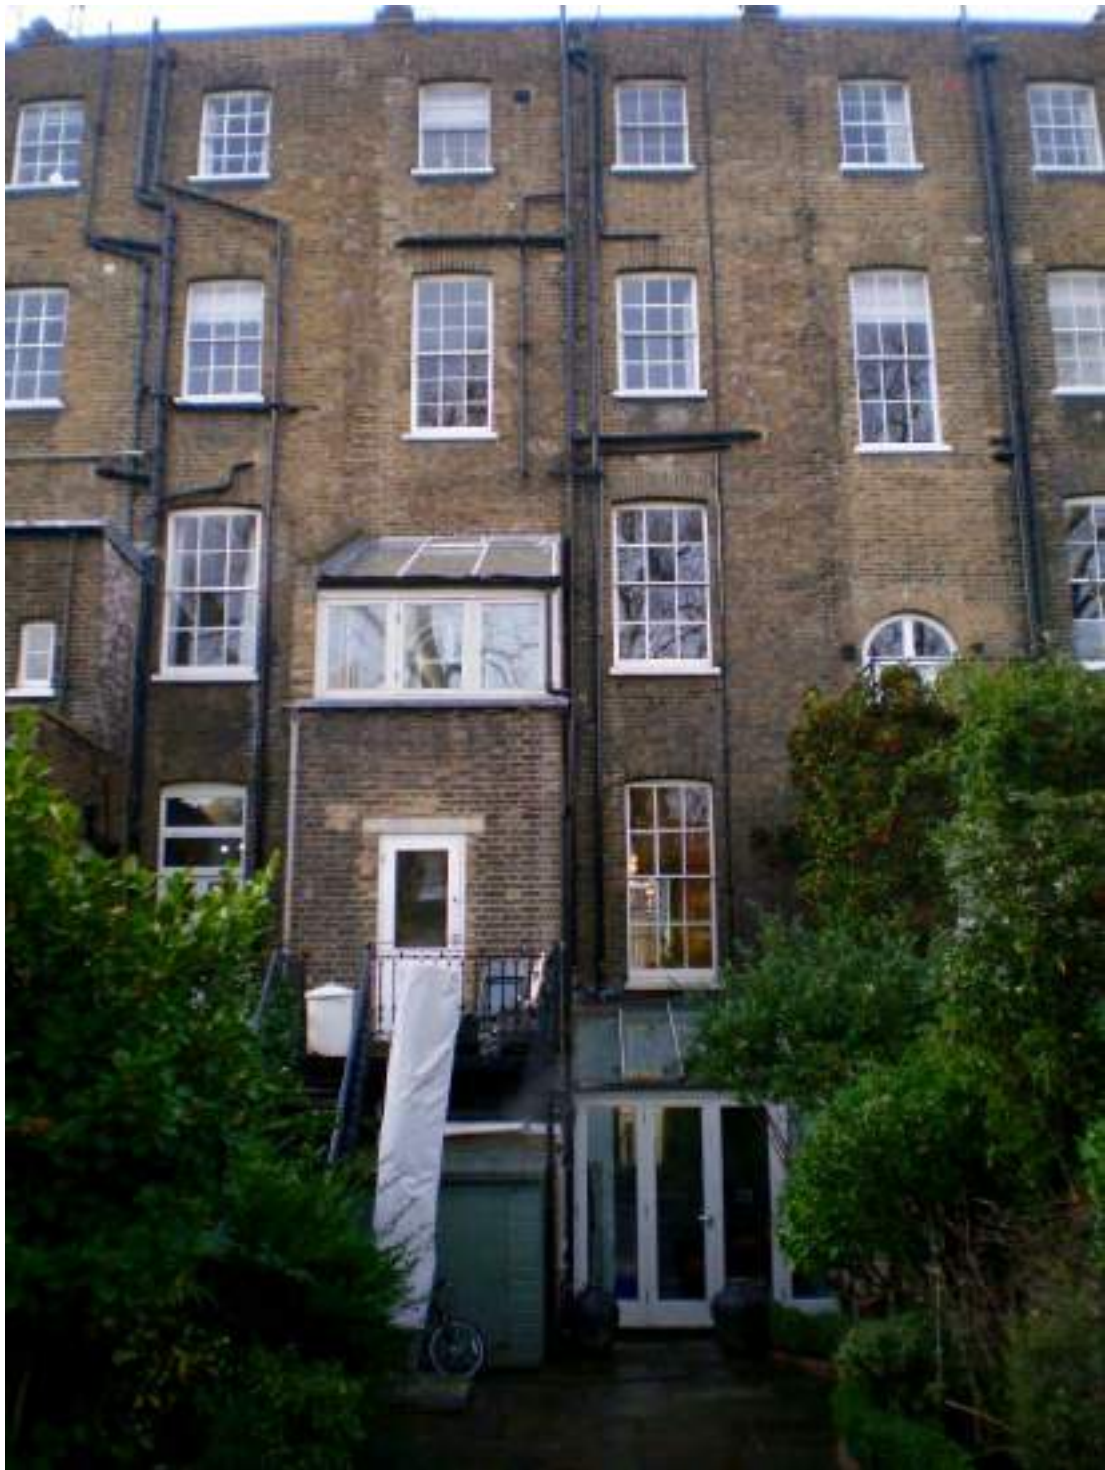
Rear Elevation. Overall, Medium Significance. Untidy pipework - harmful alteration.

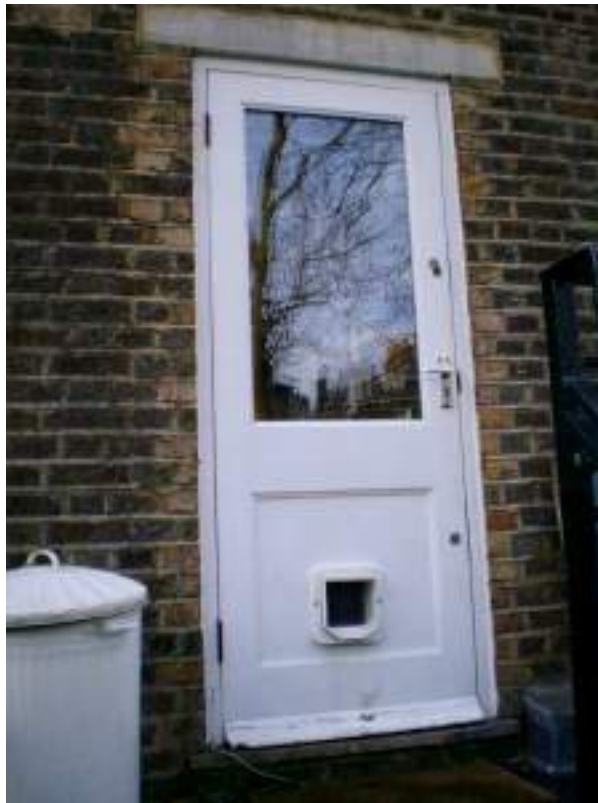
Modern door and concrete lintel. No Significance. Harmful modern alterations.

- Remove the concrete lintel above the rear wing's ground floor door and construct a segmental curved brick on end arch.
- Replace the single-storey rear extension's modern flush door with a traditional boarded door with butt and beaded tongue and grooved boarding.

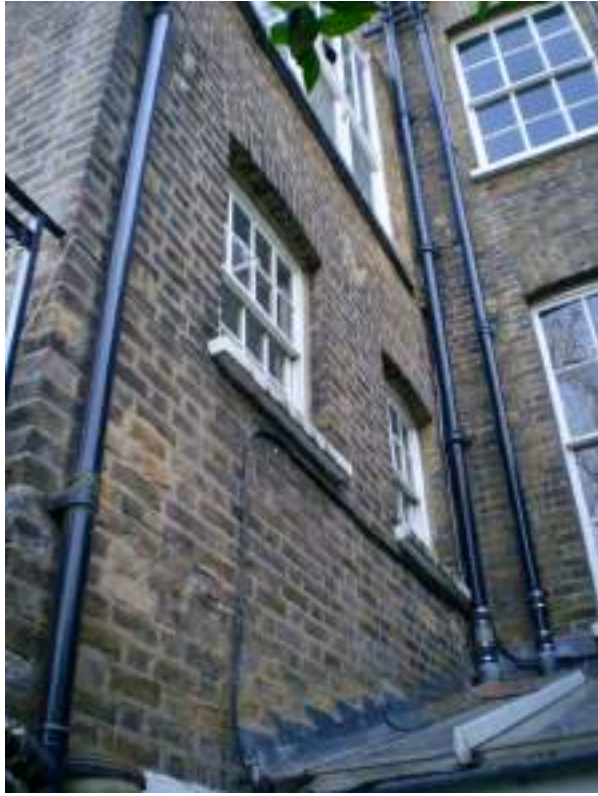
North flank wall of rear wing. Medium Significance.

- Replace the window in the north flank wall of the rear wing at basement level with a more appropriate one with glazing bar divisions to match the building's original fenestration.

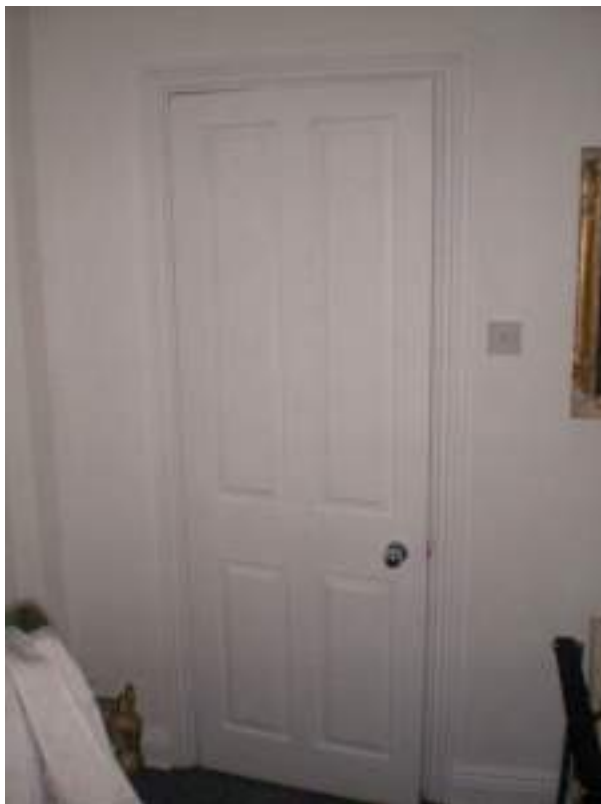
Basement front room. Modern four-panelled raised and fielded panelled door. No Significance. Harmfull modern alteration.

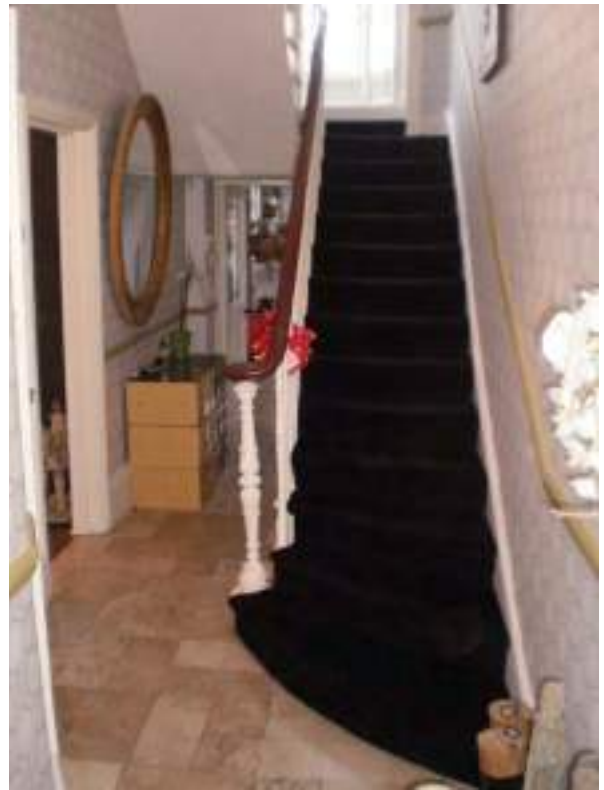
The staircase and corridor. Original plan form. High Significance. Stone floor tiling - harmful modern alteration.

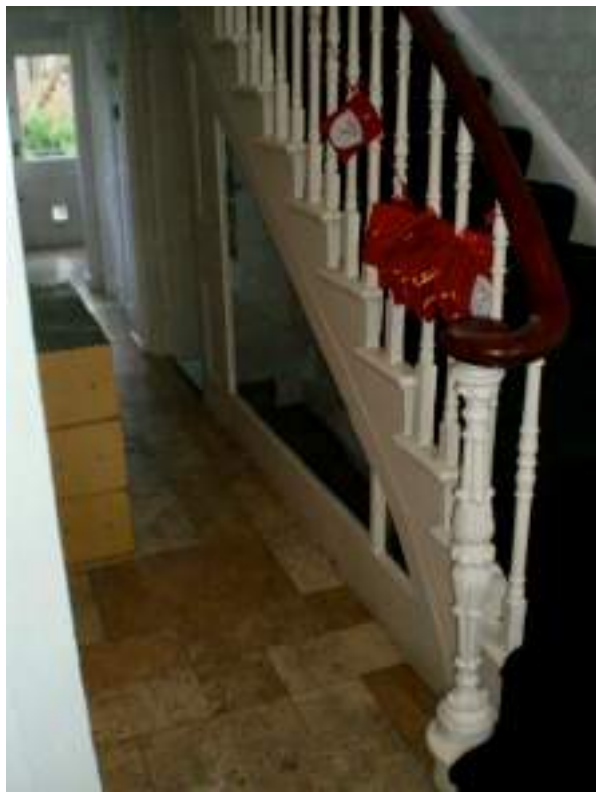
floor, where it is supported on an ornate cast iron newel post. The bannister rails are turned. Originally there was a panelled partition beneath the stairs enclosing the stairs to the basement, but the panels have been replaced with glass. This is a harmful modern alteration. Notwithstanding this alteration the stairs' heritage significance is High.

Ground floor stair. Original feature - High Significance. Panelling to underside removed and replaced with glass - Harmful modern alteration.

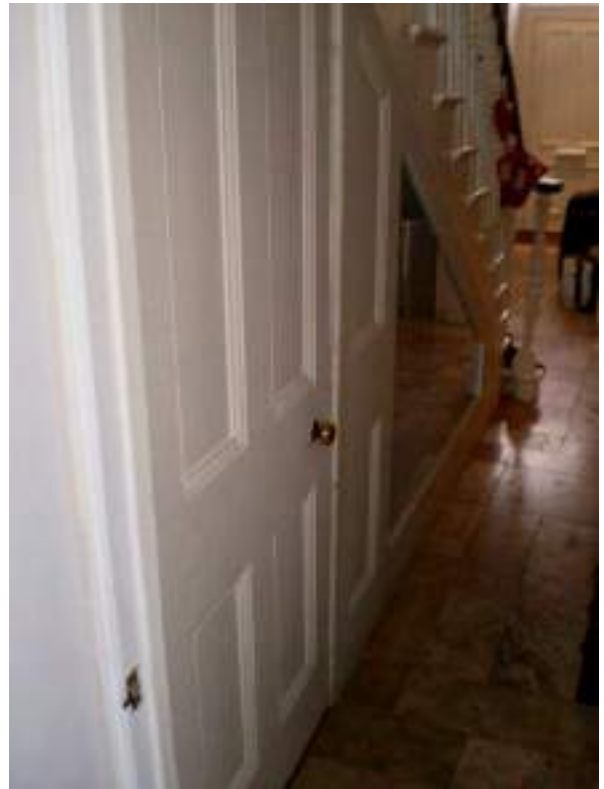
Ground Floor staircase compartment. Original door to basement stairs and surviving panelled partition - High Significance. Glazing inserted and panelling removed - harmful modern alteration.

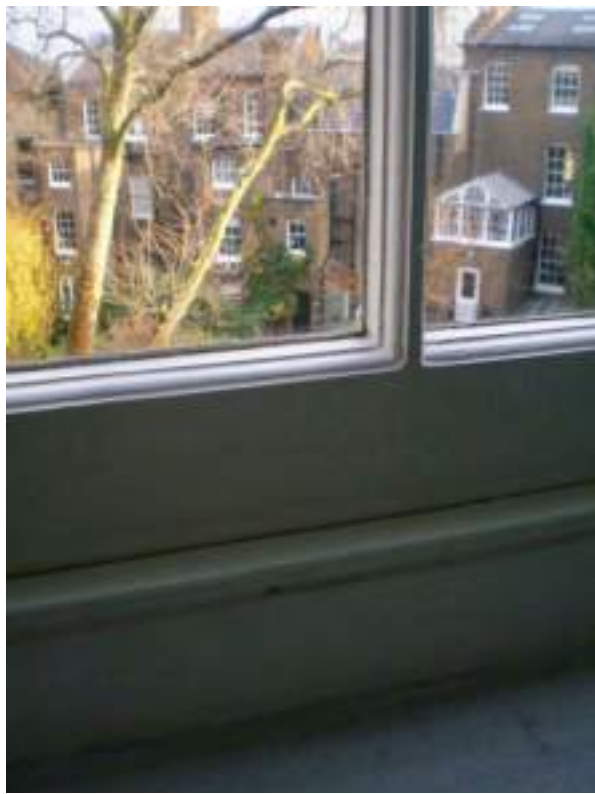
Second mezzanine level stair window. Modern replacement. Sash frame and glazing bar ovolo moulding does not match originals- No Significance. - Low architectural merit.

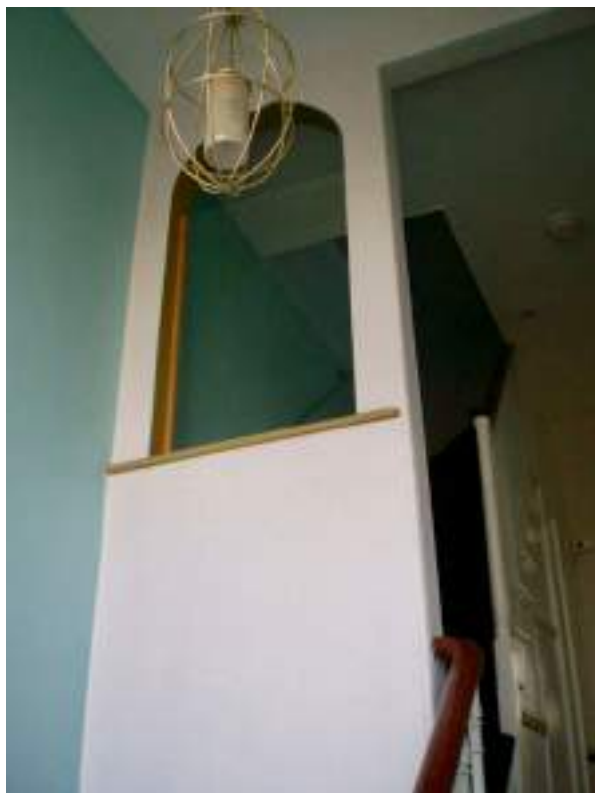
Partition between principal staircase and secondary stairs. Original Feature - High Significance. Arched opening a harmful modern alteration.

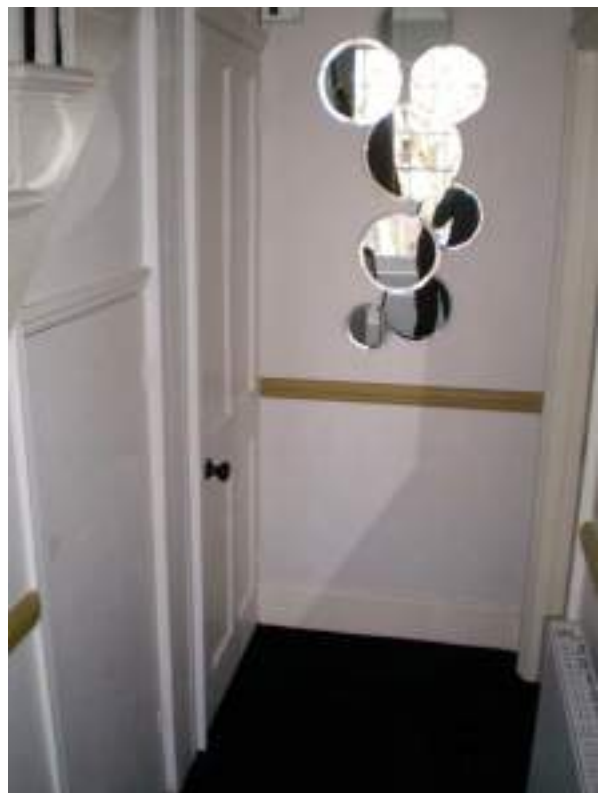
Second floor landing. Airing cupboard and altered partition wall and door position of front room. Harmful Modern alteration.

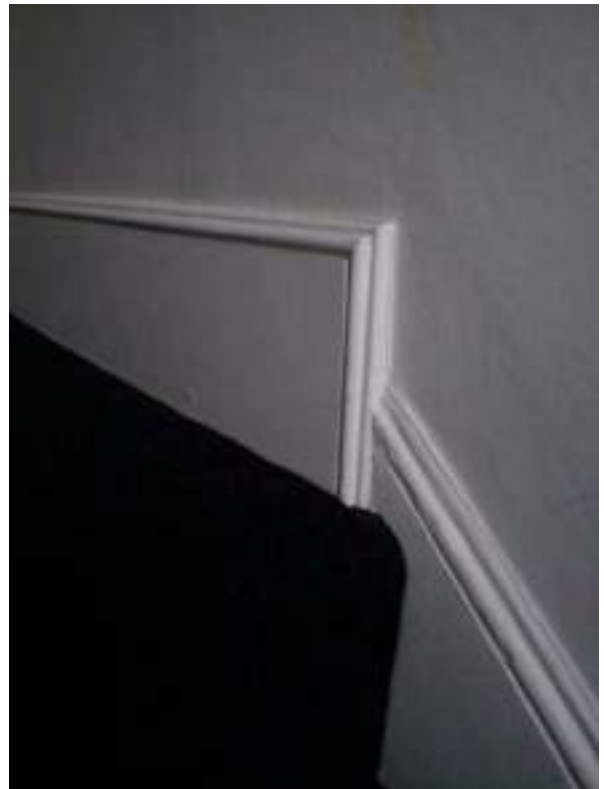
Detail of second floor stair's original skirting board - High Significance, and second floor landing's modern skirting board not an accurate match - No Significance.

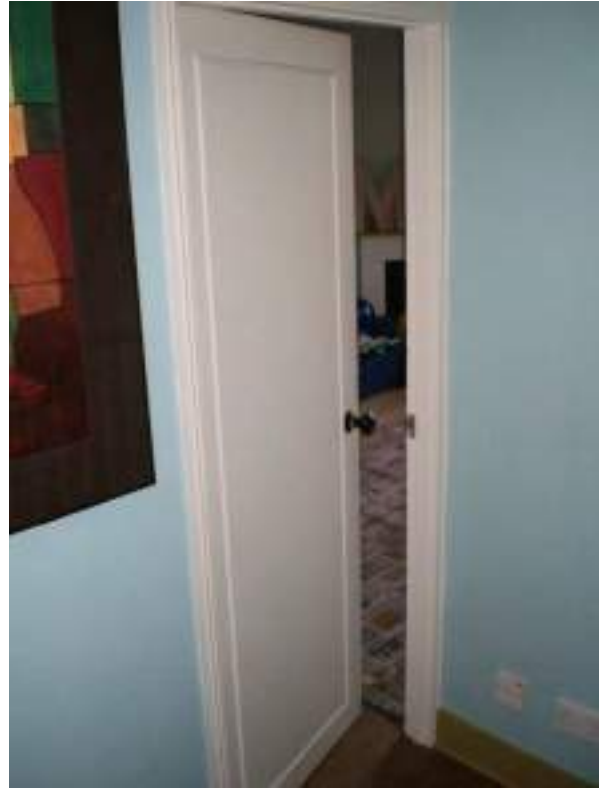
Third floor landing - Non-original door and partition walls - Harmful modern alterations.

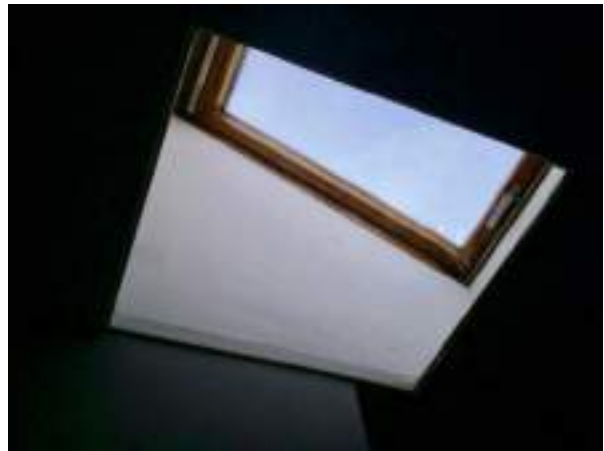
Modern replacement rooflight above third floor landing - Harmful modern alteration.

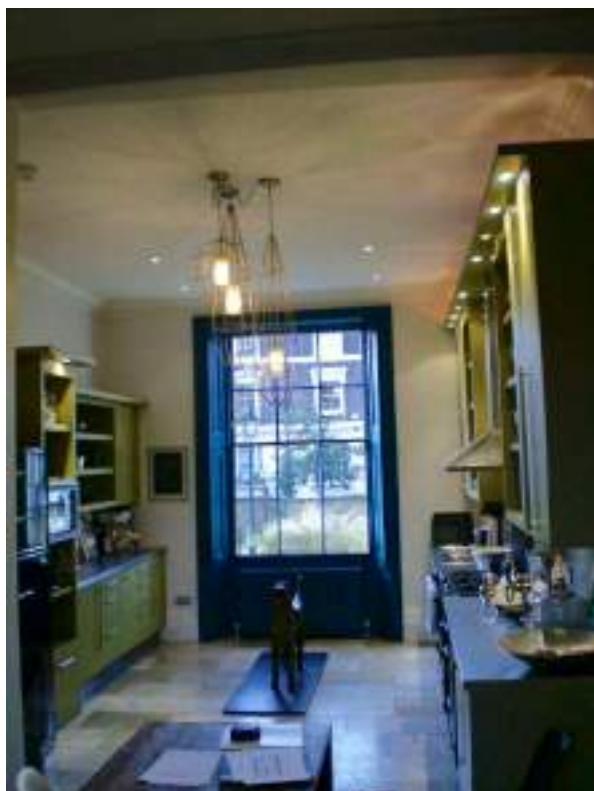
Ground floor front room. Overall - Medium Significance. Stone flooring - Harmful modern alteration.

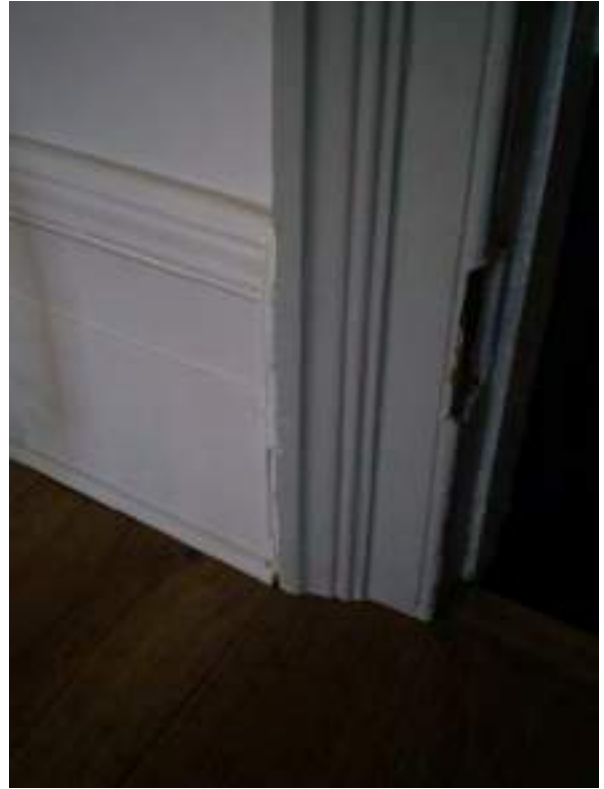
First floor front room. Non-original long ovolo window joinery detail - No Significance.

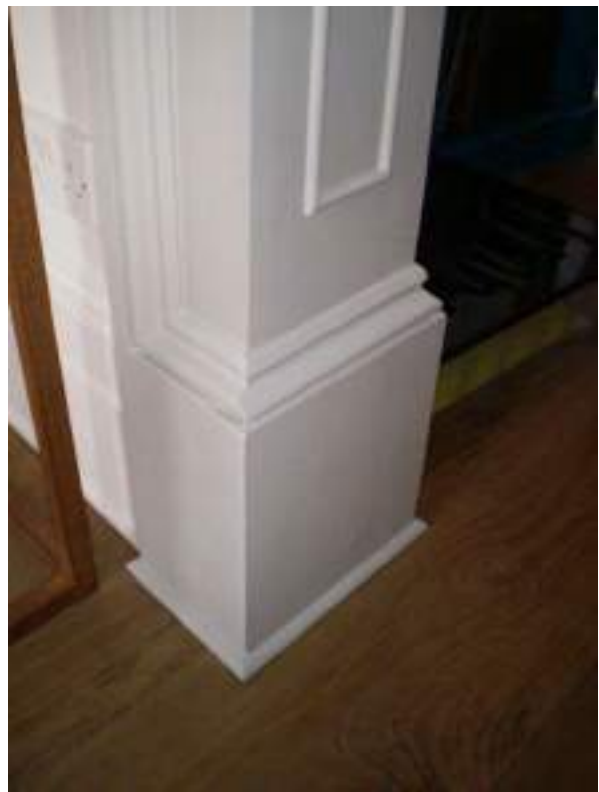
First floor front room. Detail non-original arch lining, architrave and plinth - No Significance. Low architectural merit.

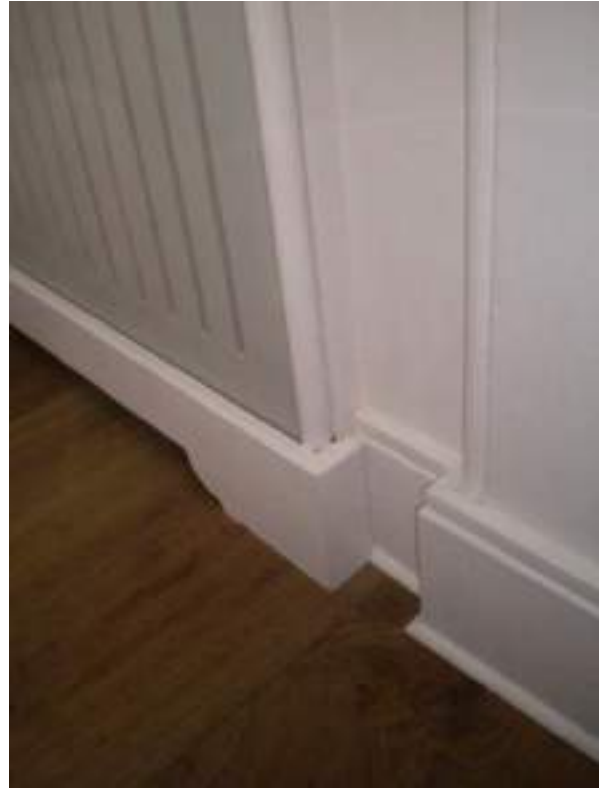
Second floor front room. Non-original skirting boards, a near match - No Significance.

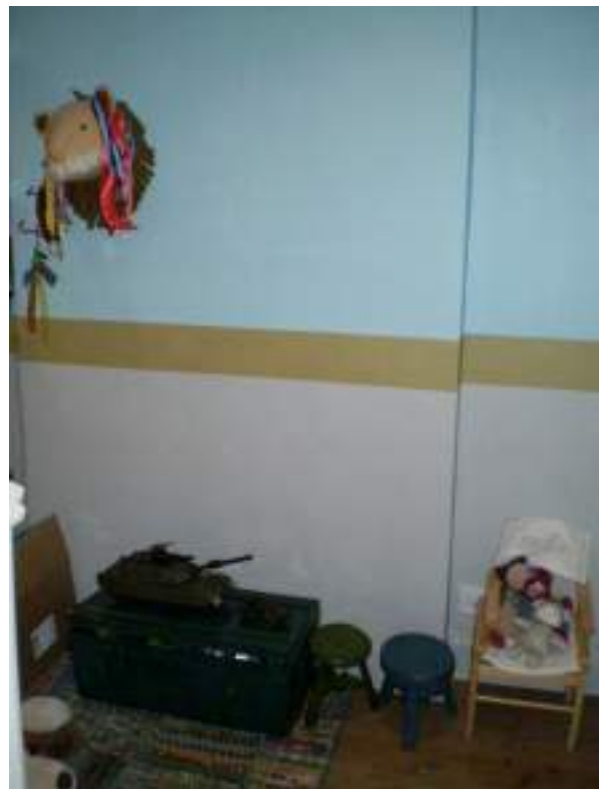
Third floor front north room. Original chimneybreast - Low Significance. Fireplace removed - Harmful alteration.

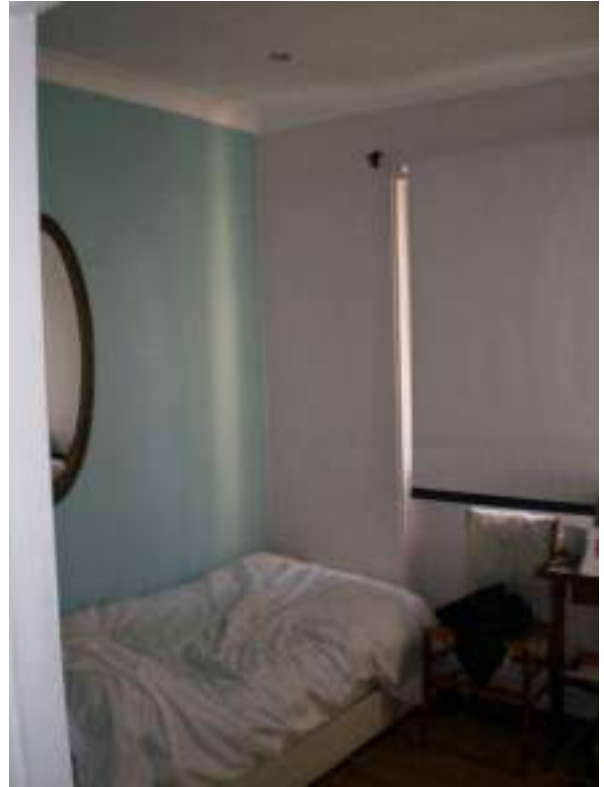
Third floor front north room. Original skirting board in recess - Low Significance. Modern skirting board around chimneybreast not an exact match.

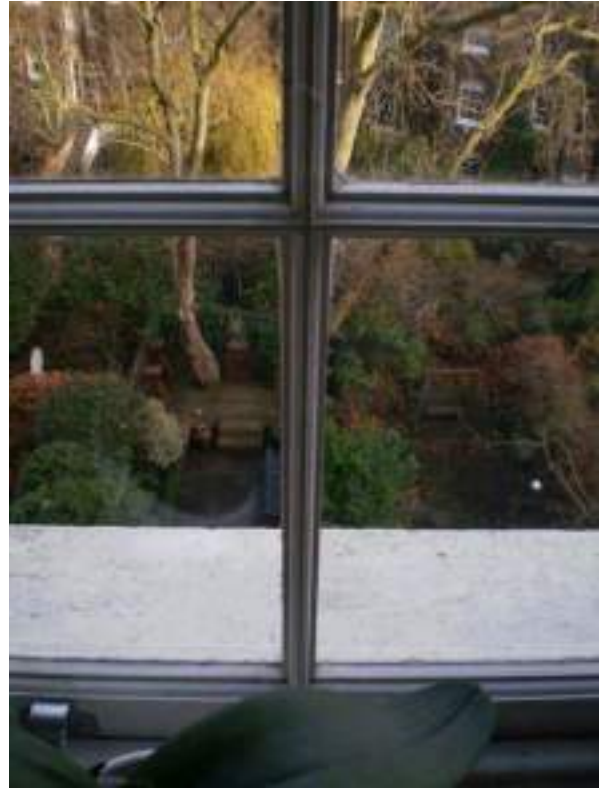
Third floor rear south bathroom window. Modern replacement. Joinery mouldings do not match originals.
