CONSERVATION STRUCTURAL ENGINEER'S ADVICE

REPAIRS TO DEFECTIVE BRICKWORK

**94 HAVERSTOCK HILL
LONDON, NW3**

JULY 2016

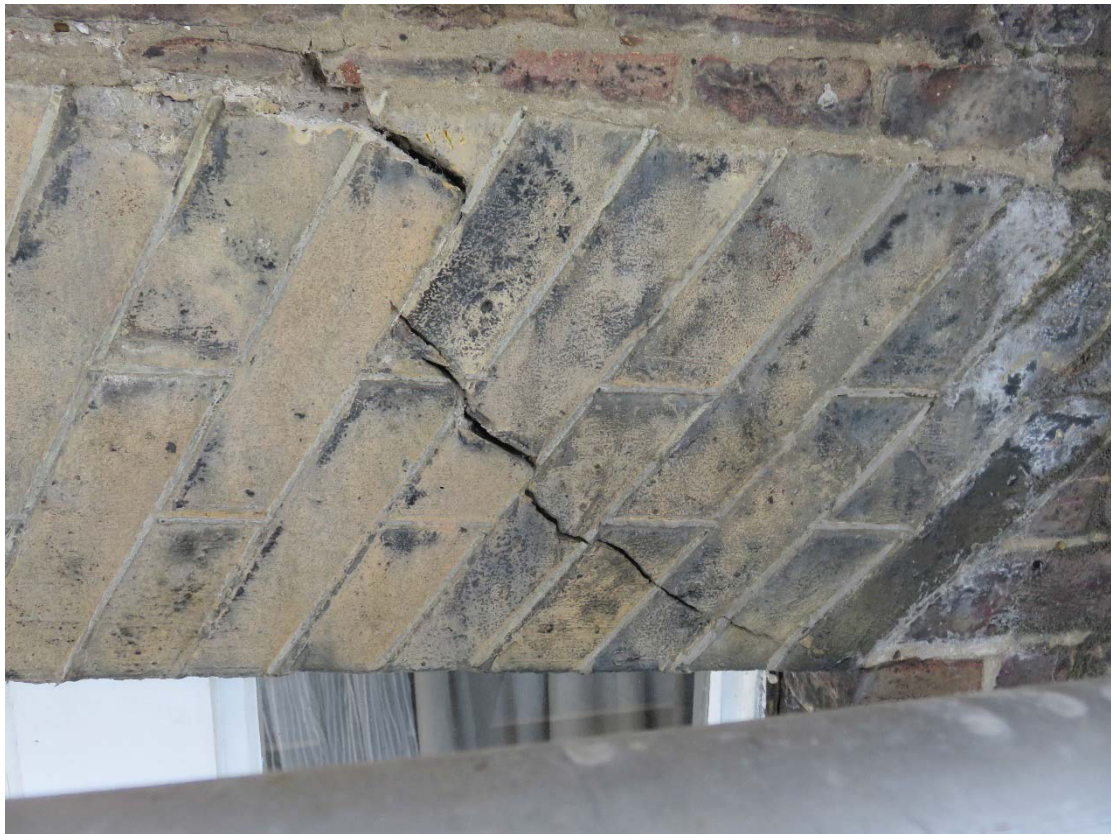
Photo 7251

3.1 Rear Elevation First Floor, Only Window Arch at this Level.

(Photograph 7251) Historic crack through the right hand side of the arch as viewed, but any dipping or dropping of the arch is trivial. Rake out the joint and repoint across the crack. The arch generally is tuck pointed, mostly in good order with a few bits to be made good.

Before raking out and repointing insert one heavy timber prop made tight with folding wedges under the fractured area, remove on completion of work.

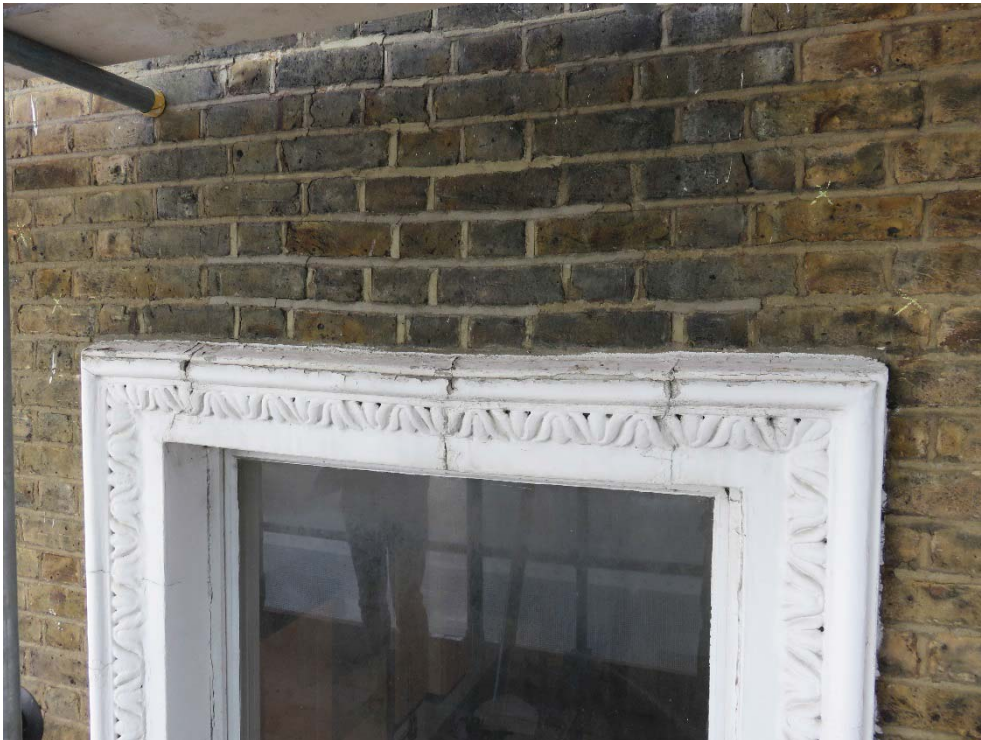
Photo 7252

3.2 Flank Elevation Rear Window First Floor

Ornate rendered surround with decorative band. Window head has dipped in the middle in the past, mostly historic, though with perhaps slight recent movement.

However, situation does not merit the loss of historic fabric involved in cutting out what we take to be original decorative elements and lintels.

Cut out bed jointed brickwork 40mm deep in the first brick course and third brick course above the window, as marked with chalk cross on **Photograph 7252** and insert 6mm “Helifix” square twisted stainless steel bar set in “Helibond” grout. The length of bars about 1.7m/1.8m. Each bar to be inserted and grouted and pointed up before the next recess cut out. Cracks in the decorative render, cut back and made good.

Before doing any of the work insert timber spreader plate and two timber props with folding wedges underneath the soffit of the head of the window, and remove on completion.

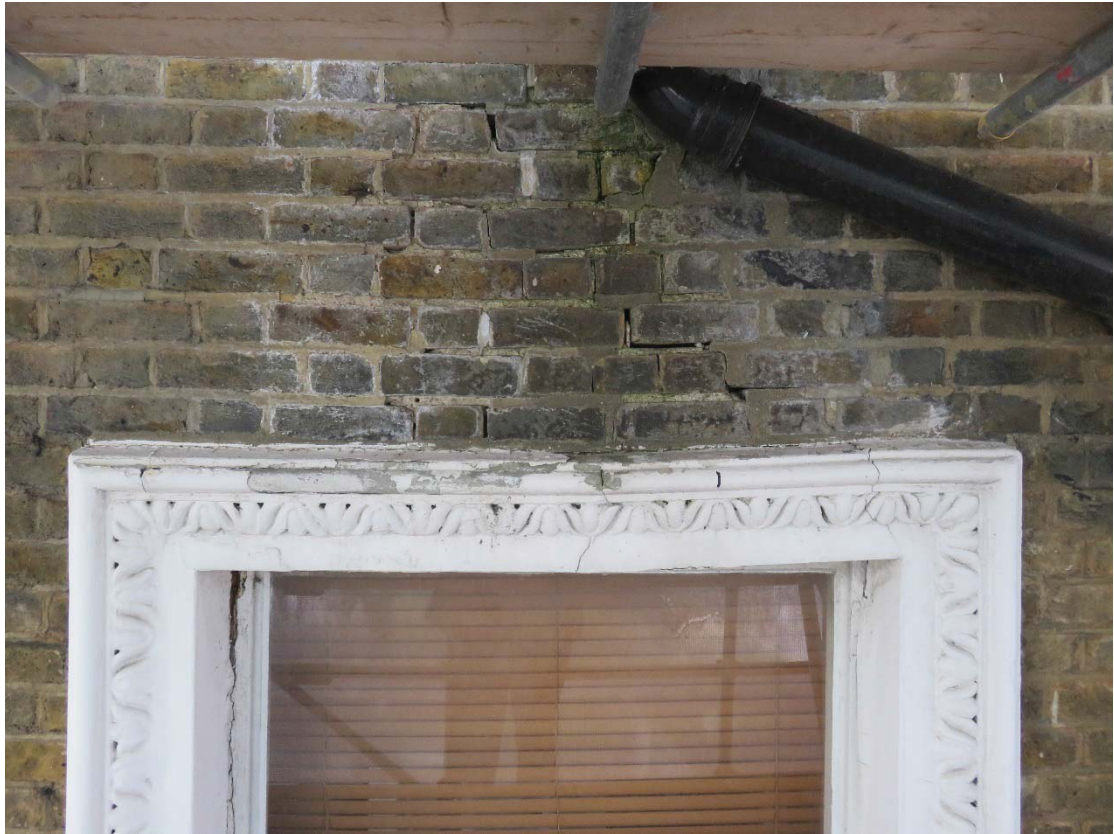
Photo 7253

3.3 **First Floor Flank Wall Middle Window.**

(Photograph 7253) This has sagged in the middle and open bed joints have occurred in the brickwork above to about 5mm or 6mm. In the past there has been severe water washing down from defective rainwater goods above. Window lintel cracked as previous, but here much higher risk of decay in the timber lintel. There is said to be cracking on the inside face.

Prop lintel on the outside with timber spreader plate and two heavy timber props. Likewise on the inside, strip plaster on the inside, check timber lintel which may well be decayed, cut out and replace with concrete lintel 140mm wide 100mm deep with at least 150mm bearing each end.

Outside take cast of decorative moulding and set aside. Take off decorative moulding carefully keep in the lintel propped, expose what is taken to be timber lintel, prop brickwork above, take out timber lintel, install concrete lintel 100mm wide, 140mm deep with bearing 170mm i.e. just within the decorative reveals so the end of the pre-cast lintel is not exposed.

Rebuild small area of brickwork above about two to three bricks long over about four brick courses. Rake out second bed joint above the window head and install one “Helifix” square twist bar with the window about 1.7m long.

If, as may be possible the moulding comes off in pieces, it can be put back fixed with stainless steel screws, otherwise fix stainless steel expanded mesh over the new concrete lintel, run new sand:cement moulding to match existing decorative elements.

Check that all rainwater goods above are in good order and valley gutter etc., swept clean.

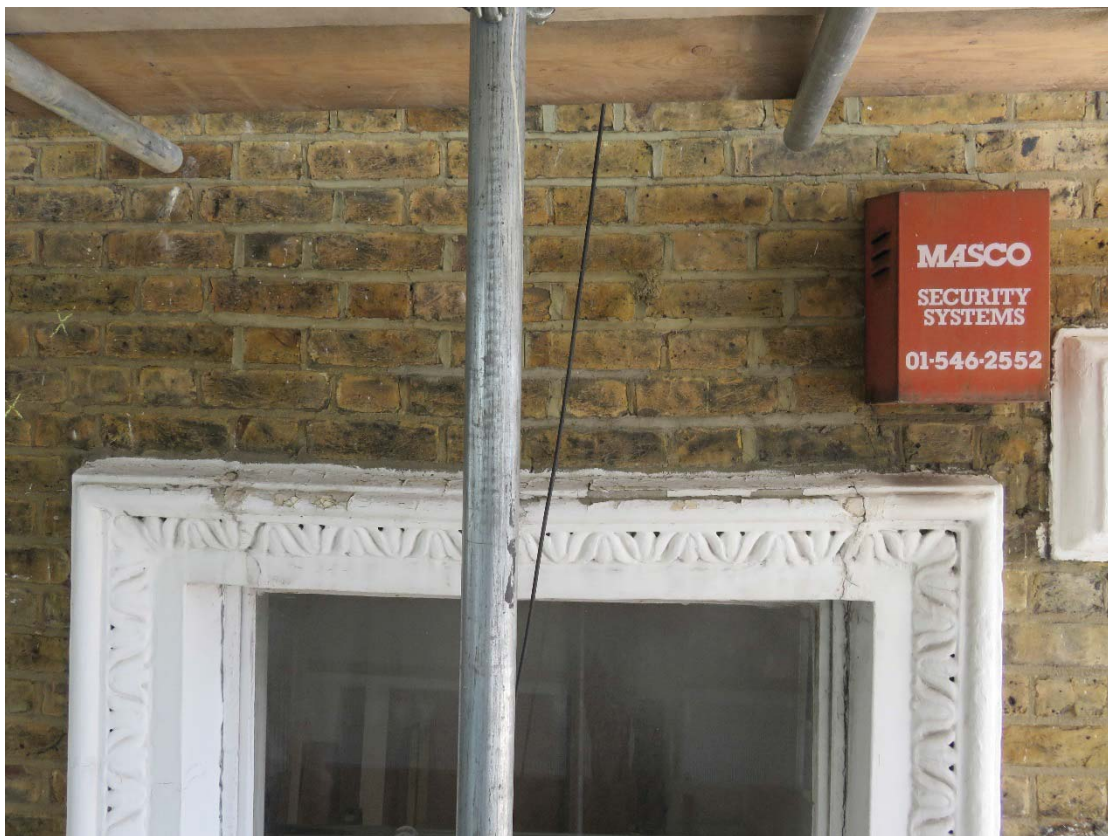
Photo 7254

3.4 **Flank Wall Forward Window**

(Photograph 7254) Slight distortion in the head of the window, minor cracking through the decorative moulding, prop the window head, discard the redundant security box on the right hand side, cut out bed joints in the brickwork above 40mm deep, first bed joint and third bed joint above the window insert 6mm “Helifix” square twist stainless steel bar set in “Helibond” and grout and repoint to match existing. Rake out and make good the cracks in the decorative moulding and remove props.

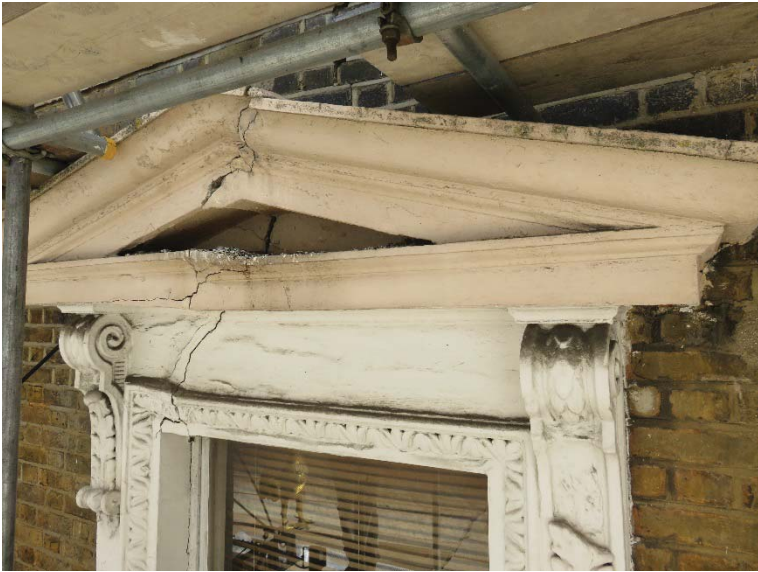
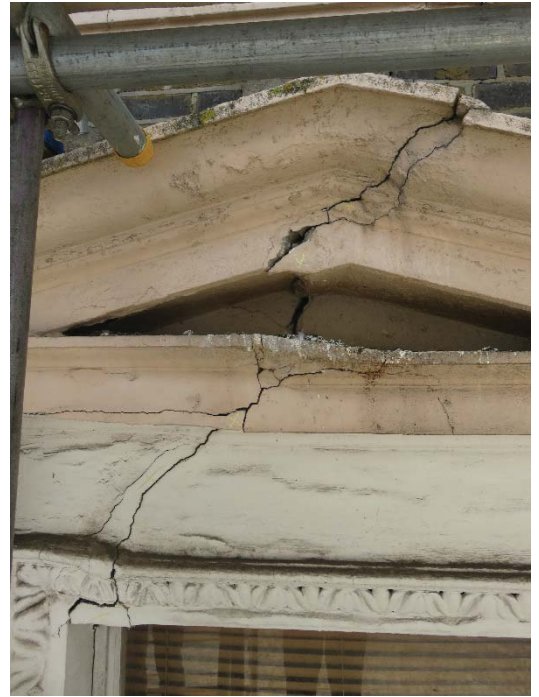
3.5 **First Floor Front Elevation, Left Hand of the Three Windows**

Significant crack through the window head decorative detail, the horizontal cantilevering pediment and the moulded arch above.

Prop the window head and then carefully take out the broken elements to examine the construction, these marked with yellow chalk on site. See **photograph 7255 and 7256**.

The cantilever outstand element may be brickwork built out from the face of the wall and then rendered or pieces of Yorkstone or similar built into the wall cantilevering out, not clear today, and not possible to open up to inspect until propped.

Rake out all the broken material.

Take off the decorative corbel brackets, right and left of the window and set aside for replacement on completion. Take off decorative element and vertical plain rendered area, take out existing lintel which is either decayed timber or failed brick arch, install concrete lintel 100mm wide, 150mm deep with 220mm bearing each end, put back decorative elements on stainless steel mesh.

Make good with stainless steel mesh and render the horizontal and pedimented decorative elements.

Directly above the window rake out and stitch the brickwork using two or three carefully chosen matching bricks, cut out two bed joints in the brickwork about 1.8m long, 40mm deep and bed in 6mm stainless steel “Helifix” bar as before.

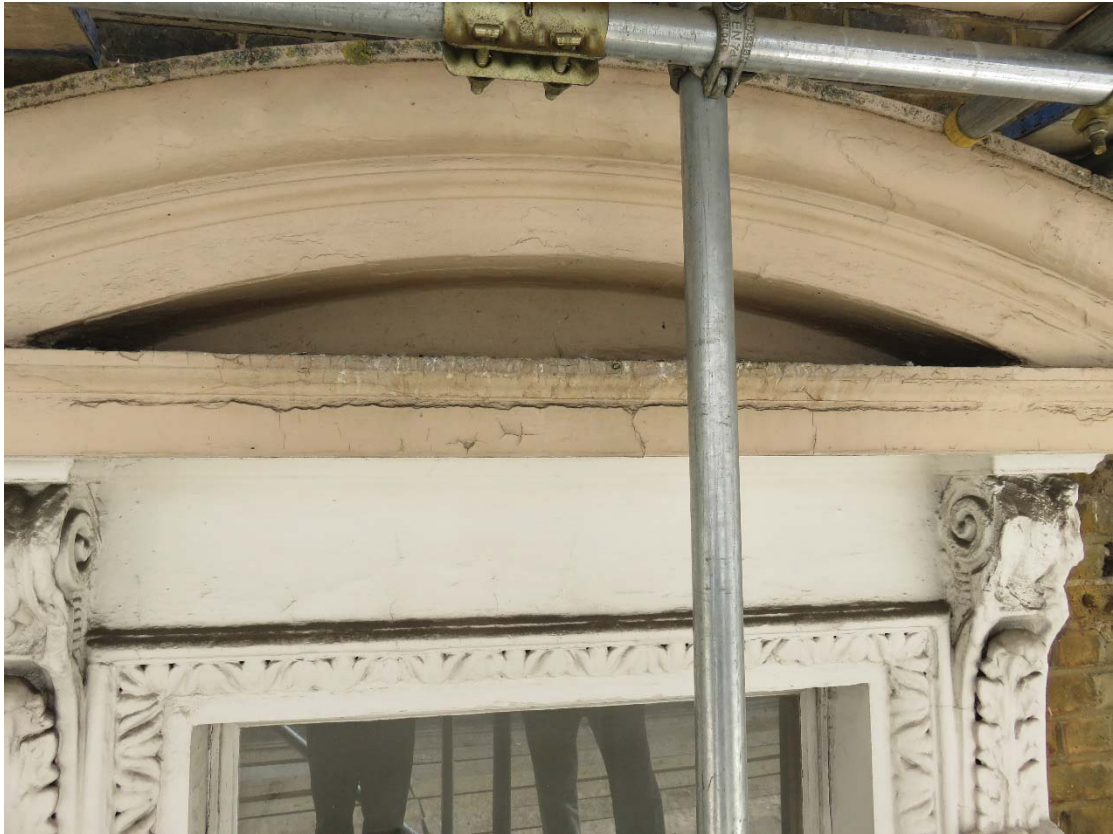
Photo 7258

3.6 **First Floor Central Window**

(Photograph 7258) Scrape off old paintwork on the horizontal pediment, check condition of stone or render behind, but otherwise no apparent structural defect.

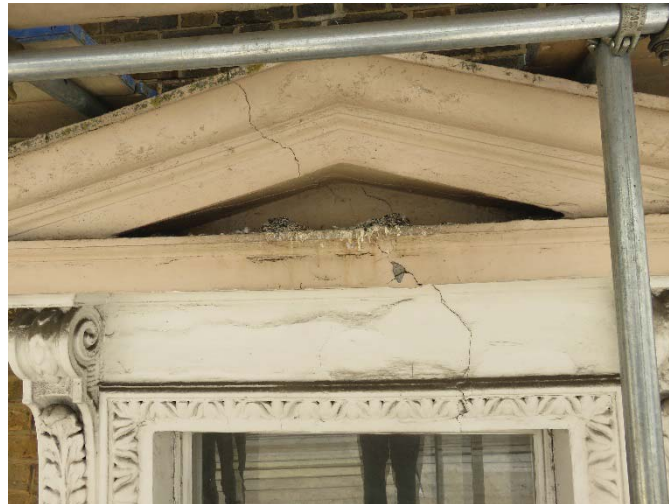
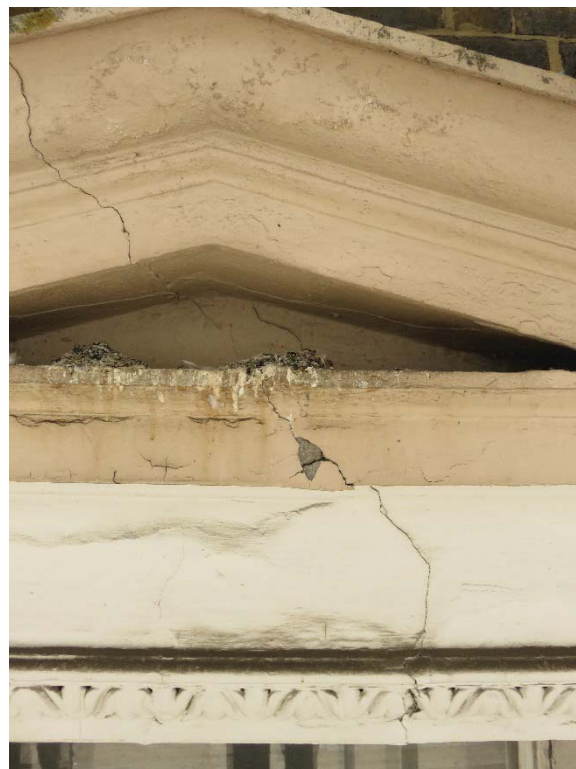
3.7 **First Floor Right Hand Window**

(Photographs 7259 and 7260) This in fair order, slight cracking through the decorative element and the horizontal outstand above. Prop head of window, break out any loose fragments on the horizontal elements and simply make good.

In the brickwork above run two courses of 6mm “Helifix” bar as previous.

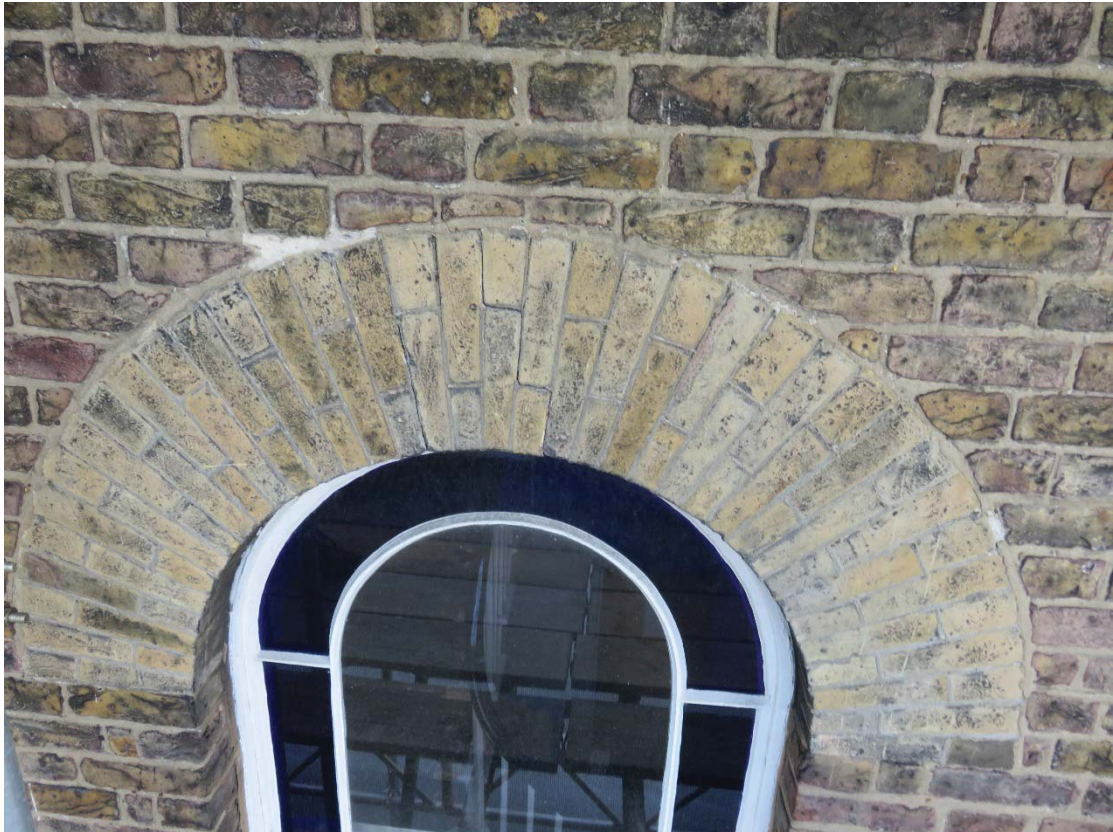
Photo 7261

3.8 **Second Floor Rear Elevation**

(Photograph 7261) This is the stair window at half landing level. Plain brickwork semi-circular arch, slight raking out and replacement of tuck pointing.

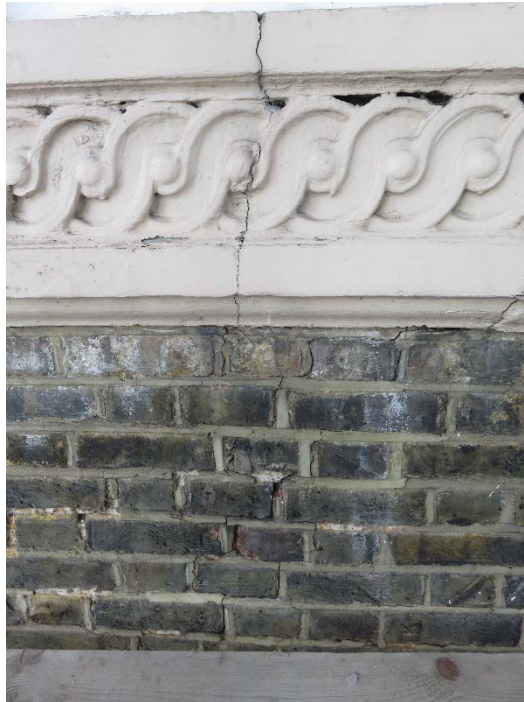
Photo 7262

3.9 **Second Floor Flank Wall above Rear Window Below**

Crack running up through the brickwork. Rake out and insert two more “Helifix” bars about 1.8m long as previous. First brick course and third brick course below the decorative “Grioche” band. **(Photograph 7262).**

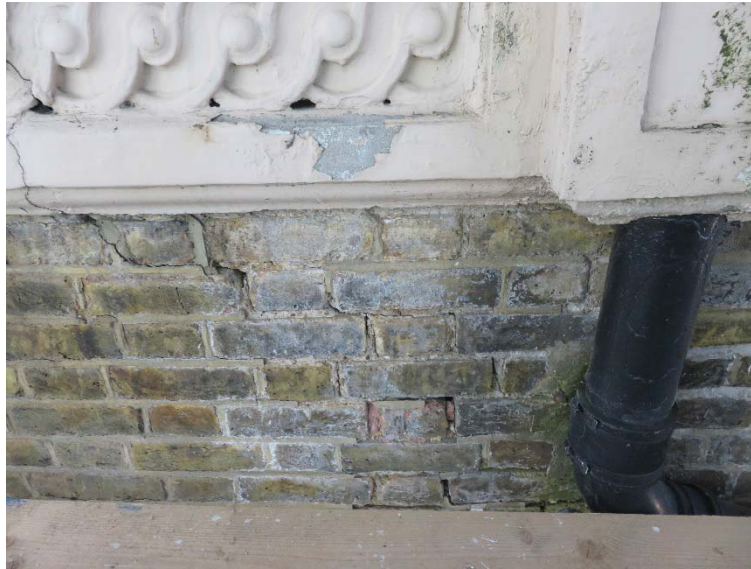
Photo 7263

Above the middle window brickwork mortar has been washed out as below. This to be raked out and deep pointed to reset the bricks. **(Photograph 7263).**

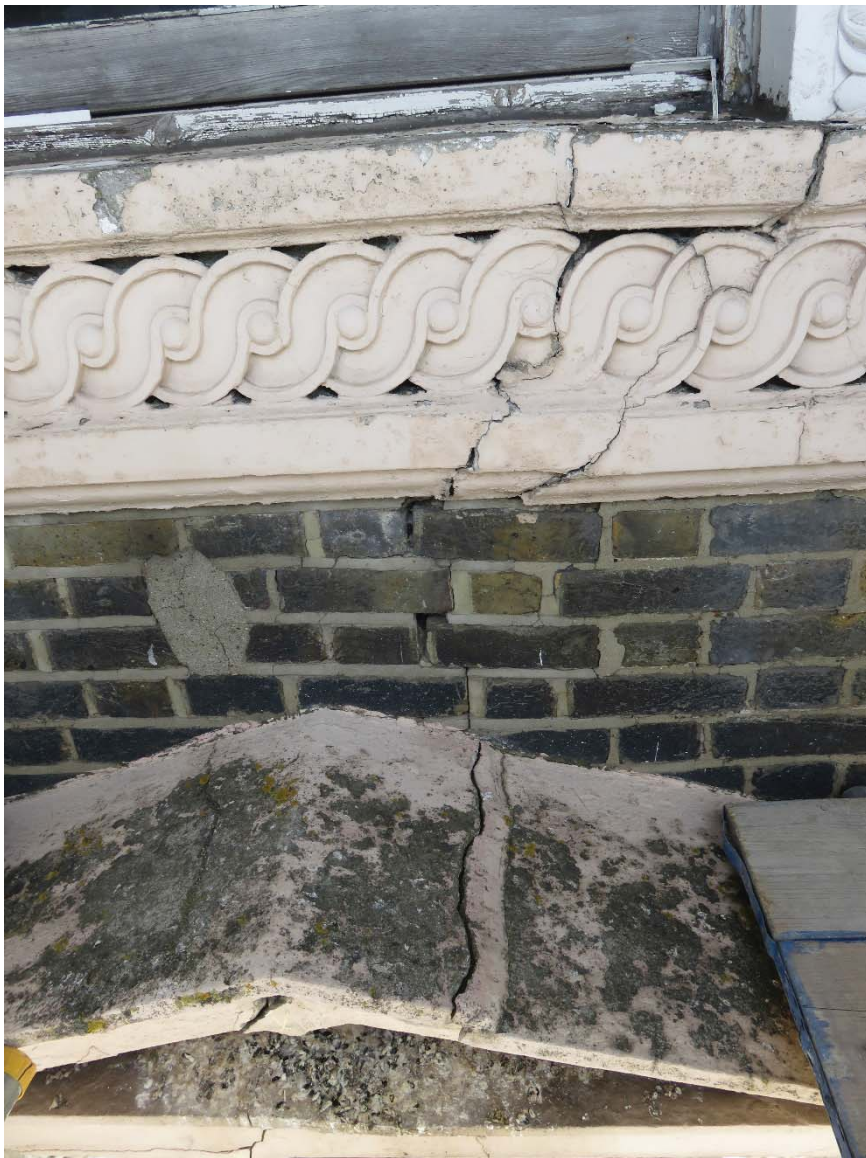
Photo 7264

3.11 **Second Floor Front above Left Hand of Three Windows and Below Cill of Left Hand of Three Windows**

(Photograph 7264) Cracking up through the brickwork, fix “Helifix” bars as previous. Take out all previous repairs and make good.

It is inherent in this work that the distortion is built into the building in areas like this remain, it is not part of the conservation practice to try and “straighten-out” the building.

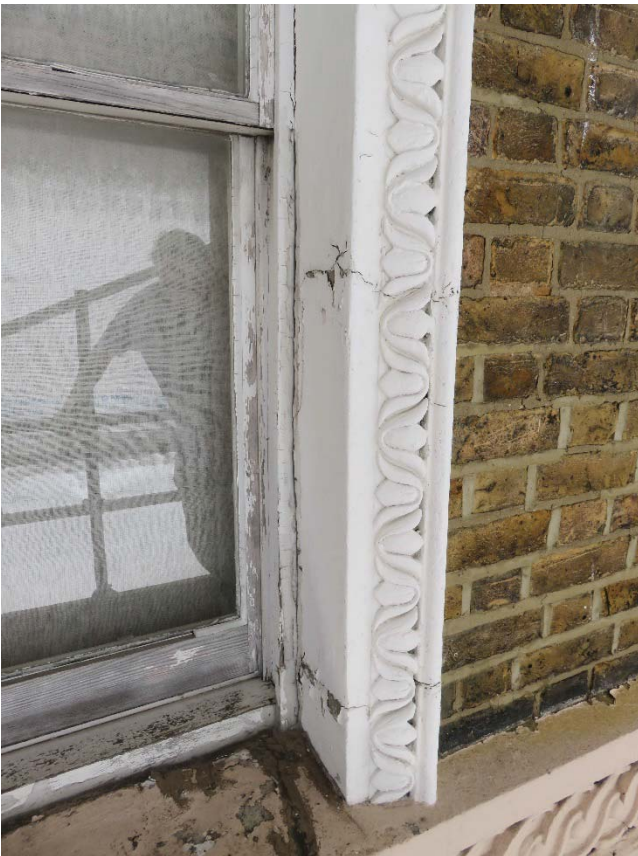
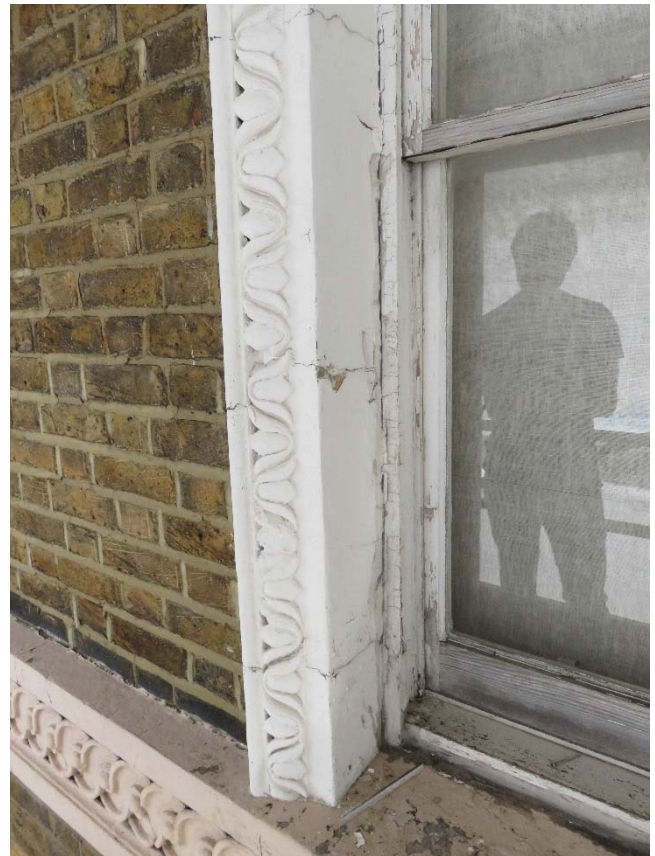
3.13 **Second Floor Front Window Right Hand Reveal**

(Photograph 7266) Horizontal cracks at 400mm centres. Left hand reveal horizontal cracks through the rendered reveal at 350mm centres **(Photograph 7265)**. No precise cause in relation to this cracking. May be day joints, may be joints between pre-cast decorative elements, joints to be raked out and made good, not structural concern.

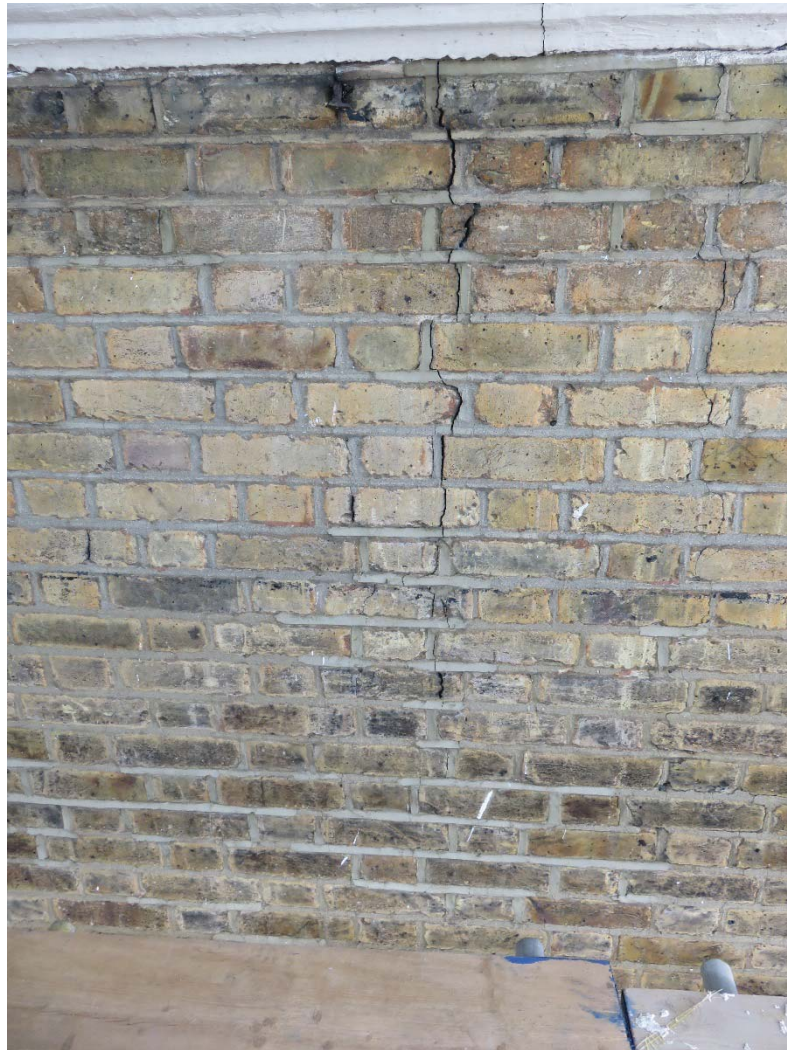
Photo 7268

3.16 **Flank Wall Above Central Window**

(Photograph 7268). Almost above but slightly to the rear of the first floor central window cracking runs up to the top decorative band, again add three “Helifix” bars about 900mm long as previous.

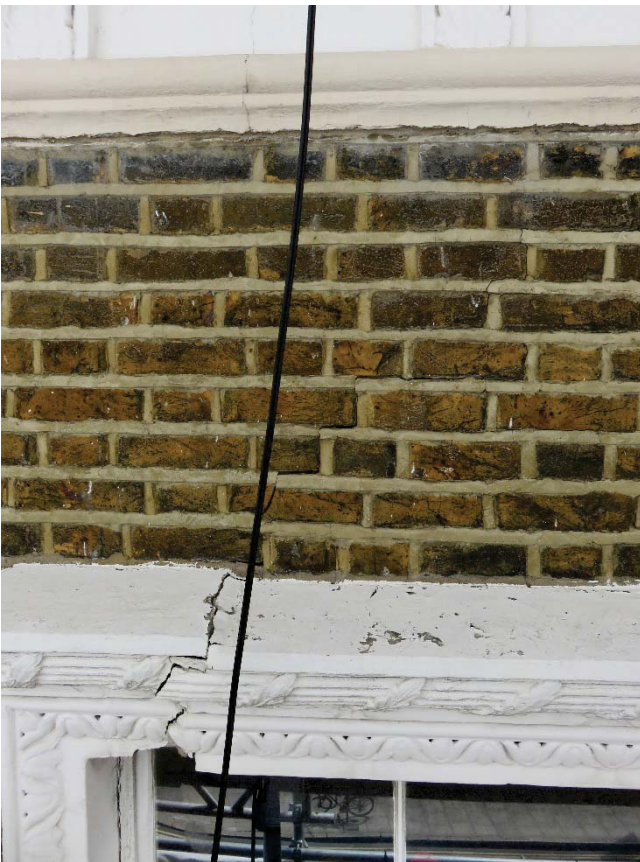
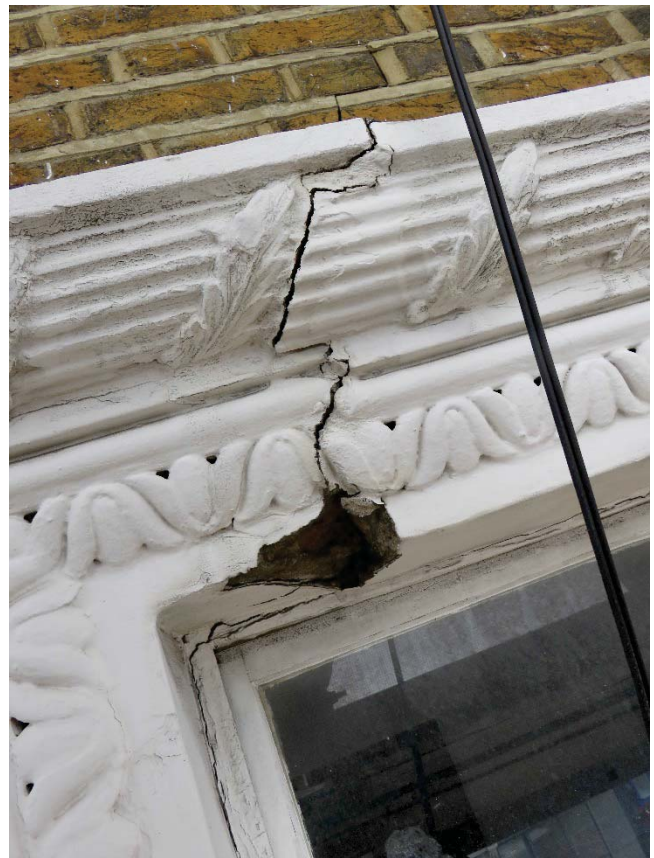
3.17 **Front Elevation Head of Second Floor Left Hand Window**

(**Photograph 7269**) Left hand window to front elevation fracturing through the left part of the decorative window head and fragment of mortar missing. (**Photograph 7270**).

The brickwork has dropped about 4mm or 5mm, rake out and insert three “Helifix” bars about 900mm long in alternate bed joints.

Prop window head, decorative head of window - take off the decorative moulding above, take out lintel which may be timber lintel or more likely straight soldier course type brick arch, insert pre-cast concrete lintel about 150mm bearing each end, but not so long as to show outside the rendered reveal, fix stainless steel expanded metal mesh and fix back decorative elements or replace as necessary.

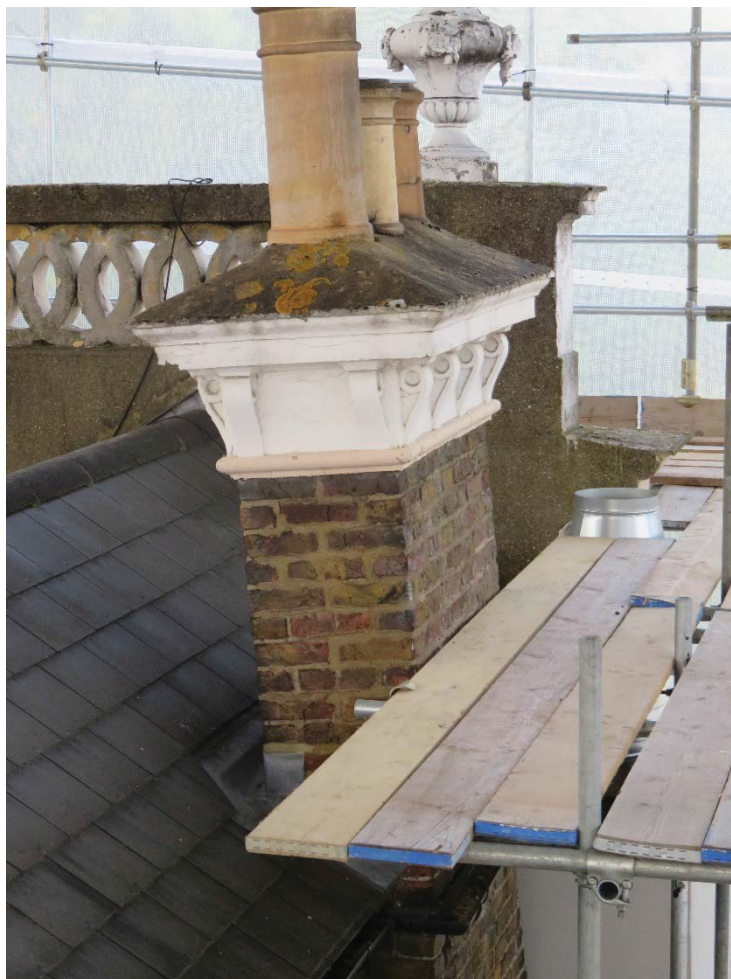
Photo 7275

3.20 **Significant Chimney at Rear Left Corner**

(Photograph 7275) This leans inwards, but it is two bricks wide about 450mm wide and about 1.4m up to the edge of the capping above the inner face of the roof slope.

New mansard slope is steeper than this and should be designed to fix to the chimney and provide further restraint to it, although chimney should be stable in its own right.

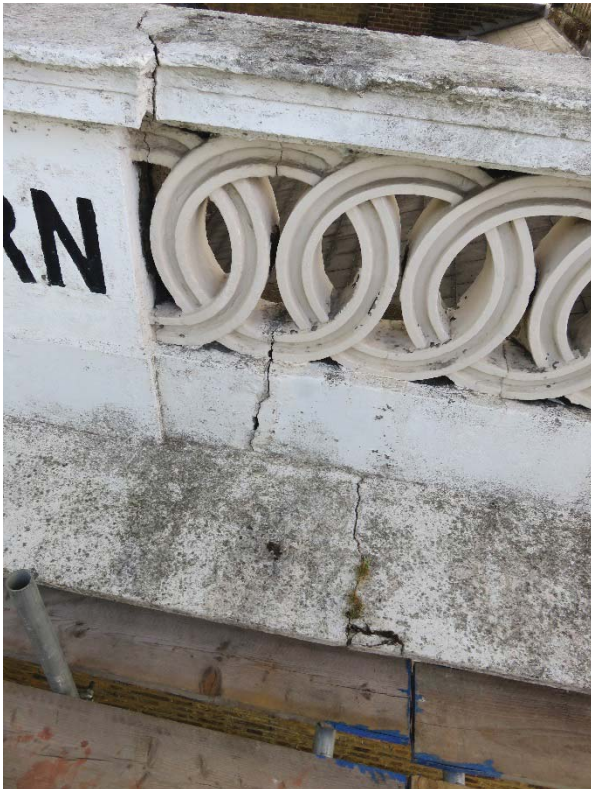
Photo 7276

3.21 **Flank Wall to Rear of Forward Window at High Level**

(Photograph 7276) Fracture continues up through the outstand coping and the decorative bands above and the top coping. The whole area to be checked with tapping hammer and any loose bits repaired and the top of the coping at least one or two stainless steel staples or ‘dogs’ inserted in the brickwork.

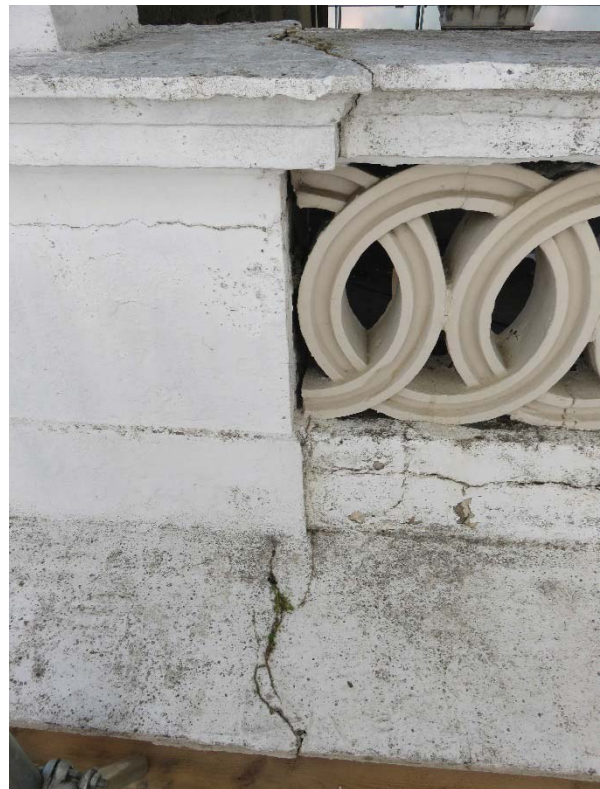
Photo 7277

(Photograph 7277) Top level front left corner, again cracking up through the coping of the decorative band up through the top of the coping, this to be stitched with stainless steel.
