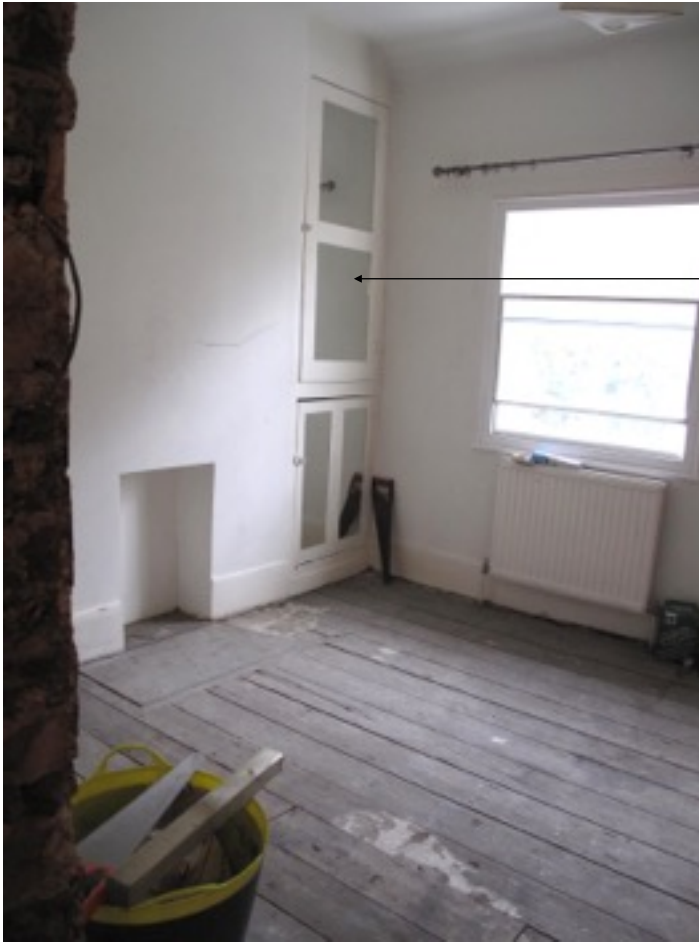
Non original mirrored glass glued to surface of cupboard. Very difficult to remove glass without damaging the wood panels behind.

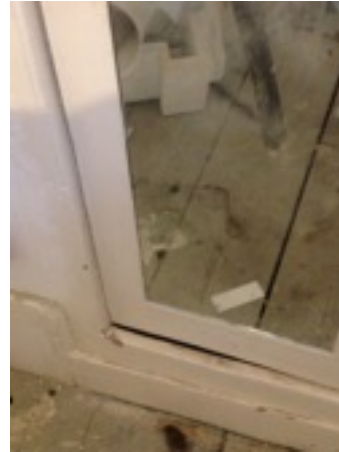
Warped doors and chips around door frame

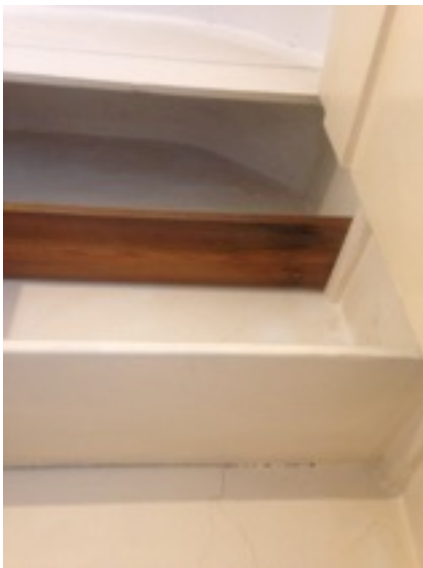
Non original slats and patching work has been carried out on the cupboard, which is unsightly and has caused cracking.
