### **Arboricultural Supervision Report - BS5837:2012** **in relation to implemented development:**

7th February 2017

1-44 Denyer House  
Grove End Lodge  
College Lane  
London  
NW5 1BJ

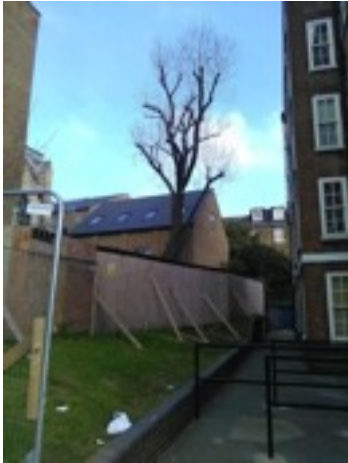
##### **3.1 Canopy outline of tree T1 as viewed in a north easterly direction**

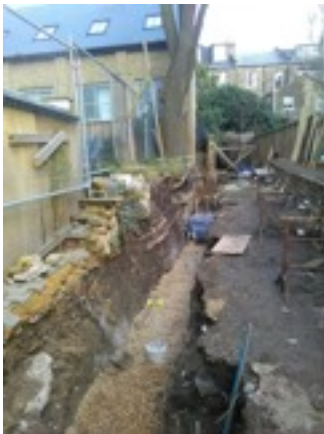
##### **3.2 Exposed base of tree T1 further to full removal of wall dismantling of previous foundations and casting of ground beam atop pile foundations as viewed in an easterly direction**

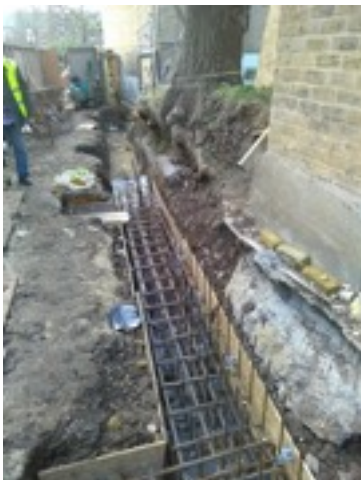
##### **3.2 Exposed base of tree T1 further to full removal of wall dismantling of previous foundations and casting of ground beam atop pile foundations as viewed in an westerly direction**

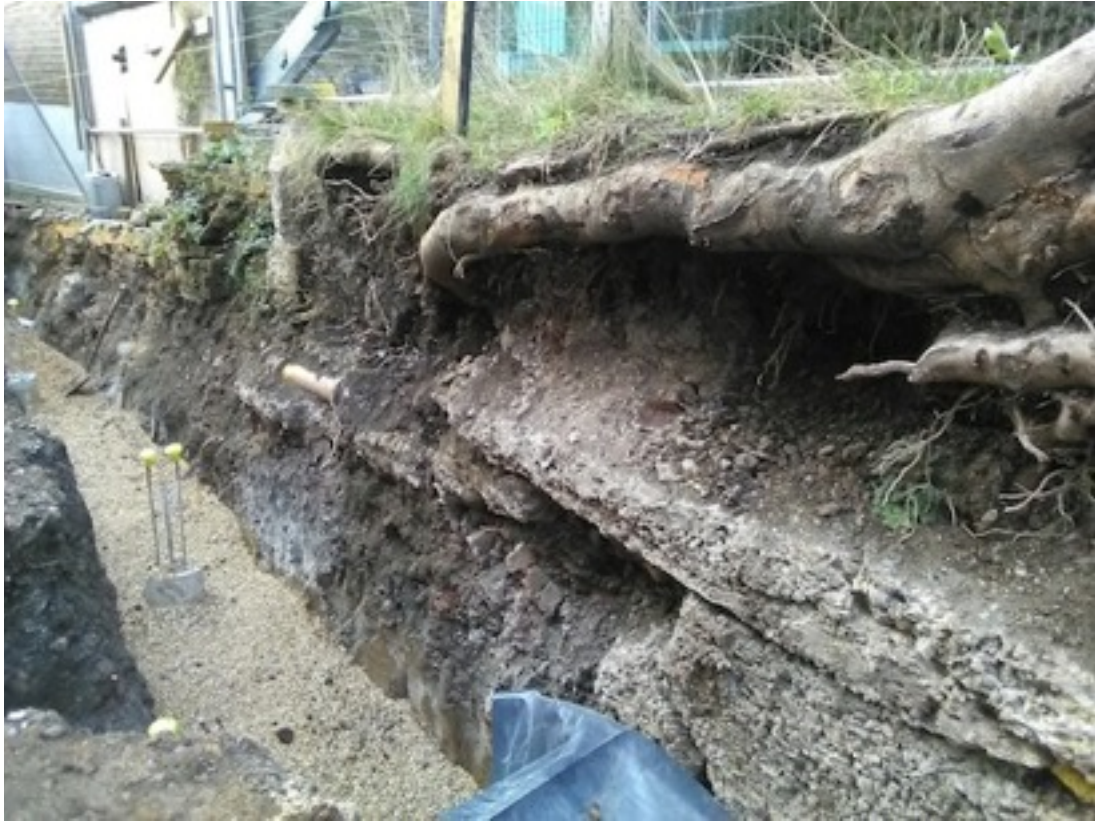
- To the west of the main stem on the boundary line this proportion of tree root / concrete base extends to the west for 2.3m at which point a 700mm depth of root mass / soil is formed on top of a 250mm concrete infill. Beneath this layer is a void where infill has either not occurred and is likely the cause of movement within the tree root system further to wind loading where uplift provides the movement of soil due to the un-compacted and unstable nature of the ground

2.4.2 The existence of this concrete slab suggests that on rebuilding the boundary wall the concrete infill has been implemented to account for loss made up ground or soil which previously existed beneath the tree root system. Taking account of the likely further movement of this infill or void beneath this tree where significant pressure is applied by the tree, the tree was initially recommended for a further reduction in height to reduce wind loading upon this tree. However having fully removed the ground beam and further inspected full removal with an appropriate replacement scheme is recommended.

3.4 Pre-existing concrete infill from likely previous construction of boundary wall with voids beneath to west of main stem of tree T1 as annotated

6. Prior to the commencement of planting the ground where the previous tree has been removed should be replaced with fresh topsoil within a recommended 2000mm radius from the previous location of tree T1 (within Grove End Lodge only). This should include the removal of all pre-existing concrete infill and associated aggregates to a depth of 1500mm for the specified area

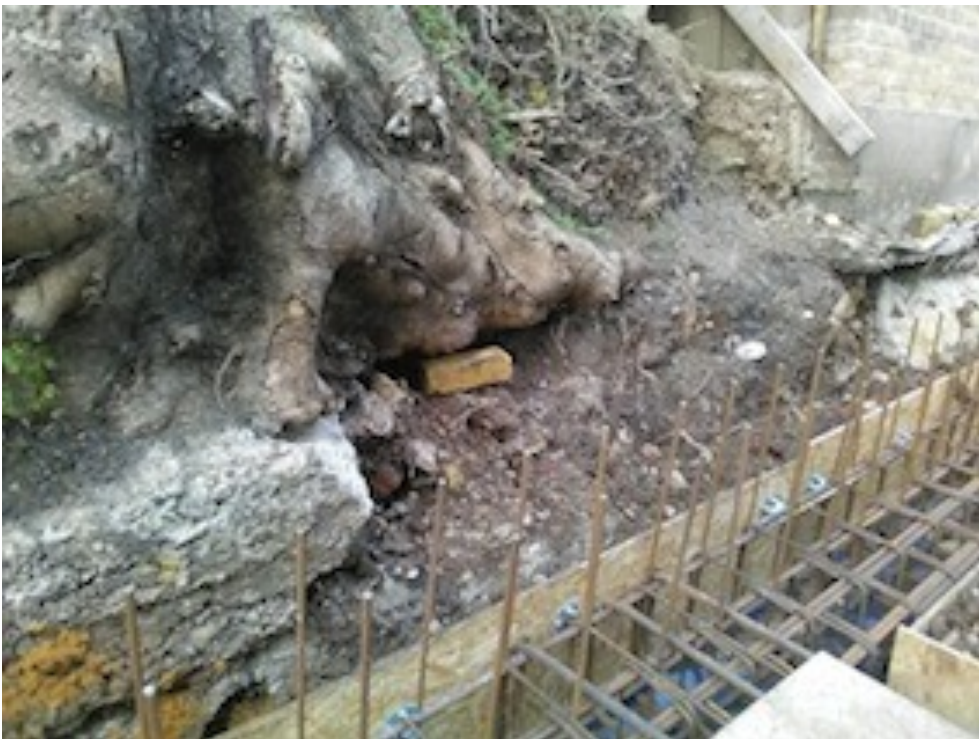
- Directly beneath the base of the tree there is an 800mm depth of anchorage and basal root mass which remains in good condition
- To the east of the main stem on the boundary line between the 2 properties the exposed ground shows the root mass / anchorage roots continuing to extend at approximately 800mm below ground level with made up ground and soil beneath this level. At the point at which the tree roots / garden meets the development the nature and extent of tree roots is not clear.

3.5 Photograph of base of tree / initial root plate where wall and associated foundations have been removed with new ground beam cast. Note void beneath tree to east also and abrupt deflection of tree root upon the concrete infill

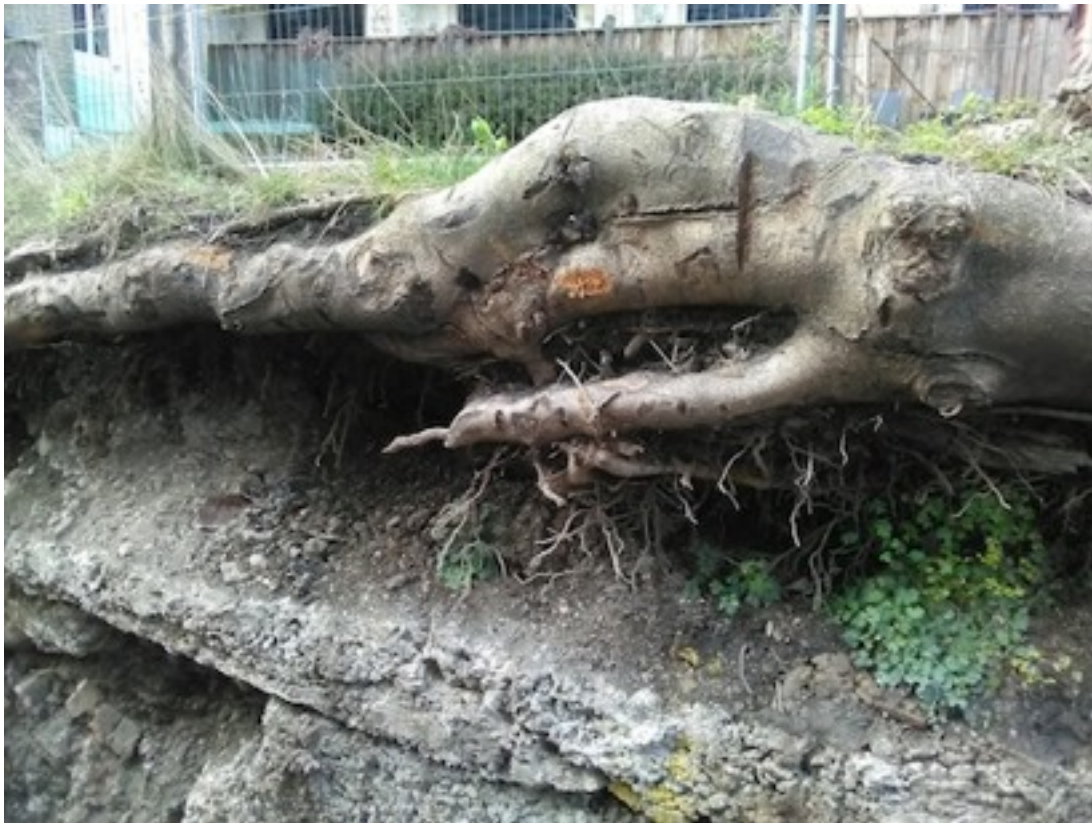
3.5 Photograph of lateral roots to west with void beneath tree root plate to west and ad hoc cast concrete infill combined with loose topsoil

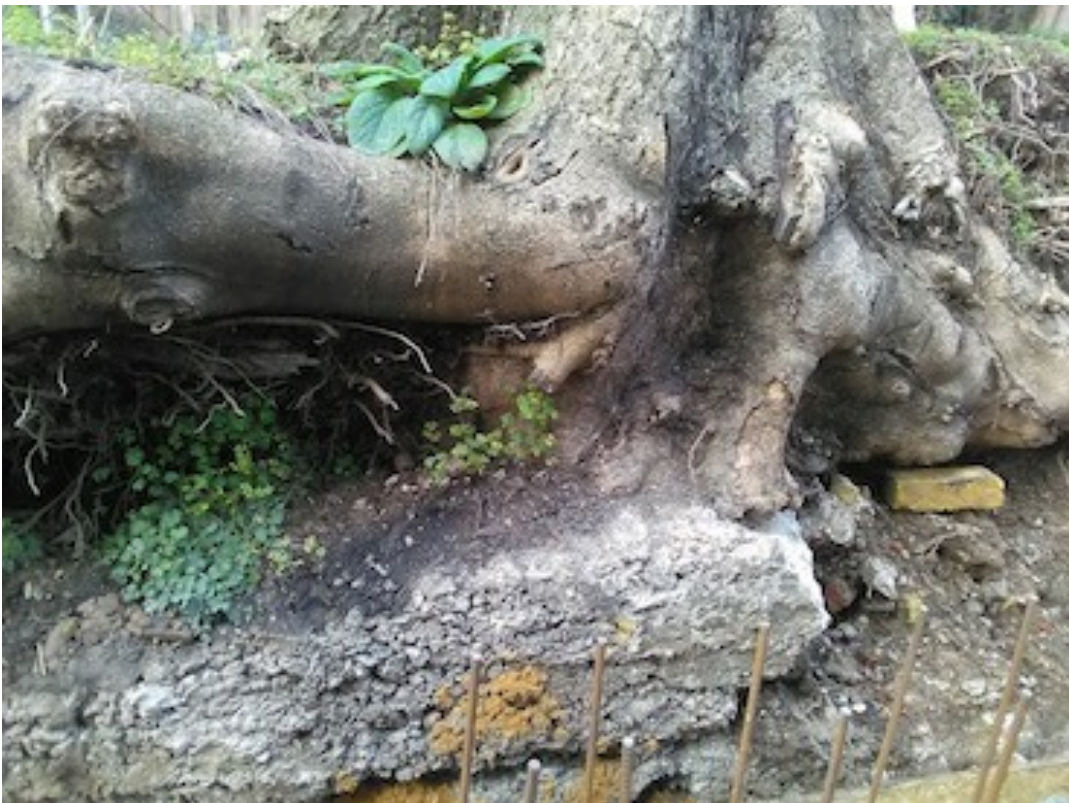
- There exists as shown in photographs within *Section 4* further selective voids where the ground directly beneath the tree is exposed and cutting back within / under the root plate system in a northerly direction. These voids are not a result of development site works but are pre-existing from where on building of the wall previously it would have not been possible to fully infill the ground beneath the tree upon building up the height of the wall

3.7 Photograph of base of tree / initial root plate where wall and associated foundations have been removed with new ground beam cast. Note void beneath tree to west also and abrupt deflection of tree root upon the informal concrete infill which exists directly beneath the tree
