Ref:15027/AKn/005

**RE: CENTREPOINT – HISTORIC STAIR TREADS**

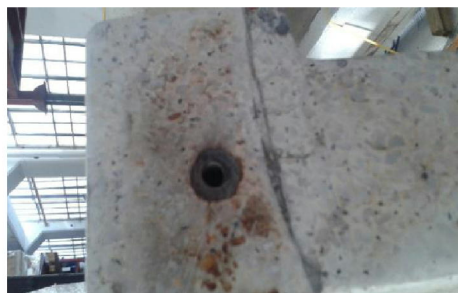
1: Visible corrosion staining and ferrous fixing.

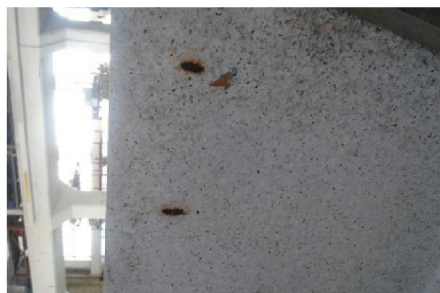
2: Visible corrosion staining, reinforcement too close.

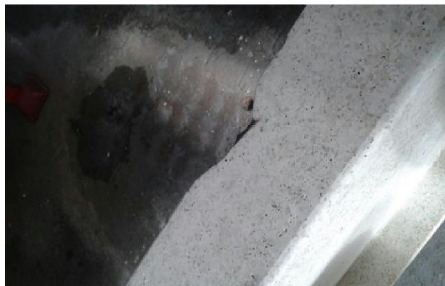
*3: Breaks to faces of lead edge of stair tread.*

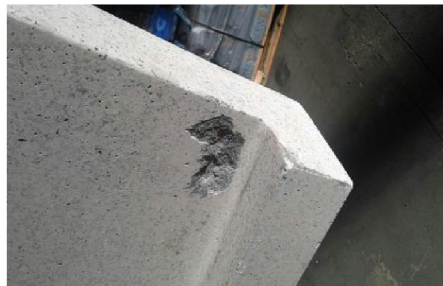
*4: Spalled area exposing reinforcement.*

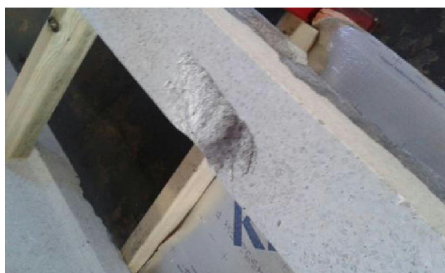
*5: Spalled terrazzo.*

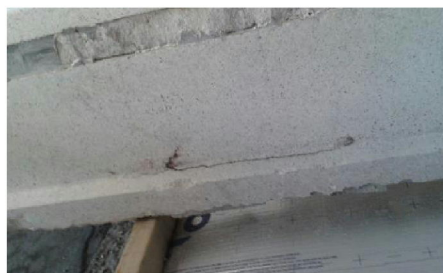
*6: Cracks to terrazzo.*
