THE MOSAIC

RESTORATION COMPANY

REF: Guildford Place, wall tile repairs

Following your recent instruction and my visit to site on 6th February 2017 I am pleased to submit my recommendations and costs to carry out the proposed wall tile repairs to the Ladies and Gents Toilets at Guildford Place, London.

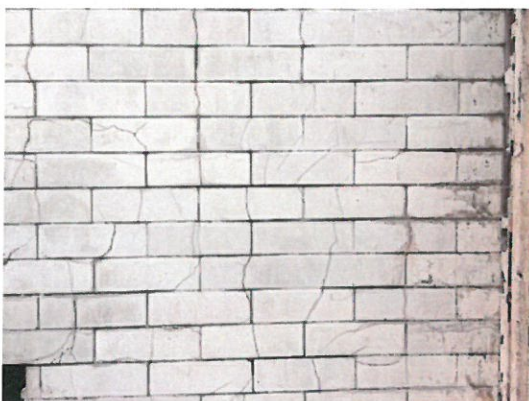
While on site we carried out a small cleaning trail approximately 1 meter square in the Gents Toilets (see images before & after attached). As expected, the surface dirt and grime was easily removed, but unfortunately the ingrained dirt and surface cracking remained. I was surprised at the extent of surface cracking and this needs careful consideration. If the areas of the building are to be re-commissioned, I fear there may be hygiene issues if the structural movement is on going with cracks and fissures being almost impossible to keep clean.

Cleaning trial to Gent Toilet wall, drawing A107b

Before

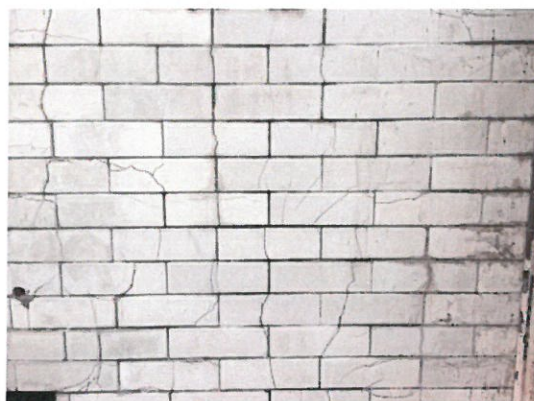
After, very little improvement

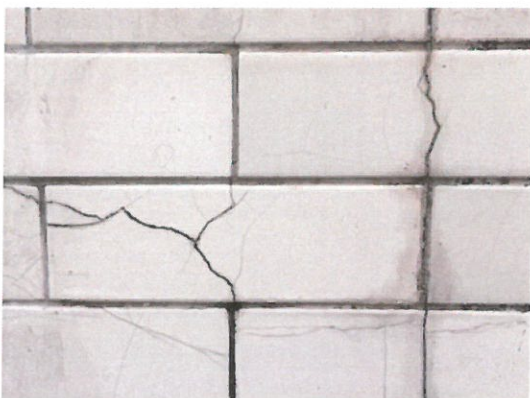
The glazed tile face is typically thin and not very forgiving in this type of environment. As a result of the movement most of the tiles, especially in the Gents Toilets have many cracks or fissures, and or ingrained staining. This staining has ingressed the tile surface and cannot be removed successful by chemical or poultice cleaning methods.

Movement cracks causing surface cracks / fissure

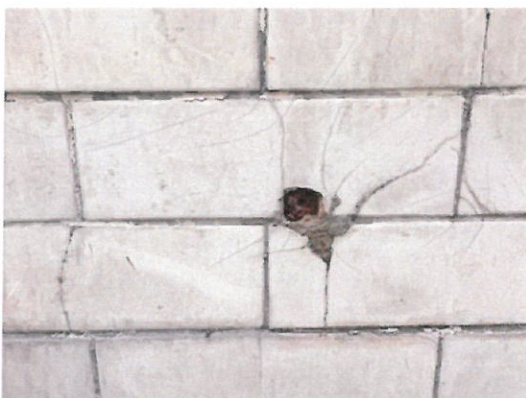
Impact damage, previous wall fixing damage

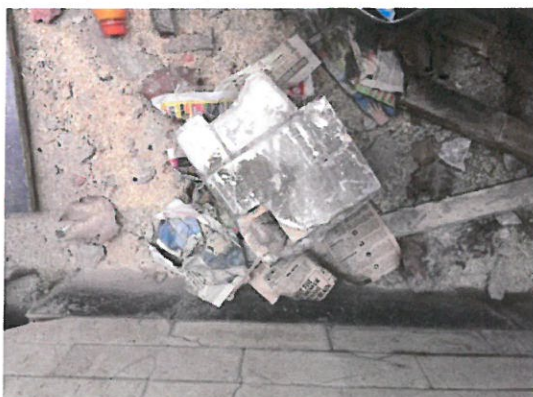
Detached sections from vulnerable areas at high level

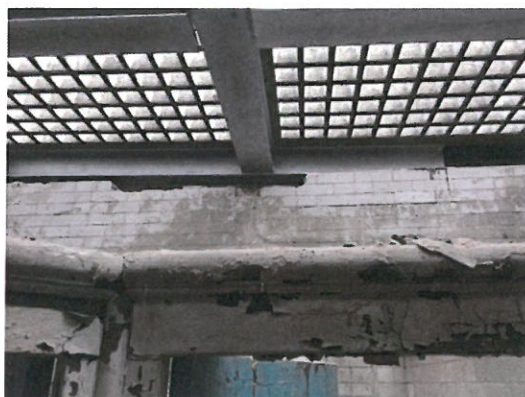
Missing and damaged tiles at high level following reinstatement of new roof light

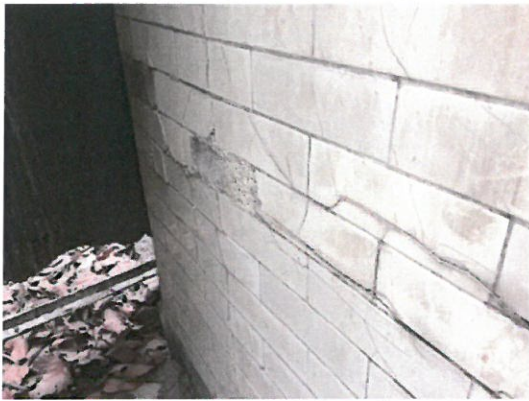
Structural failure, horizontal crack

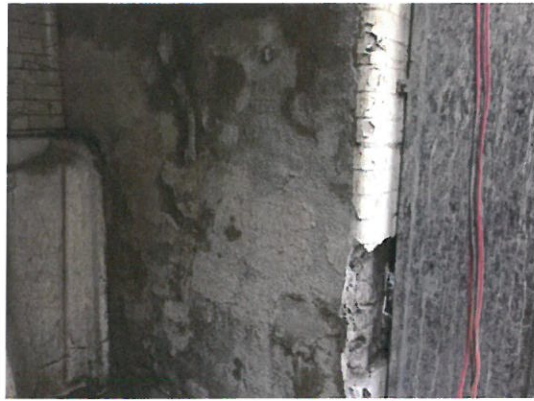
Large rendered section, missing tiles

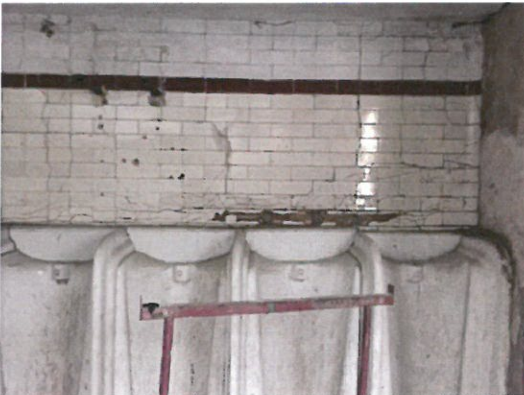
Delaminated tiles above urinals

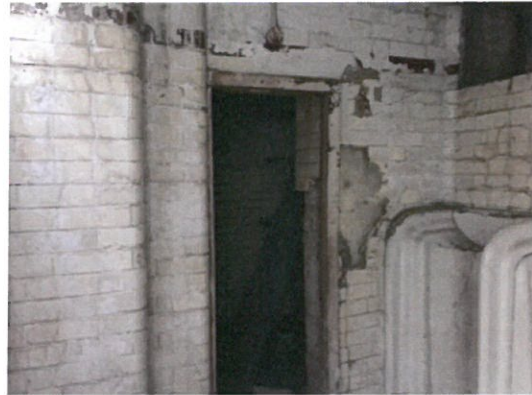
Paint in tiles surface, numerous missing sections

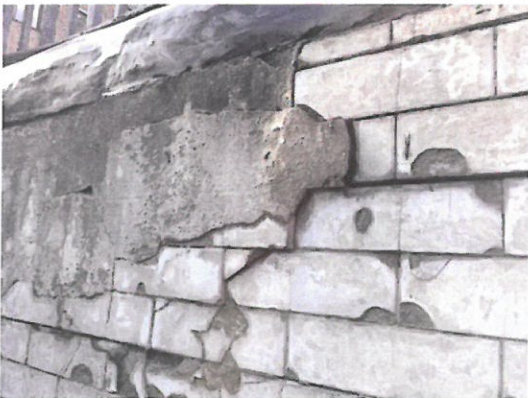
Exterior wall, previous unsympathetic repairs, indicating historic structural failure

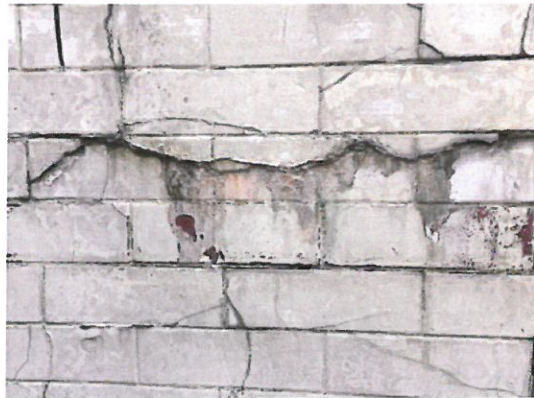
Exterior wall, severe movement and moisture ingress

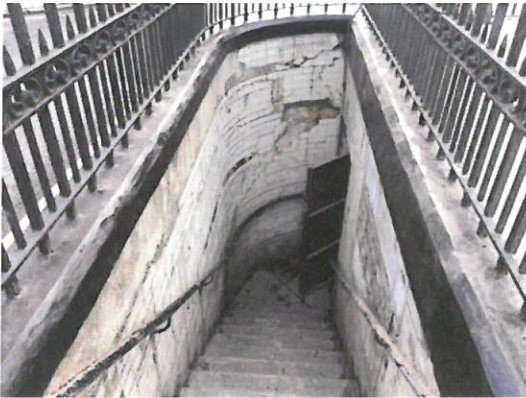
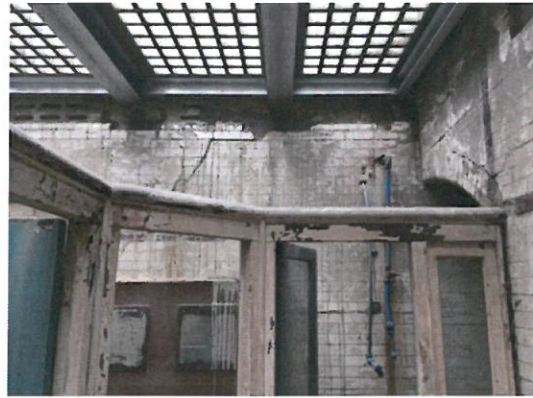
Generally in better condition than Gents Toilet,
Repairs required at high level

1. I suggest the best example of the existing tile decoration be repaired, ideally an internal wall in the Ladies toilet where structural failure and moisture ingress are not present. This wall could be restored to illustrate how the original Toilets were decorated, using handmade replacement Craven Dunnill tiles where necessary.

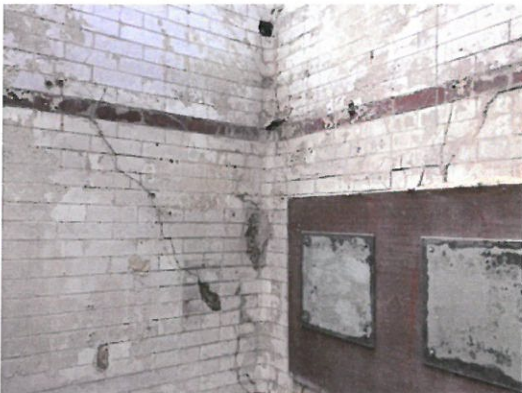
Severe structural crack, wall paint on tiles

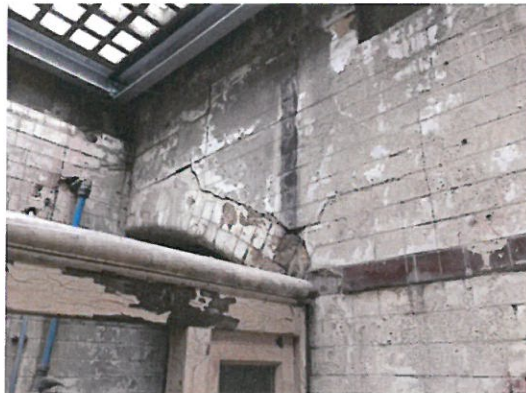
Arched lintel has failed, repaired by pinning or
removing and reinstating

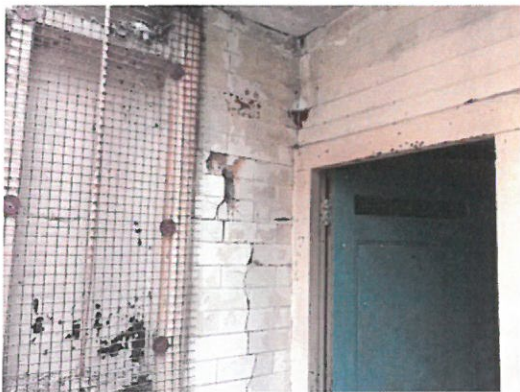
Severe cracking either side of entrance door, structural as well as cosmetic repairs required
