Note on the condition of the surfaces around the ash tree

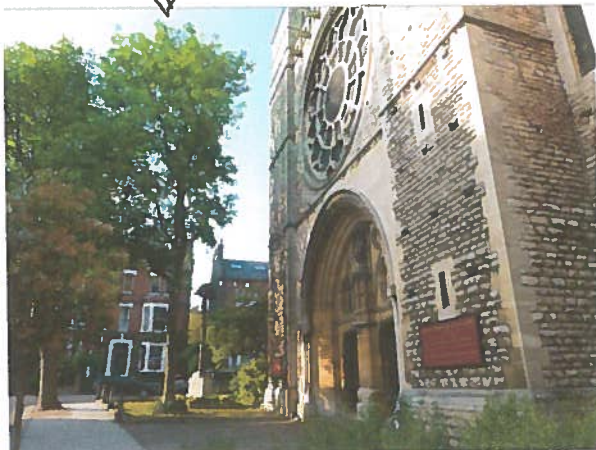
The plans, which have gained planning approval showed the retention of the tree within the new hard landscaping, however it has been increasingly the cause of disruption to the adjoining surfaces/ The photographs show the considerable effect of tree root activity, and it is a useful coincidence that the pavings and low wall are due to be replaced in the pending alteration work.

1. The tree root activity has been accelerating, and it will not be possible to protect the approved landscaping details without a re-design that incorporates a much larger un-paved area, which would encroach on the main circulation areas in front of the west doors.
2. The tree is relatively close to the building and a large London Plane on the public footpath, leaving the growth of its crown quite restricted to a vertical orientation that is at the point of outstripping the height of the building. The church would like to replace it with a smaller ornamental tree that would be easier to maintain. Historic photography indicates that the tree has only been there since the 1970's, and there is a keen desire to avoid future problems if major work is required that would disrupt the work being undertaken this year.

View from south

A recent report on the condition of the tree did not conclude that it was in a dangerous state, however we have two concerns that support the parish's proposal to replace it with a smaller ornamental tree.

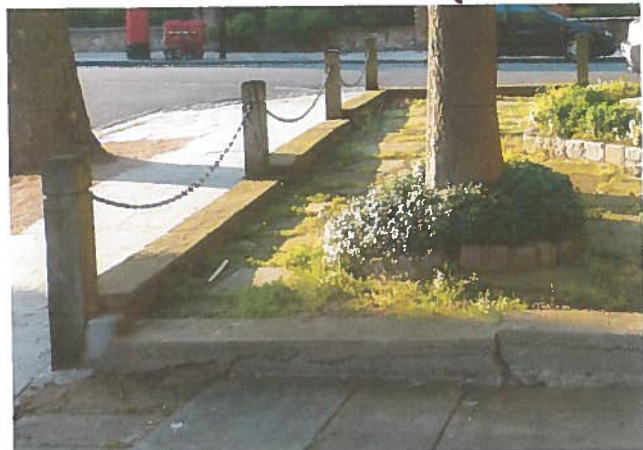
Detail at base

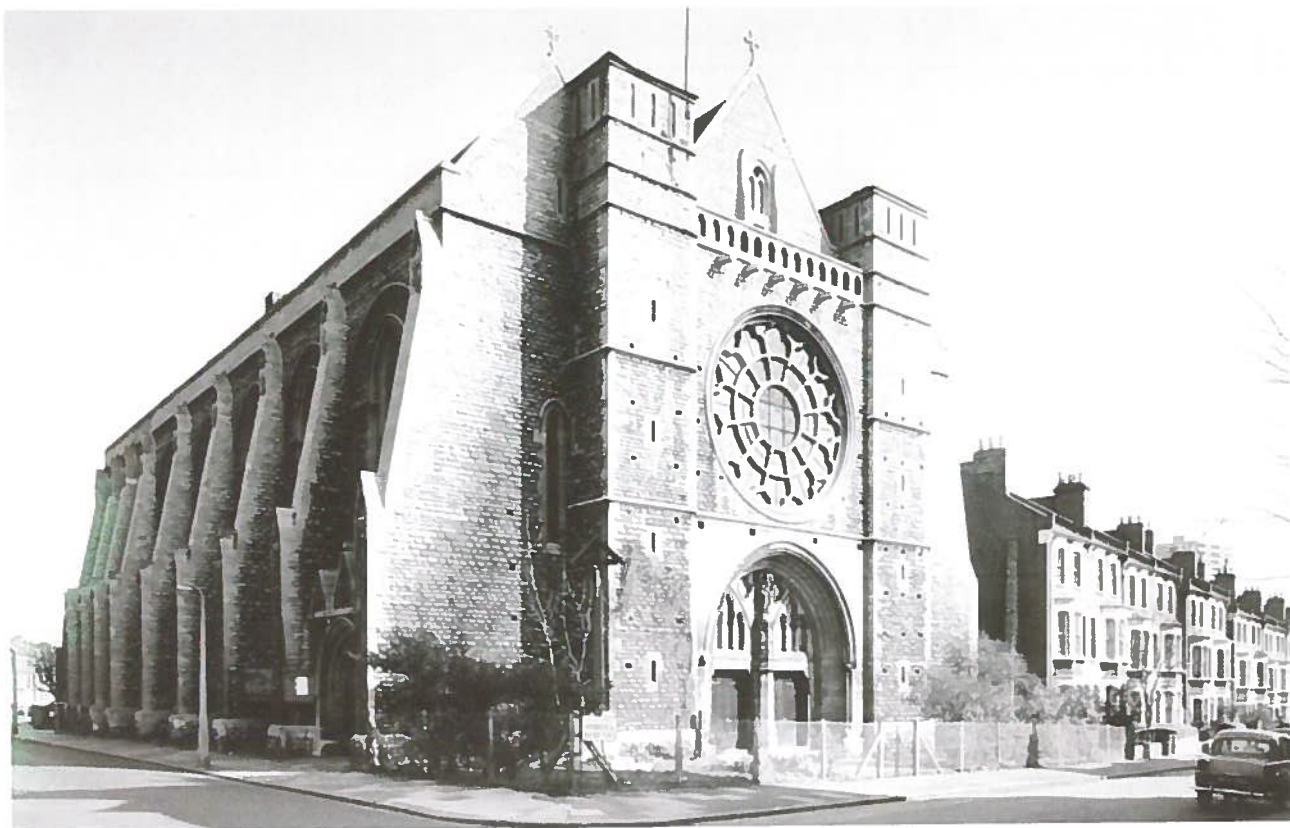
Overleaf – Photo from Historic England archive March 1967

The tree in question was not present in the photograph. The proposal to replace it, in connection with the approved landscaping work, will still result in the scene being much greener than depicted at that time.
