## Simon Pryce Arboriculture

### Report

**Site:** 91 Redington Road, London, NW3

**Subject:** Trees and proposed new summer house in the rear garden.

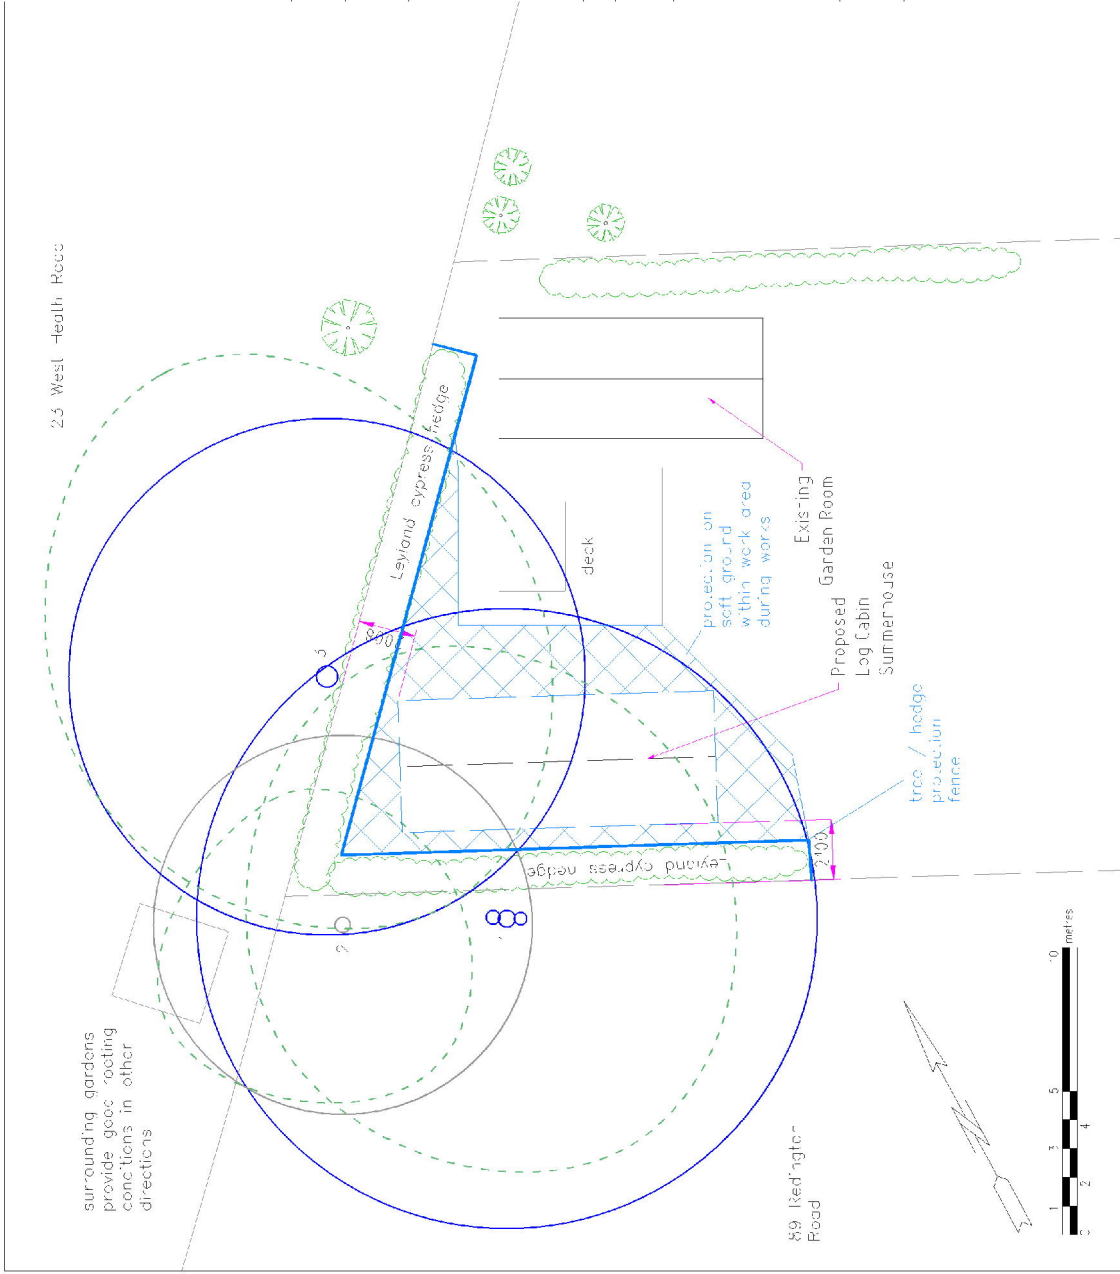
Title:  
Summer house in rear garden - proposed layout & tree protection plan (TPP)

- 5.1 The boundary fences will not impede root growth so the trees have uniform rooting conditions, possibly impeded slightly by the sunken deck, so the circular RPAs shown on the site plan will be a reasonably accurate reflection of actual root spread. The new building is completely within the RPA of tree 1 and extends into those of the other two to some degree. The table below shows the areas concerned relative to the RPA areas and the distance between the building and the trunk diameters. With tree 1 the diameter of 900mm is the equivalent single trunk with the same cross section as the existing three:

- 5.2 The areas affected by the building are relatively small percentages of the RPAs and, while the trees are not as resilient as younger specimens, these are within what healthy individuals like these will tolerate. The shape of the building in relation to the tree locations mean that it is fairly close to the trunks, but in all cases it is farther away than three times the diameter (D/T greater than 3), i.e. beyond where most of the structural roots will be. This indicates that the trees are not unduly vulnerable to direct damage from the construction of the foundations, particularly as they have unrestricted space for root growth in every other direction.

- 5.3 Some roots will inevitably be under the building and before any work starts it would be advisable to hand dig an exploratory trench round the building perimeter to check whether any large ones are present. Depending on their sizes and locations they can either be cut cleanly or worked round.

- 5.4 This is a small scale project with no access for heavy plant or machinery and the trees are all in adjacent gardens well away from the only access route, so they are not unduly vulnerable to incidental damage. Work space will be needed all around the building, so some protective measures would be needed to safeguard underlying roots and the boundary hedges. With light pedestrian traffic that can be achieved with heavy duty plywood or scaffold planks laid over a geotextile membrane and a layer of woodchip or similar material to even out any hollows. The hedge can be protected with sectional welded mesh fencing (Heras or similar) and heavy duty plywood.

- 5.5 The plan showing the proposed layout illustrates suitable layouts for fencing and ground protection and serves as the tree protection plan (TPP) recommended by BS5837:2012. Once the layout is finalised, these can be specified in more detail in an arboricultural method statement if required.
