**Michael  
Jackson  
Consulting**

## **Condition Survey of Existing Roof**

**The Forum  
9-17 Highgate Rd  
Kentish Town  
London  
NW5 1JY**

**Re-Roof to Main Auditorium**

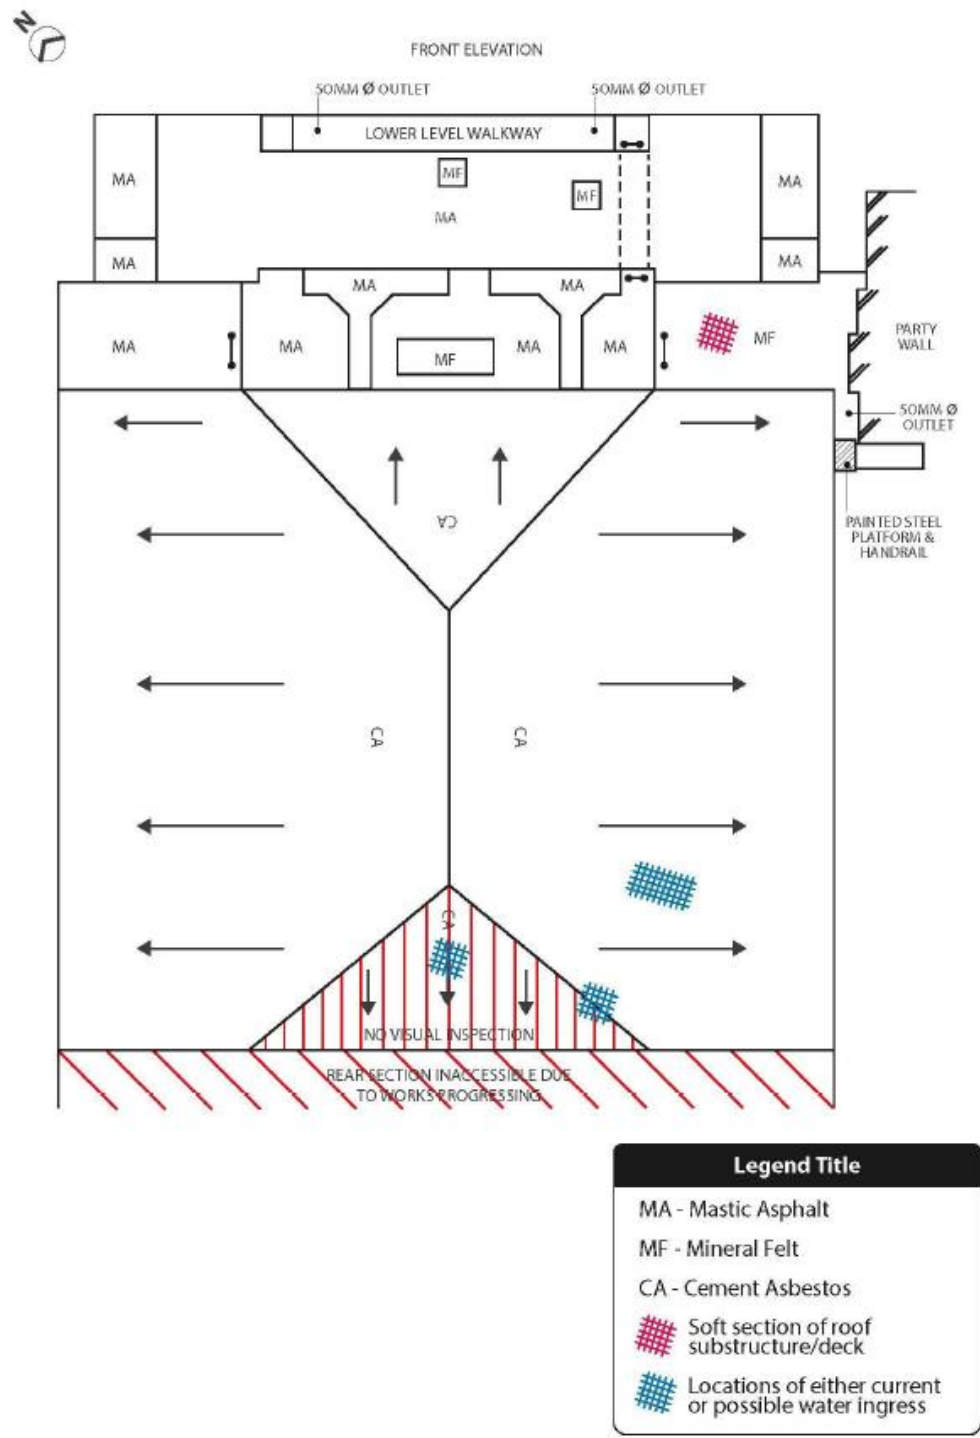
Figure 4—1 Roof Plan

Some sections of the lapped joints to the sheets are lifted with daylight evident from within the roof void which would suggest possible defective hook bolts in these locations. Eaves roof sheets to the south facing roof slope are impact damaged which could lead to water ingress in heavy rainfall.

Sections of the roof sheets to the north-east corner are damaged and liable to water ingress at present. Some roof sheets were noted to have been replaced historically with either similar or cement based roof sheets. As this type of roof covering is classified as a fragile roof covering access for repairs and replacement work is particularly difficult, in terms of safety, and costly. As noted within the structural assessment it is understood that there has been some more recent water ingress to parts of the roof void with buckets located beneath to catch and water.

The heads of some of the steel hook bolt fixings are corroded with some painted with either bitumen or Acrypol to prevent further deterioration. The bolts are thought to be original and water ingress around them will corrode and weaken their fixing strength in the long term.

The profiled cement asbestos roof covering will continue to leak due to the existing holes, raised roof sheets, poor temporary repairs, existing damaged sheets and generally poor and unsafe temporary access to all areas of the pitched roof (please refer to Figure 4-1 Roof Plan below).

Based upon the above we recommend that the roof covering is carefully removed in accordance with HSE guidelines and replaced with a new roof covering to provide a long-term watertight solution.

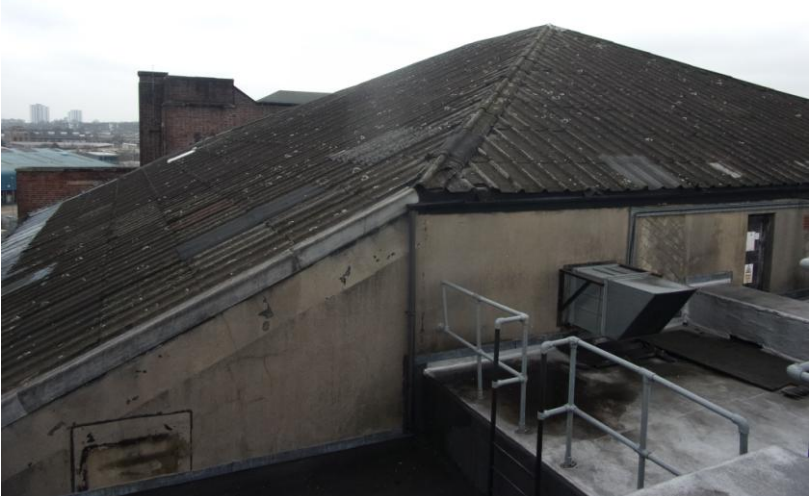
<b>Address:</b>	O2 Forum Kentish Town				<b>Report No:</b>	2687	
					<b>Survey Date:</b>	10/03/2016	
					<b>Surveyors:</b>	J Wilshaw	
<b>Area/Location:</b> Exterior							
<b>Position:</b> Pitched roof							
<b>Item /Material:</b> Cement sheets							
<b>Sample Taken:</b>	<b>YES</b>	<input checked="" type="checkbox"/>	<b>NO</b>	<input type="checkbox"/>	<b>Laboratory:</b>	WES	
<b>Sample Number:</b> 2687/01	<b>Analysis:</b> Chrysotile						
<b>Product Type</b>	<b>Extent of Damage</b>	<b>Surface Treatment</b>		<b>Asbestos Type</b>	<b>Material Assessment Score</b>	<b>Asbestos Material Type</b>	
Plastic/AC/Dec Finish 1	None 0	Plastics/Resin 0		Chrysotile 1			
AIB/Millboard/Woven/Paper 2	Low – Scratches/ Broken Edge 1	AC/Painted AIB/ Enclosed Ins/Spray 1		Amphibole excluding Crocidolite 2			
Ins/Spray Coating 3	Medium – Broken Boards/Debris 2	Unsealed AIB/ Sealed Ins/Spray 2		Crocidolite 3			
	High – Damaged Ins/Spray Debris 3	Unsealed Ins/Spray 3

1	1	1		1	4	Asbestos Cement	
<b>Extent of Material:</b>	>1000m <sup>2</sup>						
<b>Accessibility:</b>	Easy	<input type="checkbox"/>	Medium	<input type="checkbox"/>	Difficult	<input checked="" type="checkbox"/>	
<b>Recommendations:</b>	Manage Risk						
<b>Comments:</b>	Damage evident to various perimeter panels, rainwater goods and service pipework is of UPVC and metal.

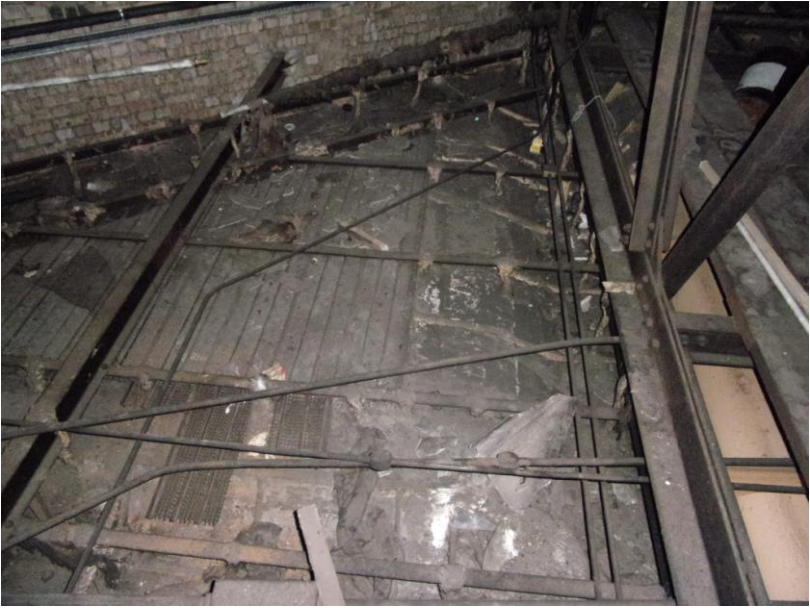
<b>Address:</b>	O2 Forum Kentish Town				<b>Report No:</b> 2687	
					<b>Survey Date:</b> 10/03/2016	
					<b>Surveyors:</b> J Wilshaw	
<b>Area/Location:</b> Roof void						
<b>Position:</b> Above dome						
<b>Item /Material:</b> Cement sheet debris						
<b>Sample Taken:</b>		<b>YES</b>	<input checked="" type="checkbox"/>	<b>NO</b>	<input type="checkbox"/>	<b>Laboratory:</b> WES
<b>Sample Number:</b> 2687/05		<b>Analysis:</b> Chrysotile				
<b>Product Type</b>	<b>Extent of Damage</b>	<b>Surface Treatment</b>		<b>Asbestos Type</b>	<b>Material Assessment Score</b>	<b>Asbestos Material Type</b>
Plastic/AC/Dec Finish 1	None 0	Plastics/Resin 0		Chrysotile 1		
AIB/Millboard/Woven/Paper 2	Low – Scratches/ Broken Edge 1	AC/Painted AIB/ Enclosed Ins/Spray 1		Amphibole excluding Crocidolite 2		
Ins/Spray Coating 3	Medium – Broken Boards/Debris 2	Unsealed AIB/ Sealed Ins/Spray 2		Crocidolite 3		
	High – Damaged Ins/Spray Debris 3	Unsealed Ins/Spray 3

1	1	1		1	4	<b>Asbestos Cement</b>
<b>Extent of Material:</b>		Various Areas				
<b>Accessibility:</b>		Easy		Medium	<input checked="" type="checkbox"/>	Difficult
<b>Recommendations:</b>		Manage Risk				
<b>Comments:</b>		Damaged pieces of asbestos cement roof sheet material is present to the floor area of the void. Small pieces evident throughout.
