Asbestos Survey Report
Project Ref. No: 111867
19A Rowley Way
Refurbishment survey

London Borough of Camden

19A Rowley Way

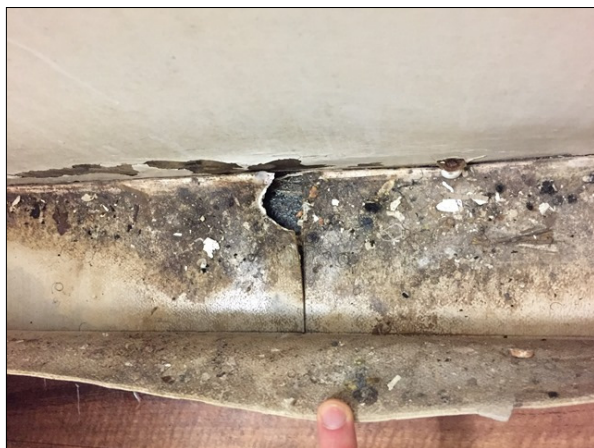
General			
Inspection Dates:	26/01/2017 to 26/01/2017	Reference No.:	01a
Surveyor:	MH		
Component:	Bitumen		
Asbestos?:	No asbestos detected		
Asbestos type(s):	N/A

Risk Analysis			
Condition:	N/A	Accessibility:	N/A
Friability:	N/A	Exposure:	N/A
Surface:	N/A	Amount:	N/A
Position:	N/A	RISK:	NONE

Asbestos cream vinyl floor tiles with bitumen under lino (Asbestos is in the bitumen only). (5 sqm.)

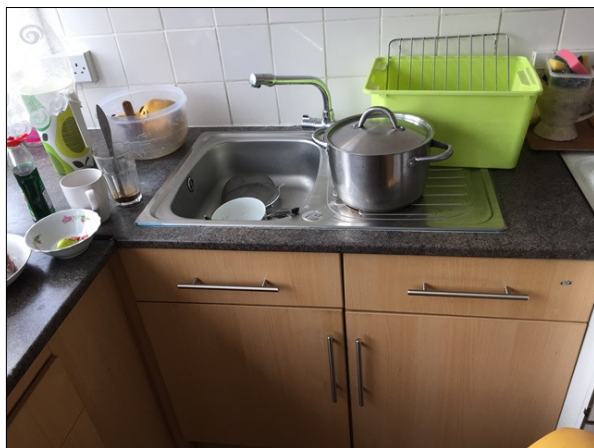
General			
Inspection Dates:	26/01/2017 to 26/01/2017	Reference No.:	02a
Surveyor:	MH		
Component:	Bitumen		
Asbestos?:	No asbestos detected		
Asbestos type(s):	N/A

Risk Analysis			
Condition:	N/A	Accessibility:	N/A
Friability:	N/A	Exposure:	N/A
Surface:	N/A	Amount:	N/A
Position:	N/A	RISK:	NONE

Non asbestos bitumen sink pad. (<1 sqm.)

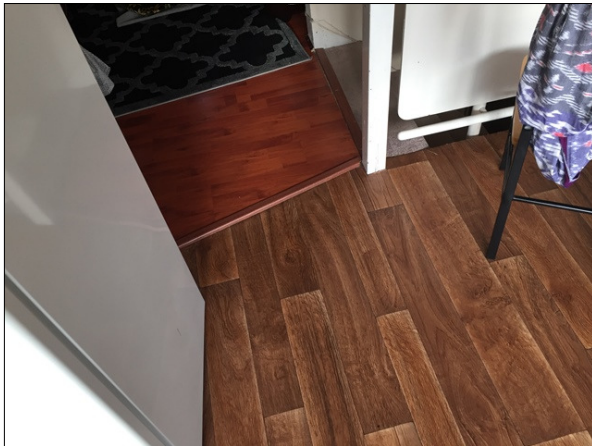
General			
Inspection Dates:	26/01/2017 to 26/01/2017	Reference No.:	NA001
Surveyor:	MH		
Component:	Presumed ACM		
Asbestos?:	Presumed		
Asbestos type(s):	Amosite, chrysotile, crocidolite, anthophyllite, actinolite, tremolite

Risk Analysis			
Condition:	High damage/delamination	Accessibility:	Routinely disturbed (3)
Friability:	High	Exposure:	Public
Surface:	Unsealed coatings and lagging	Amount:	<= 10 sq m (1)
Position:	Room up to 100 sq m (2)	RISK:	HIGH (12)

No access under laminate flooring - Damage limitations.

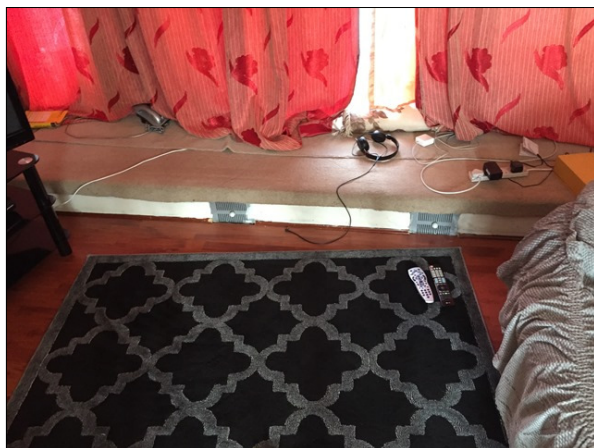
General			
Inspection Dates:	26/01/2017 to 26/01/2017	Reference No.:	NA002
Surveyor:	MH		
Component:	Presumed ACM		
Asbestos?:	Presumed		
Asbestos type(s):	Amosite, chrysotile, crocidolite, anthophyllite, actinolite, tremolite

Risk Analysis			
Condition:	High damage/delamination	Accessibility:	Routinely disturbed (3)
Friability:	High	Exposure:	Public
Surface:	Unsealed coatings and lagging	Amount:	<= 10 sq m (1)
Position:	Room up to 100 sq m (2)	RISK:	HIGH (12)

No access within sealed timber boxing -
Damage limitations.

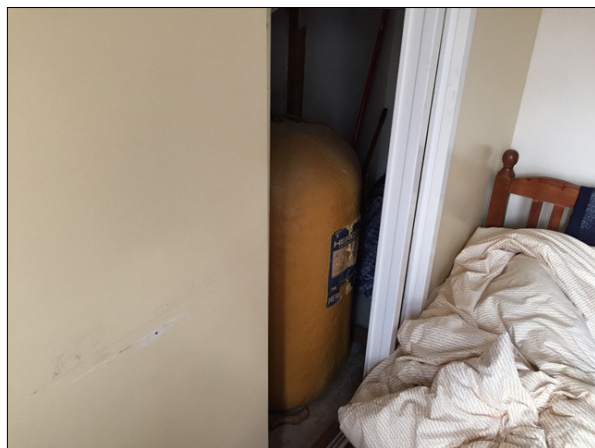
General			
Inspection Dates:	26/01/2017 to 26/01/2017	Reference No.:	NA003
Surveyor:	MH		
Component:	Presumed ACM		
Asbestos?:	Presumed		
Asbestos type(s):	Amosite, chrysotile, crocidolite, anthophyllite, actinolite, tremolite

Risk Analysis			
Condition:	High damage/delamination	Accessibility:	Routinely disturbed (3)
Friability:	High	Exposure:	Public
Surface:	Unsealed coatings and lagging	Amount:	<= 10 sq m (1)
Position:	Room up to 100 sq m (2)	RISK:	HIGH (12)

Limited access within Bed Cup - Stored items and furniture - Viewed from door only.

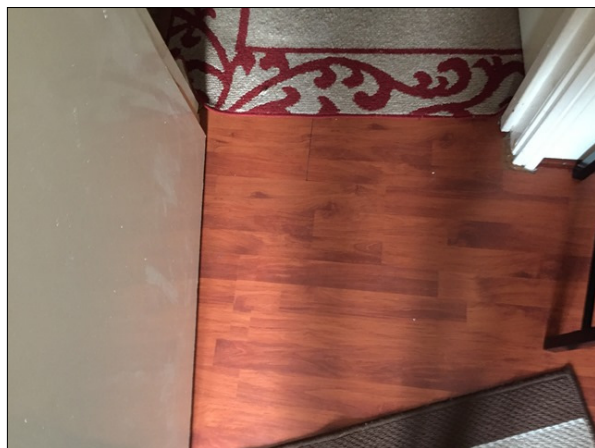
General			
Inspection Dates:	26/01/2017 to 26/01/2017	Reference No.:	NA004
Surveyor:	MH		
Component:	Presumed ACM		
Asbestos?:	Presumed		
Asbestos type(s):	Amosite, chrysotile, crocidolite, anthophyllite, actinolite, tremolite

Risk Analysis			
Condition:	High damage/delamination	Accessibility:	Routinely disturbed (3)
Friability:	High	Exposure:	Public
Surface:	Unsealed coatings and lagging	Amount:	<= 10 sq m (1)
Position:	Room up to 100 sq m (2)	RISK:	HIGH (12)

No access under laminate flooring - Damage limitations.

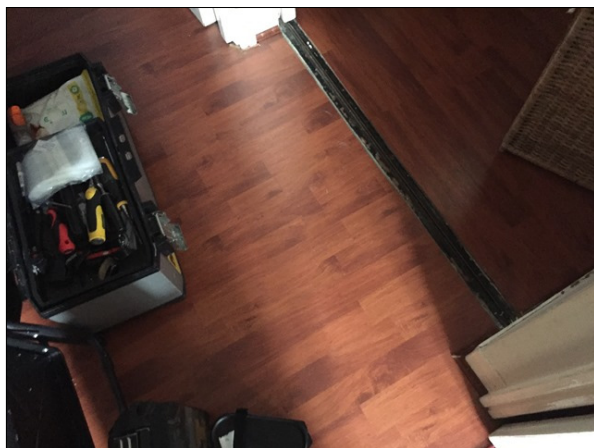
General			
Inspection Dates:	26/01/2017 to 26/01/2017	Reference No.:	NA005
Surveyor:	MH		
Component:	Presumed ACM		
Asbestos?:	Presumed		
Asbestos type(s):	Amosite, chrysotile, crocidolite, anthophyllite, actinolite, tremolite

Risk Analysis			
Condition:	High damage/delamination	Accessibility:	Routinely disturbed (3)
Friability:	High	Exposure:	Public
Surface:	Unsealed coatings and lagging	Amount:	<= 10 sq m (1)
Position:	Room up to 100 sq m (2)	RISK:	HIGH (12)

No access under laminate flooring - Damage limitations.

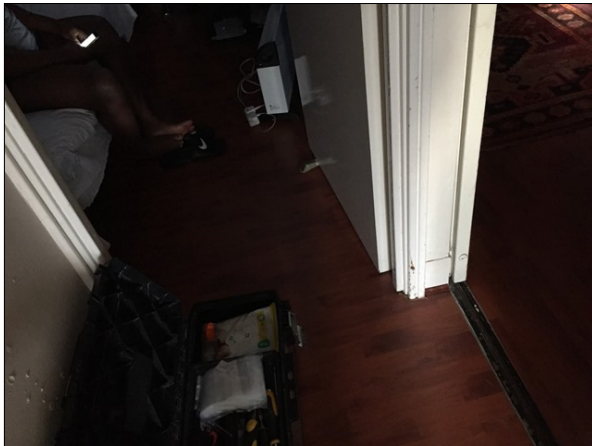
General			
Inspection Dates:	26/01/2017 to 26/01/2017	Reference No.:	NA006
Surveyor:	MH		
Component:	Presumed ACM		
Asbestos?:	Presumed		
Asbestos type(s):	Amosite, chrysotile, crocidolite, anthophyllite, actinolite, tremolite

Risk Analysis			
Condition:	High damage/delamination	Accessibility:	Routinely disturbed (3)
Friability:	High	Exposure:	Public
Surface:	Unsealed coatings and lagging	Amount:	<= 10 sq m (1)
Position:	Room up to 100 sq m (2)	RISK:	HIGH (12)

No access under laminate flooring - Damage limitations.

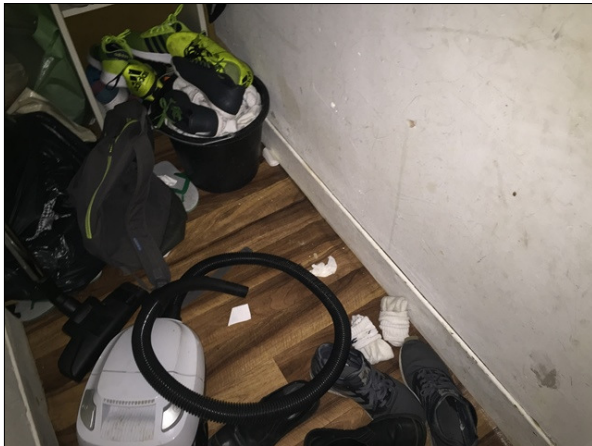
General			
Inspection Dates:	26/01/2017 to 26/01/2017	Reference No.:	NA007
Surveyor:	MH		
Component:	Presumed ACM		
Asbestos?:	Presumed		
Asbestos type(s):	Amosite, chrysotile, crocidolite, anthophyllite, actinolite, tremolite

Risk Analysis			
Condition:	High damage/delamination	Accessibility:	Routinely disturbed (3)
Friability:	High	Exposure:	Public
Surface:	Unsealed coatings and lagging	Amount:	<= 10 sq m (1)
Position:	Room up to 100 sq m (2)	RISK:	HIGH (12)

No access under laminate flooring - Damage limitations.
