#### 1.0 INTRODUCTION

Further to the completion of our visual structural inspection undertaken October 2015, J P Chick and Partners have been appointed by Mr Michael Citron, to undertake the intrusive investigation recommended in our original report to confirm the existing construction and provide a preliminary structural arrangement for consideration. This report shall be read in conjunction with our original report.

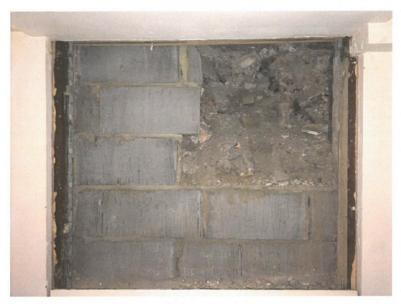
The clients' builder removed the finishing panel and an area of blockwork used to infill what is believed to be a window / coal chute which revealed the presumed void to be filled with what appeared to be general construction rubble; crushed concrete, masonry and the like.

Photo A – Blockwork removed from window / coal chute revealing construction rubble material.

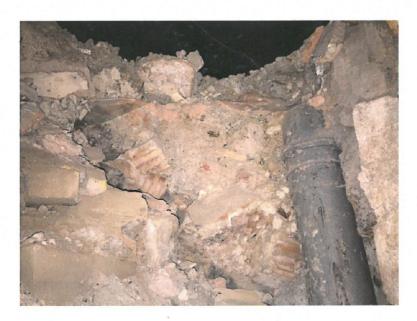
The ground floor slab of the butchers was visible which we consider to be bearing on the fill material. A vertical plastic pipe was also visible immediately to the right of the opening which when traced back through the building is believed to be a rainwater downpipe that serves the rear extension roof. It is considered that this pipe along with other rainwater and foul water pipes from the rear of the building are routed down to the basement, across to the front elevation where they discharge into a sewer within Regents Park Road.

Photo B – Rainwater pipe and underside of slab to butchers preparation area.

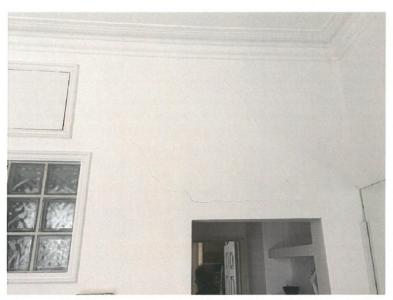
The cracking observed during our initial inspection to the load bearing wall has spread although the crack widths have remained similar. The previous distortions observed to the doorway and floor do not appear to have worsened.

Photo C - Cracking to internal load bearing wall appears to have spread, crack widths have remained static.

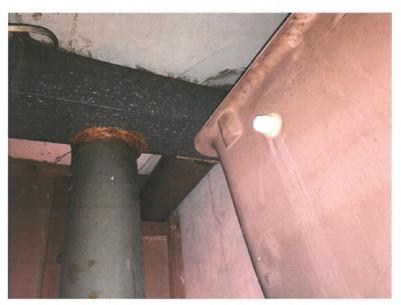
We inspected the internal structure, joist spans and load bearing walls via an existing hatch in the suspended ceiling located within the bathroom. Unfortunately, the joist spans were hidden behind what appeared to be the original lathe and plaster finishes. A single duct was observed above the suspended ceiling which presumably provides air extraction / ventilation which were traced through the flat to a vent in the rear wall.

Photo D - Air extraction / ventilation ducting within suspended ceiling located within Bathroom.

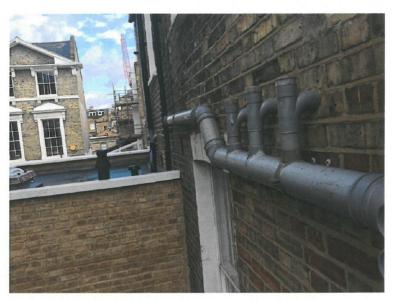
Photo E – Existing assumed foul water pipework from 2<sup>nd</sup> floor flat to be relocated.
