Refurbishment and Demolition Asbestos Survey

Magnet
65-67 Holmes Road
London
NW5 3AU

Ref: ACE1842

28th November 2016

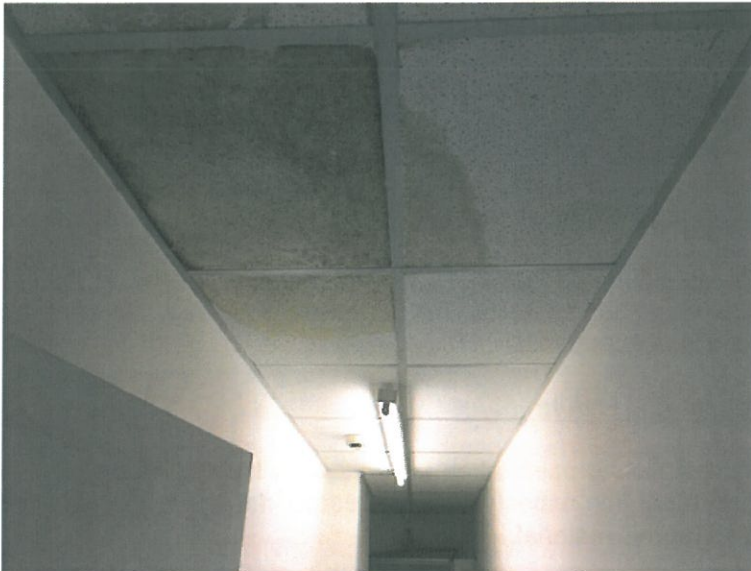
Sample reference 01 – Ceiling tiles

The bulk sample of tile taken from the ceiling located in the side store has proven negative to contain asbestos, ***no asbestos detected***, therefore no further action is required for this material.

Sample 01 – Ceiling tiles – ***No asbestos detected.***

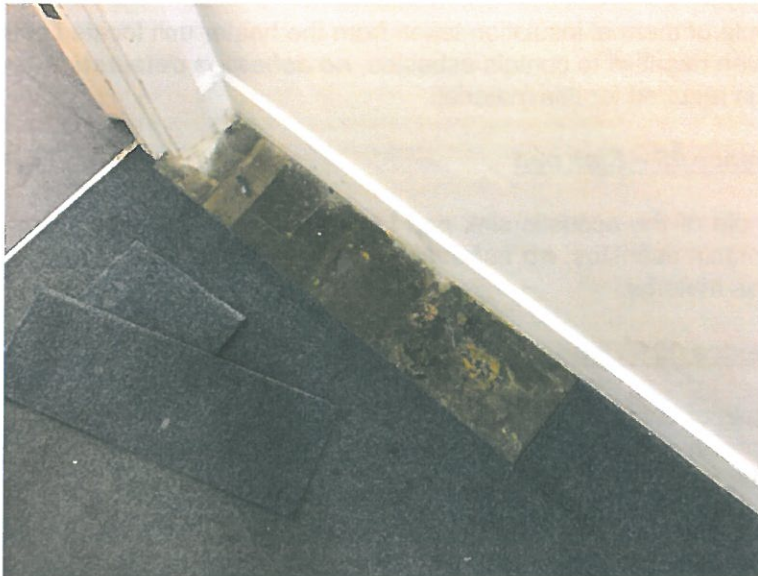
Sample reference 02 – Bitumen adhesive

The bulk sample of bitumen adhesive taken from the floor located in the offices has proven negative to contain asbestos, ***no asbestos detected***, therefore no further action is required for this material.

Sample 02 – Bitumen adhesive to floor – ***No asbestos detected.***

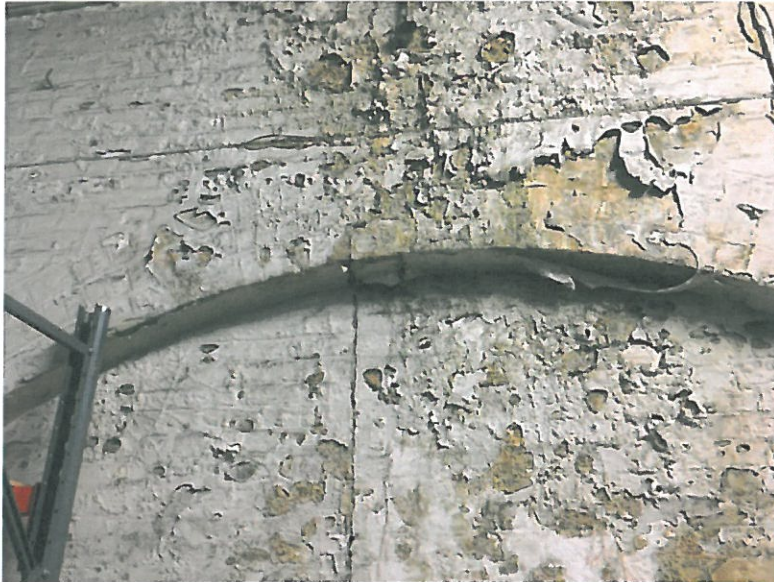
Sample reference 03 – Flaking paint

The bulk sample of flaking paint taken from the wall located in the plant area has proven negative to contain asbestos, ***no asbestos detected***, therefore no further action is required for this material.

Sample 03 – Flaking paint to wall – *No asbestos detected.*

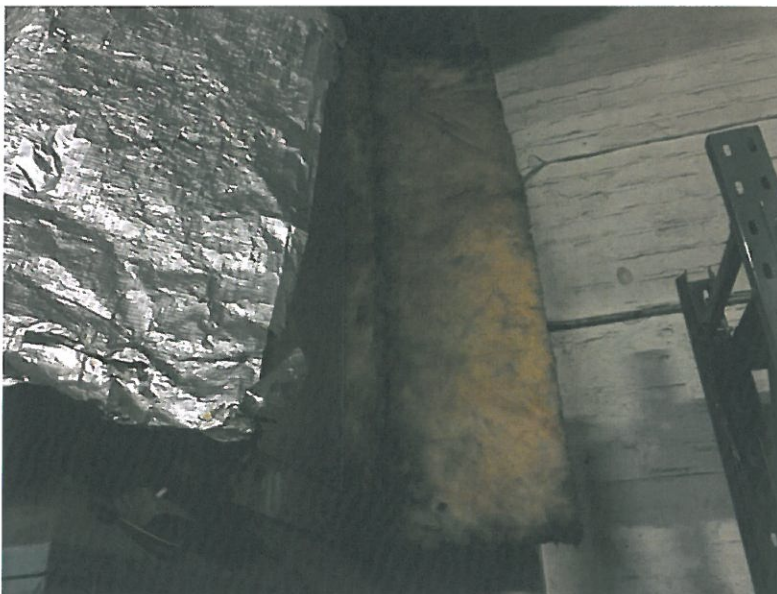
Sample reference 04 – Thermal insulation

The bulk sample of thermal insulation taken from the heater unit located in the plant room has proven negative to contain asbestos, ***no asbestos detected***, therefore no further action is required for this material.

Sample 04 – Thermal insulation to heater unit – *No asbestos detected.*

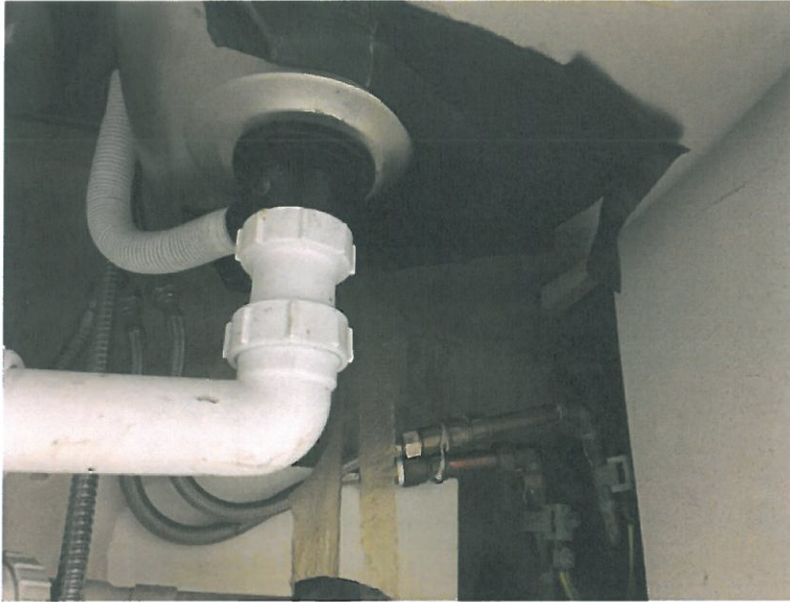
Sample reference 05 – Sink pad

The bulk sample of the acoustic sink pad taken from the kitchen sink has proven negative to contain asbestos, ***no asbestos detected***, therefore no further action is required for this material.

Sample 05 – Acoustic sink pad – *No asbestos detected.*

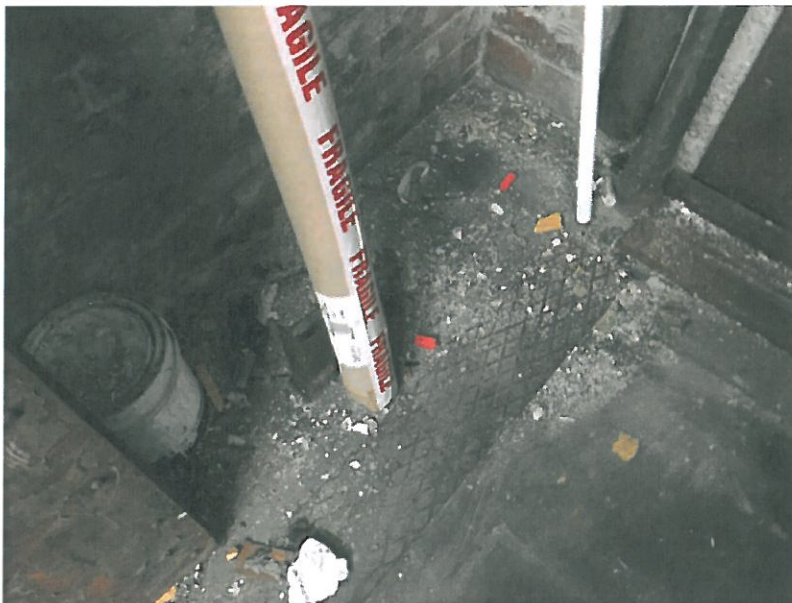
Sample reference 06 – Debris

The bulk sample of debris taken from the floor located in the warehouse has proven negative to contain asbestos, ***no asbestos detected***, therefore no further action is required for this material.

Sample 06 – Debris to floor – *No asbestos detected.*
