Cooper Associates

CA3559.01

22 September 2016

1 Marquis Road - 22a Canteloves Road, London NW1.

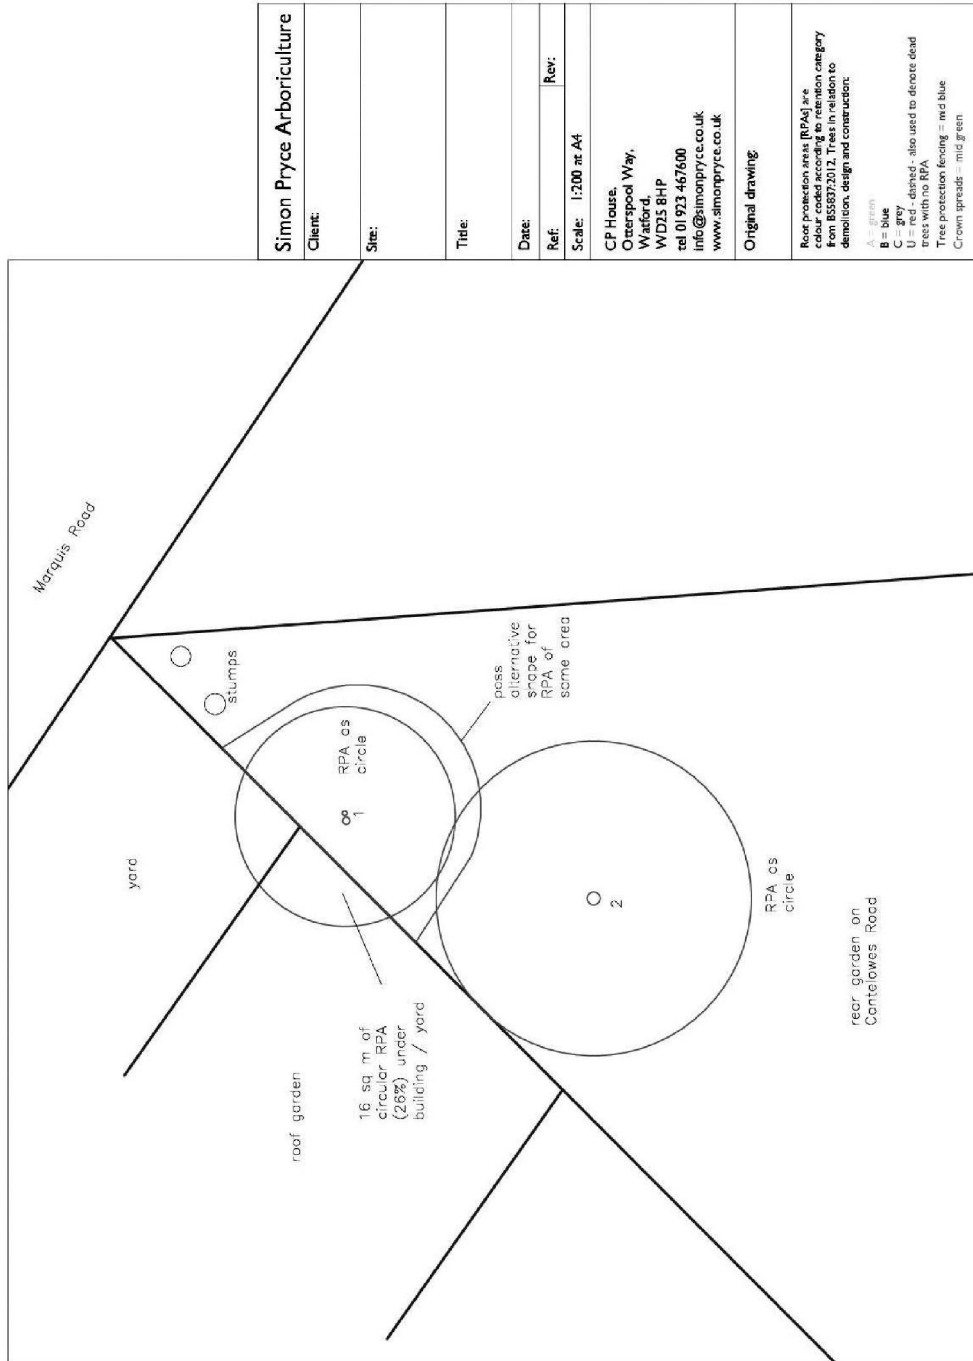
These are shown on your Arboriculturalist's site plan, which we attach at our fig one. We estimate the two sycamore trees to be 1.8 m and 6.4 m away from your single story building and that they are both in excess of 15 m high.

Fig 1:
Basic plan layout showing your property and the adjacent trees.

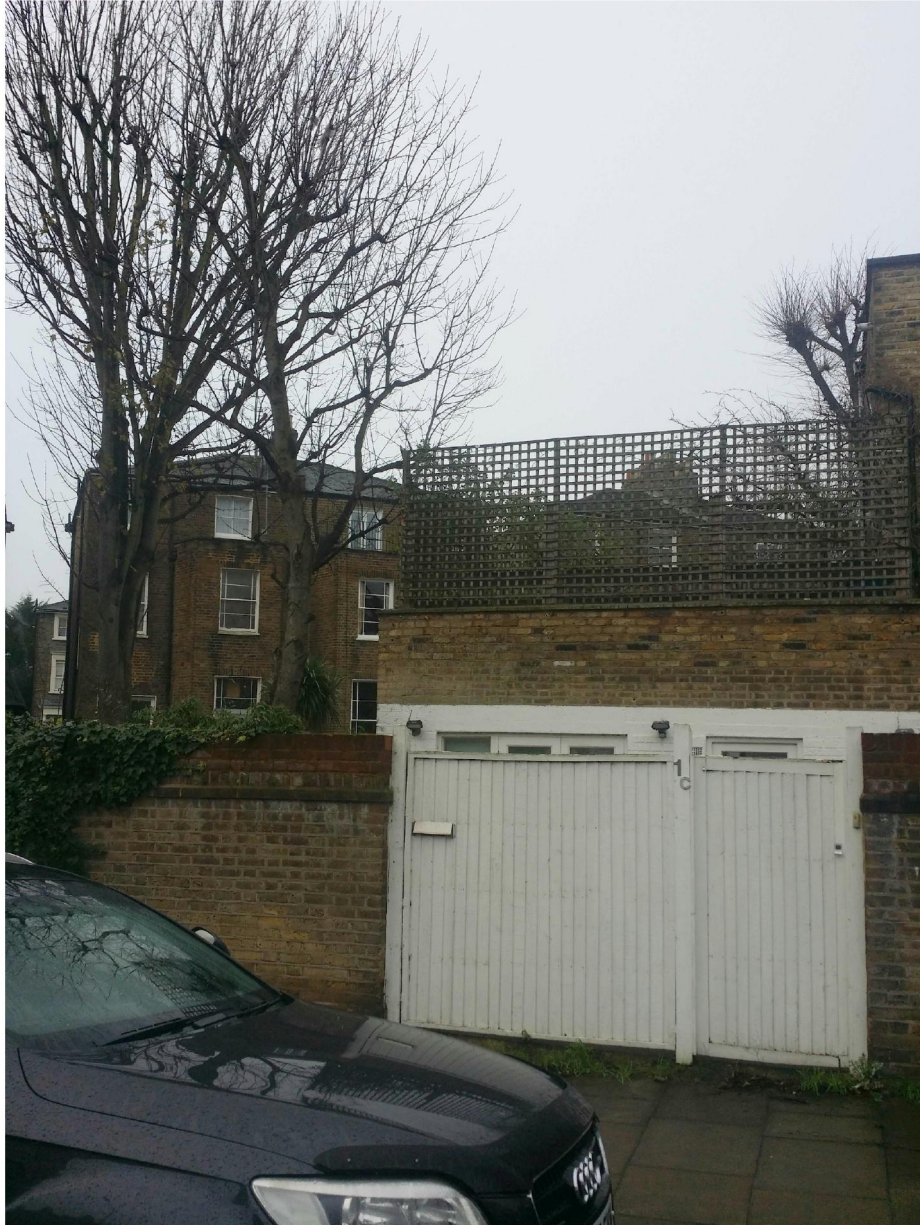
Photo one: shows property from the road, with trees to the left.

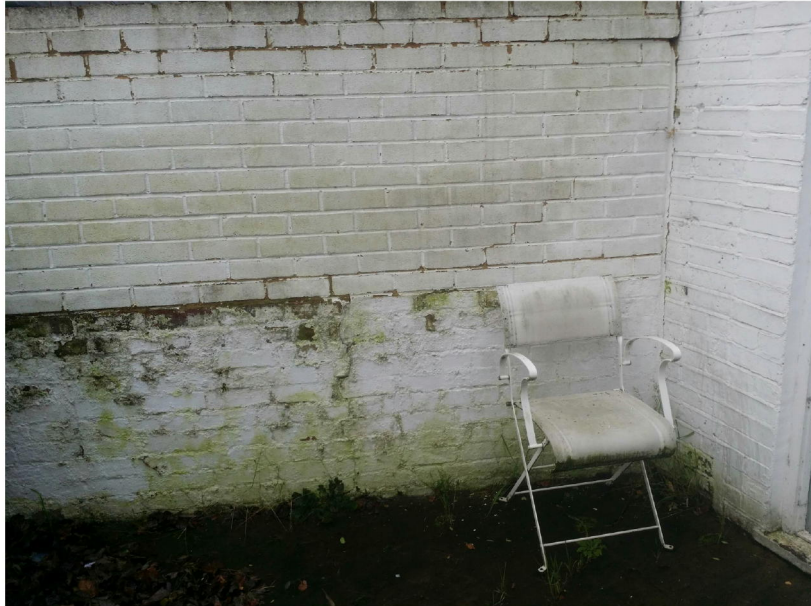
Although the boundary wall is 225 mm wide, below the neighbours ground level (approximately 800 millimetres higher than your front ground level), it is only a half brick or 100 mm wide above the higher ground level. This brickwork is badly cracked in places and is potentially unsafe, in particular if lent against.

Photo two: shows left hand boundary wall with cracking. Lower section is 225 mm thick brickwork; the upper more modern section is 100 mm thick.

We recommend that the long-term solution would be to have the nearest tree taken down and the old tree stump that is pushing on the boundary wall, removed; however this action could in itself cause damage.

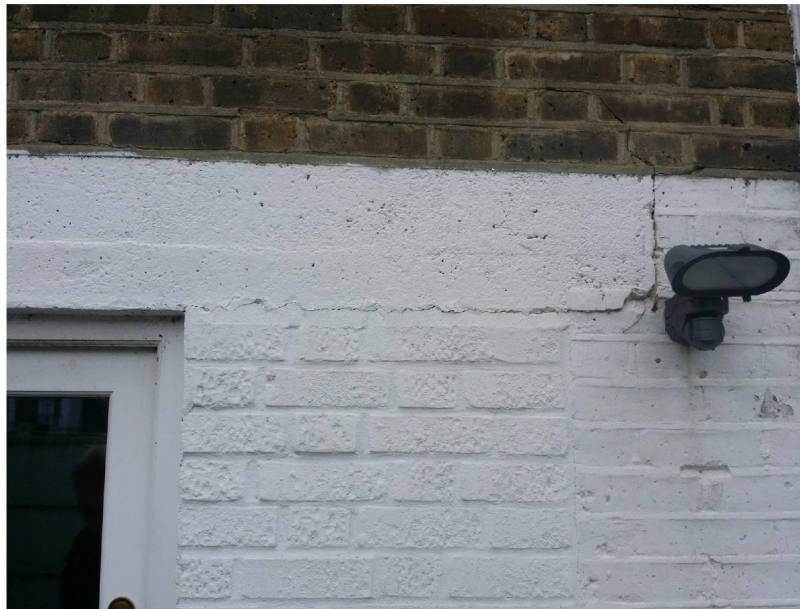
As the various photos attached to this report show, the front elevation of the building has suffered from foundation movement. Cracking can be seen around the concrete lintel over the wide opening, which would originally have been the entrance to the garage. The boundary garden wall between the two properties has movement cracks.

Photo three: shows cracking around the right-hand bearing of the main lintel.

Should you become aware that either of these problems is occurring, you should have the cracking made good, either by

injecting a sealant or by injecting an epoxy resin into the crack, to tie the brickwork together.

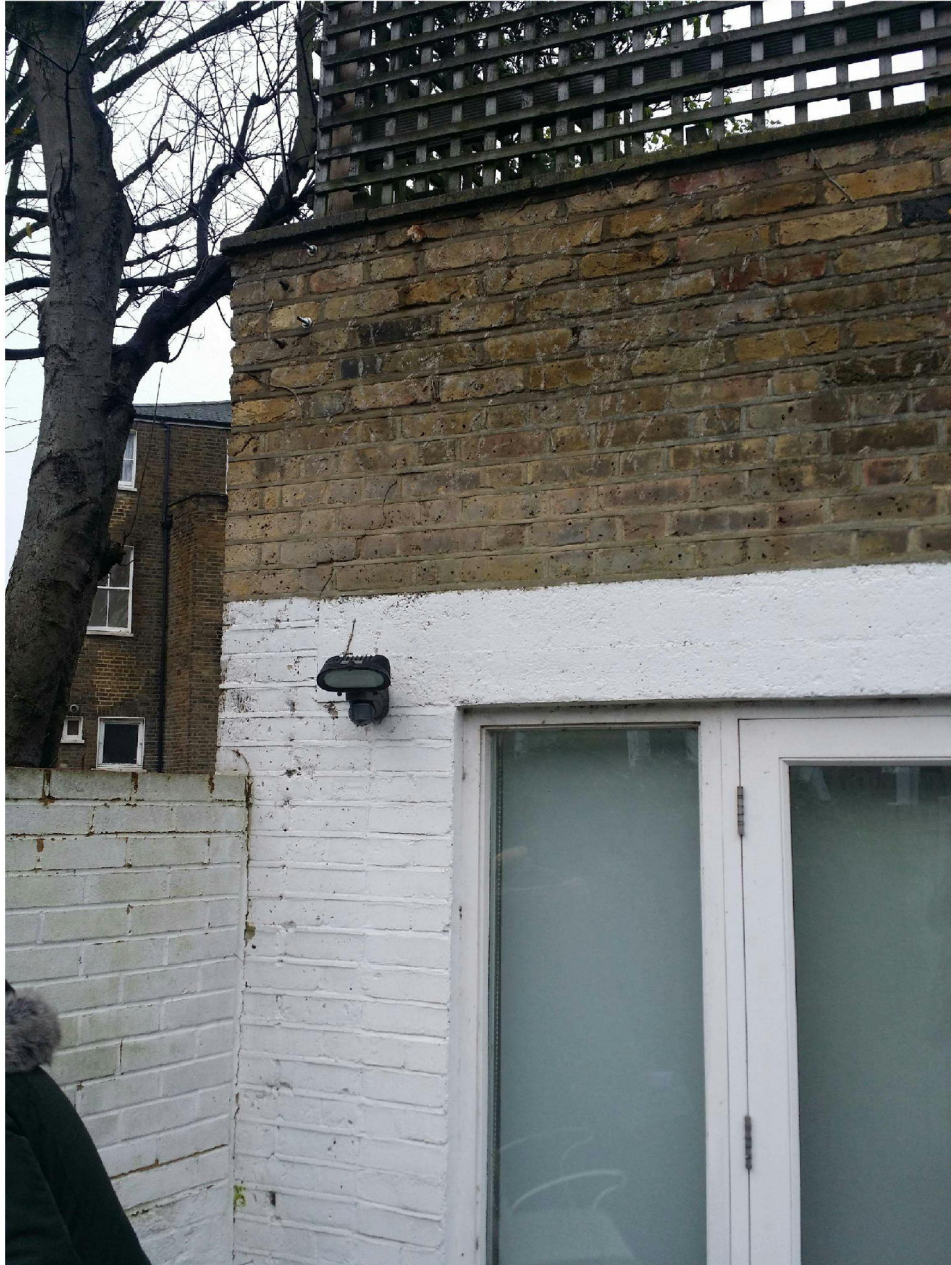
Photo four, shows diagonal cracking above the left-hand bearing of the lintel.
