13 Kemplay Road, Hampstead

Tree Survey Report (updated)

16th September 2016

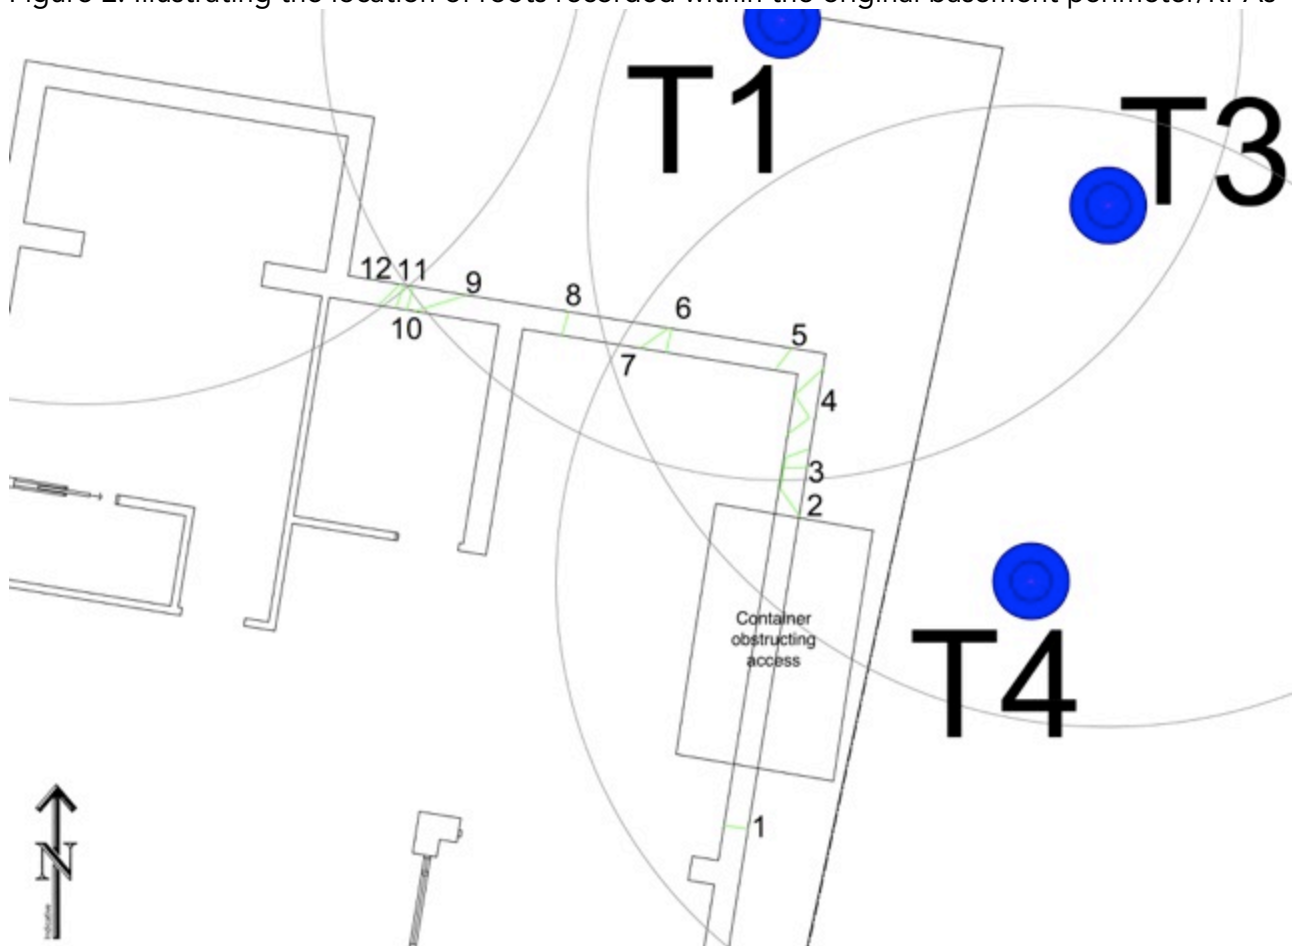
Figure 2: Illustrating the location of roots recorded within the original basement perimeter/RPAs

Many roots were identified but only roots with a diameter of 20mm or above were recorded. For the purpose of presenting the results, each recorded root has been assigned a number from 1 to 12 as per the following photographs, which can be cross-referenced with Figure 2 below.

In relation to T1 and T3-4 and the exploratory root investigations, of the twelve roots identified in Section 3, the majority (10) have a diameter of 25mm or below and two roots have a diameter 35mm.

The majority of the roots found are 25mm or below which indicates they can be pruned if necessary in accordance with the BS. However, two of the roots found on the northern flank of the proposed basement line are above 25mm in diameter and considering the limited rooting space of T1, these roots are considered to be significant and should therefore be retained as detailed in a subsequent section.

To minimise the impact of the proposed works on the trees, it is recommended that the excavation line of the northern flank is moved one metre south from the current position, which will ensure that a total of 5.5m² of available rooting space can be retained. Refer to the accompanying Root Location Plan, reference number 16_1206_RLP_NT_Rev_A for the relationship between the survey trench and the revised extent of the proposed basement. The wall of the ground floor can continue along the line of the exiting dwelling as the foundation can be cantilevered from the basement wall.

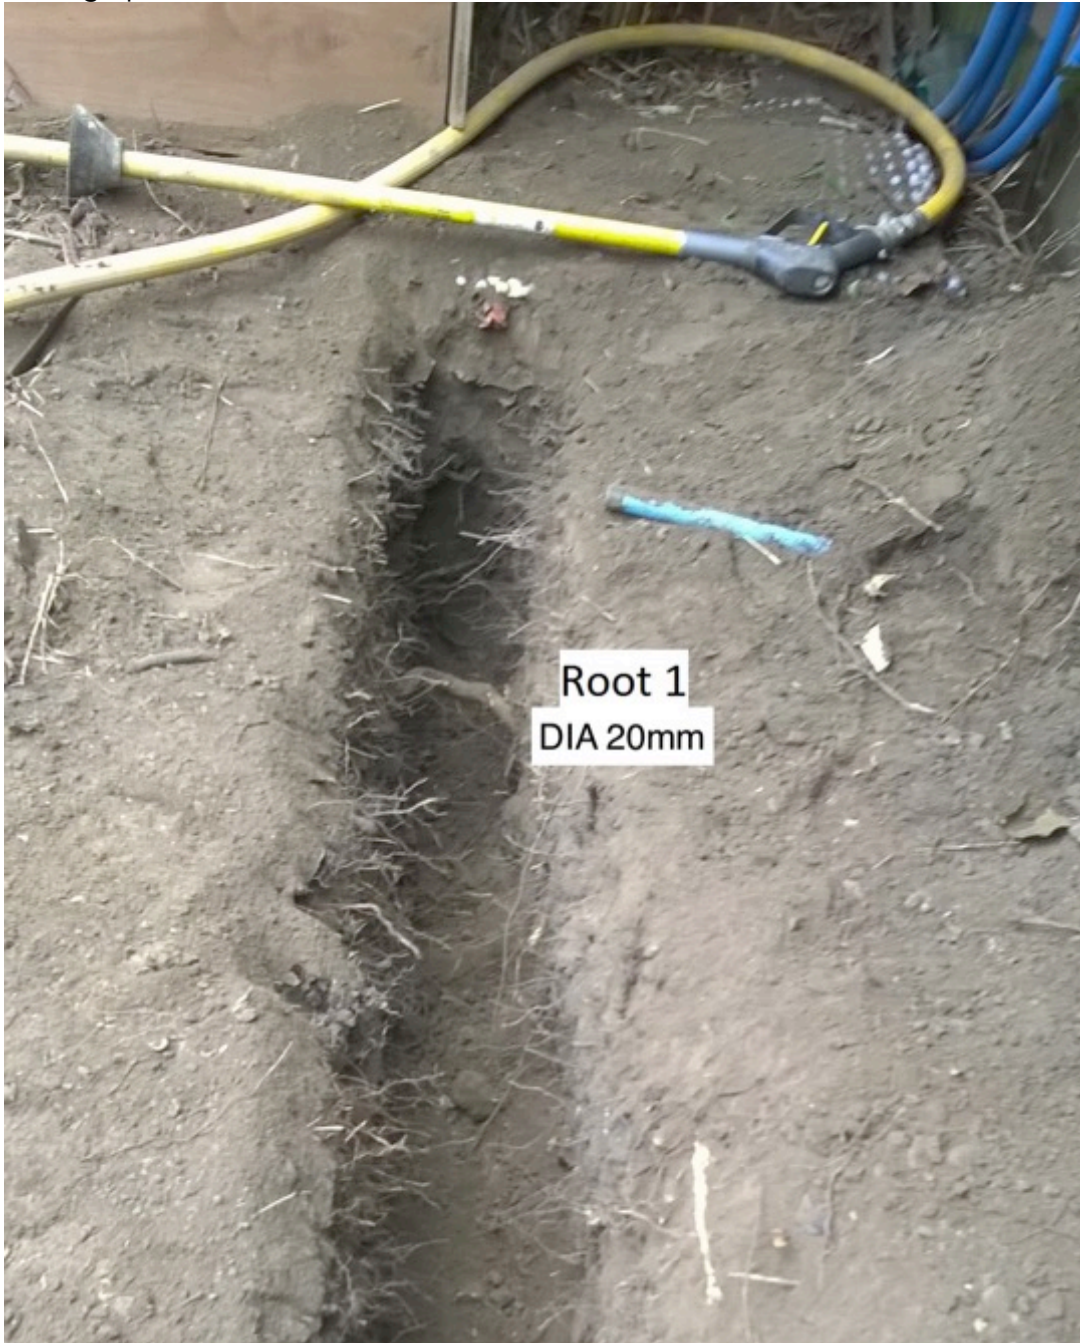
Photograph 1: Root 1

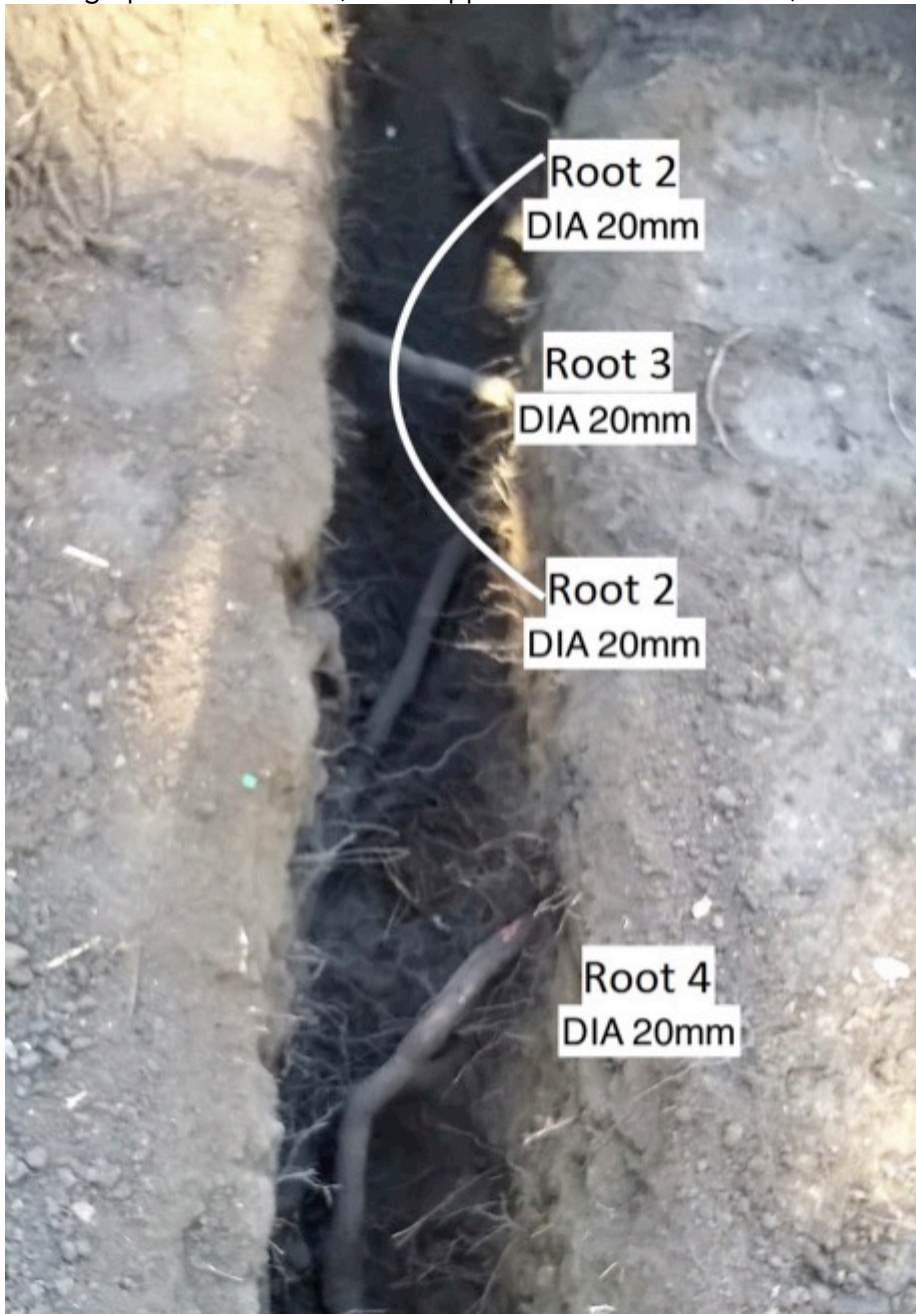
Photograph 2: Roots 2-4 (root 2 appears twice in the trench)

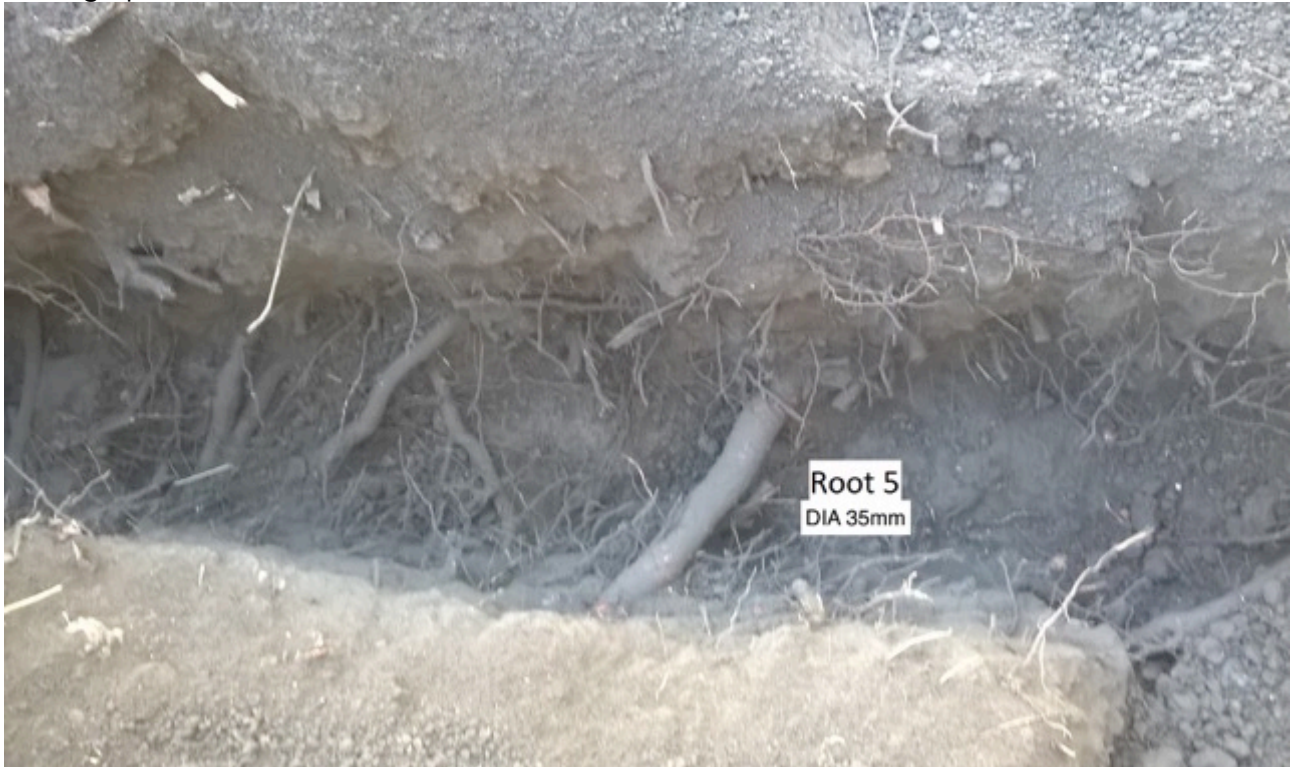
Photograph 3: Root 5

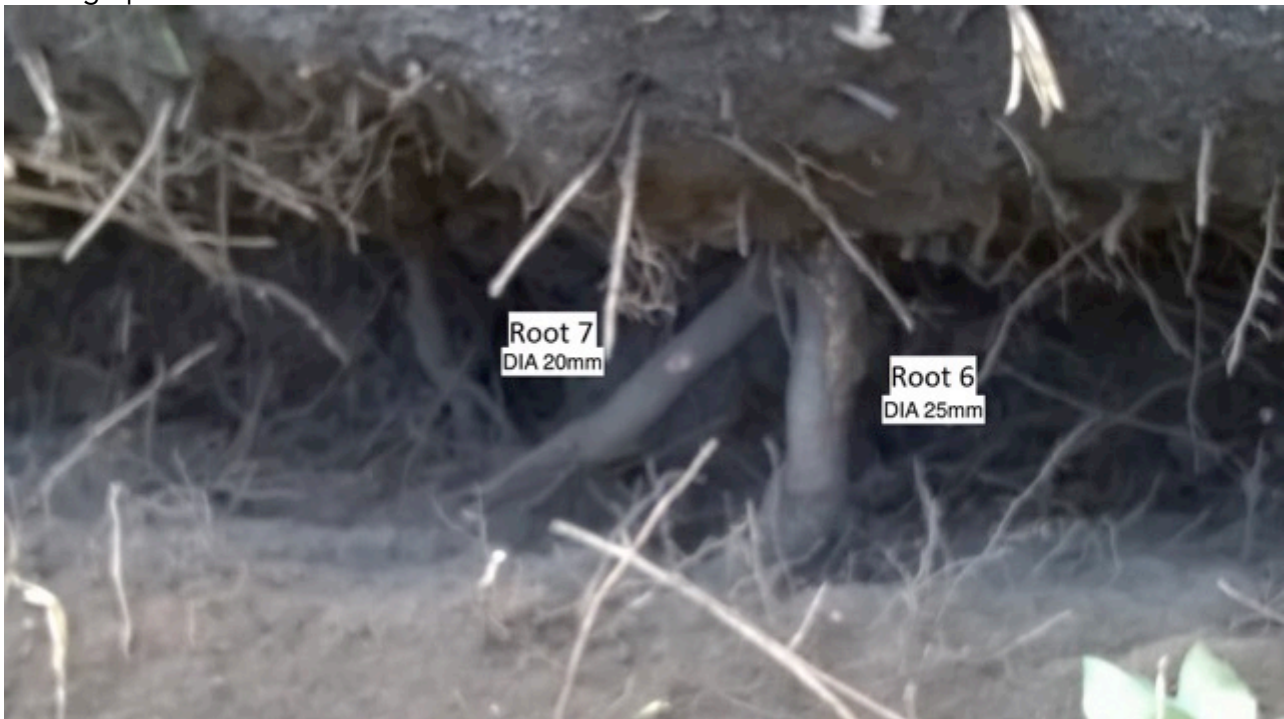
Photograph 4: Root 6-7

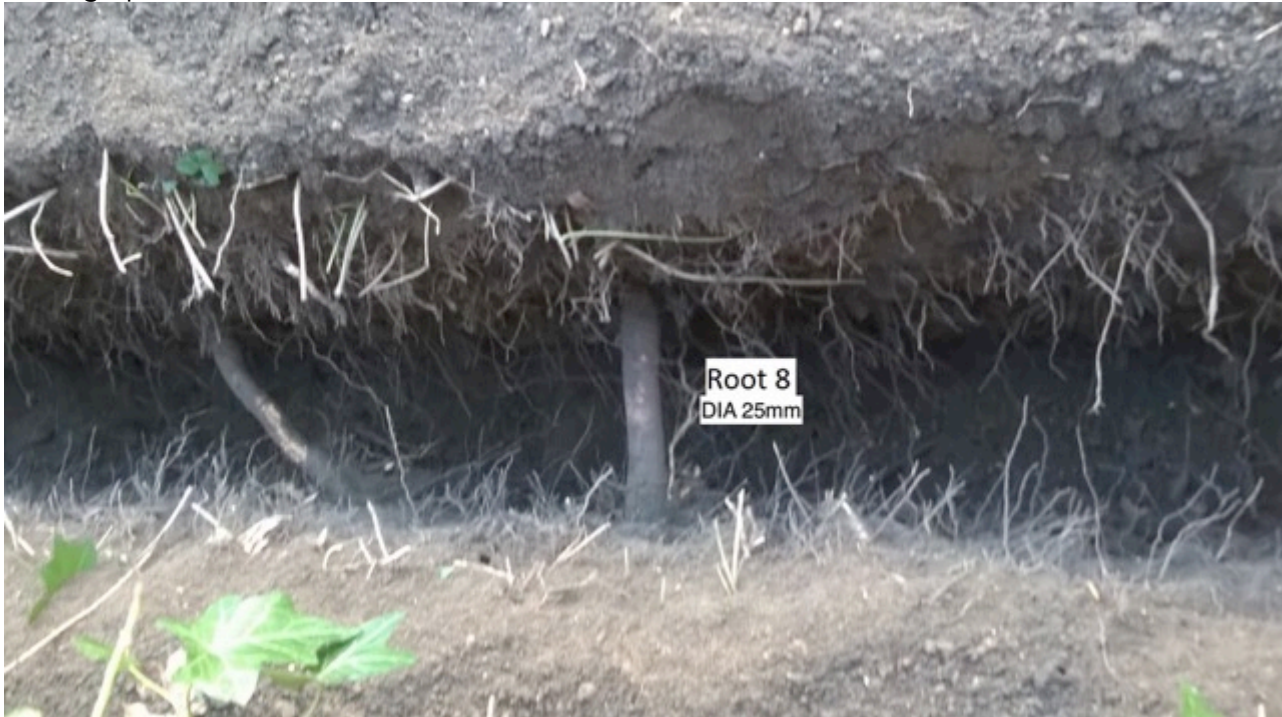
Photograph 5: Root 8

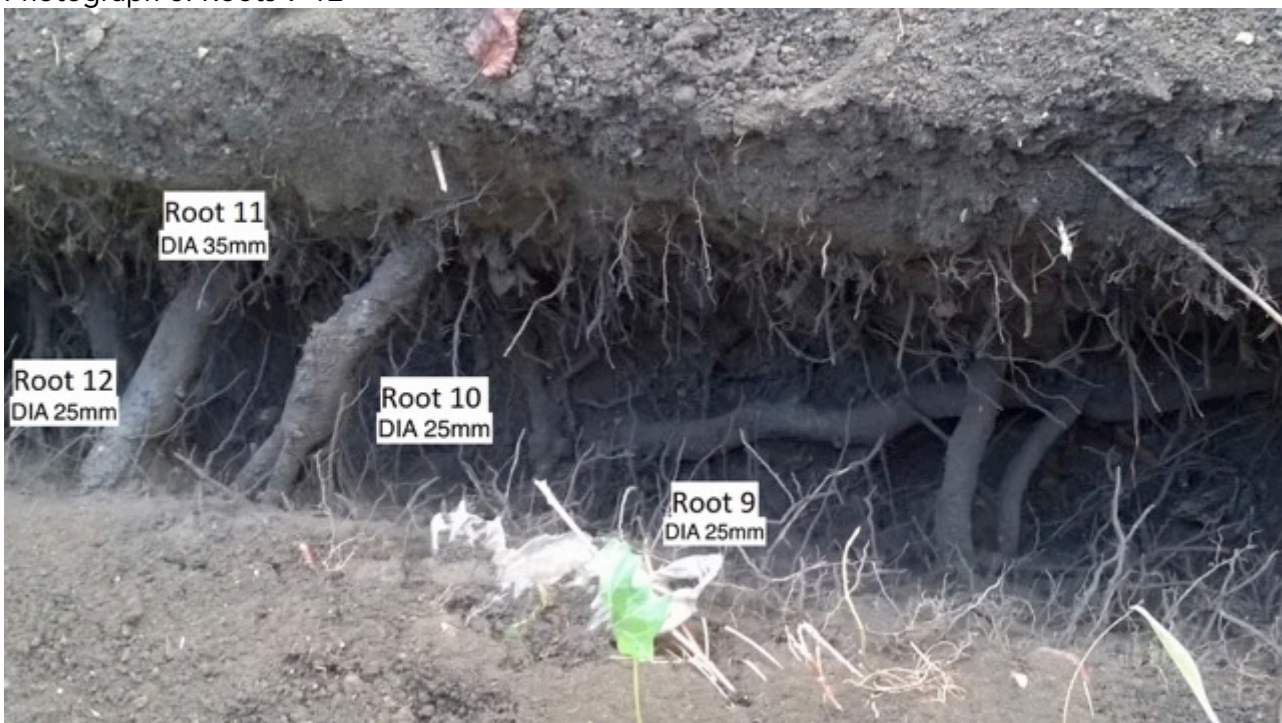
Photograph 6: Roots 9-12
