My ref 16/121

Plane tree to the rear of 35/36 Belsize Park, NW3 4DY

1. Further to your recent instructions I returned and reinspected the tree and wall on 2 February. This report updates my initial one of 13 November 2014.

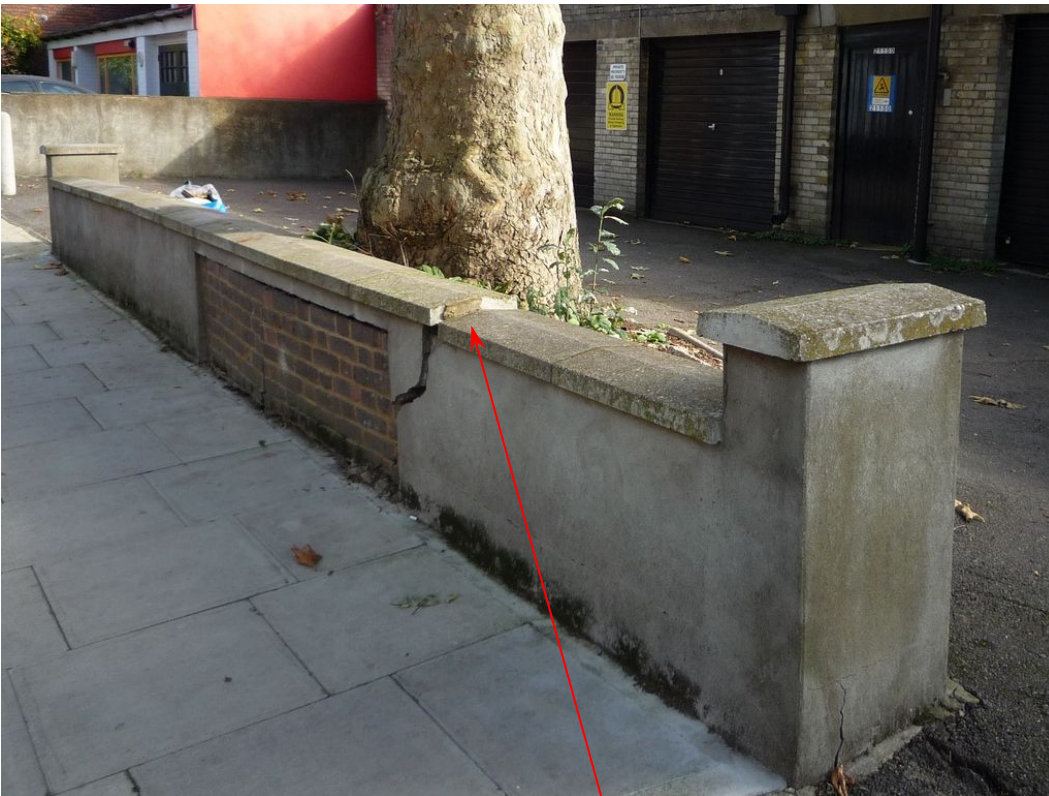
4. The damage to the wall is noticeably more severe, in particular the section of parapet next to the tree has lifted further and the brick infill panel has been pushed further outwards. Photographs 1 and 2 overleaf were taken in 2014 and 2017 and show the differences. On this occasion I also measured the displacements, so we can monitor the movement if necessary. The current vertical lift at the crack in the parapet is about 50mm and the outward displacement in the top of the panel half way along the brick to the right of the central crack is just under 30mm, see photos 3 & 4.

1) Wall in October 2014

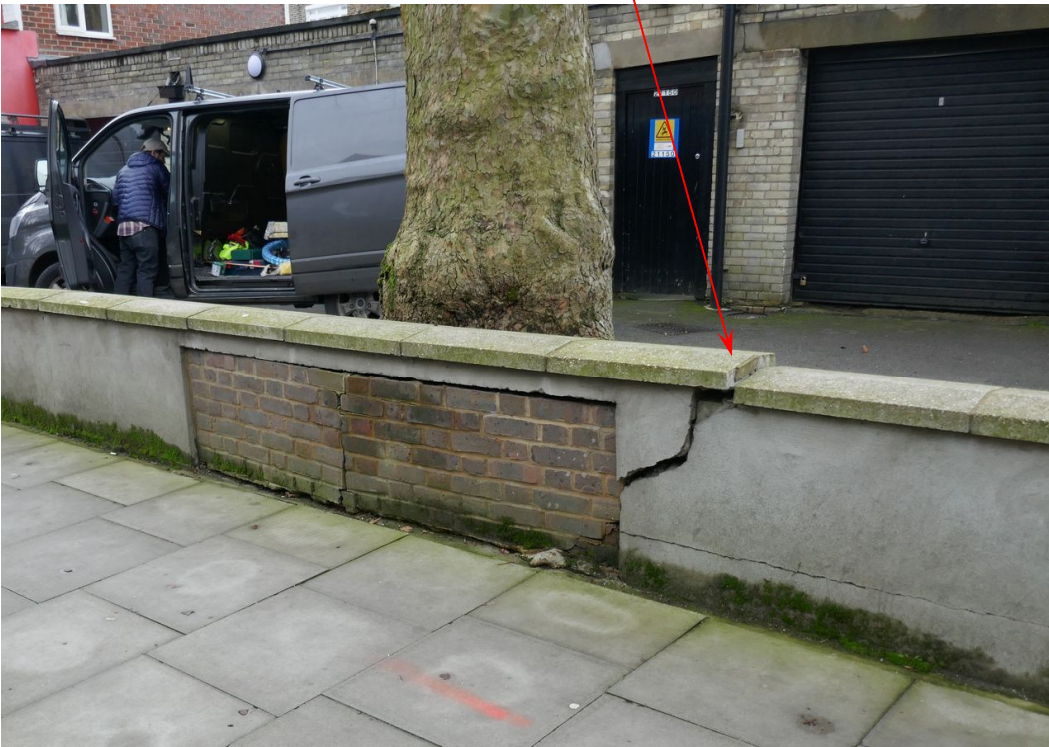
6. The tree might be causing some soil shrinkage under the wall, but any effects of that are being eclipsed by the direct pressure on the wall, which is being lifted by the growth of roots beneath and pushed outwards by the expansion of the main roots and lower trunk behind. That is happening quite slowly, but the tree is capable of growing much larger, so the movement will be progressive, slowed slightly by the regular pruning. The wall does not appear to be an immediate hazard, but will continue to deteriorate and is becoming unsightly.

2) Wall in February 2017, damage noticeably more severe, as more of the end of the lifted section is visible.

7. The wall appears to be beyond any practical repair, so the available options would be to replace the damaged section or the entire length. Railings would accommodate movement better; they might become embedded in the tree as it grows, although that would not harm it significantly. A new wall or replacement section capable of resisting its spread would have to be much more robust than it is at present, possibly made from reinforced concrete, and would need to be bridged over underlying roots.

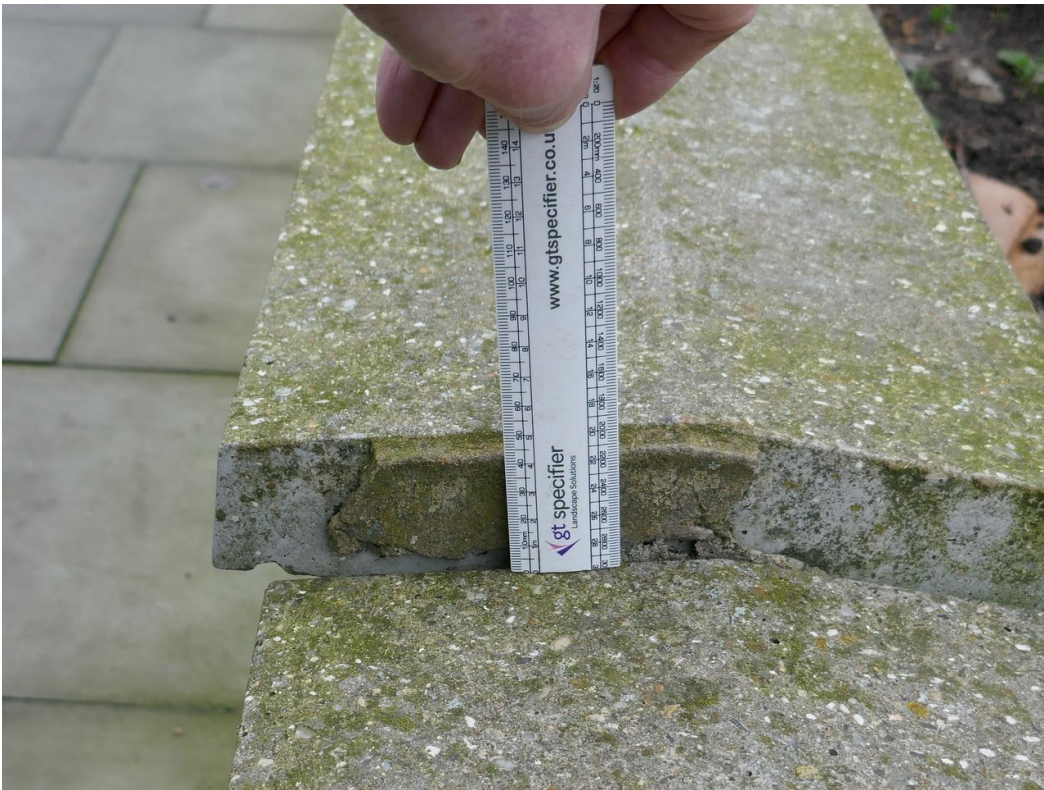
3) Vertical displacement about 50mm

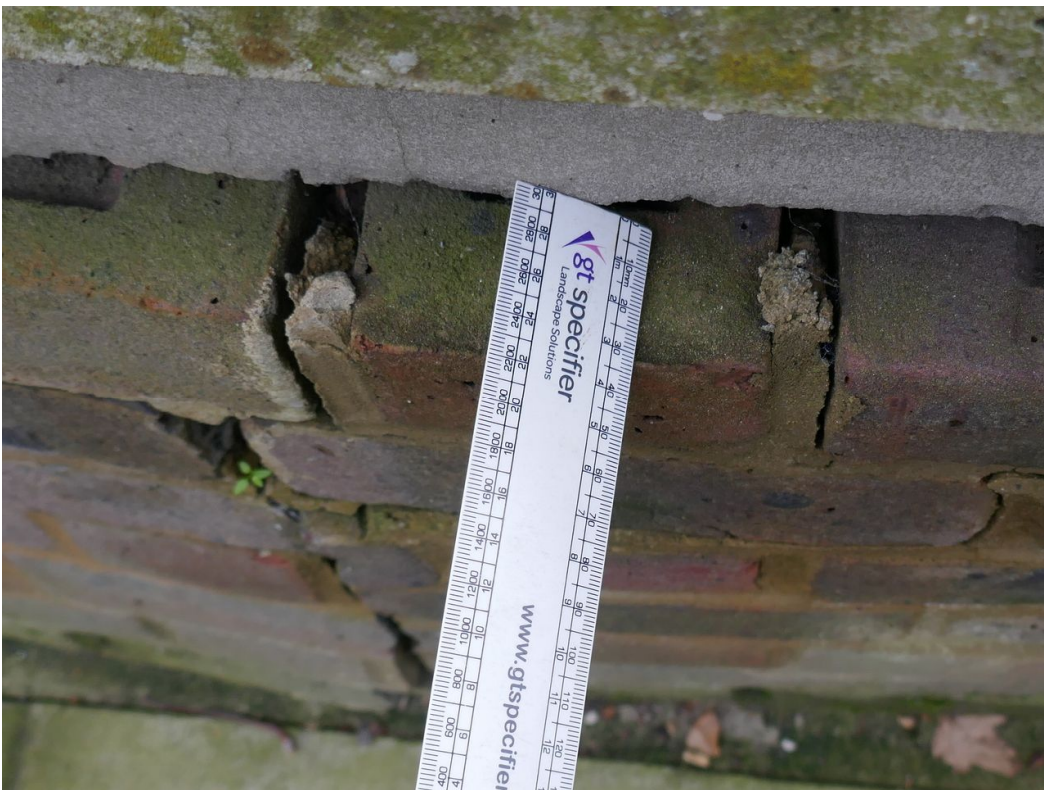
4) Lateral displacement just under 30mm
