Oxford Dendrochronology Laboratory

Roof at 45 Red Lion Street, Holborn (WC1R 4PF)

5.4 APPENDIX 4: EXISTING WINDOW SCHEDULE

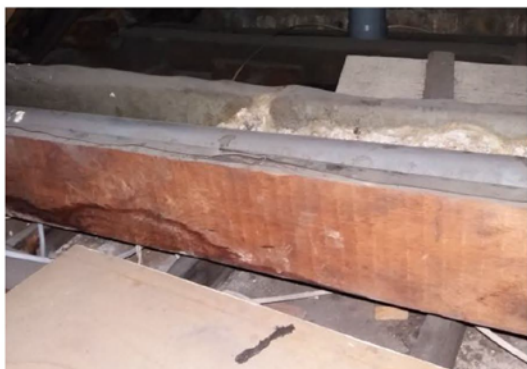
Modern machine-sawn collar with remnants of older timber behind

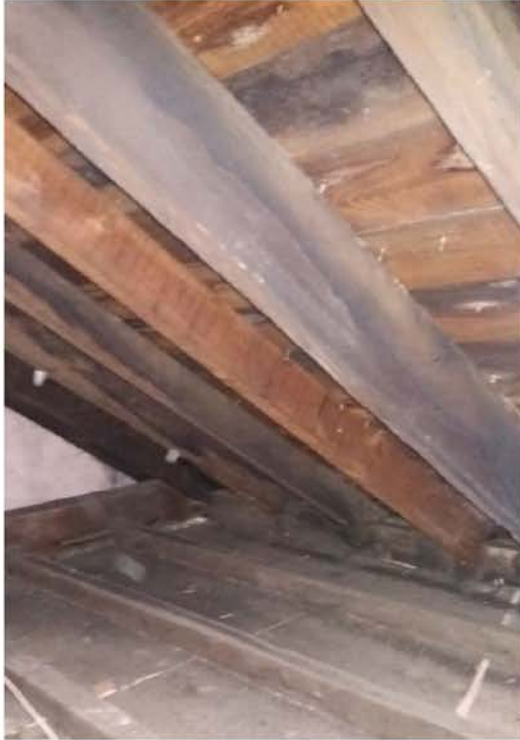
Variable-sized rafters of different ages – one can clearly see the newest machine-sawn rafter in mid-shot (more orange) – whilst the others in this shot are unlikely to be original, with the possible exception of the one on the extreme right of shot (small part only showing).

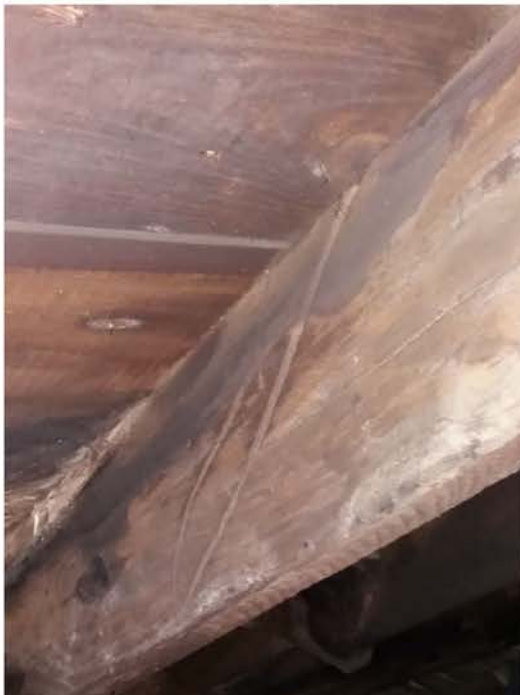
'Baltic' mark on common rafter on the north side of the roof, indicating that this probably is an original timber.

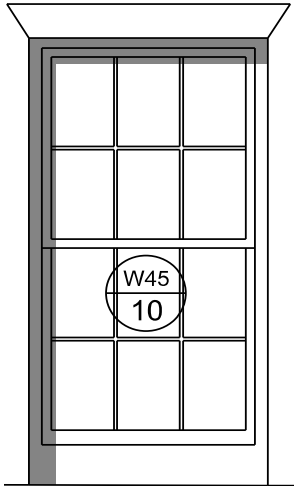
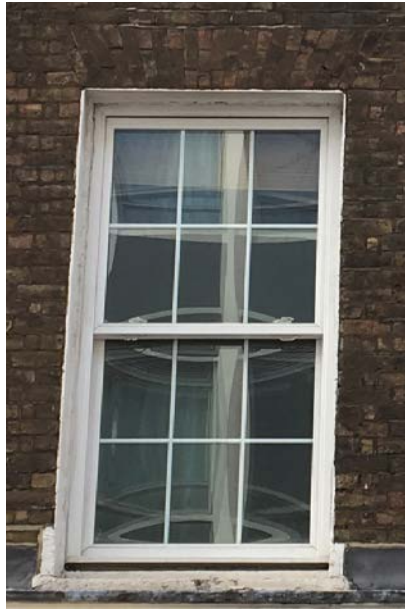
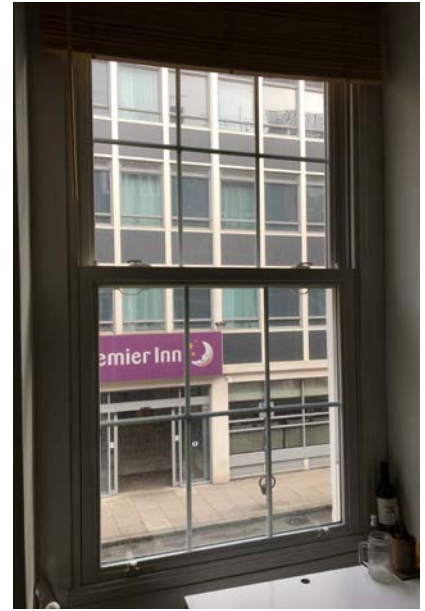
Recessed double-glazed uPVC sash windows with stuck-on glazing bars.
Condition: Good, though clearly not appropriate

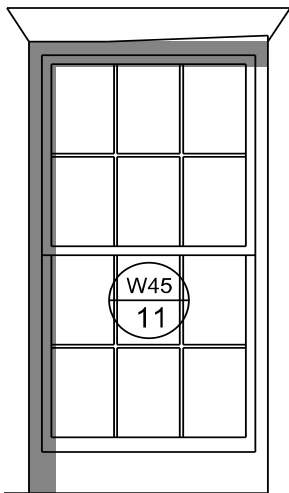
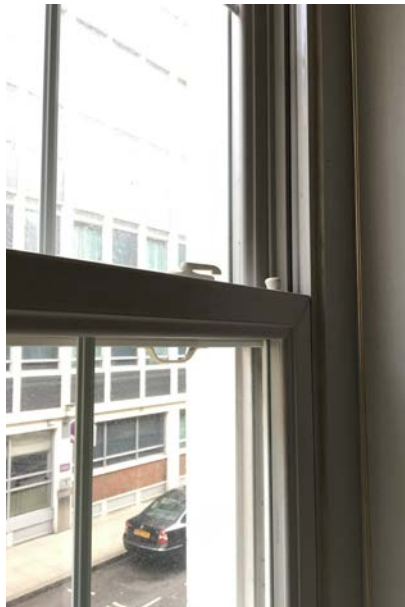
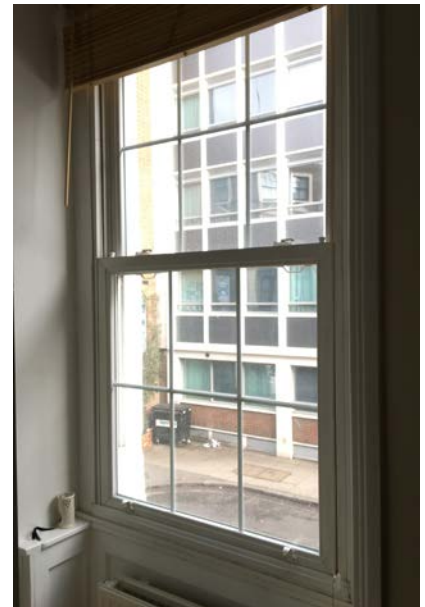
Recessed double-glazed uPVC sash windows with stuck-on glazing bars
Condition: Good, though clearly not appropriate

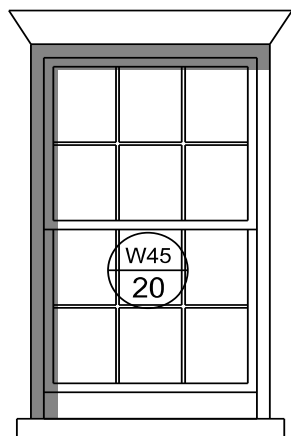
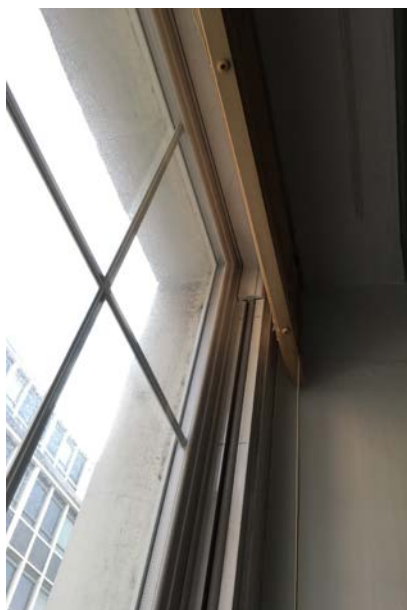
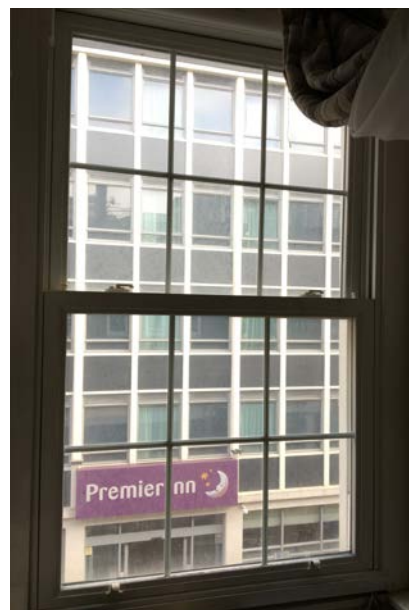
Recessed double-glazed uPVC sash windows with stuck-on glazing bars

Condition: Good, though clearly not appropriate

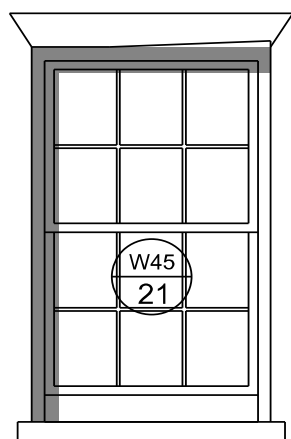
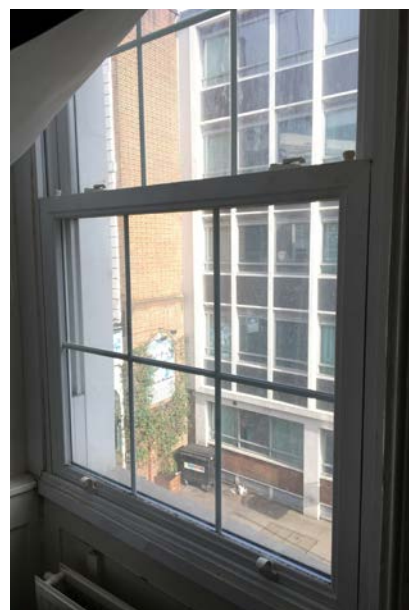
Recessed double-glazed uPVC sash windows with stuck-on glazing bars

Condition: Good, though clearly not appropriate

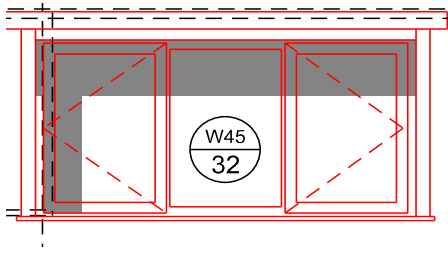
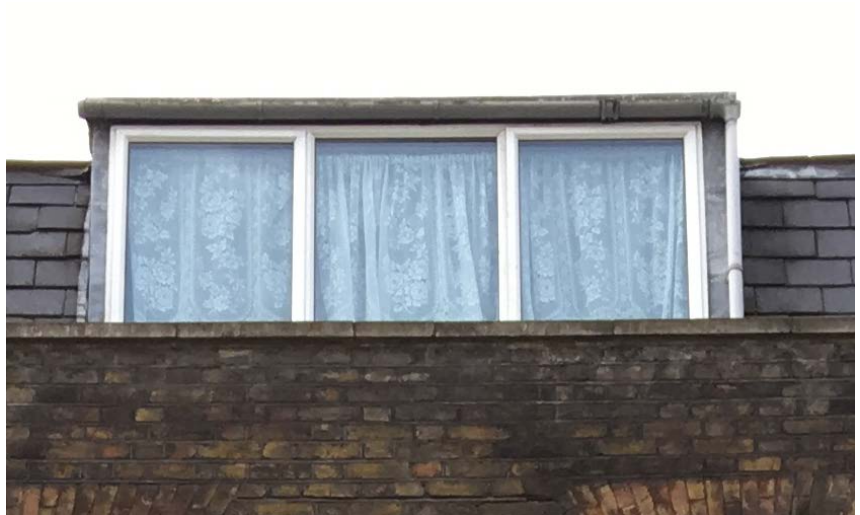
Triple uPVC casement within lead-cheeked dormer with bitumen felt roof
Condition: Poor and in need of replacement

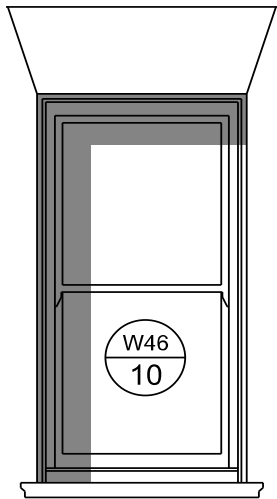
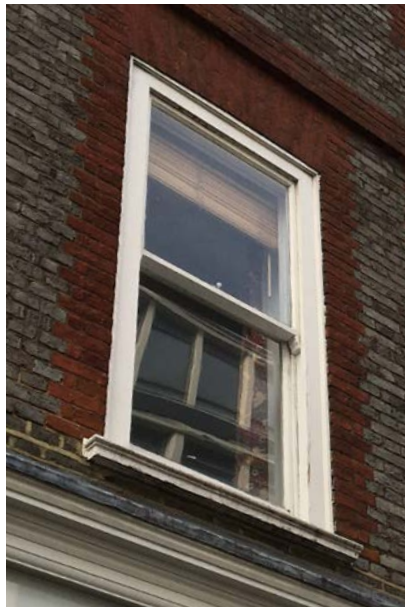
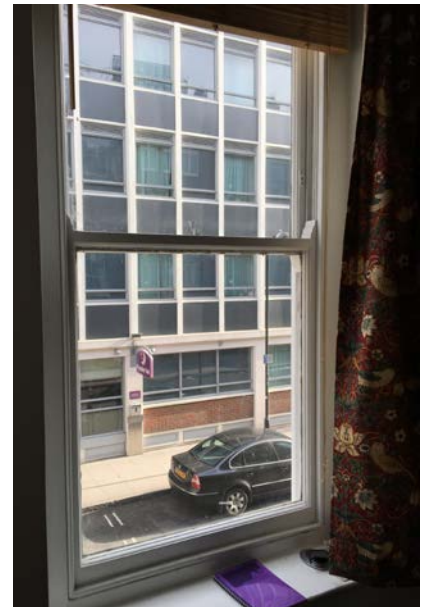
Modern single-glazed timber-framed sash (no glazing bars)
Condition: Moderate. In need of redecoration and some repairs.

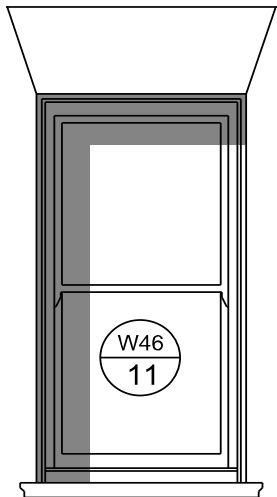
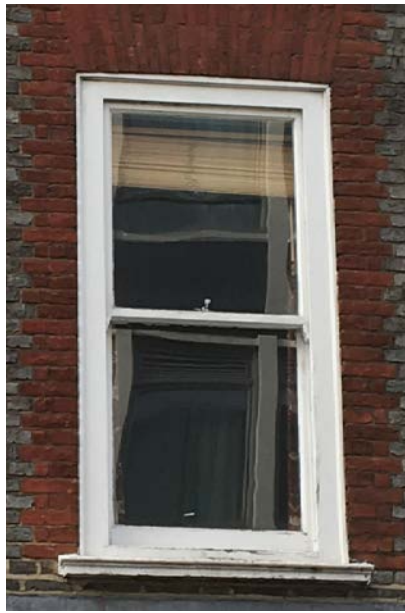
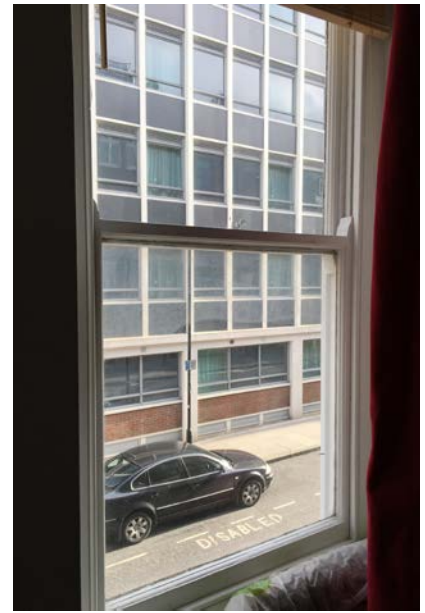
Modern single-glazed timber-framed sash (no glazing bars)
Condition: Moderate. In need of redecoration and some repairs.

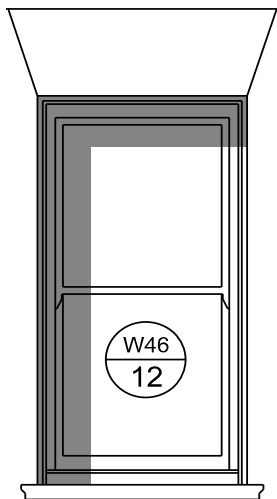
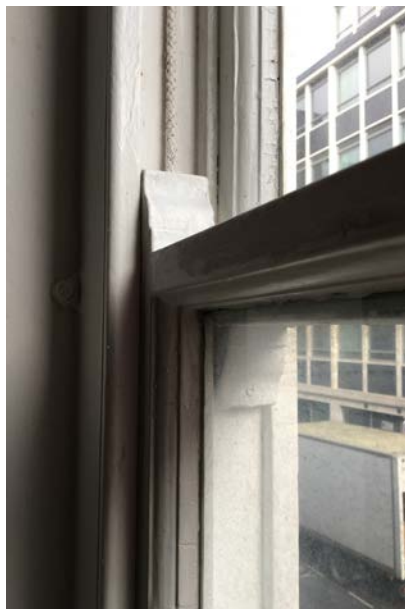
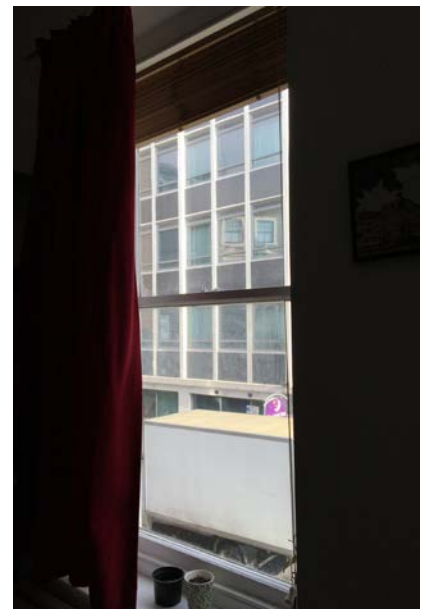
Modern single-glazed timber-framed sash (no glazing bars)
Condition: Moderate. In need of redecoration and some repairs.

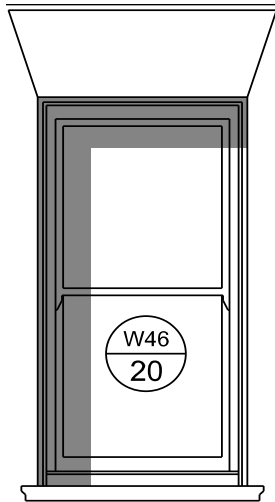
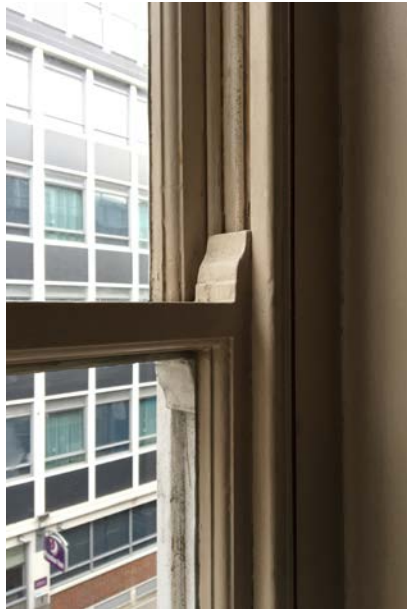
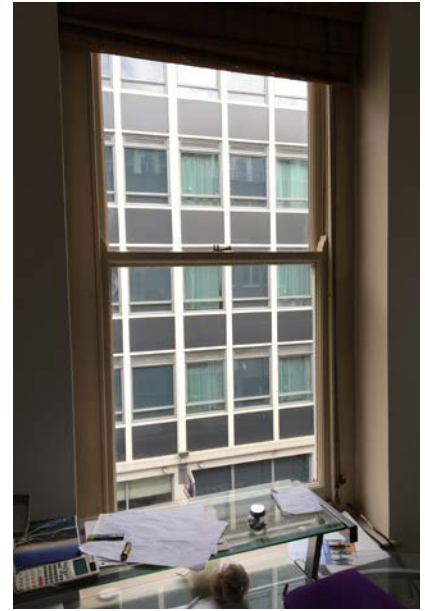
Modern single-glazed timber-framed sash (no glazing bars)
Condition: Moderate. In need of redecoration and some repairs.

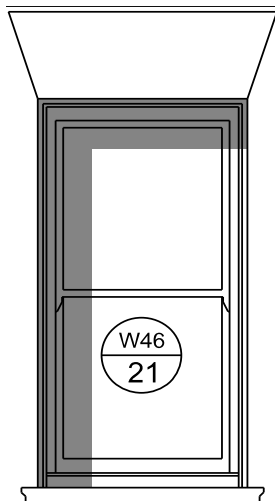
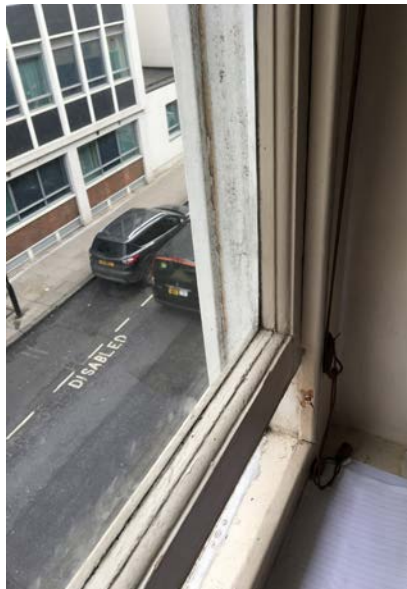
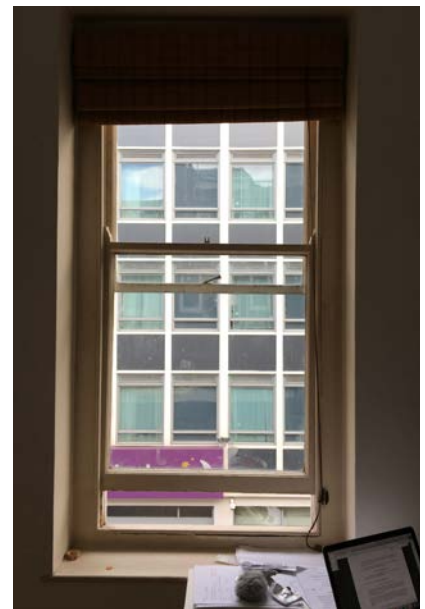
Modern single-glazed timber-framed sash (no glazing bars)
Condition: Moderate. In need of redecoration and some repairs.

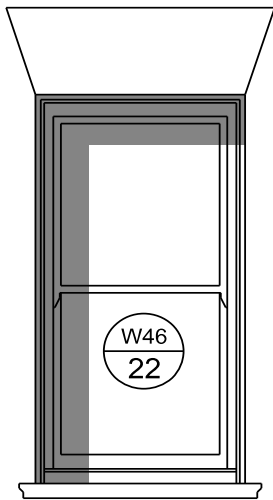
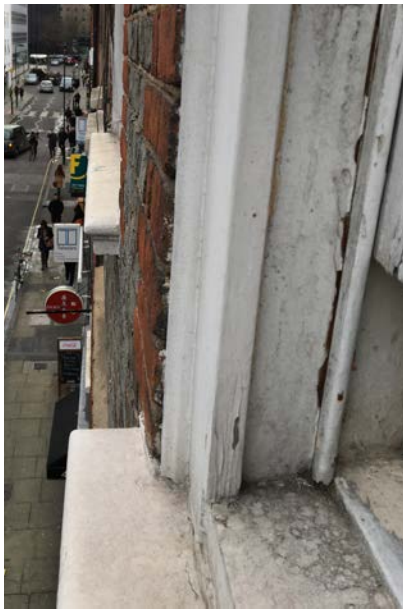
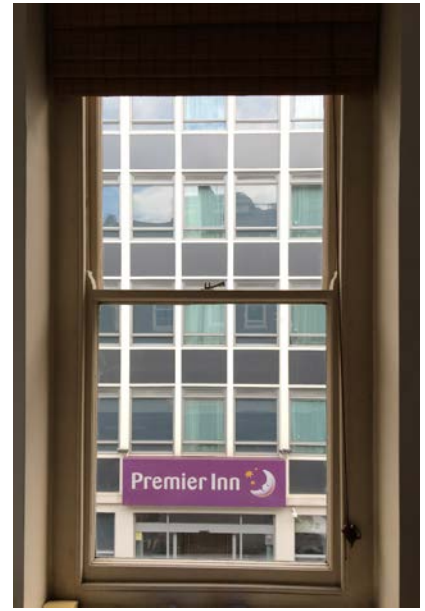
Modern single-glazed timber-framed sash (no glazing bars)

Condition: Moderate. In need of redecoration and some repairs.

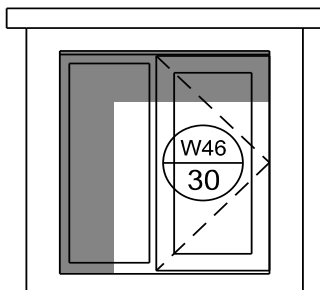
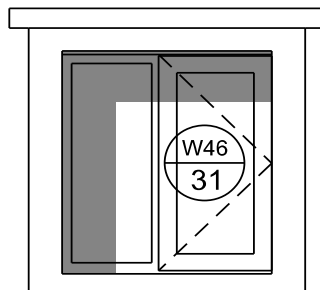
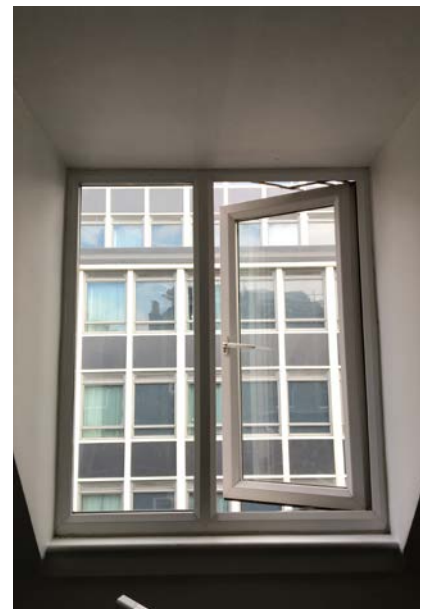
2no. uPVC casement windows - individual dormers with tiled cheeks and bitumen felt roofs.

Condition: Poor and in need of replacement

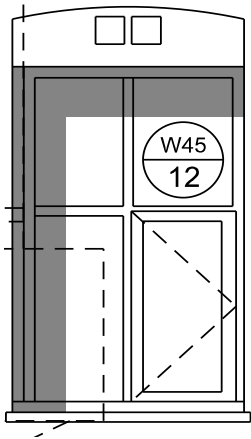
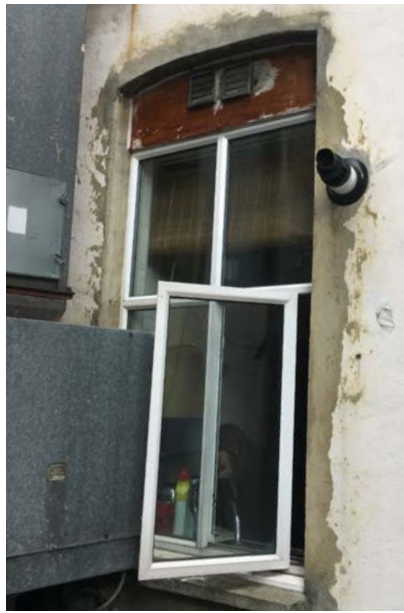
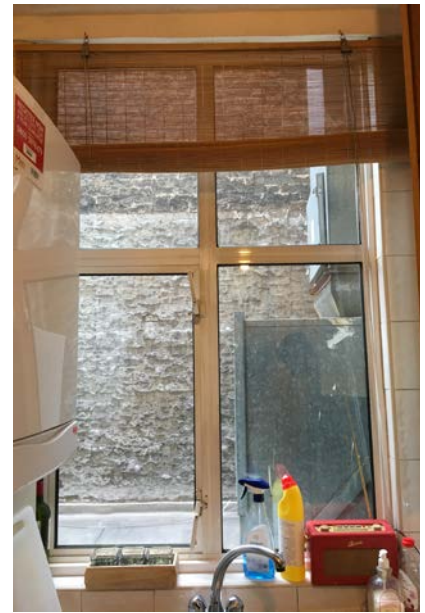
uPVC casement window with timber panel and extract grills above
Condition: Poor and in need of replacement

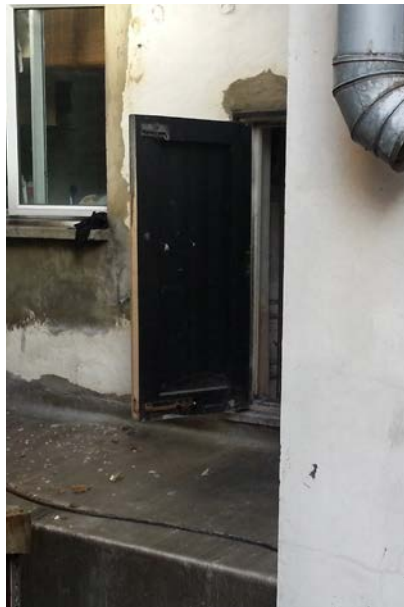
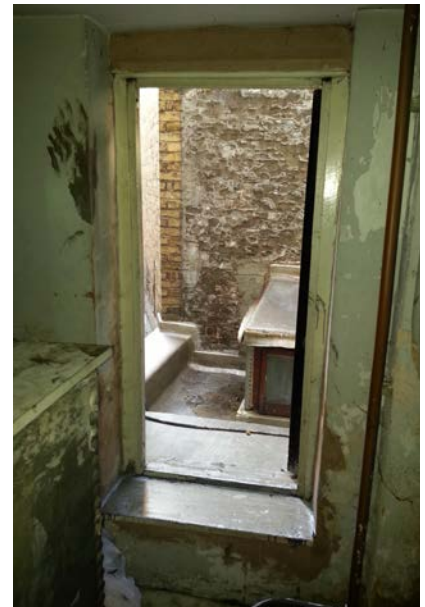
Solid timber door for roof access only
Condition: Poor. Much of the wood is rotten and in need of repair

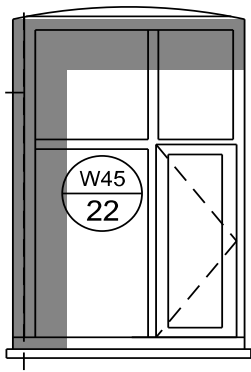
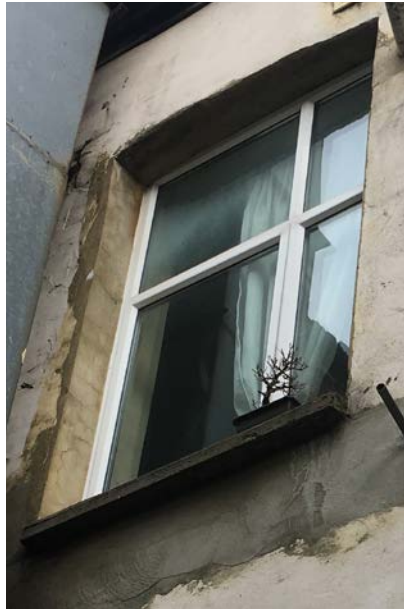
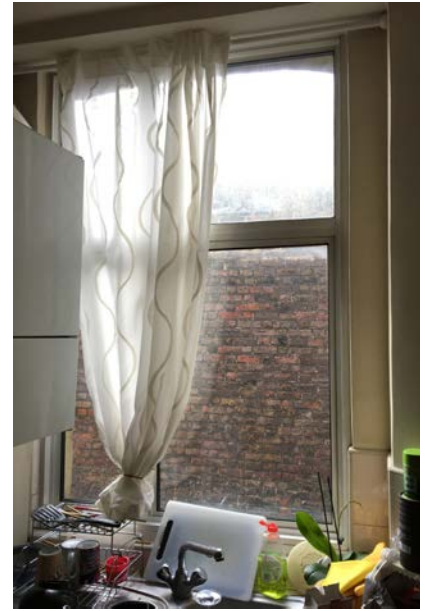
uPVC casement window

Condition: Poor and in need of replacement

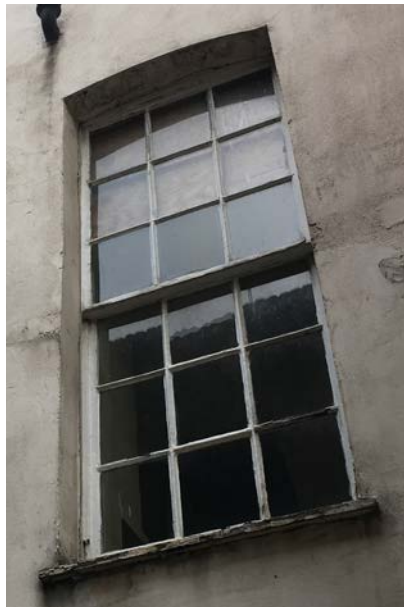
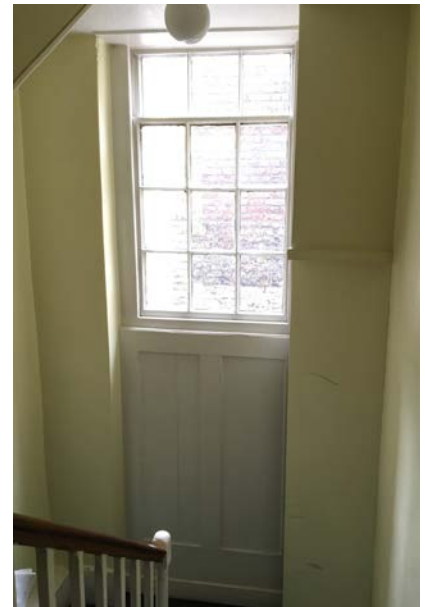
Original large timber sash

Condition: Poor. In need of careful repair and re-decoration.

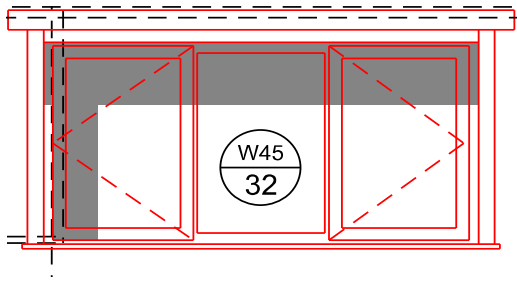
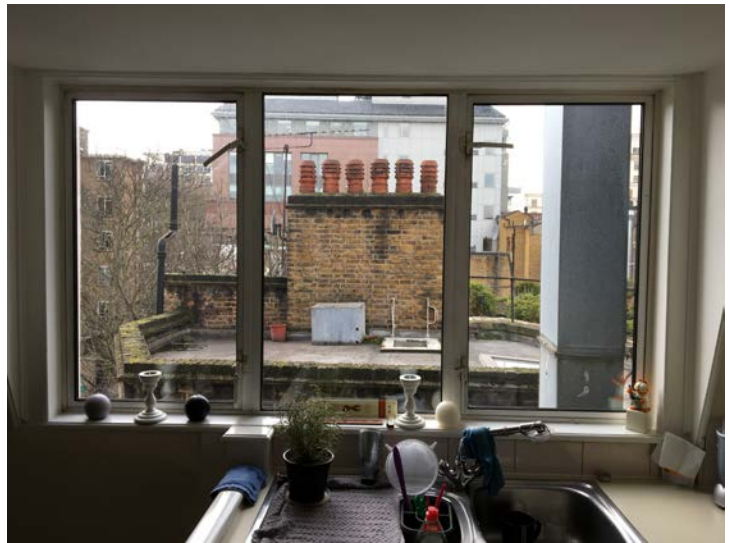
Triple uPVC casement within lead-cheeked dormer with bitumen felt roof

Condition: Poor and in need of replacement

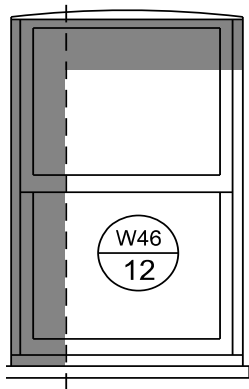
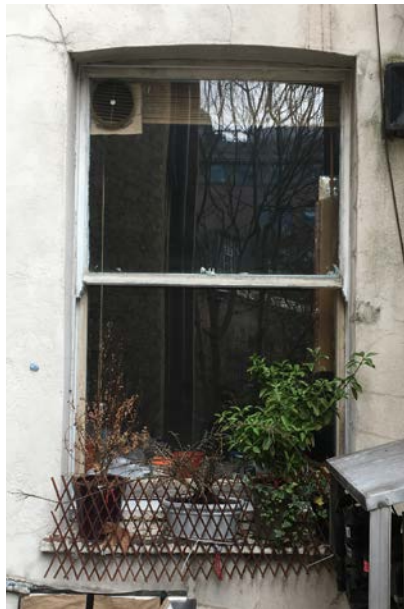
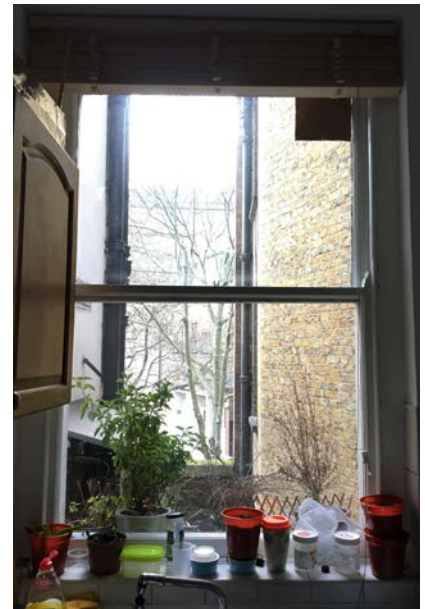
Modern single-glazed timber-framed sash (no glazing bars)

Condition: Poor. In need of redecoration and extensive repairs.

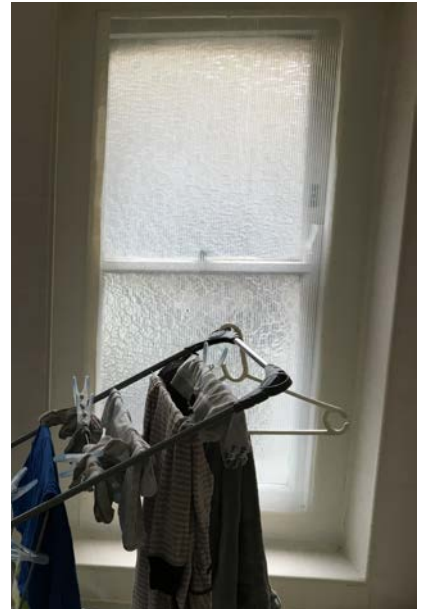
Modern single-glazed (obscure glass) timber-framed sash (no glazing bars).
Condition: Poor. In need of redecoration and extensive repairs.

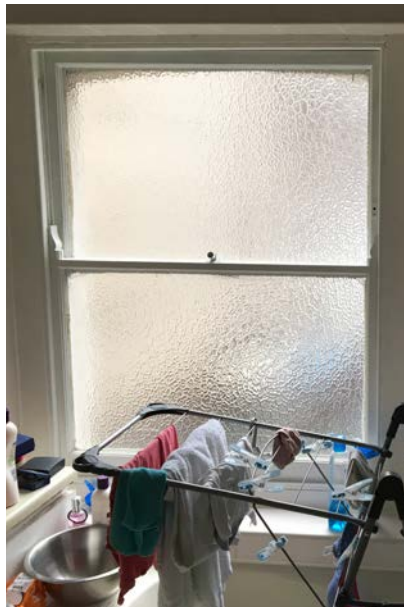
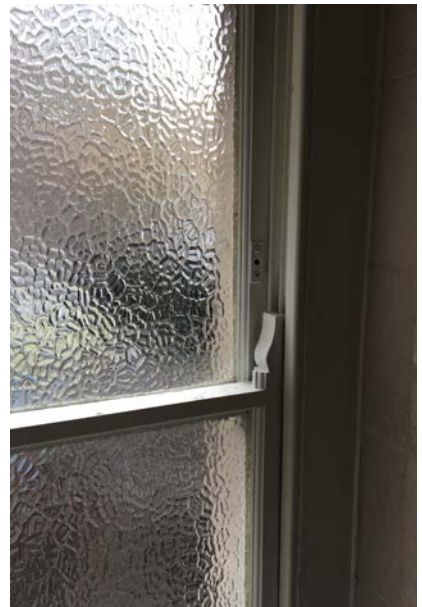
Modern single-glazed (obscure glass) timber-framed sash (no glazing bars)
Condition: Poor. In need of redecoration and extensive repairs.

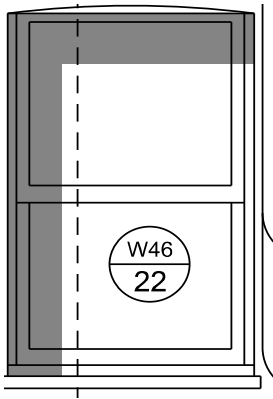
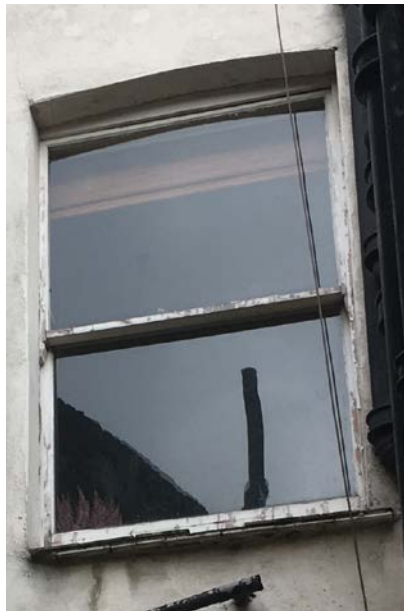
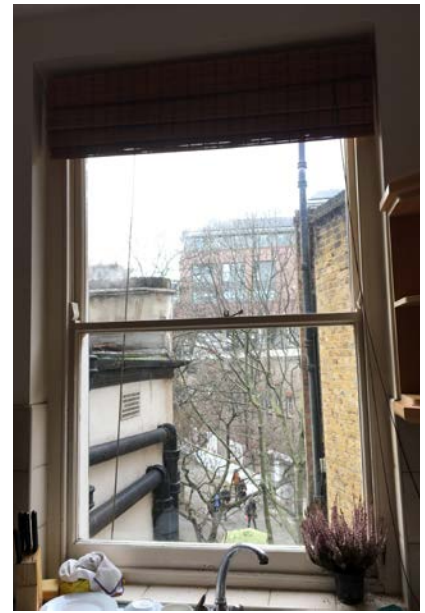
Modern single-glazed timber-framed sash (no glazing bars)
Condition: Poor. In need of redecoration and extensive repairs.

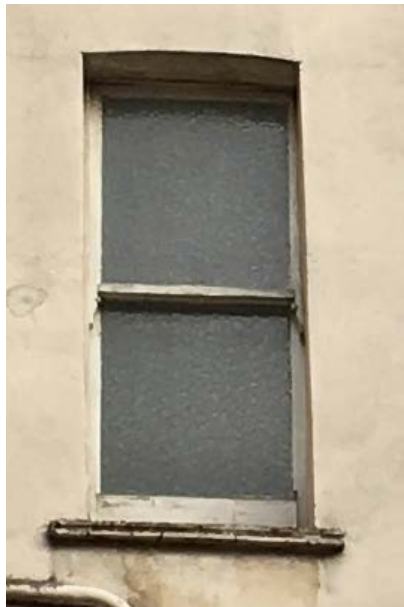
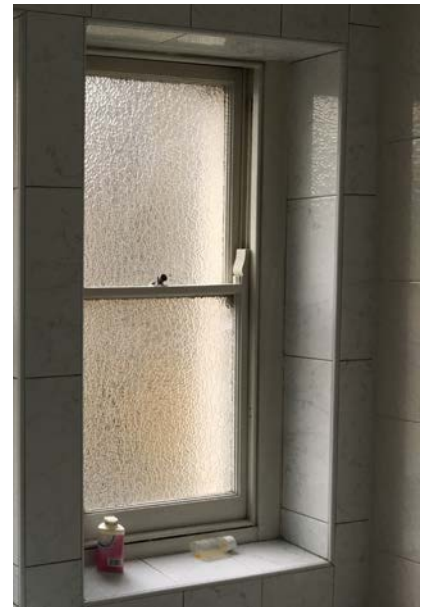
Modern single-glazed timber-framed sash (no glazing bars)
Condition: Poor. In need of redecoration and extensive repairs.

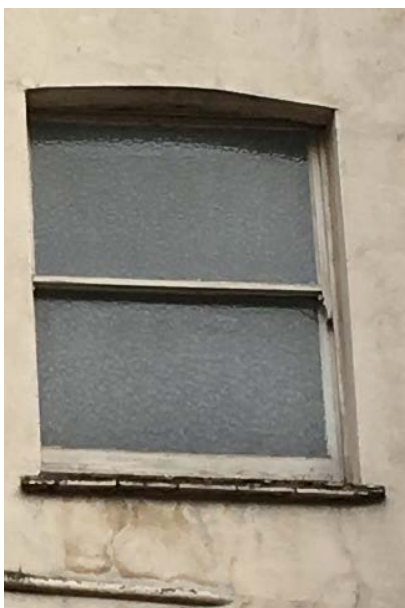
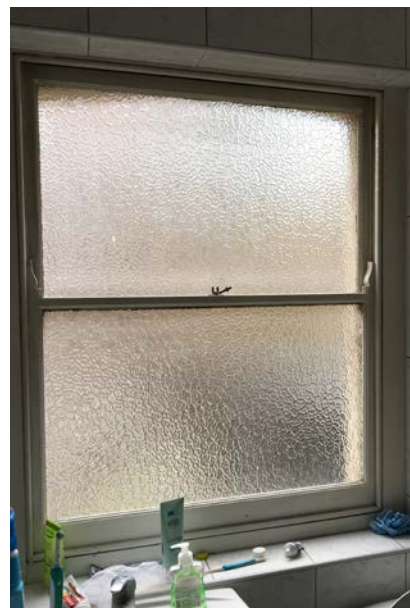
Modern single-glazed timber-framed sash (no glazing bars)
Condition: Poor. In need of redecoration and extensive repairs.

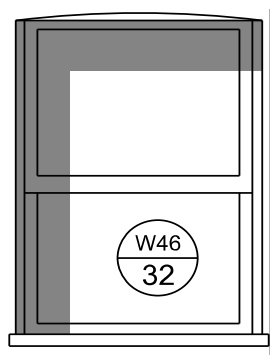
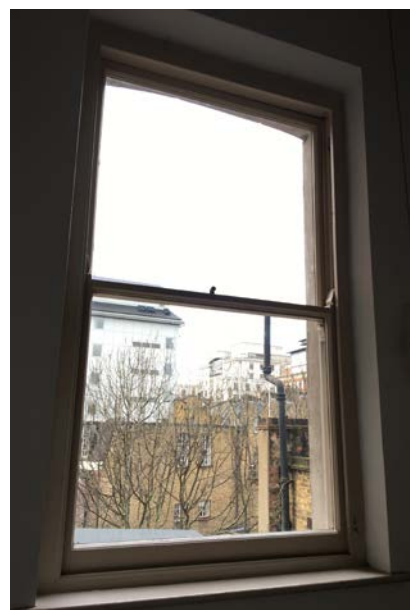
Modern single-glazed timber-framed sash (no glazing bars)
Condition: Poor. In need of redecoration and extensive repairs.

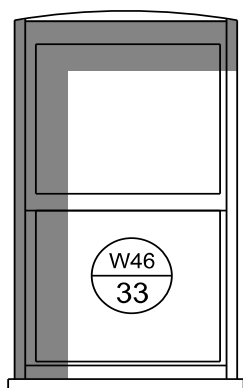
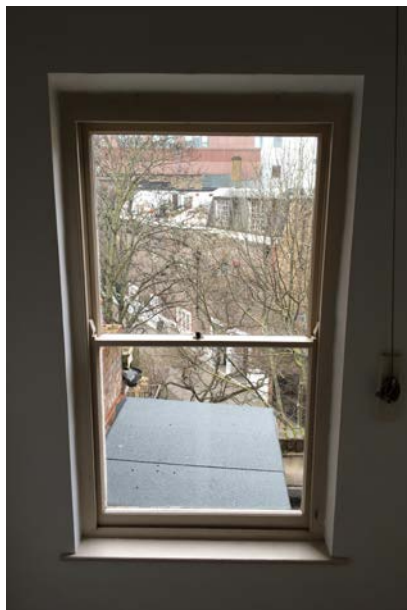
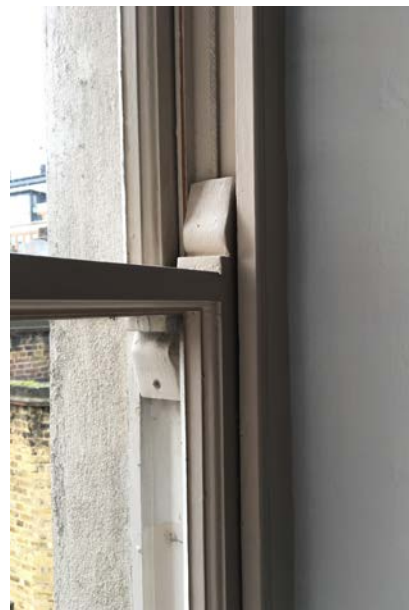
Modern single-glazed timber-framed sash (no glazing bars)

Condition: Poor. In need of redecoration and extensive repairs.
