# TREE INSPECTION FORM

LOCATION	Bedford Square, London, WC1B 3JA
DATE	27/03/17
INSPECTOR	Bruce Blackman BSc (Hons), Cert Arb,

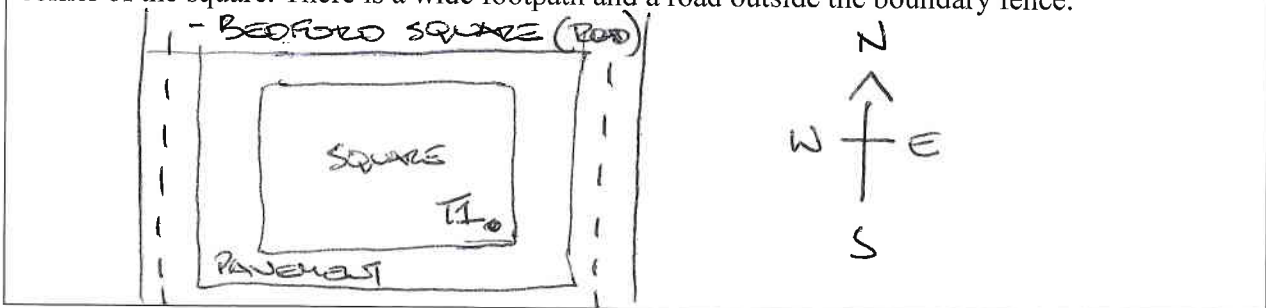
For a location plan see below. The tree is located near the boundary fence within the south east corner of the square. There is a wide footpath and a road outside the boundary fence.

Tree no.	Condition	Targets	Hazard Assessment
T1	Fair	Footpath, Road,	The tree is leaning over the footpath and road. There are signs that the lean is progressive due to movement of the root ball which is bulging/lifting. Also the tree has loose bark on the upper side and vertical cracks representing potential shear forces in the stem. <b>Given the high use of the area I believe this tree is a high risk of failure and potential for injury/damage.</b>

Tree no.	Priority	Specification	Notes
T1	Emergency	Fell
