## Site Visit Report

<b>Project:</b>	45A Lancaster Grove, London, NW3 4HB		
<b>Visited by:</b>	Aoife Gleeson	<b>Weather:</b>	Light rain
<b>Date and Time:</b>	22 March 2017, 9.00am	<b>Distribution:</b>	London Borough of Camden
<b>File Ref:</b>	AGag12336-61-240317 - Site Visit Report 45 Lancaster Grove.doc	<b>Photos taken:</b>	Yes
<b>Planning Reference:</b>	2015/2534/P	<b>Project Number:</b>	12336-61

- 1.2. The purpose of the inspection was to identify any structural defects to the neighbouring properties that could possibly have been caused by the construction of the basement to 45 Lancaster Grove.

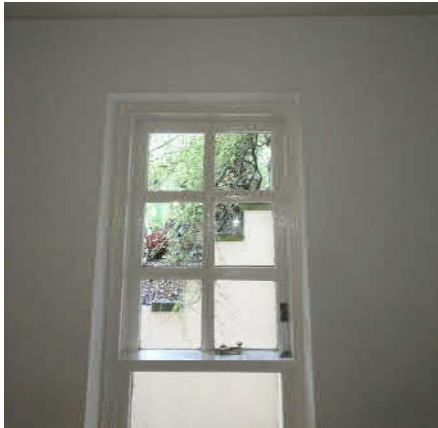
- 2.3. Internally no significant cracking was noted to the rear or side wall of the property. Some minor hairline cracks were noted in the plaster around the window (Photo 1).

Photo 1 - Rear Wall Internal

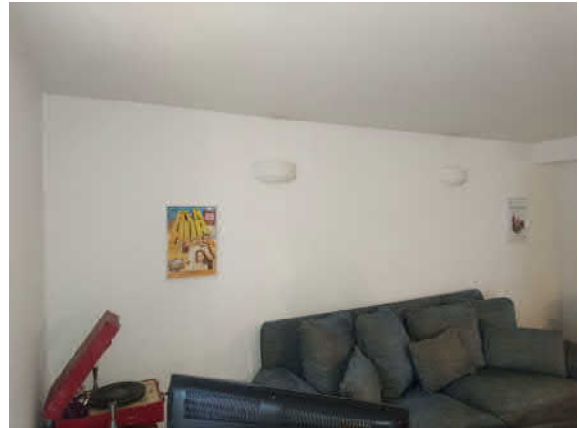
Photo 2 - Side Wall Internal

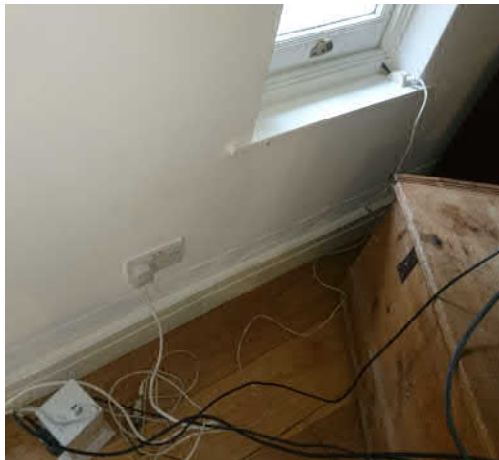
- 2.4. Repairs to the waterproof membrane were noted above the skirting board on the rear wall (Photo 3).
- 2.5. Externally no significant cracking was noted to the rear or side brickwork walls of the property (Photo 4) or to the rendered retaining walls. White staining was noted to the first six courses of brickwork (Photo 5 and 6).

Photo 3 - Repairs to Waterproof Membrane

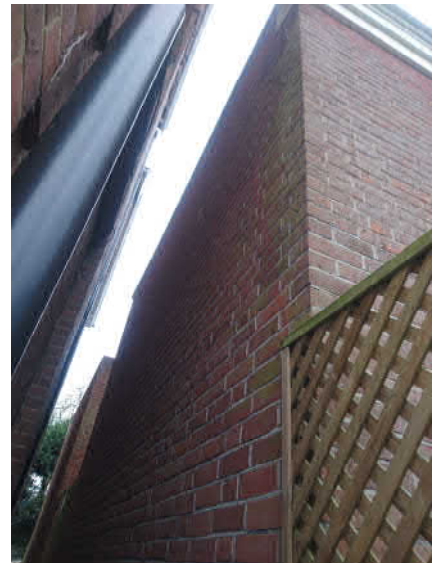
Photo 4 - Side Wall Property External

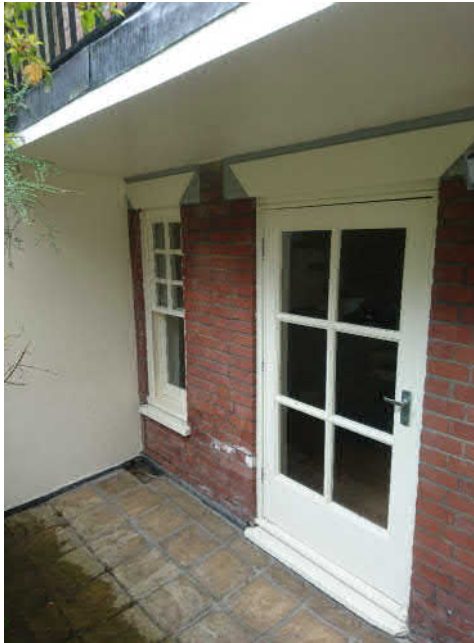
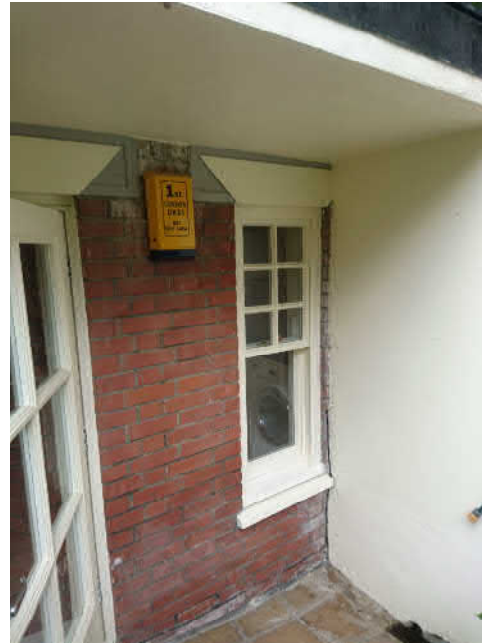
Photos 5 and 6 - External Wall Lower Ground location of reported leaks

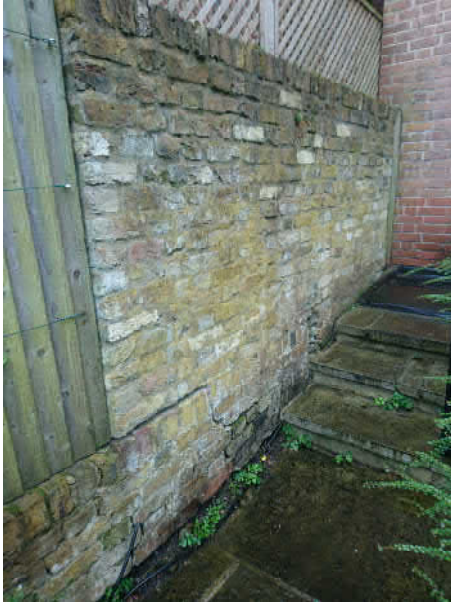
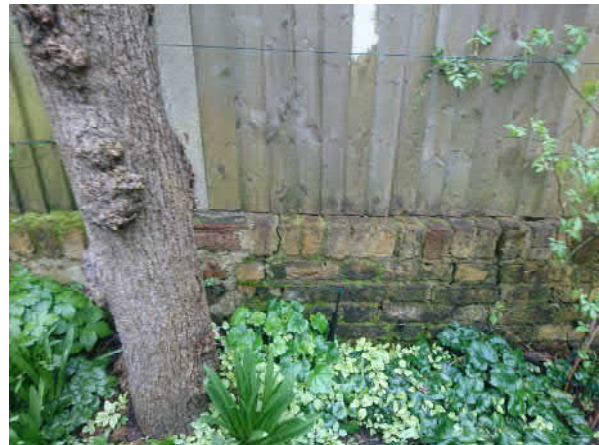
- 2.6. There is significant damage to the garden wall between 43a and 45 Lancaster Grove. Large cracks are noted along the length of the wall (Photo 7 and 8).

Photos 7 and 8 – Damage to Garden Wall between 43a and 45 Lancaster Grove

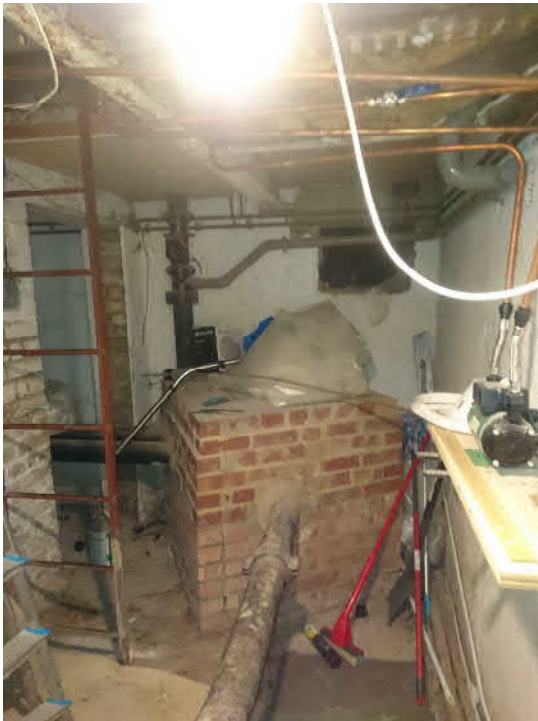
- 3.2. The basement only has full height headroom to a small section central to the building. Access to the wall adjacent to 45 Lancaster Grove is through a crawl space only and it was not possible to carry out an inspection. The basement is not habitable and is used as a services room only (Photo 9).

Photo 9 – Access to basement crawl space

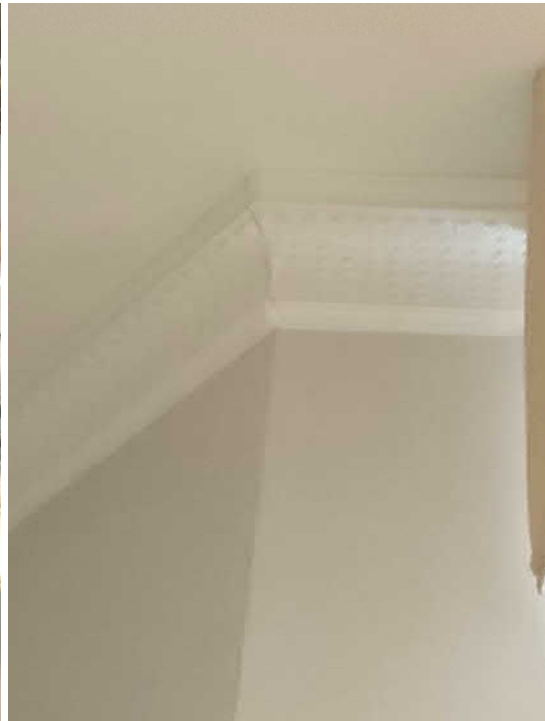
- 3.3. Internally no significant cracking or damage was noted to the side or rear walls at both ground and first floor.
- 3.4. A hairline crack was noted in the cornice at ground floor on the wall adjacent to 45 Lancaster Grove (Photo 10).

Photo 10 – Damage to Cornice

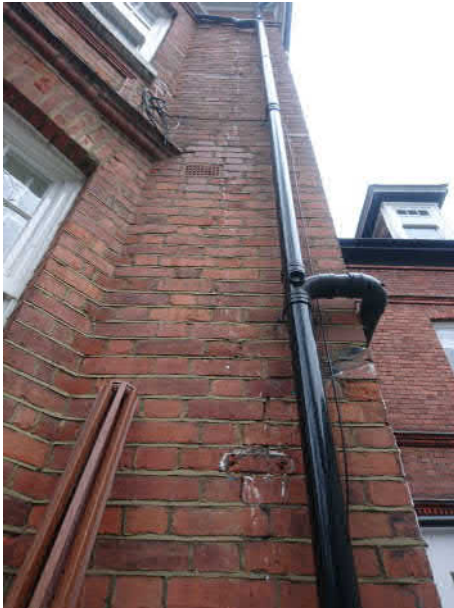
- 3.6. Externally no significant defects were noted to the side or rear walls of the property (Photo 11).
- 3.7. The rear garden is uneven and damage noted to the paving slabs (Photo 12).

Photo 11 – Rear of property external

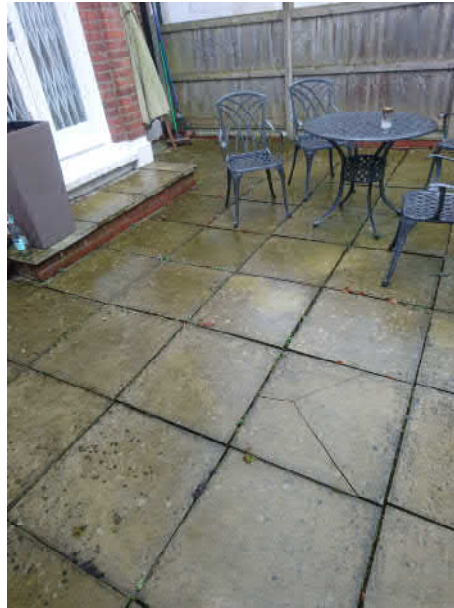
Photo 12 – Settlement and damage to rear paving
