## Report in support of mechanical ventilation removal to Galleries 43 and 45

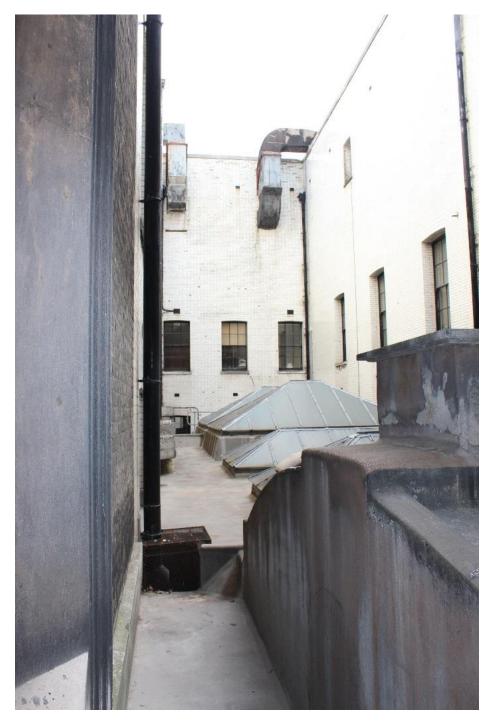
View of ductwork serving Galleries 43-45

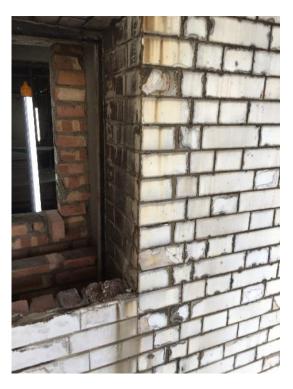
After removal of ductwork

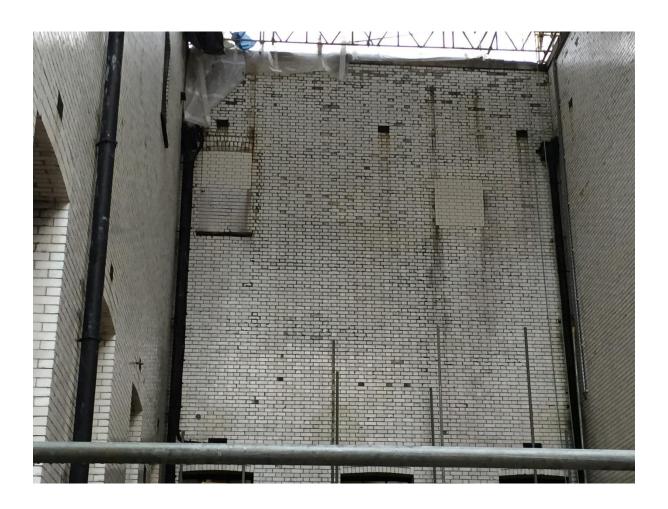
View from inside gallery after duct removed

The completed glazed brick works

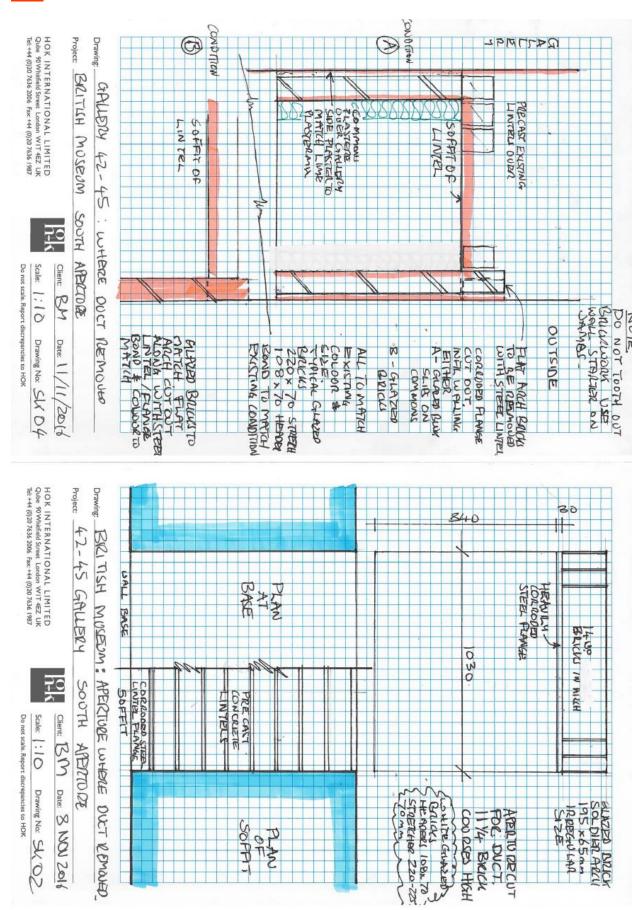
Detail at south end of lightwell - existing condition and works carried out
