Bracknell Gate, Frogna Lane, London, NW3

Structural Engineer's Inspection Report

Prepared by: **Natasha Cleaver & Gurjinder Puar**  
 Job Number: **25433**

Date	Version	Notes / Amendments / Issue Purpose
28.07.2016	1	For Information

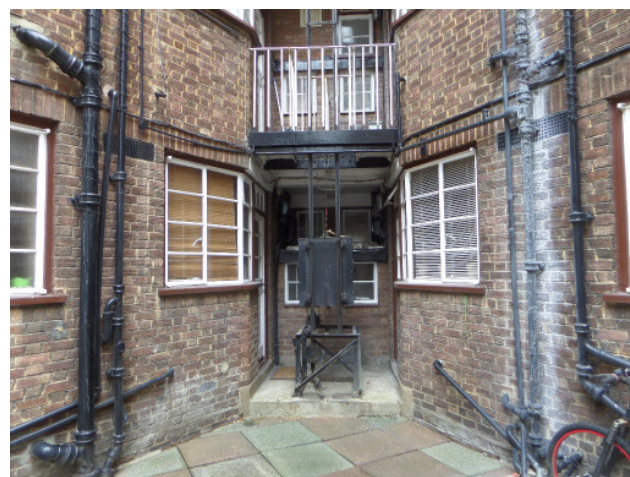
Typical Hoist, now redundant.

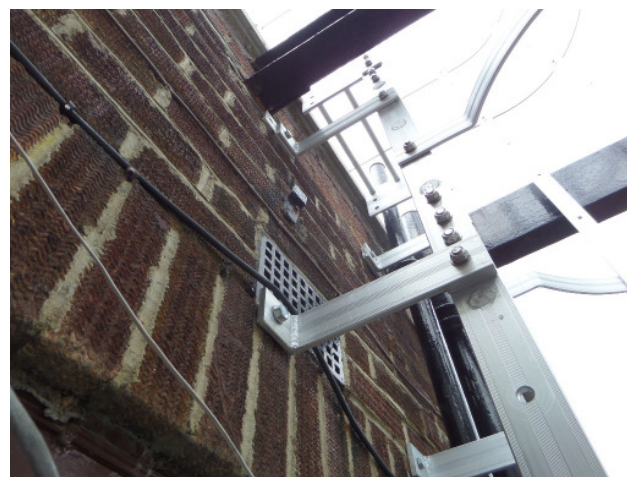
Example of renewed fixings to balcony

At all levels of all Blocks, previous remedial works are evident; most notably renewed balustrade fixings to some balconies and the addition of new steel angles to support areas of the metalwork plate around the hoist openings. These works appear to be fairly recent and have probably taken place at different times judging from the types of materials and methods used.

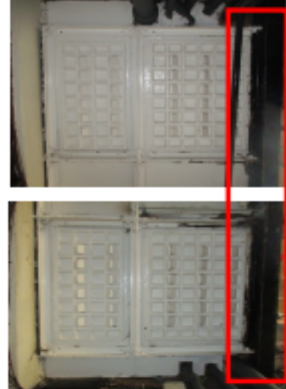
The major item of note for future use of the balconies is the front RSJ on Blocks A and C has lost its top flange from continued water exposure – possibly accelerated from window boxes and plants on the balconies. When the remaining, reduced section of the RSJ is considered, including the loading from the balustrades, the RSJ section is considered inadequate. This section requires replacing with a like for like section.

BLOCK	LEVEL	REF	DESCRIPTION	IMAGE	REPAIR
A	1	1	Rusty, loss of material/section

- Temporarily prop front of balcony and balustrades.
- Cut off/ unfix balustrades and angles connected to RSJ
- Remove existing RSJ in its entirety and follow instructions above for cleaning and repainting edges of floorplate and angles.
- Introduce new 200x100x10 RHS section to be painted with a two part zinc phosphate epoxy primer/ high build MIO to a total (minimum) of 180 microns. Splices will not be accepted in beams.
- Reconnect existing floorplates, angles and balustrades and follow the steps above including stripe coat for replacing bolts and fasteners.

Replace Beam
		2	Rusty

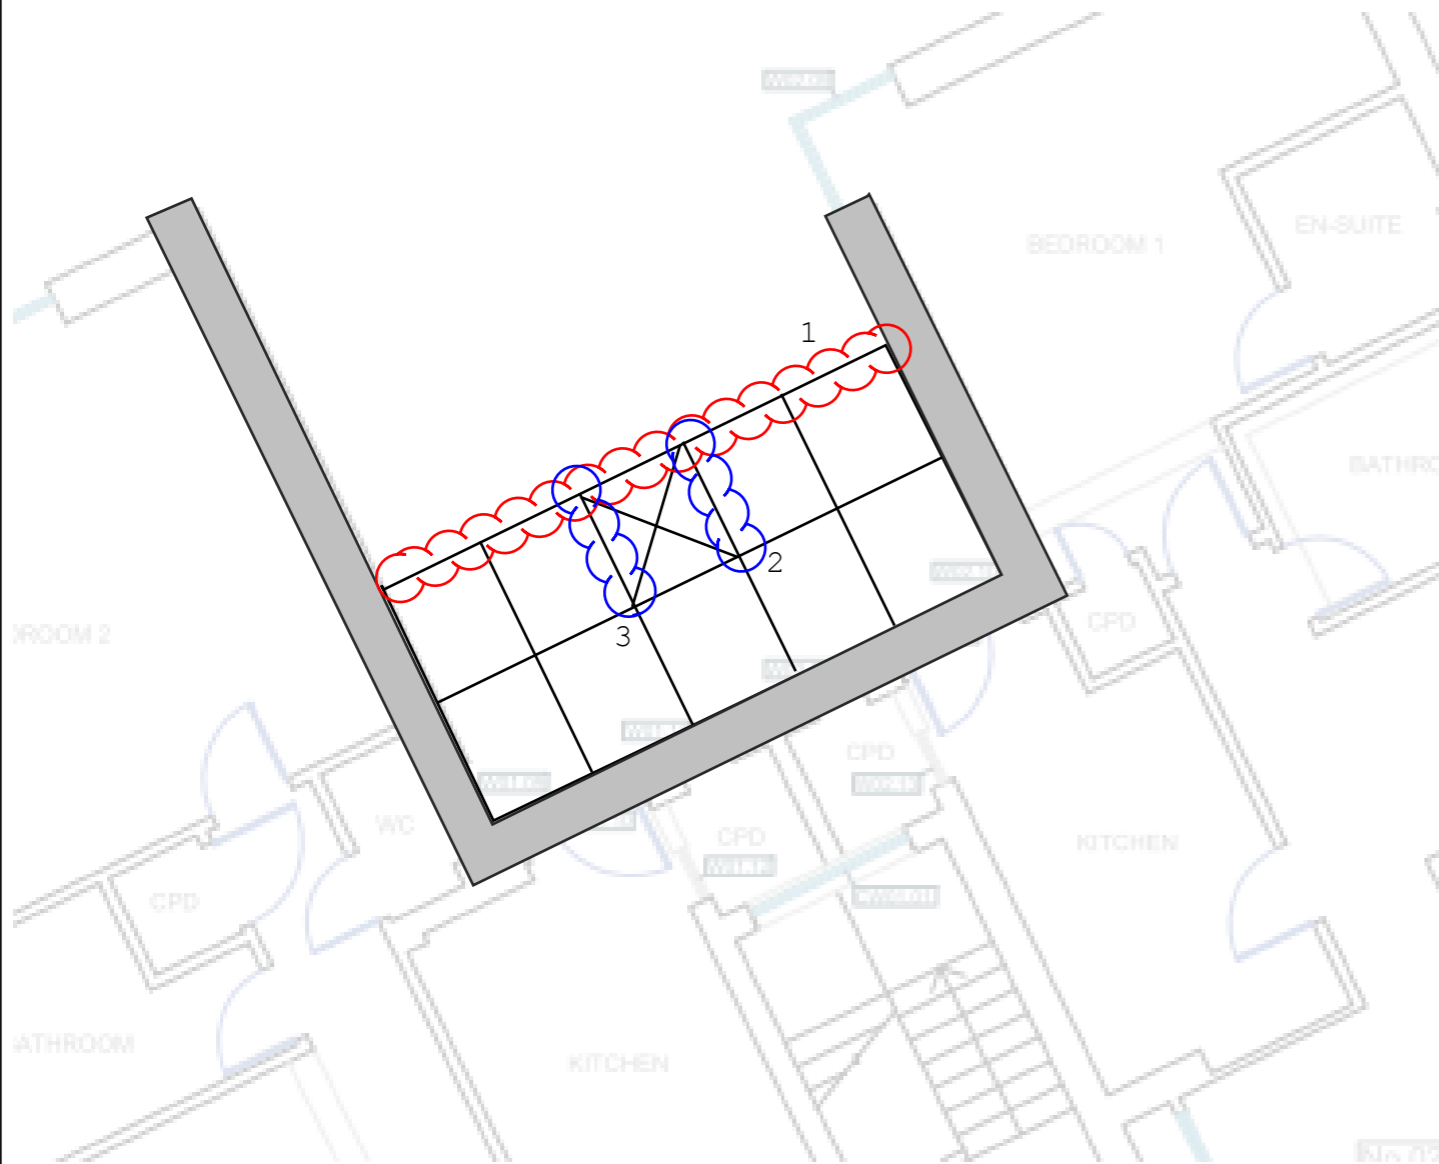
BLOCK A - 2nd Floor Balcony

BLOCK	LEVEL	REF	DESCRIPTION	IMAGE	REPAIR
A	2	1	Rusty, loss of material/section	 	Replace Beam
		2	Rusty, loss of material/section	 	Clean and Repair as specified
		3	Rusty, loss of material/section	 	Clean and Repair as specified

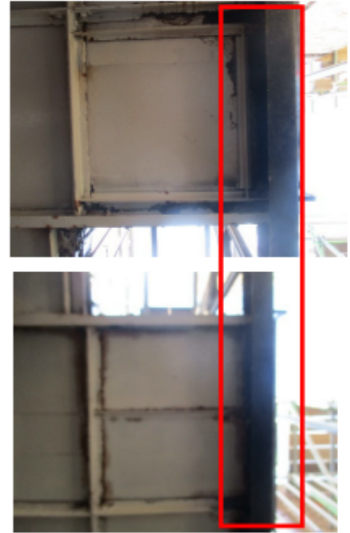
BLOCK	LEVEL	REF	DESCRIPTION	IMAGE	REPAIR
A	3	1	Rusty, loss of material/section

Replace Beam
		2	Rusty, loss of material/section

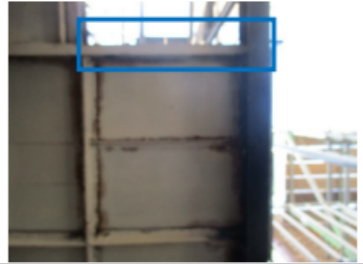
Clean and Repair as specified
		3	Rusty, loss of material/section

Clean and Repair as specified

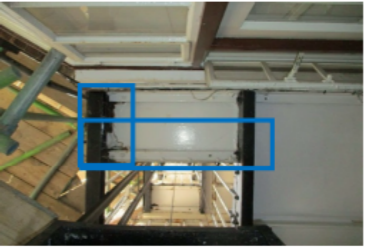
BLOCK	LEVEL	REF	DESCRIPTION	IMAGE	REPAIR
B		1, 2	Rusty, loss of material/section

Clean and Repair as specified
		3, 4	Rusty, loss of material/section

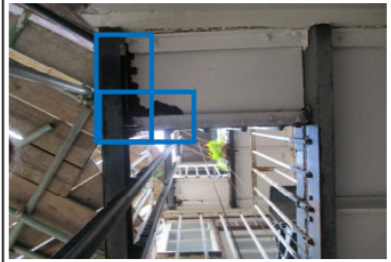
BLOCK	LEVEL	REF	DESCRIPTION	IMAGE	REPAIR
B	2	1	Rusty, loss of material/section

Clean and Repair as specified
		2	Rusty

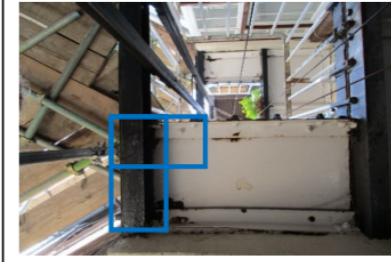
Clean and Repair as specified
		3	Rusty

Clean and Repair as specified

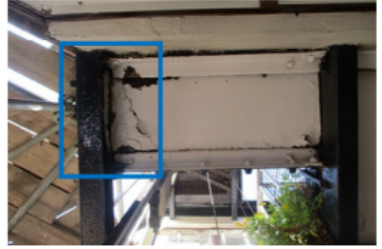
BLOCK	LEVEL	REF	DESCRIPTION	IMAGE	REPAIR
B	3	1	Rusty, loss of material/section

Clean and Repair as specified
		2	Rusty, loss of material/section

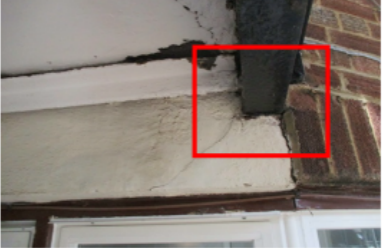
Clean and Repair as specified
			Cracking below bearing

Expose bearing to check for corrosion. Clean and Repair as specified
			Cracking below bearing

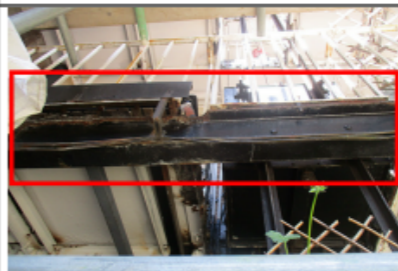
BLOCK	LEVEL	REF	DESCRIPTION	IMAGE	REPAIR
C	2	1	Rusty, loss of material/section

Replace Beam
		2	Rusty, loss of material/section		Clean and Repair as specified
		3	Rusty, loss of material/section

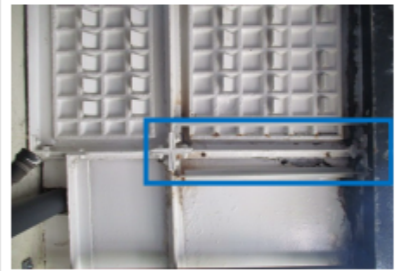
Clean and Repair as specified
		4	Rusty

Clean and Repair as specified

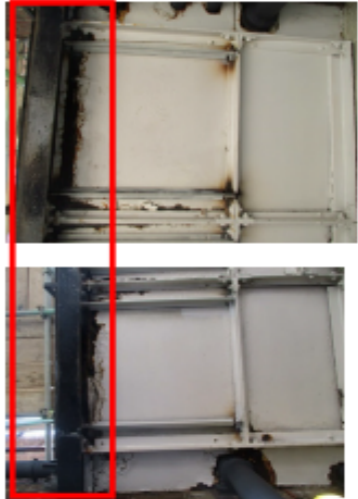
BLOCK	LEVEL	REF	DESCRIPTION	IMAGE	REPAIR
C	3	1	Rusty, loss of material/section

Replace Beam
		2	Rusty, loss of material/section
