# Arboricultural Report

## Decay Detection Investigation Report

Bedford Square  
Bedford Estates  
Bloomsbury  
London  
WC1B 3JA

**160523-PT-02**

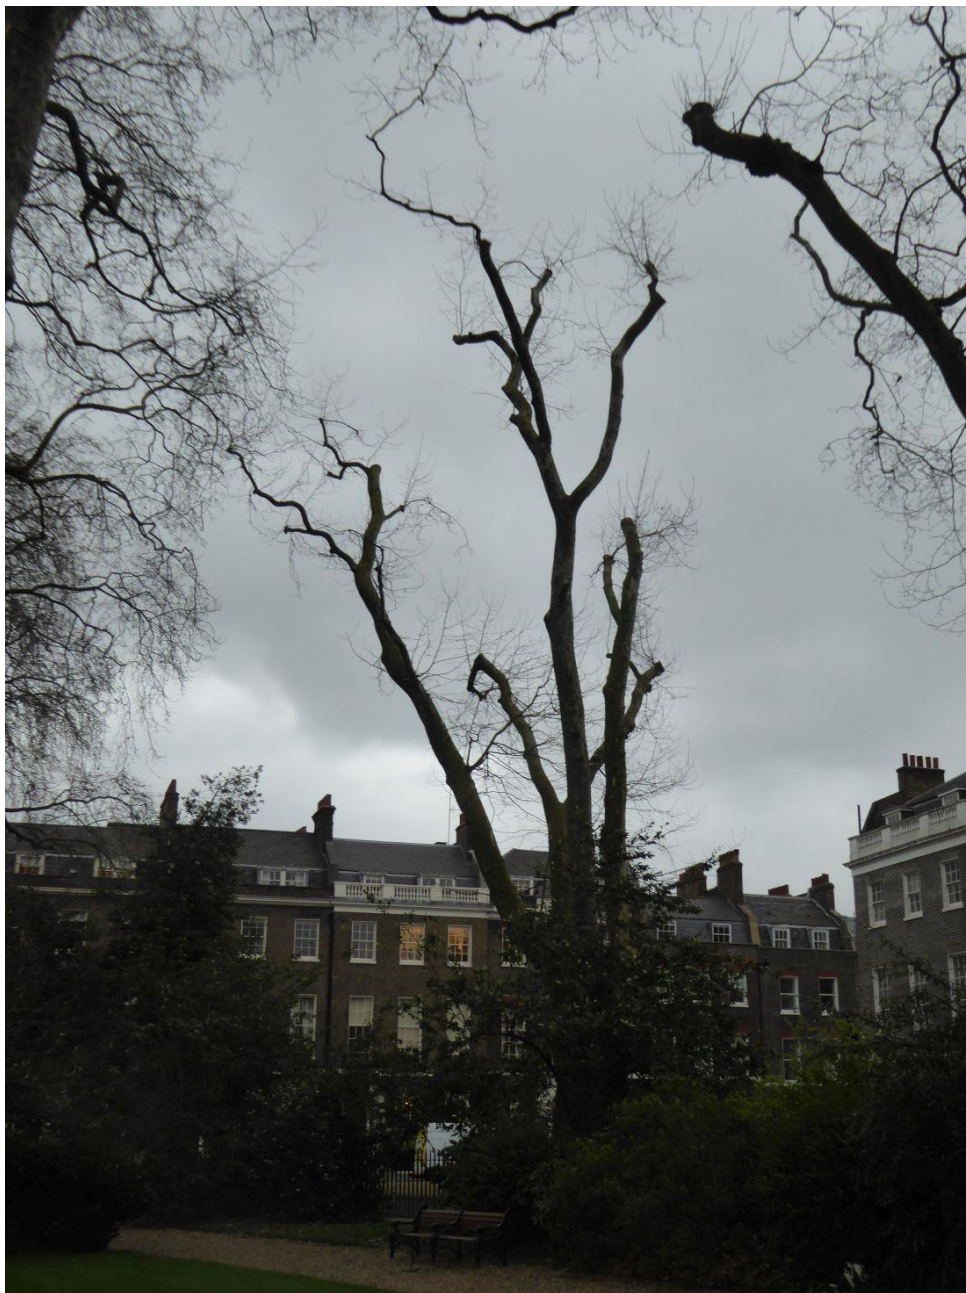
Image 2 T90 plane tree viewed from the north west

- 2.11 T90 has been heavily reduced in the recent past, T82 (plane) and T142 (elm) have been crown reduced with the last 12 months or so. T90 (plane) has poor vitality, T82 and T142 have fair vitality.
- 2.12 T90 (plane) and T82 (plane) have fungal fruiting bodies of *Rigidoporus ulmarius* and T90 also has *Perreniporia fraxinea* at the base. T142 (elm) has a narrow column of dead bark and dysfunctional wood likely associated with an historic branch removal.

- 5.1 T90 plane should be felled and the stump removed to facilitate replacement planting, within 12 months.
- 5.2 Due to pathogens currently affecting plane trees in Europe, Massaria and Plane Wilt, for example, it is recommended that a large specimen Tulip Tree – *Liriodendron tulpifera* is planted as a replacement tree in the first winter following the removal of the plane tree.
- 5.3 T82 plane - recommend reduce height to suitable growth points approximately 1-2m below previous reduction points to minimise wind loading on tree, and reduce elongated lower lateral branches by approximately 2-3m to help reduce sail area and minimise wind loading within 6 months.
- 5.4 T82 should have additional decay detection investigations at the base in two years.
- 5.5 As the trees are protected the local authority must be contacted for permission prior to any works being undertaken.

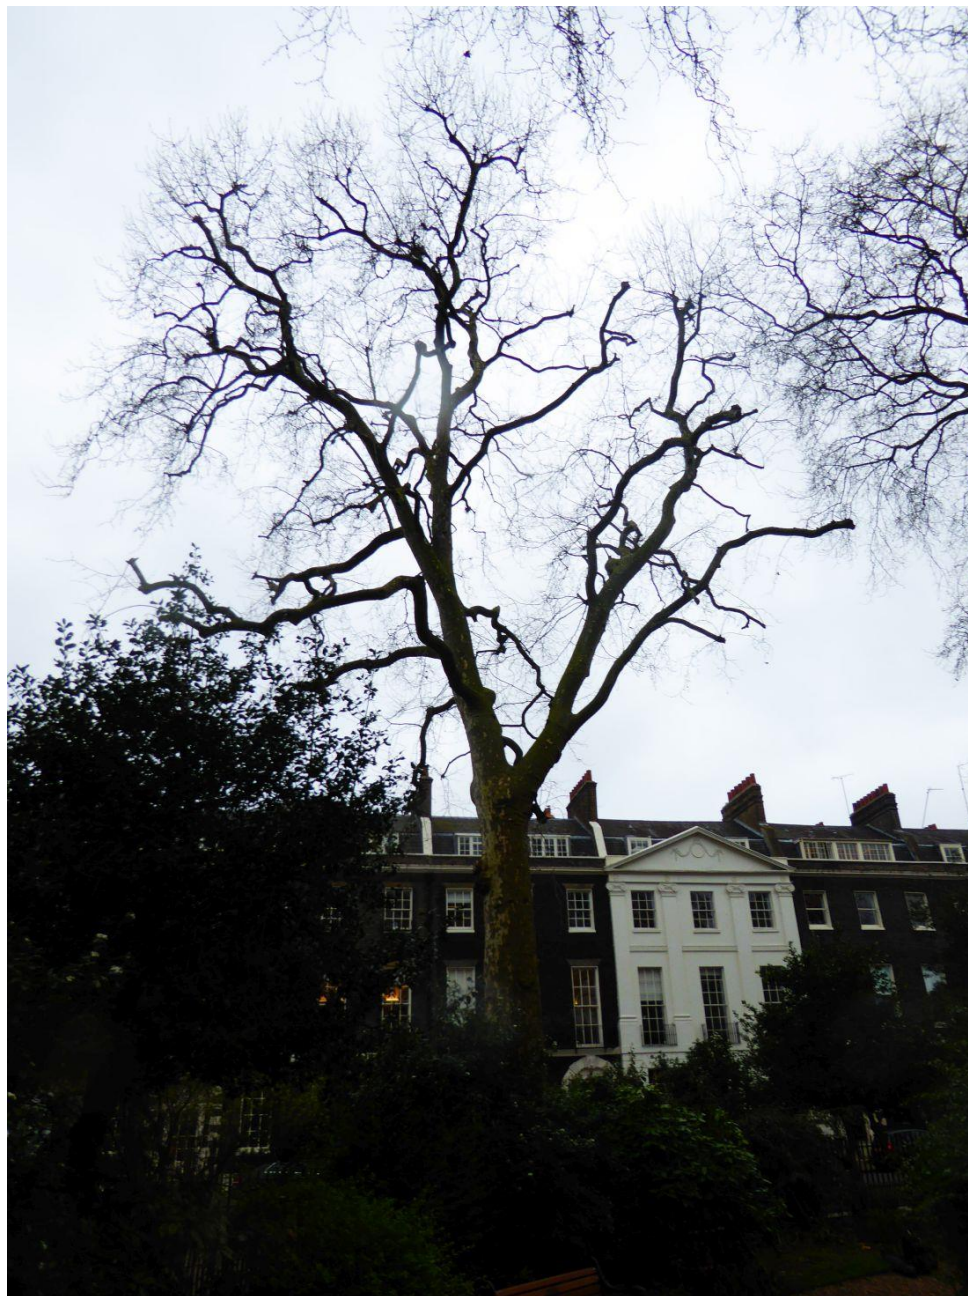
Image 3 T82 plane tree viewed from the north east

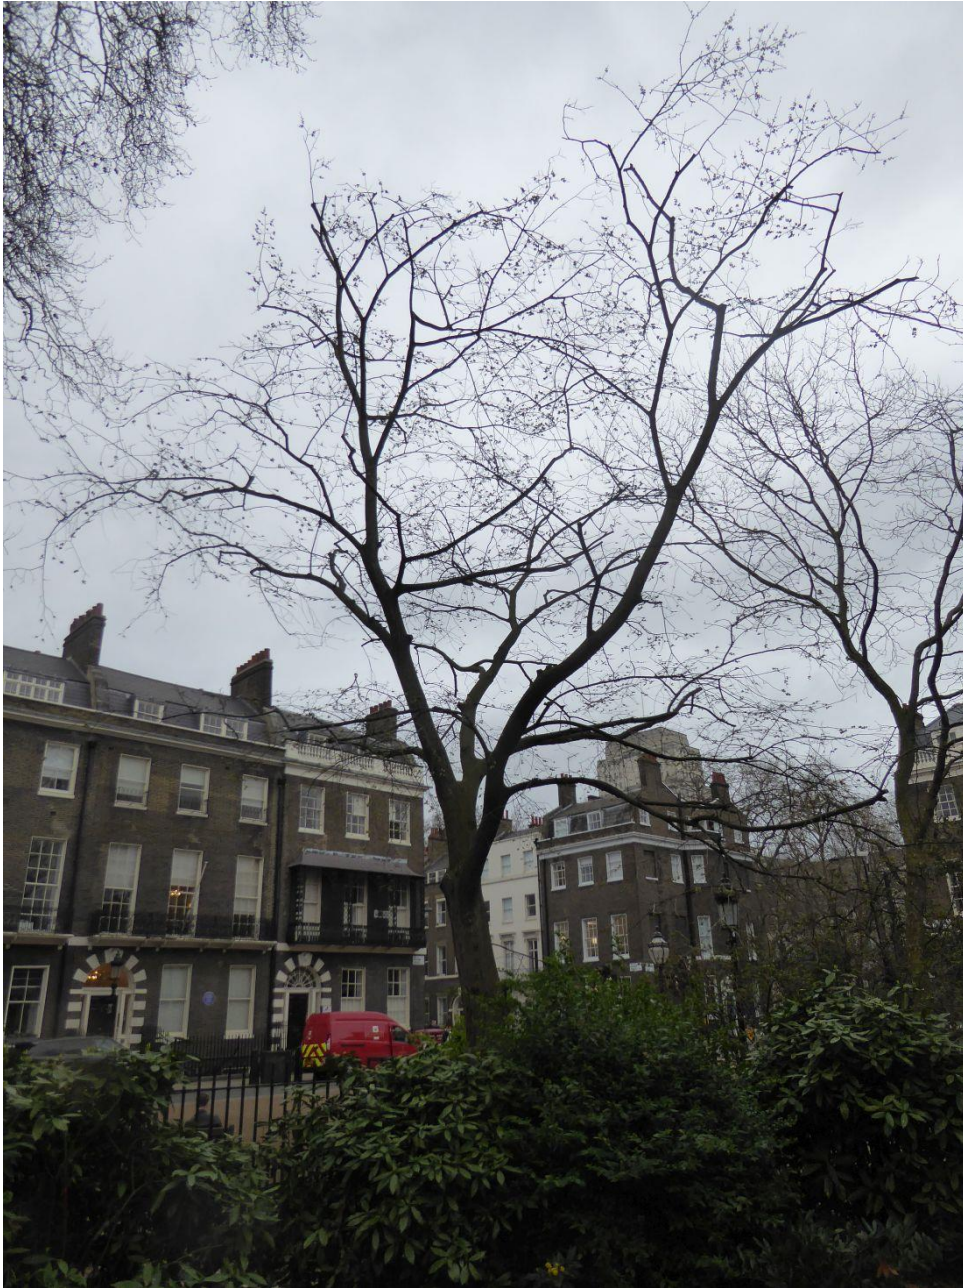
Image 4 T142 elm tree viewed from the south

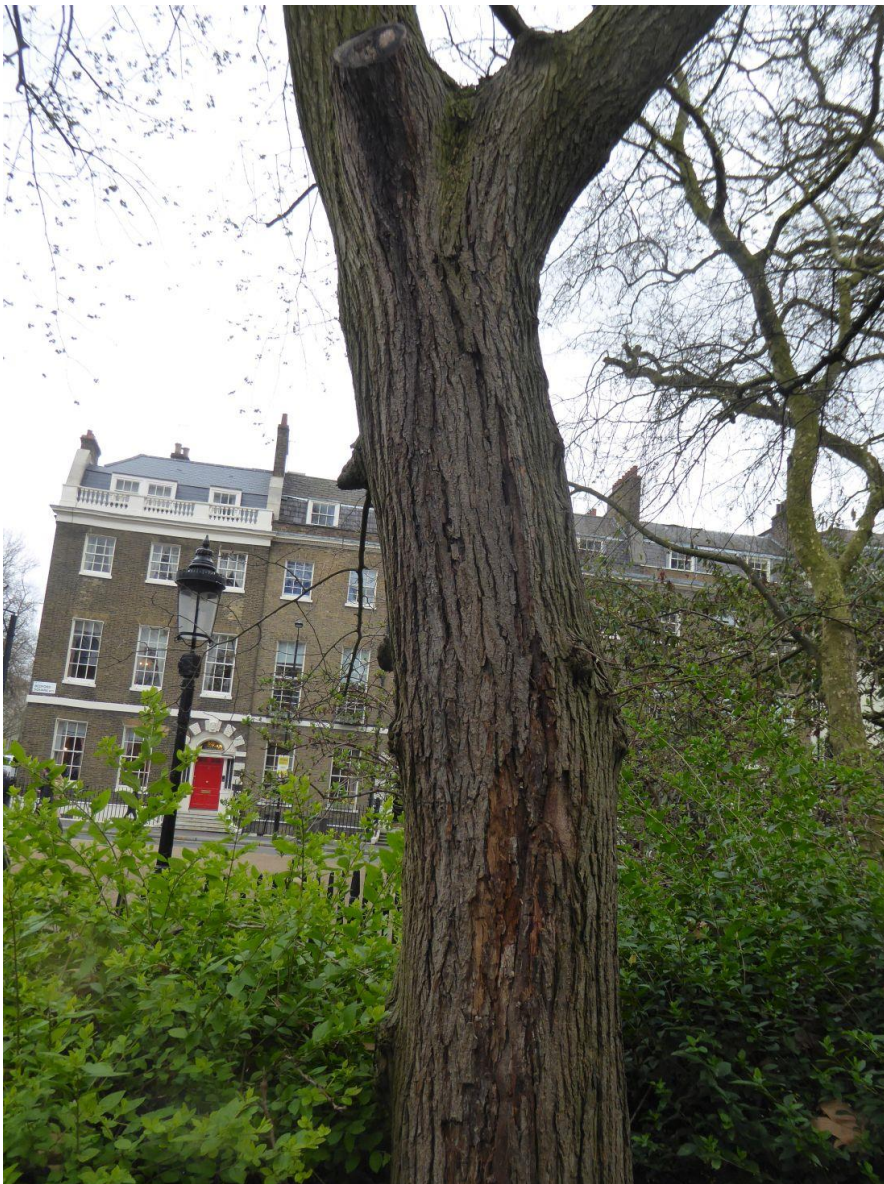
Image 5 damaged section below pruning wound on T142 Elm

- 2.13 T90 and T82 (planes) have very significant reaction growth at the base which may be indicative of reaction to historic white rot, though no white rot fungal fruiting bodies were observed on T82.
- 2.14 T142 (elm) has some callous growth by the strip of dead bark and dysfunctional wood, and has recently been crown reduced following our initial inspection last year.

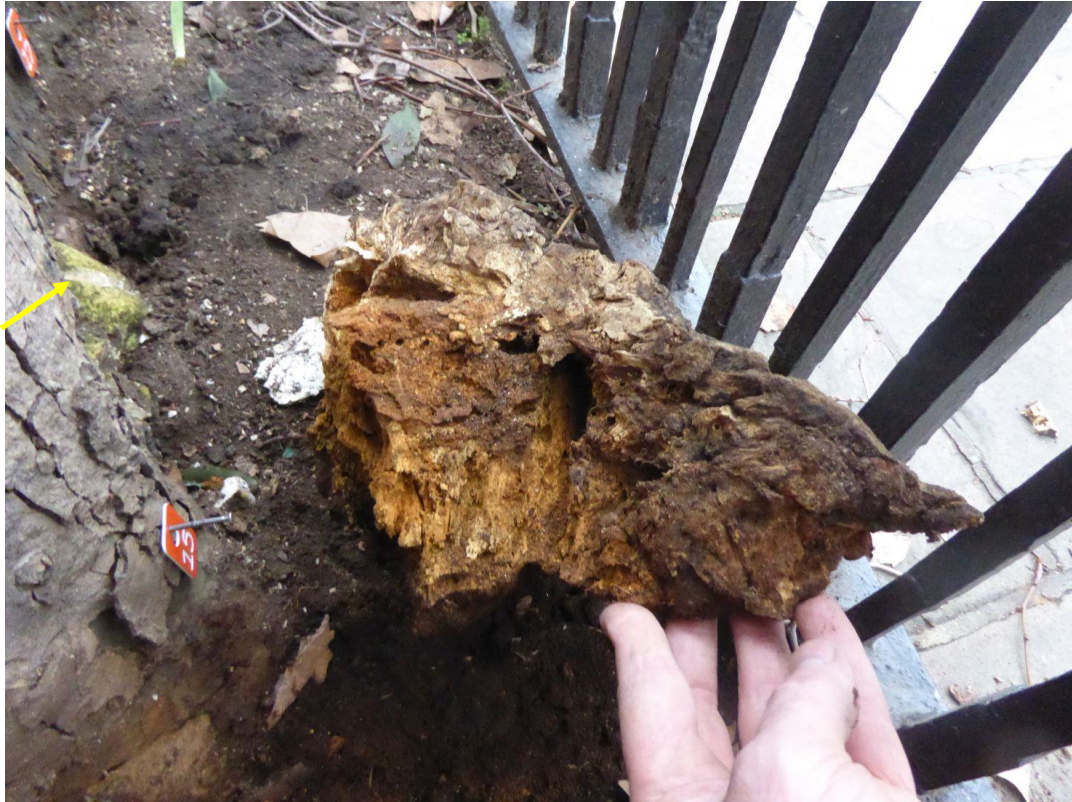
Image 6 *Rigidoporous ulmarius* (juvenile, left) and probable *Perreniporia fraxinea* (decayed, right) fungal fruit bodies at the base of T90 plane.

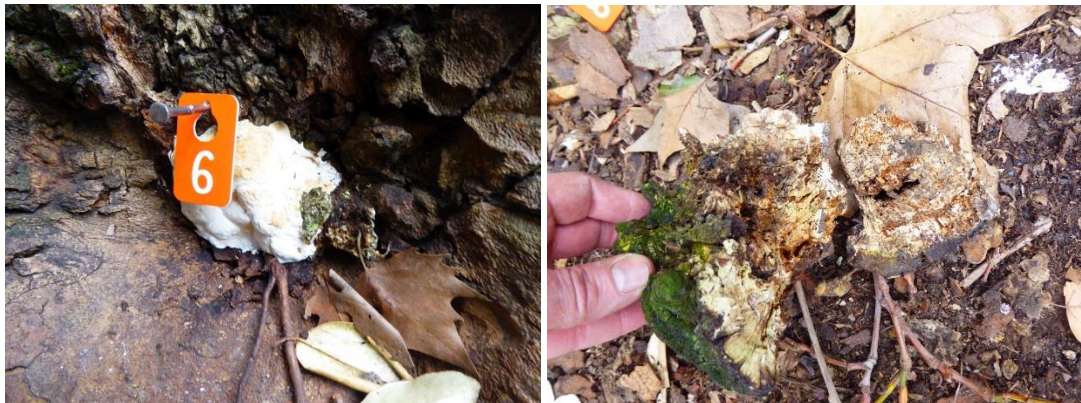
Images 7 & 8 probable *Rigidoporous ulmarius* (juvenile - left , decayed - right) fungal fruit bodies at the base of T82 plane.

- 3.5 The above tomogram shows significant internal decay surrounding by a considerable amount of remaining sound wood at the test height. The positions of a juvenile *Rigidoporus ulmarius* fungal fruiting bodies is indicated by the icon at measuring point 6 (image 7).
- 3.6 An additional, decayed fungal fruiting body, probably *Rigidoporus ulmarius*, was found on the ground in that area (image 8).

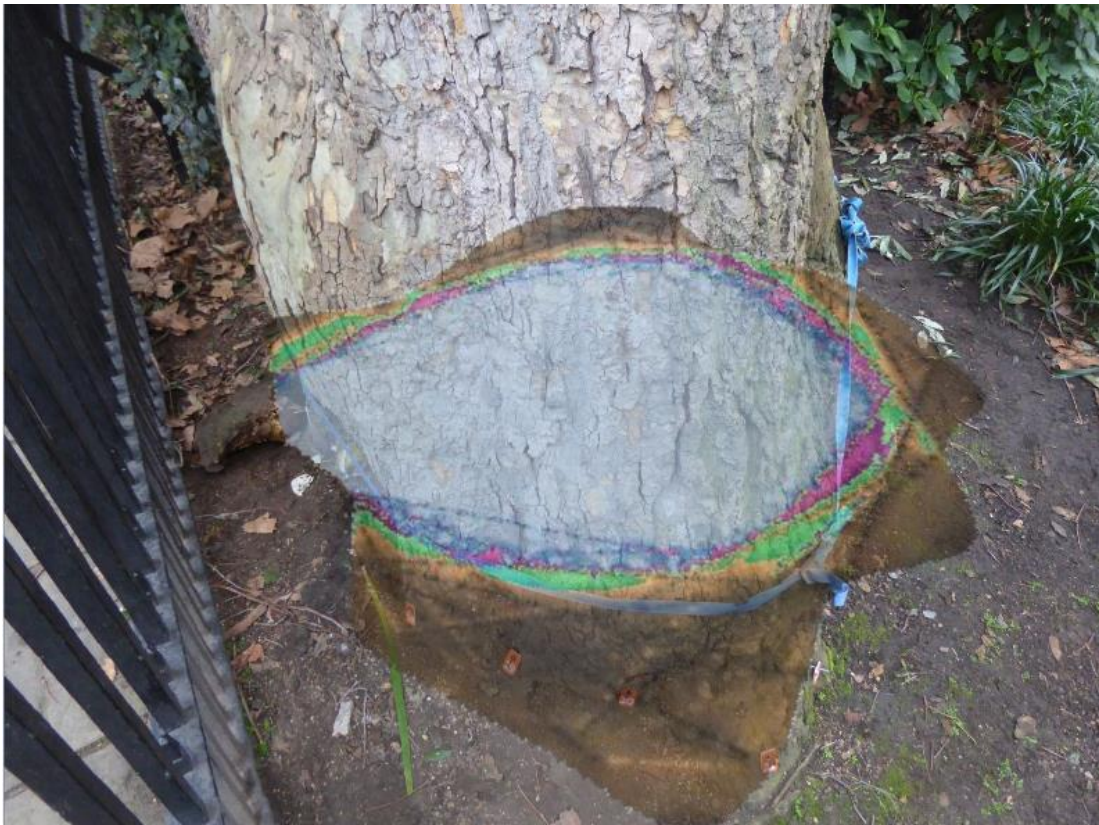
Image 9 T90 plane with the approximate position of the PiCUS tomogram overlaid

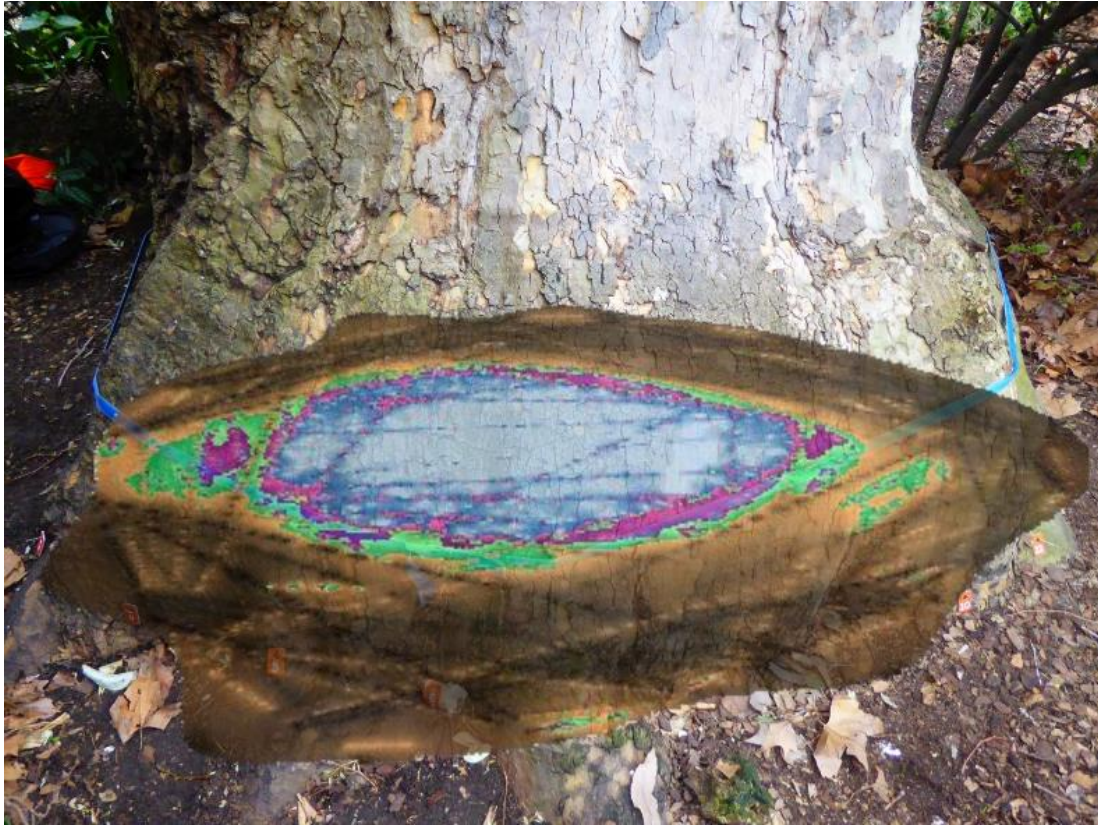
Image 10 T82 plane with the approximate position of the PiCUS tomogram overlaid

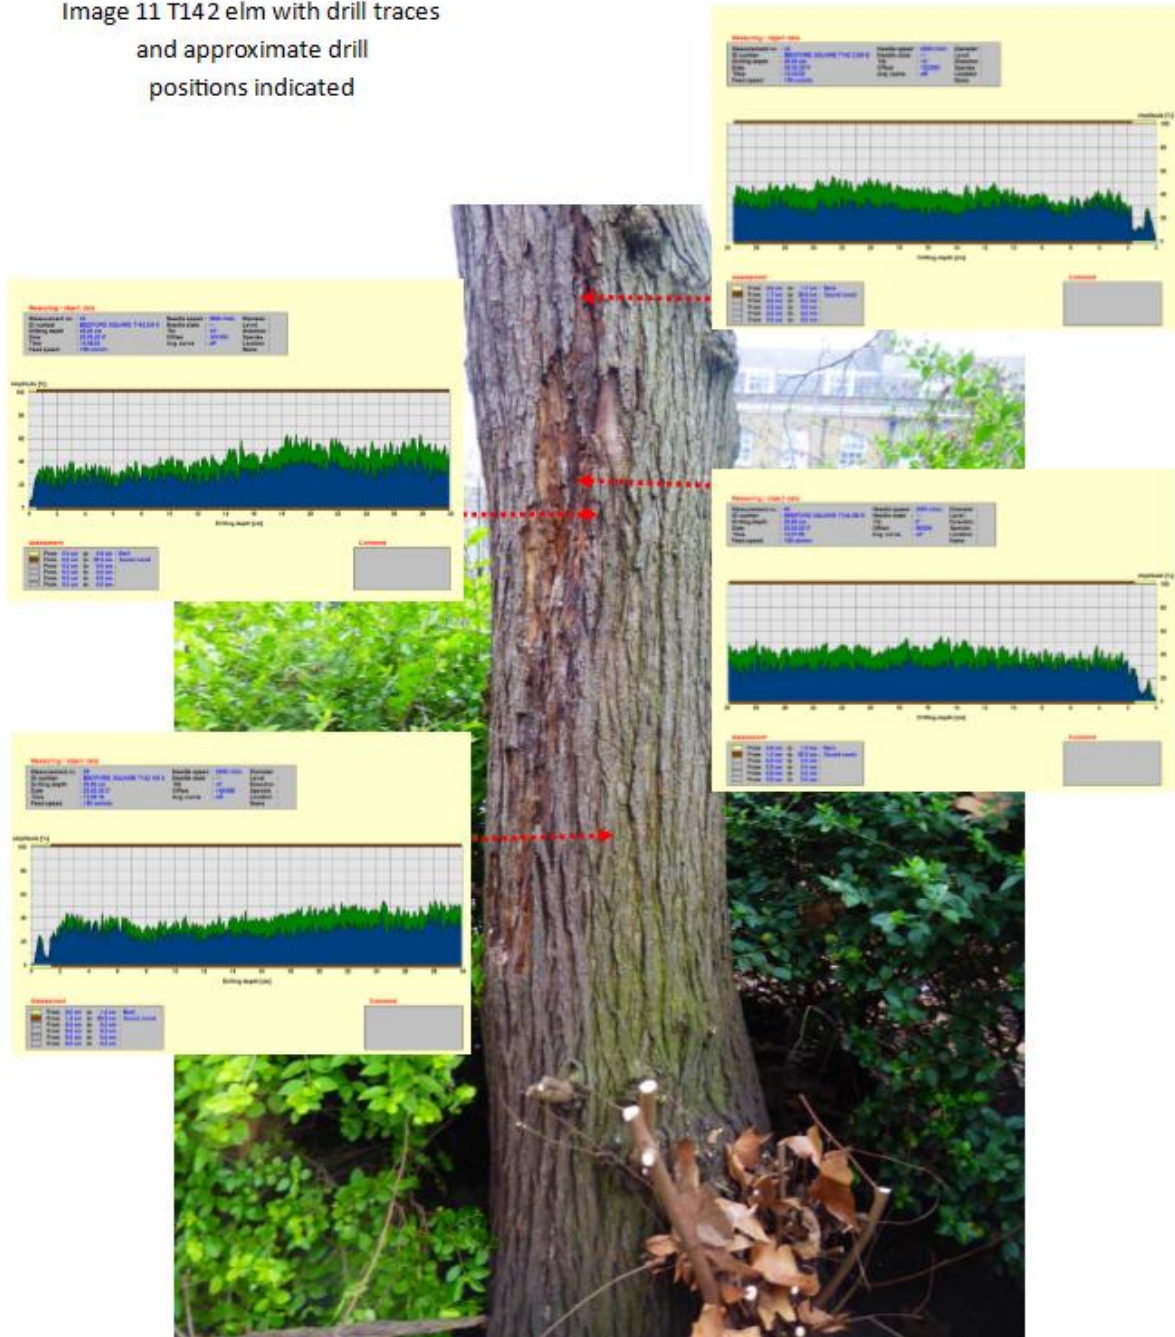
Image 11 T142 elm with drill traces and approximate drill positions indicated

3.7 The Resistograph testing showed sound wood with a high resistance to drilling at each test height (image 11).

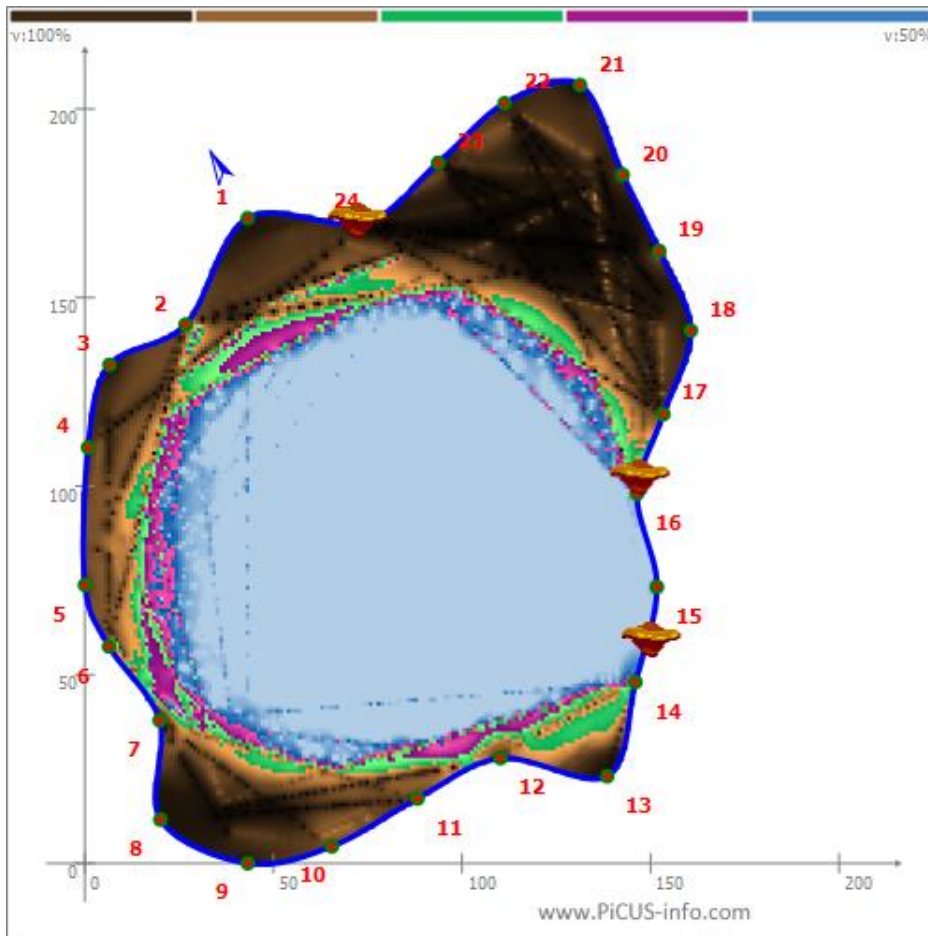
Image 12 – T90 plane tree PiCUS tomogram taken at approximately 6cm above ground level.

- 3.1 The PiCUS tomogram of T90 plane tree at 6cm shows extensive internal decay at the test height.
- 3.2 A juvenile fungal fruiting body of *Rigidoporus ulmarius* is present by measuring point 16 and a decayed fungal fruiting body, probably *Perreniporia fraxinea* was present by measuring point 15 (see image 6).
- 3.3 There is another juvenile fungal fruiting body at measuring point 24 which is likely to be of one of the two species previously referred to.
- 3.4 The crown shows poor vitality with limited regrowth following the reduction (image 2).

- 4.1 T90 plane has very significant decay at the base, poor vitality following heavy crown reduction work, and the condition of the roots colonised by *Rigidoporus ulmarius* and *Perreniporia fraxinea* is unknown.
- 4.2 The tree has a very limited useful lifespan.
- 4.3 T82 plane has significant decay at the base, fair vitality following recent crown reduction work and the condition of the roots colonised by *Rigidoporus ulmarius* is also unknown.
- 4.4 The tree can remain with a reasonable useful lifespan with additional crown reduction works to minimise the effect of wind loading on the stem, regular maintenance of the tree at a lower height, and continued monitoring of the overall condition and development of decay at the base.
- 4.5 T142 elm has recently been reduced and does not currently require further works.
- 4.6 The condition of T142 should also be regularly monitored.

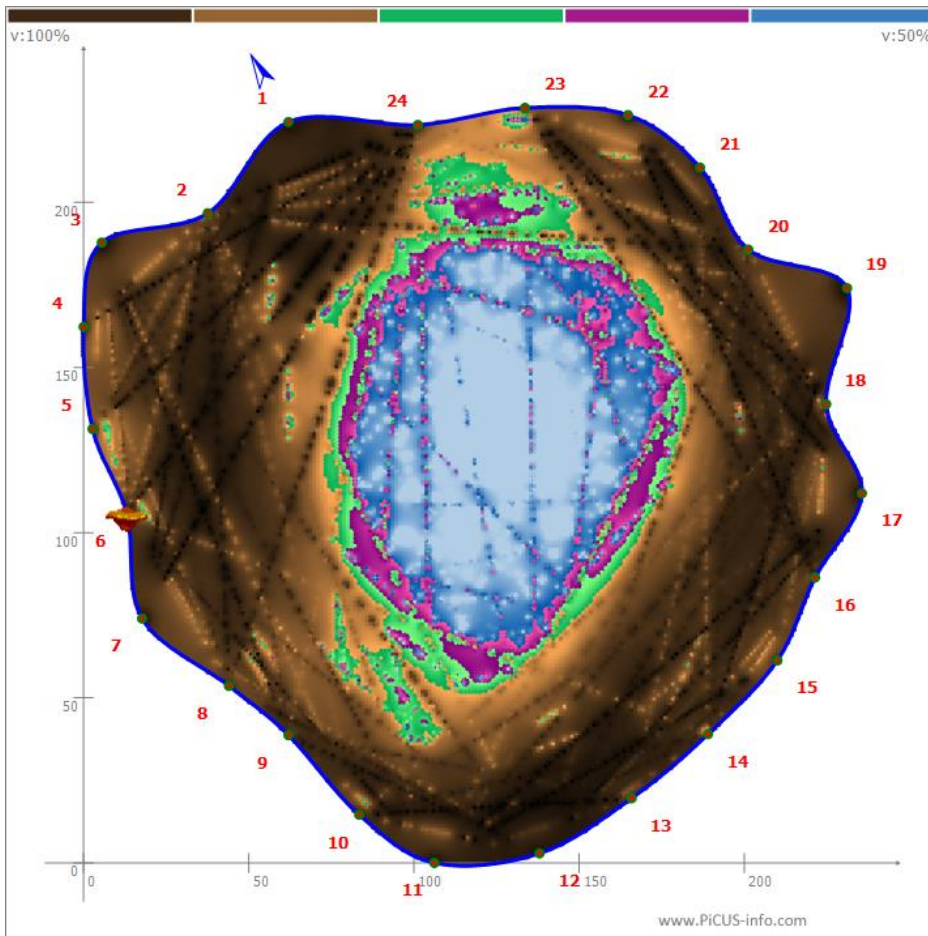
Image 13 – T82 plane PiCUS tomogram taken at approximately 4cm above ground level

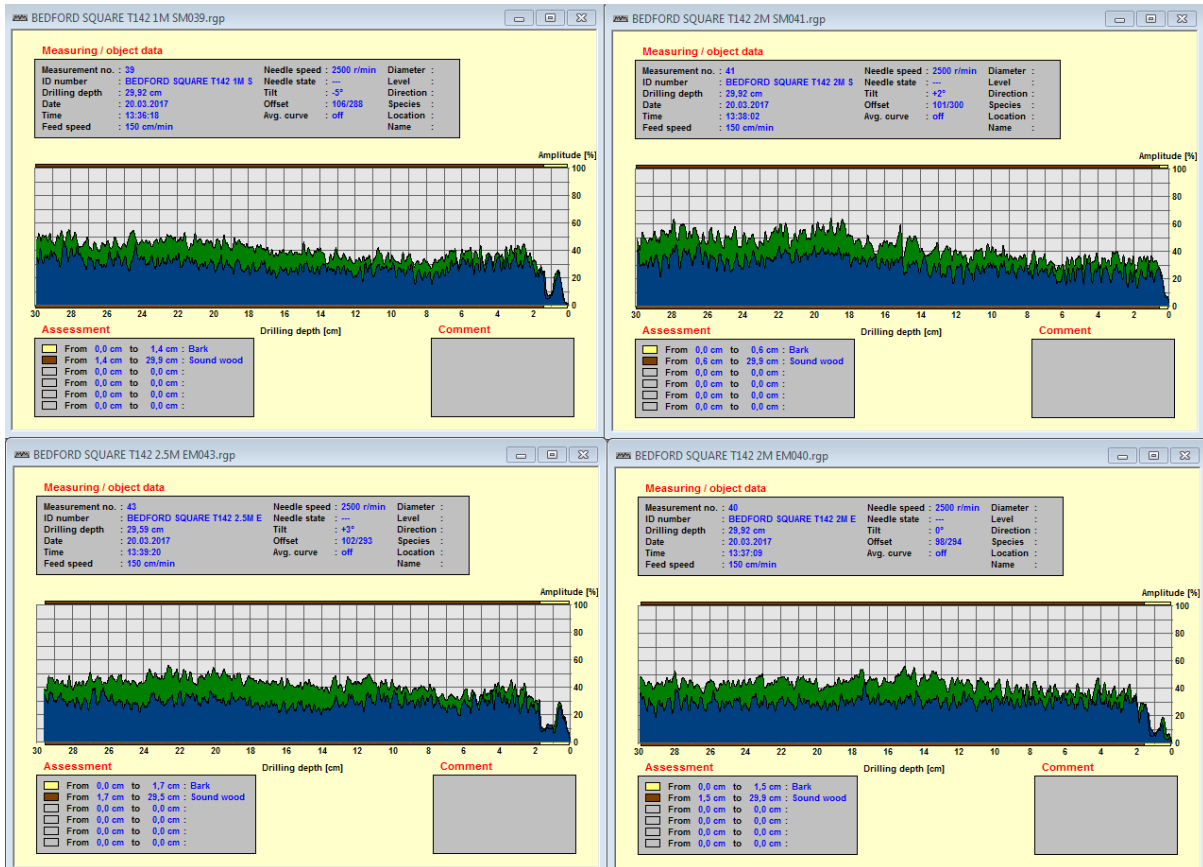
Image 14 – T142 elm Resistograph testing, results shown clockwise from top left – 1m south, 2m south, 2m east, 2.5m east. Results are read from right to left.
