# Bellamy Surveying and Consultancy Services Ltd

## Asbestos Management Survey for

Shorts Gardens LLP

60-72 Shorts Gardens/14-16 Betterton Street  
London  
WC2H 9BU

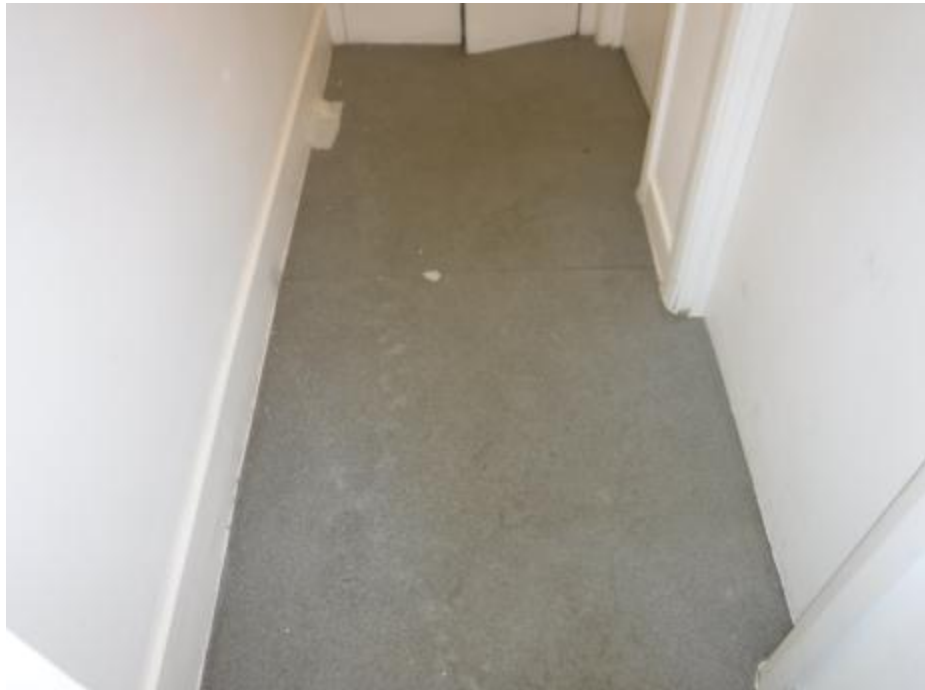
Location ID:	37936	Survey Type:	MS
Location Ref:	Sample 1	Product Type:	NADIS
Product:	Floor Screed	Damage:	NADIS
Area:	60-72 Short Gardens	Treatment:	NADIS
Floor:	Second floor	Asbestos Type:	NADIS
Room:	WC Lobby	Identification:	Identified
Surveyor Name:	Daryl Bellamy	Quantity:	Representative Flooring Sample
Drawing Ref:			
Asbestos ?	No		
Date:	21 November 2016		
Next Inspection:	Not Applicable

Material Risk Score:	0
Material Risk Band:	NADIS
Priority Risk Score:	N/A

Material Comments: A sample of floor screed was removed for laboratory bulk sampling analysis from the to wc lobby, second floor level.

Action: **No Action Required**

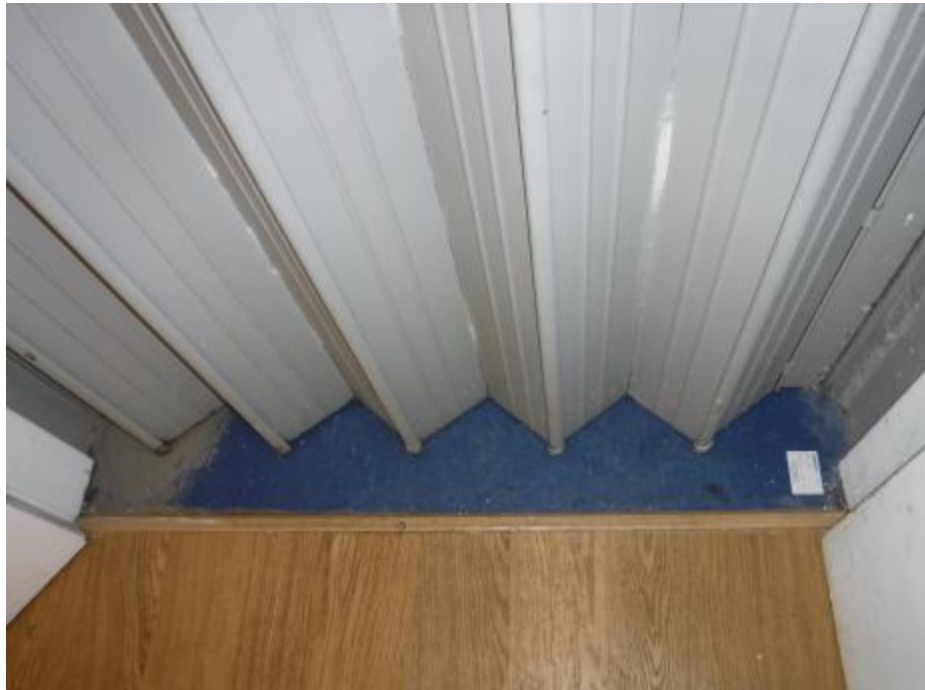
Location ID:	37937	Survey Type:	MS
Location Ref:	Sample 2	Product Type:	NADIS
Product:	Floor covering	Damage:	NADIS
Area:	60-72 Short Gardens	Treatment:	NADIS
Floor:	Second Floor	Asbestos Type:	NADIS
Room:	Office	Identification:	Identified
Surveyor Name:	Daryl Bellamy	Quantity:	Representative Flooring Sample
Drawing Ref:			
Asbestos ?	No		
Date:	21 November 2016		
Next Inspection:	Not Applicable

Material Risk Score:	0
Material Risk Band:	NADIS
Priority Risk Score:	N/A

Material Comments: A sample of floor covering (blue) was removed for laboratory bulk sampling analysis from the office (adjacent to lift), second floor level.

Action: **No Action Required**

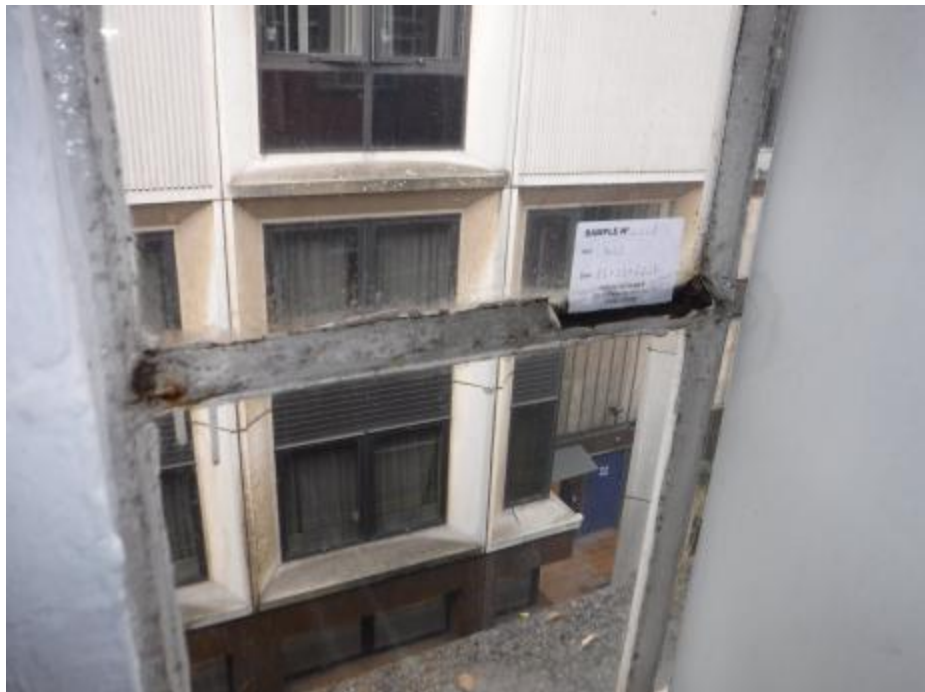
Location ID:	37938	Survey Type:	MS
Location Ref:	Sample 3	Product Type:	NADIS
Product:	Window Putty	Damage:	NADIS
Area:	60/72 Short Gardens	Treatment:	NADIS
Floor:	Second Floor	Asbestos Type:	NADIS
Room:	Office	Identification:	Identified
Surveyor Name:	Daryl Bellamy	Quantity:	Representative Window Putty
Drawing Ref:			
Asbestos ?	No		
Date:	21 November 2016		
Next Inspection:	Not Applicable

Material Risk Score:	0
Material Risk Band:	NADIS
Priority Risk Score:	N/A

Material Comments: A sample of window putty was removed for laboratory bulk sampling analysis from the office, second floor level.

Action: **No Action Required**

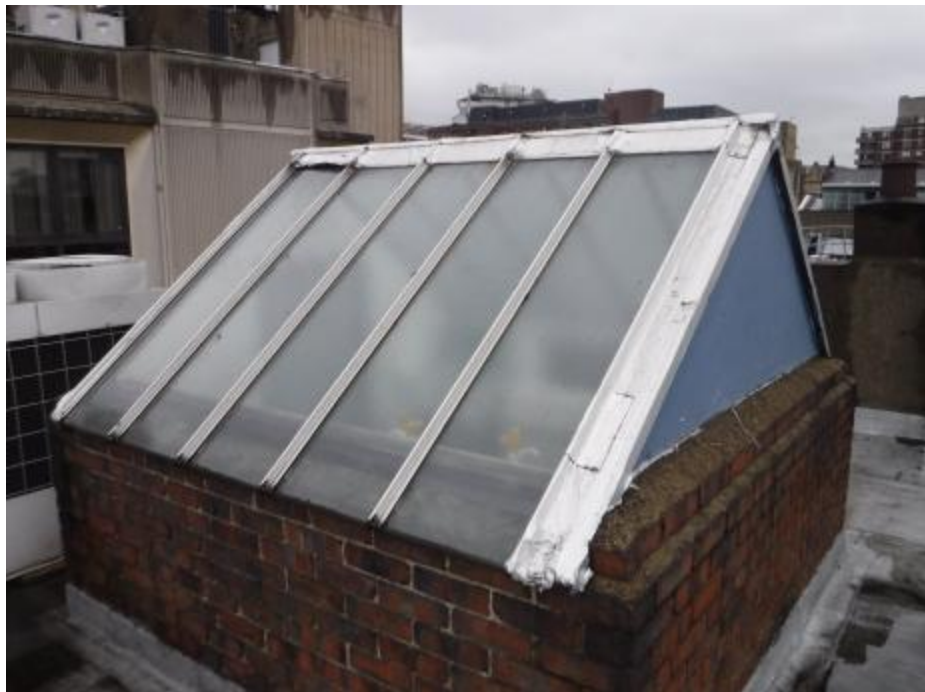
Location ID:	37940	Survey Type:	MS
Location Ref:	Photo 1	Product Type:	Ropes and woven textiles
Product:	Skylight	Damage:	No visible damage
Area:	60-72 Short Gardens	Treatment:	Enclosed sprays and lagging
Floor:	Roof	Asbestos Type:	Chrysotile
Room:	External	Identification:	Presumed
Surveyor Name:	Daryl Bellamy	Quantity:	Representative Skylight Reference
Drawing Ref:			
Asbestos ?	Yes		
Date:	21 November 2016		
Next Inspection:	21 November 2017

Material Risk Score:	4
Material Risk Band:	Very Low Risk
Priority Risk Score:	N/A

Material Comments: A photograph reference of skylight presumed to contain asbestos i.e enclosed rope seals. Roof top.

Action: **Do Not Disturb - Contractors to be Aware**

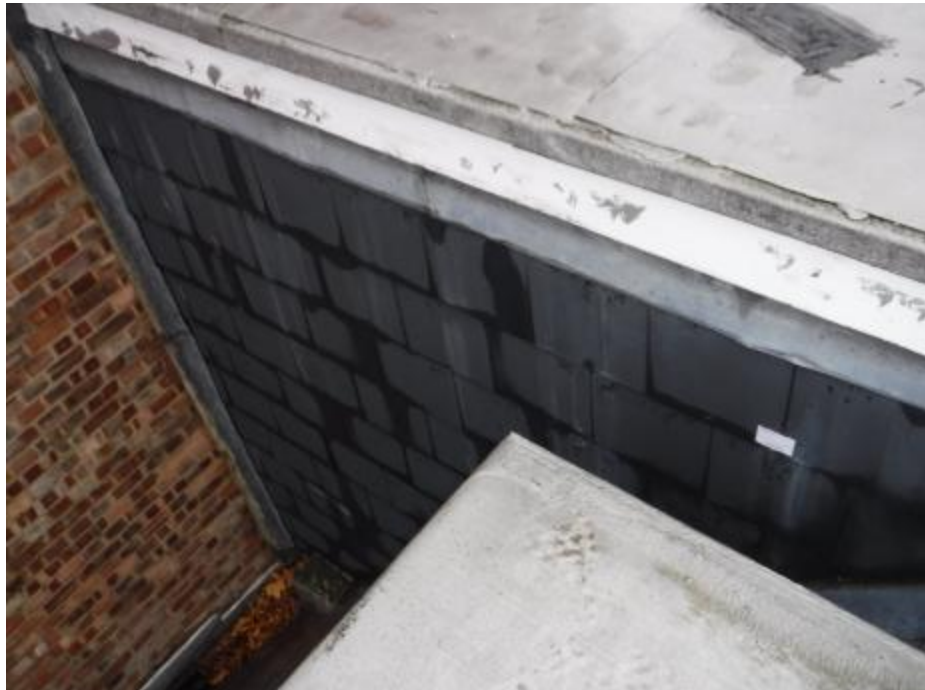
Location ID:	37941	Survey Type:	MS
Location Ref:	Sample 5	Product Type:	NADIS
Product:	Roof Tiles	Damage:	NADIS
Area:	60/72 Short Gardens	Treatment:	NADIS
Floor:	Roof	Asbestos Type:	NADIS
Room:	External	Identification:	Identified
Surveyor Name:	Daryl Bellamy	Quantity:	Approx 15m <sup>2</sup>
Drawing Ref:			
Asbestos ?	No		
Date:	21 November 2016		
Next Inspection:	Not Applicable

Material Risk Score:	0
Material Risk Band:	NADIS
Priority Risk Score:	N/A

Material Comments: A sample of roof tile was removed for laboratory bulk sampling analysis from the external roof top.

Action: **No Action Required**

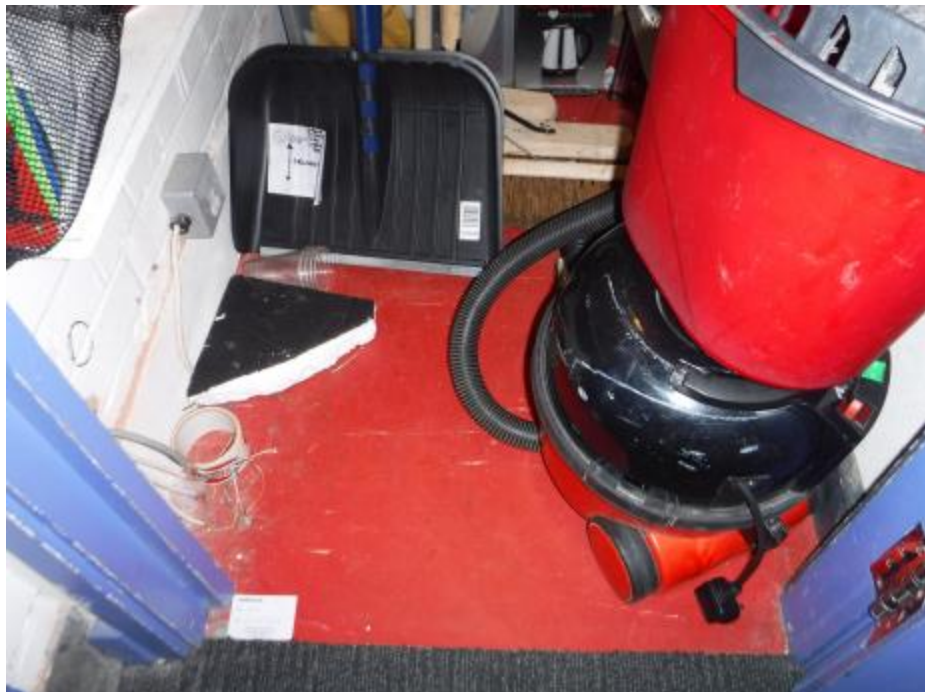
Location ID:	37949	Survey Type:	MS
Location Ref:	Sample 6	Product Type:	NADIS
Product:	Floor covering	Damage:	NADIS
Area:	14-16 Betterton Street	Treatment:	NADIS
Floor:	Third floor	Asbestos Type:	NADIS
Room:	Store cupboard	Identification:	Identified
Surveyor Name:	Daryl Bellamy	Quantity:	Approx 6m <sup>2</sup>
Drawing Ref:			
Asbestos ?	No		
Date:	21 November 2016		
Next Inspection:	Not Applicable

Material Risk Score:	0
Material Risk Band:	NADIS
Priority Risk Score:	N/A

A sample of floor covering (red) was removed for laboratory bulk sampling analysis from the store cupboard, third floor (also noted to adjacent wcs).

Action: **No Action Required**

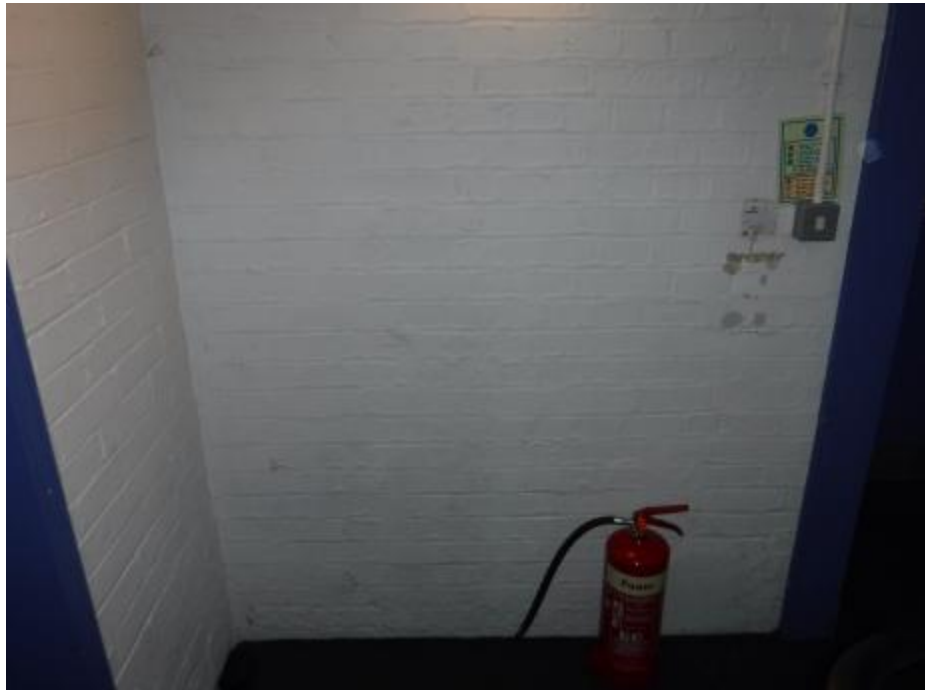
Location ID:	37950	Survey Type:	MS
Location Ref:	Sample 7	Product Type:	NADIS
Product:	Spray coating	Damage:	NADIS
Area:	14-16 Betterton Street	Treatment:	NADIS
Floor:	First floor	Asbestos Type:	NADIS
Room:	Stairs	Identification:	Identified
Surveyor Name:	Daryl Bellamy	Quantity:	Representative Spray Coat to Wall
Drawing Ref:			
Asbestos ?	No		
Date:	21 November 2016		
Next Inspection:	Not Applicable

Material Risk Score:	0
Material Risk Band:	NADIS
Priority Risk Score:	N/A

Material Comments: A sample of spray coat to wall was removed for laboratory bulk sampling analysis from the stairs, first floor level. Noted throughout stair case.

Action: **No Action Required**

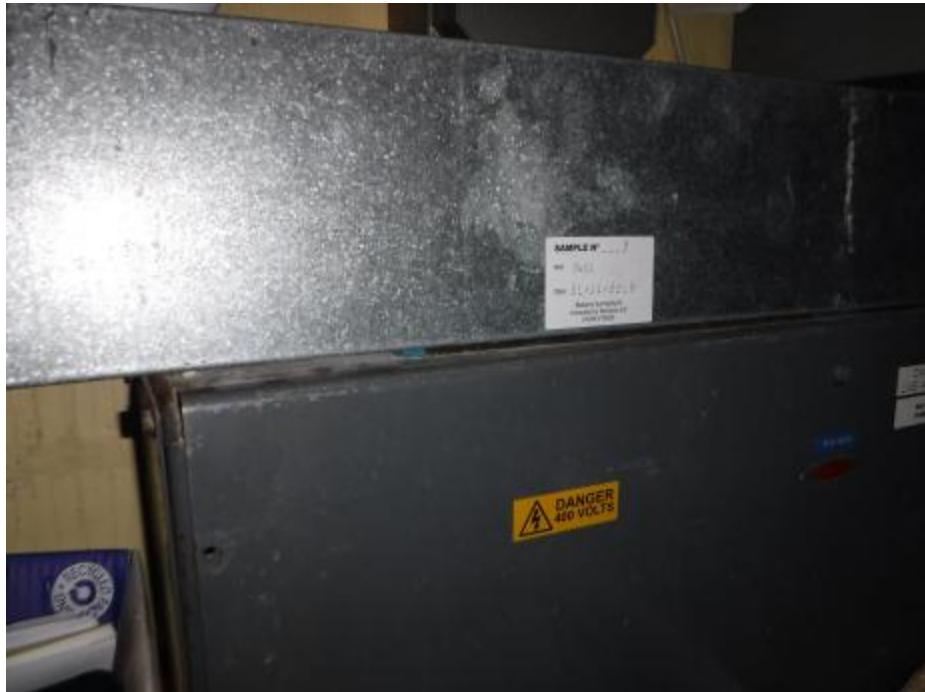
Location ID:	37951	Survey Type:	MS
Location Ref:	Sample 8	Product Type:	Asbestos cement
Product:	Lining panel	Damage:	No visible damage
Area:	60-72 Short Gardens	Treatment:	Asbestos cement sheets etc
Floor:	First floor	Asbestos Type:	Chrysotile
Room:	Electrical cupboard	Identification:	Identified
Surveyor Name:	Daryl Bellamy	Quantity:	2no
Drawing Ref:			
Asbestos ?	Yes		
Date:	21 November 2016		
Next Inspection:	21 November 2017

Material Risk Score:	3
Material Risk Band:	Very Low Risk
Priority Risk Score:	N/A

Material Comments: A sample of lining panel (beneath elec boxes) within electrical cupboard was removed for laboratory bulk sampling analysis from the office, first floor level.

Action: Apply Asbestos Warning Labels - Do Not Disturb

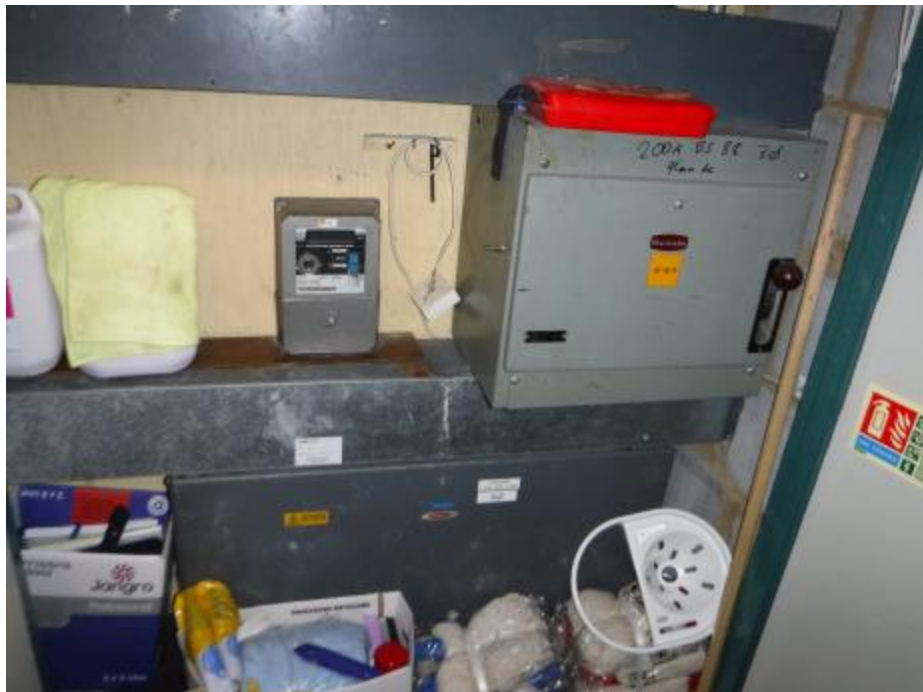
Location ID:	37952	Survey Type:	MS
Location Ref:	Photo 2	Product Type:	Ropes and woven textiles
Product:	Electrical Box	Damage:	No visible damage
Area:	60-72 Short Gardens	Treatment:	Enclosed sprays and lagging
Floor:	First floor	Asbestos Type:	Chrysotile
Room:	Electrical cupboard	Identification:	Presumed
Surveyor Name:	Daryl Bellamy	Quantity:	Representative Electrical Reference
Drawing Ref:			
Asbestos ?	Yes		
Date:	21 November 2016		
Next Inspection:	21 November 2017

Material Risk Score:	4
Material Risk Band:	Very Low Risk
Priority Risk Score:	N/A

Material Comments: A photograph reference of electrical boxes presumed to contain asbestos i.e enclosed rope seals. Office, first floor level.

Action: **Do Not Disturb - Contractors to be Aware**

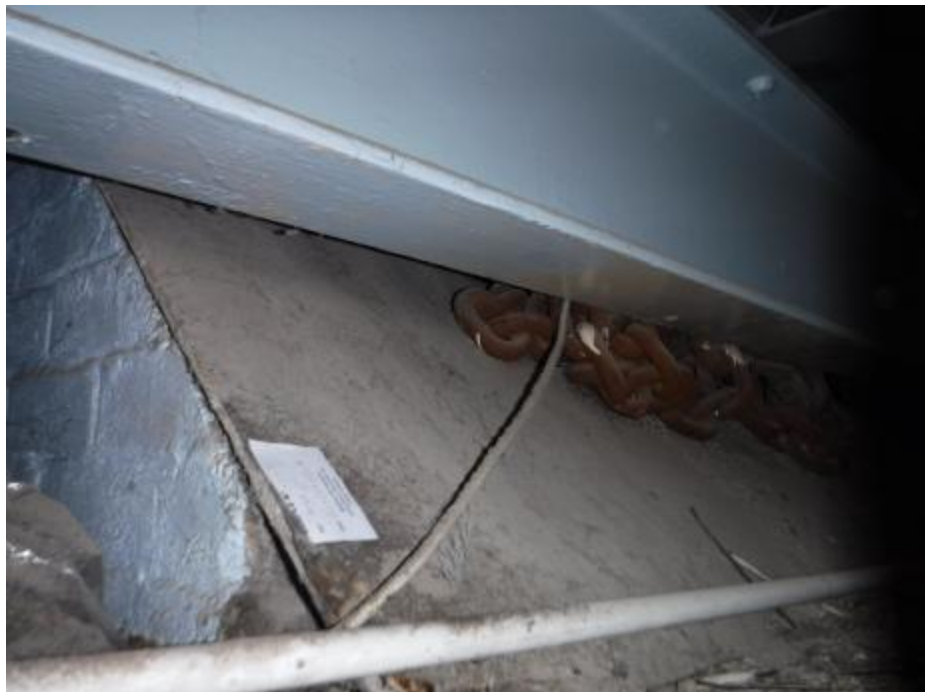
Location ID:	37964	Survey Type:	MS
Location Ref:	Sample 9	Product Type:	Asbestos cement
Product:	Cement Panel	Damage:	Low damage
Area:	60/72 Short Gardens	Treatment:	Asbestos cement sheets etc
Floor:	Ground floor	Asbestos Type:	Chrysotile
Room:	Car Park	Identification:	Identified
Surveyor Name:	Daryl Bellamy	Quantity:	Approx 4m <sup>2</sup>
Drawing Ref:			
Asbestos ?	Yes		
Date:	21 November 2016		
Next Inspection:	21 November 2017

Material Risk Score:	4
Material Risk Band:	Very Low Risk
Priority Risk Score:	N/A

Material Comments: A sample of cement panel (above plant cupboard) was removed for laboratory bulk sampling analysis from the car park, ground floor level.

Action: Encapsulate & Apply Warning Labels. Do Not Disturb

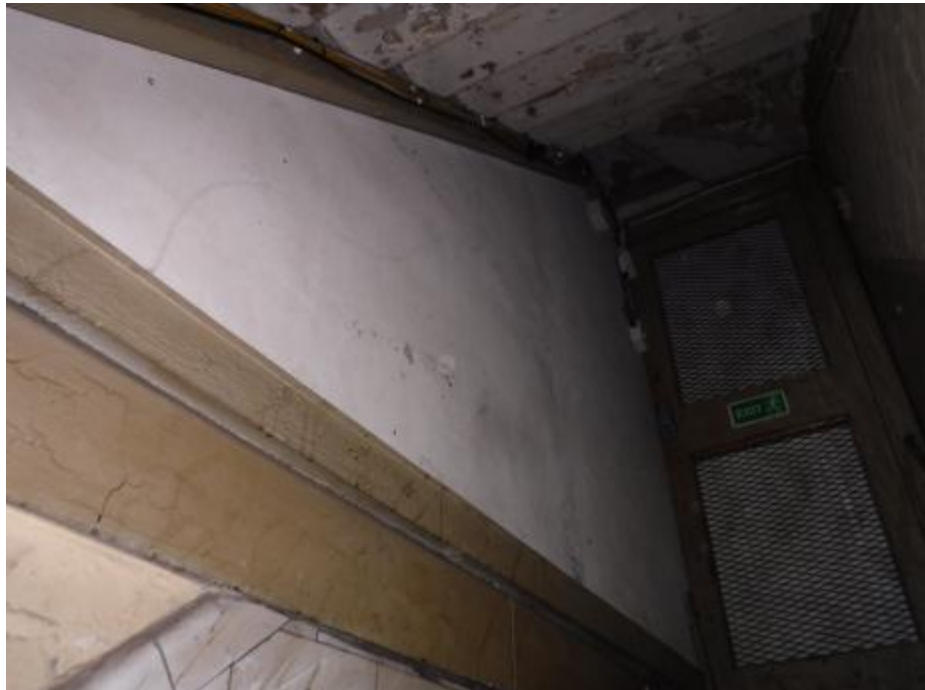
Location ID:	37987	Survey Type:	MS
Location Ref:	Sample 14	Product Type:	NADIS
Product:	Board	Damage:	NADIS
Area:	60-72 Short Gardens	Treatment:	NADIS
Floor:	Ground floor	Asbestos Type:	NADIS
Room:	Stairs	Identification:	Identified
Surveyor Name:	Daryl Bellamy	Quantity:	Approx 8m <sup>2</sup>
Drawing Ref:			
Asbestos ?	No		
Date:	21 November 2016		
Next Inspection:	Not Applicable

Material Risk Score:	0
Material Risk Band:	NADIS
Priority Risk Score:	N/A

Material Comments: A sample of board to wall was removed for laboratory bulk sampling analysis from the stairs (adjacent to short gardens basement entrance) ground floor.

Action: **No Action Required**

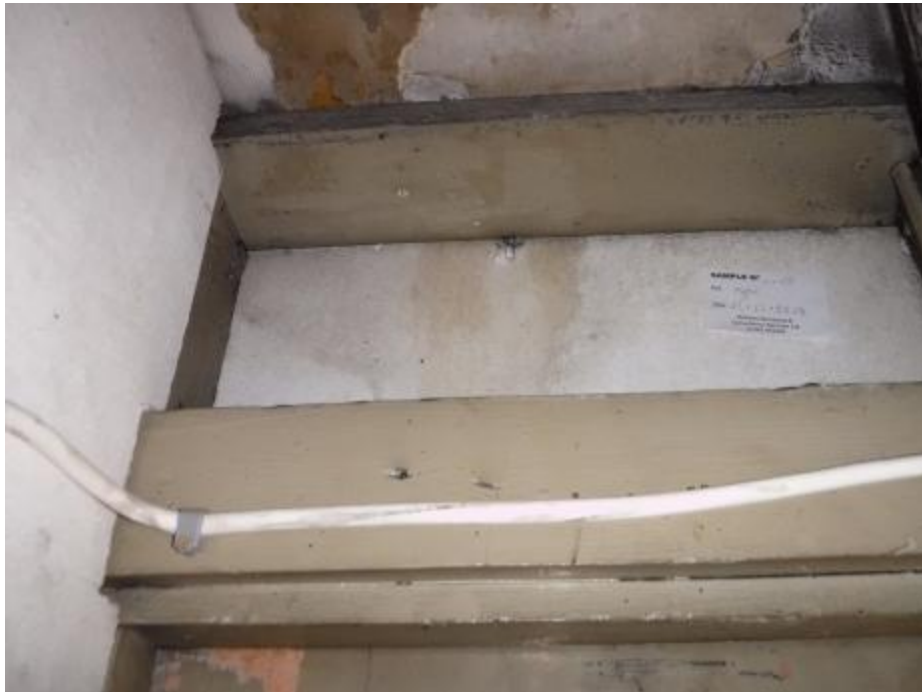
Location ID:	37988	Survey Type:	MS
Location Ref:	Sample 15	Product Type:	NADIS
Product:	Transom Panel	Damage:	NADIS
Area:	60-72 Short Gardens	Treatment:	NADIS
Floor:	Ground floor	Asbestos Type:	NADIS
Room:	Stairs	Identification:	Identified
Surveyor Name:	Daryl Bellamy	Quantity:	Approx 1m <sup>2</sup>
Drawing Ref:			
Asbestos ?	No		
Date:	21 November 2016		
Next Inspection:	Not Applicable

Material Risk Score:	0
Material Risk Band:	NADIS
Priority Risk Score:	N/A

Material Comments: A sample of board above door was removed for laboratory bulk sampling analysis from the stairs (adjacent to short gardens basement entrance) ground floor. Also noted to door.

Action: **No Action Required**

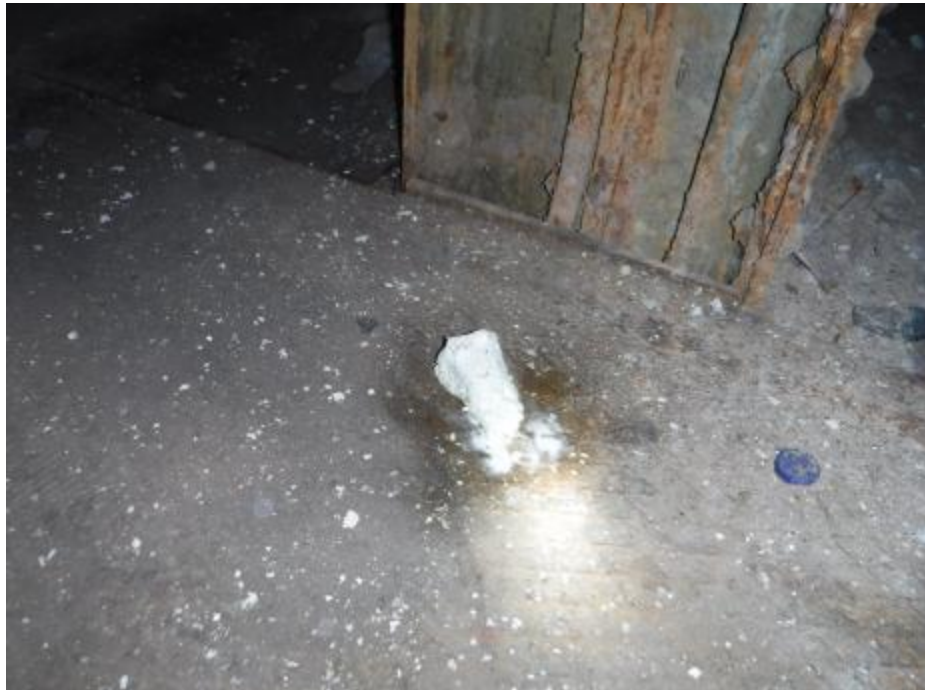
Location ID:	37990	Survey Type:	MS
Location Ref:	Sample 16	Product Type:	NADIS
Product:	Debris	Damage:	NADIS
Area:	60-72 Short Gardens	Treatment:	NADIS
Floor:	Basement	Asbestos Type:	NADIS
Room:	Main Area	Identification:	Identified
Surveyor Name:	Daryl Bellamy	Quantity:	Representative Debris Sample
Drawing Ref:			
Asbestos ?	No		
Date:	21 November 2016		
Next Inspection:	Not Applicable

Material Risk Score:	0
Material Risk Band:	NADIS
Priority Risk Score:	N/A

Material Comments: A sample of debris to floor was removed for laboratory bulk sampling analysis from the main area to the basement.

Action: **No Action Required**

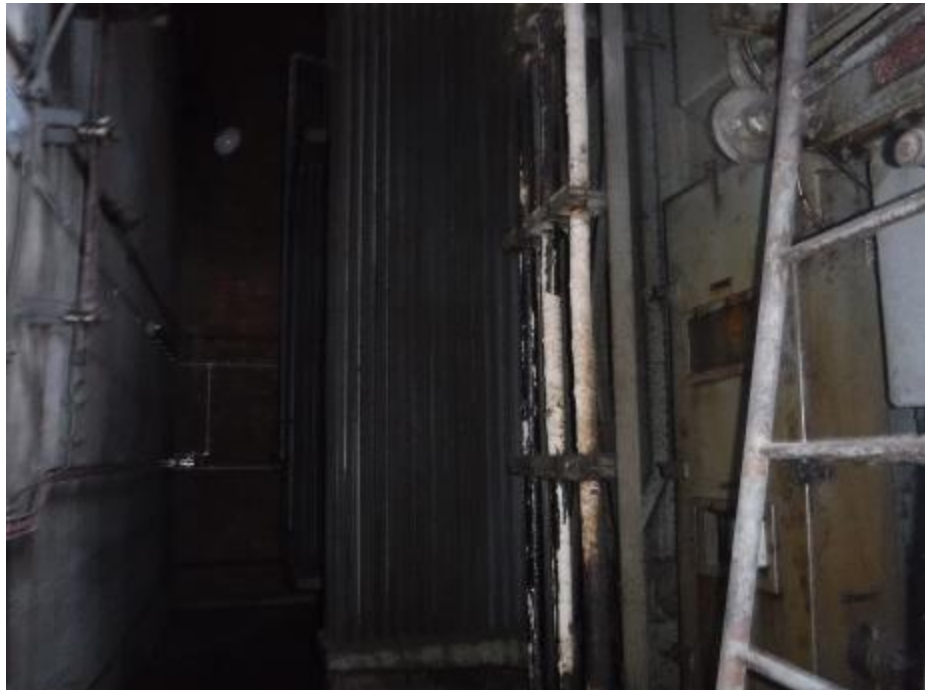
Location ID:	38079	Survey Type:	MS
Location Ref:	Photo 15	Product Type:	Ropes and woven textiles
Product:	Rope Insulation	Damage:	Low damage
Area:	60-72 Short Gardens	Treatment:	Enclosed sprays and lagging
Floor:	Ground floor	Asbestos Type:	Chrysotile
Room:	Yard	Identification:	Strongly Presumed
Surveyor Name:	Daryl Bellamy	Quantity:	Representative Rope Insulation to Cables
Drawing Ref:			
Asbestos ?	Yes		
Date:	21 November 2016		
Next Inspection:	23 May 2017

Material Risk Score:	5
Material Risk Band:	Low Risk
Priority Risk Score:	N/A

Material Comments: A photograph reference of rope insulation to large electrical plant, strongly presumed to contain asbestos. Transformer bay to yard, ground floor level. (no access).

Action: Encapsulate & Apply Warning Labels. Do Not Disturb
