**BS5837 ARBORICULTURAL REPORT,
ARBORICULTURAL IMPACT ASSESSMENT
& METHOD STATEMENT**

OUR REFERENCE	AC.2017.023
CLIENT	Mr Andy Murphy of AJ Murphy Surveyors Ltd
SITE	106 Priors Road Hampstead, London NW6 3NS
REPORT BY	I S Thompson (known as Tom) M. Arbor. A., BSc. (Hons) Arb, MSc. eFor
DATE	2nd March 2017
DATE OF SITE VISIT	27th February 2017

**Application Ref No Unknown Repairs to a garden wall that is in a poor state of repair
and presenting a potential danger to residents**

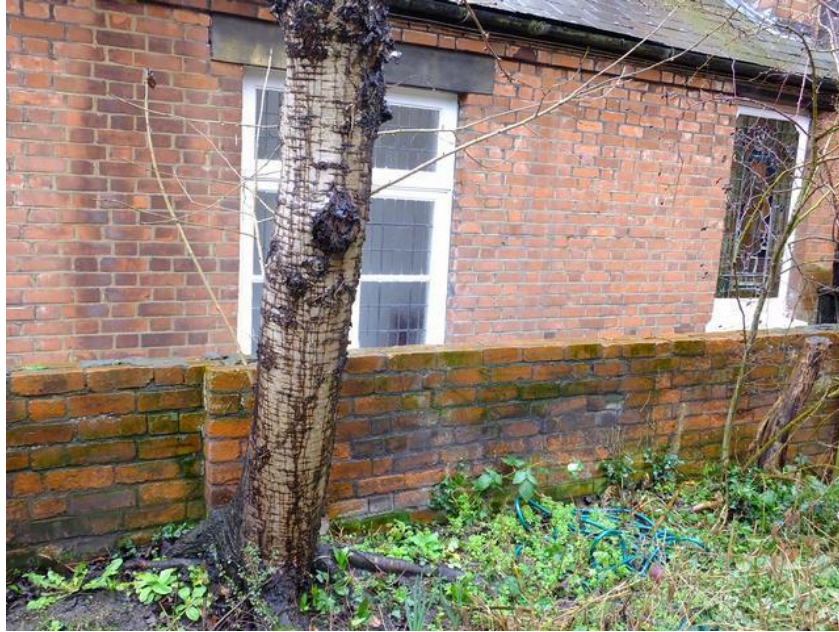
These are T1 and T2, along the side wall, and T6 along the rear wall. T1 a Cherry and T2 a Norway maple are both fairly small trees in poor condition following repeated pruning. T1 has been reduced to topped at 4m, 6m and 7, and has poor form and some large stubs with decay pockets. T2 has been topped at around 4m and has poor form. These are both recommended for removal and replacement once the wall has been completed.

Image 1 Base of T1, growing against the wall

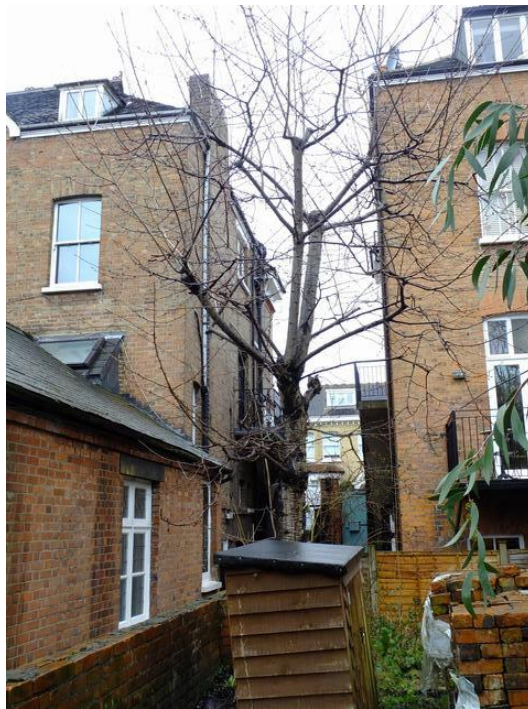
Image 2 T1, showing various reduction/topping points

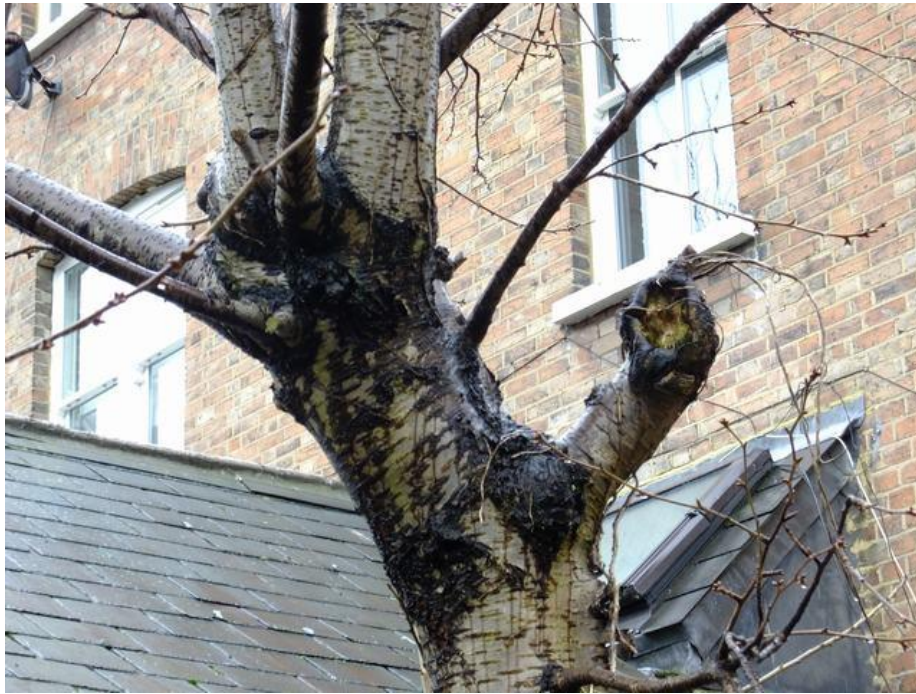
Image 3 Large stubs on T1 with decay pockets

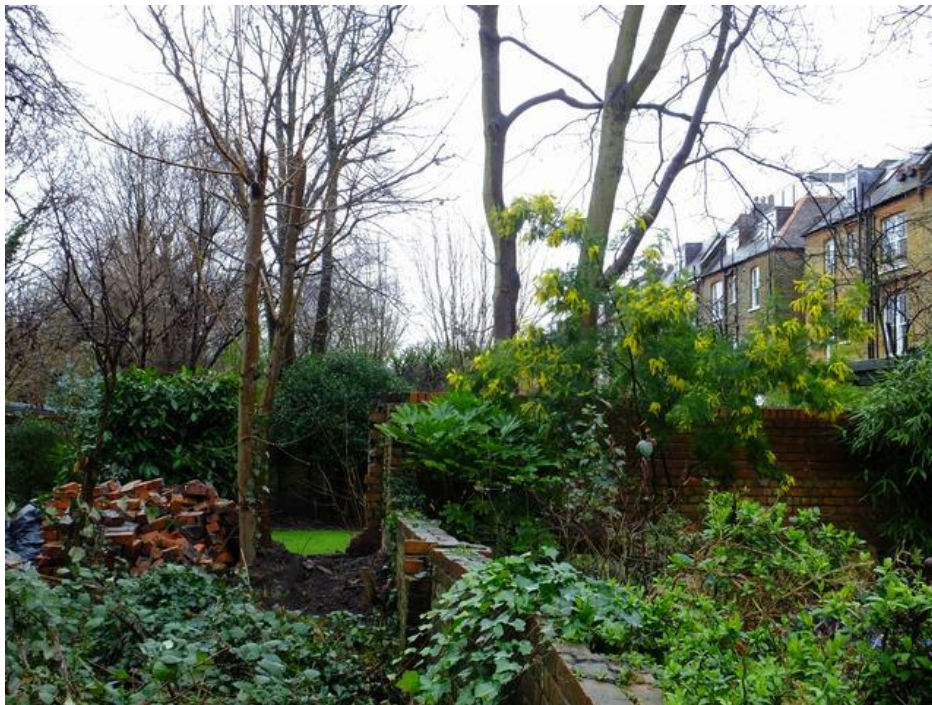
Image 4 T2 a maple to left of the wall, showing previous topping, T9 (right) & T4 (rear)

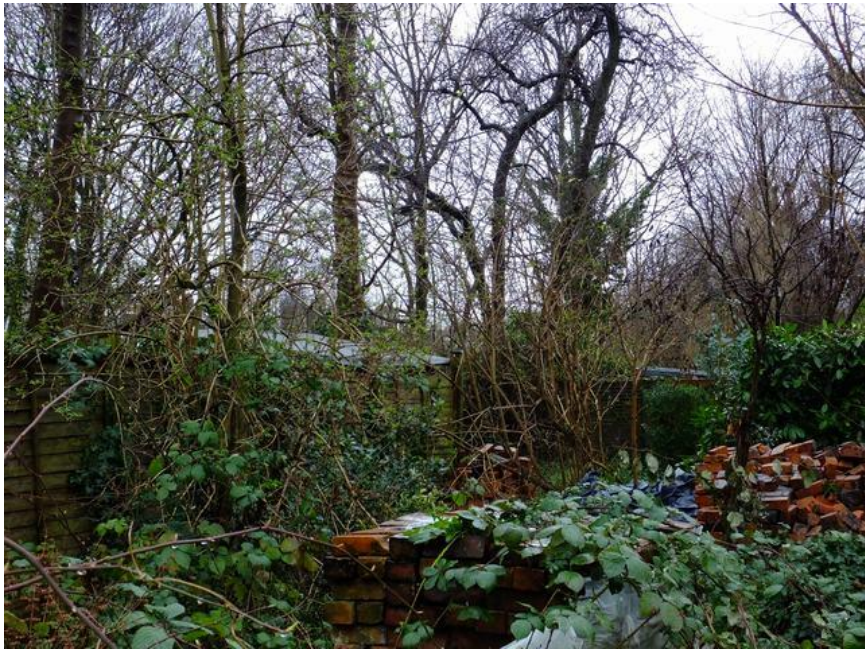
Image 5 T3 elder on the right and T10 elder on left

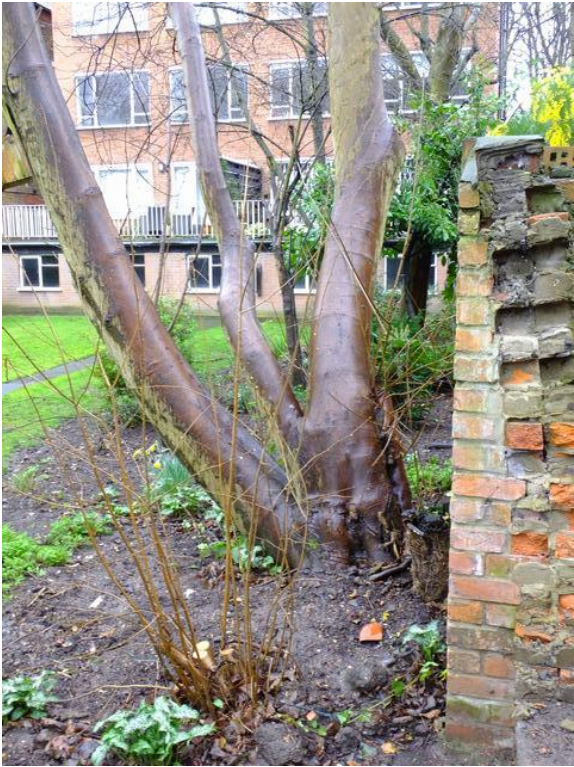
Image 6 T4, with three swept stems, growing in the flat gardens

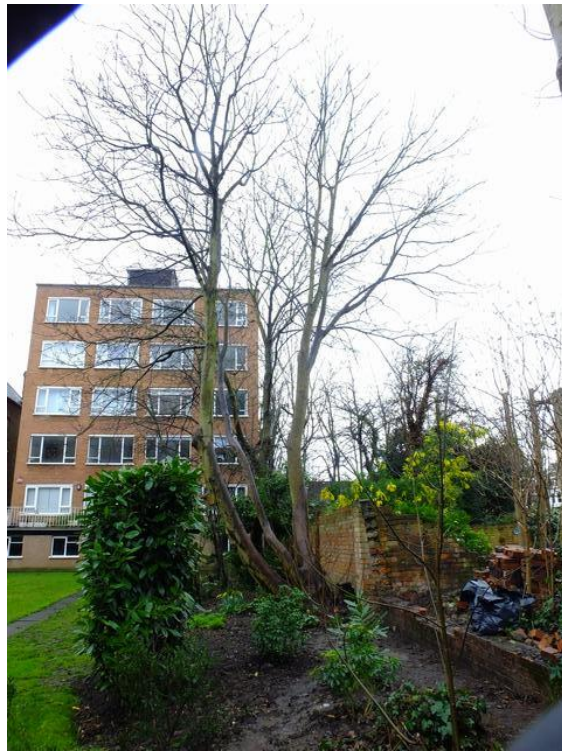
Image 7 T4 a multi stemmed sycamore in the gardens of the flats

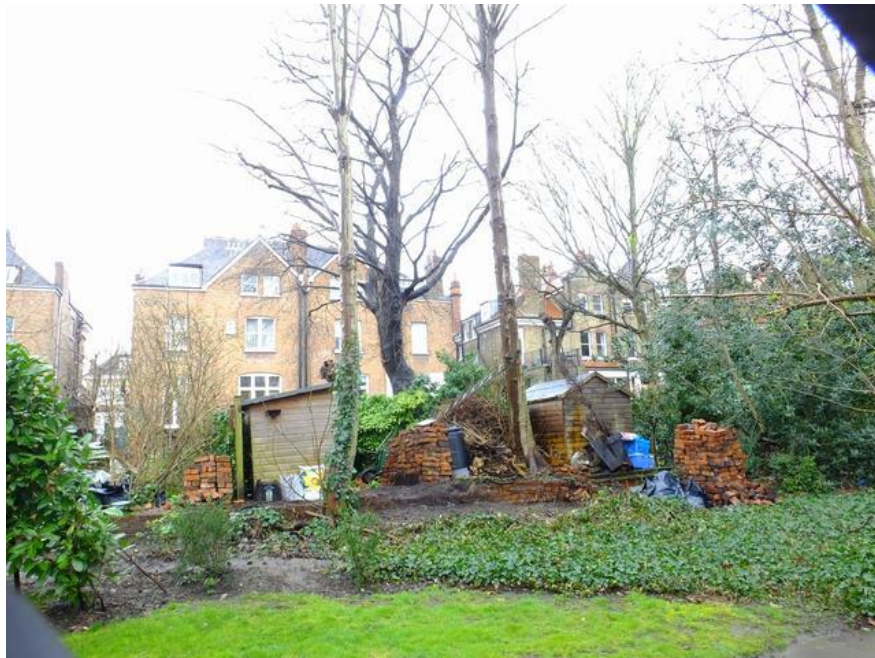
Image 8 Looking at T5, T6 and T7 from the flay gardens, showing level change at the wall

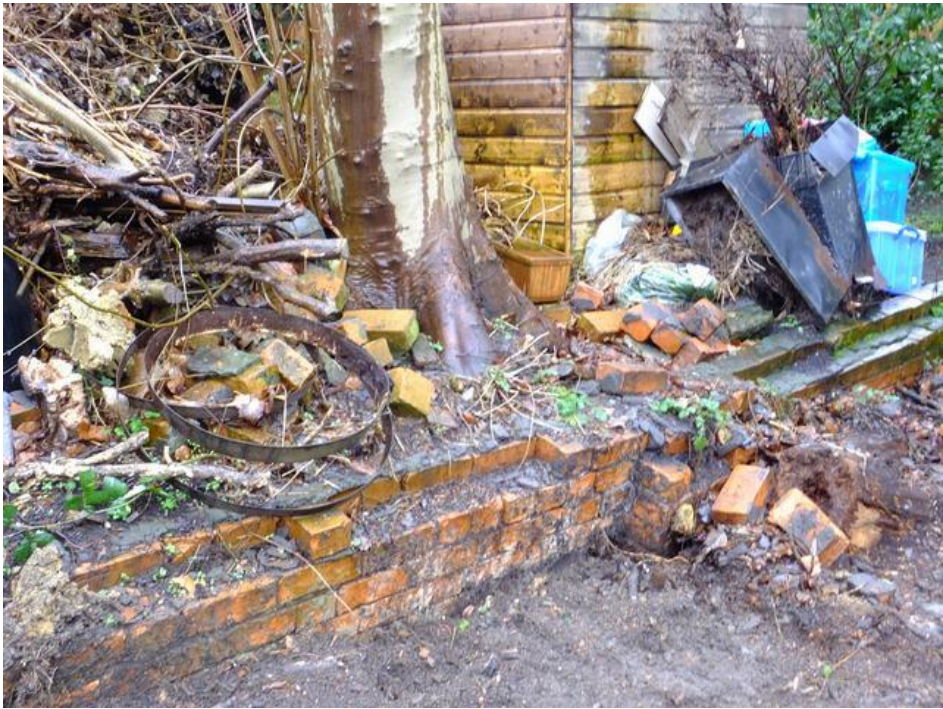
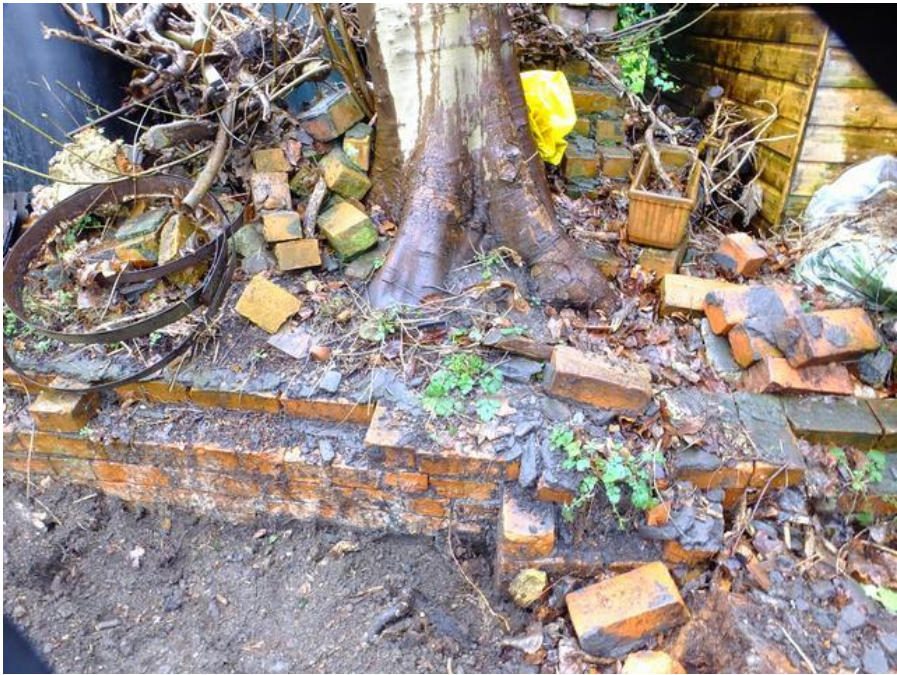
3.2.2 T6 is inside the garden of 106 but growing up against the rear wall and as this is at a higher level than the garden area of the flats, there is the potential for this tree to be destabilised when the remainder of the wall is removed. This is the reason that this is recommended for removal and replacement with a more appropriate species choice. Consequently, there will be an impact to the amenity value of the area, which shall be addressed in Section 17 Replacement Planting.

Image 9 Base of T6, showing level change and potential destabilisation once wall removed

Image 10 Base of T6, showing level change and potential destabilisation once wall removed

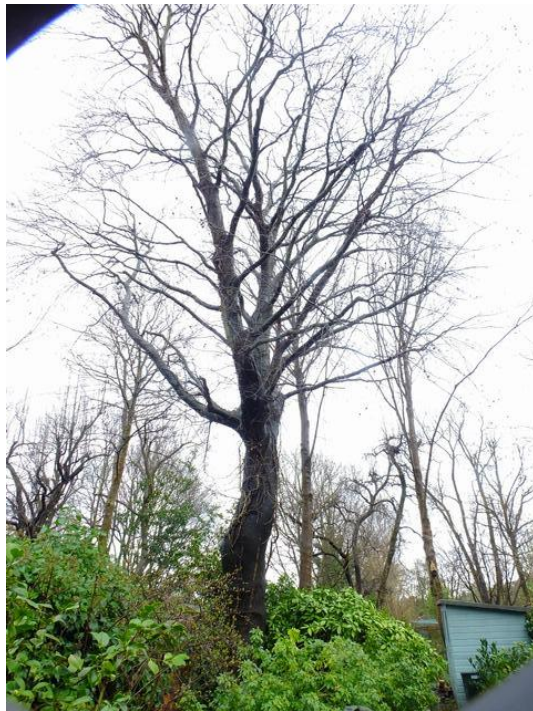
Image 11 T7 a mature beech tree

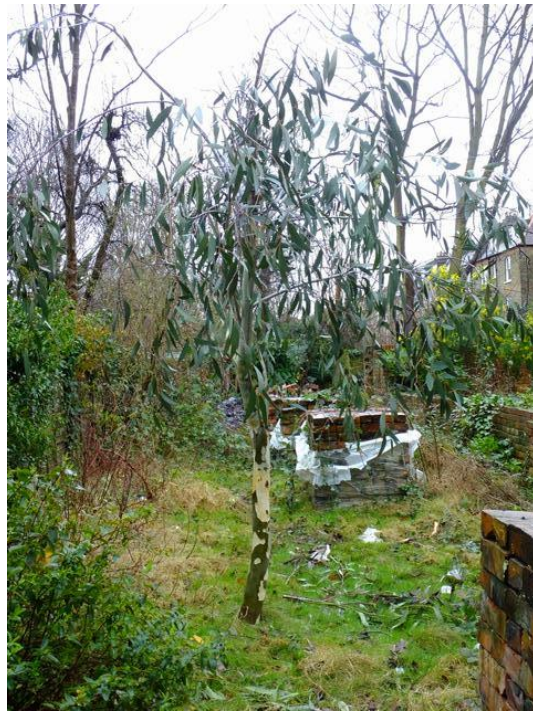
Image 12 T8 a small eucalyptus
