## ARBORICULTURAL ASSESSMENT REPORT

<b>Report By:</b>	James Allnutt		
<b>Title:</b>	Arborist	<b>Date:</b>	31 March 2015

Job Ref: 58215  
57 Aberdare Gardens, London, NW6 3AL

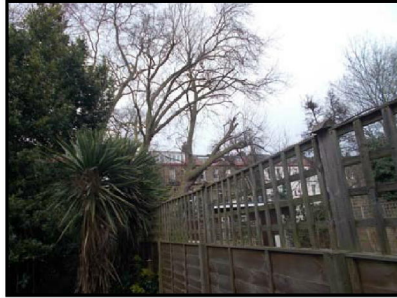
Roots have been recovered from TP1 and have been formally identified as Platanus. Given the size, species, and proximity to the location of the trial pit/borehole we consider that these roots have emanated from London Planes T1/ T2, & T9/T10.

1. T1 right, T2 left behind the policyholder's garden.

Tree No:	Species	Works Required
T1	London Plane	70% by volume hortlink reduction and repeat on 2 year cyclical for 10 years
T2	London Plane	70% by volume hortlink reduction and repeat on 2 year cyclical for 10 years
T3	Willow	Fell as close to ground level as practicable and treat stump
T4	Willow	Fell as close to ground level as practicable and treat stump
T8	Laurel	Fell as close to ground level as practicable and treat stump
T9	London Plane	70% by volume hortlink reduction and repeat on 2 year cyclical for 10 years
T10	London Plane	70% by volume hortlink reduction and repeat on 2 year cyclical for 10 years

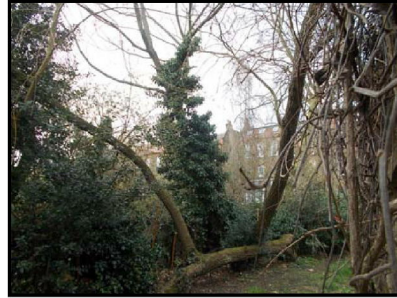
No roots relating to Willow or Laurel were recovered during investigations. However, given its size and proximity to the insured property we consider that it is likely that roots from Willows T3 & T4 as well as Laurel T8 have also extended beneath the depth of foundations.

2. T3 stem laying horizontally with T4 showing ivy on stem.

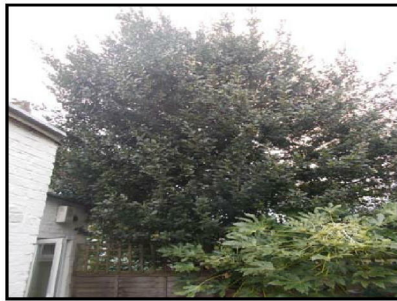
3. View showing T8.

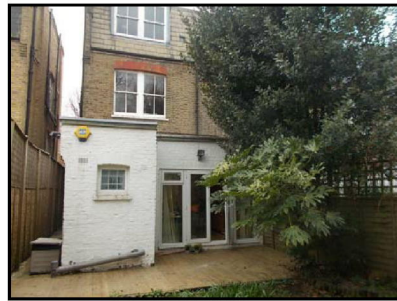
4. Rear of the property showing S1 and T8.

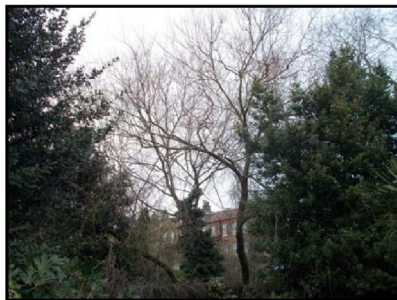
5. T4 left of centre and T3 right of centre.
