# ARBORICULTURAL ASSESSMENT REPORT

<b>For:</b>	<b>Client:</b>	Oriel Services Limited
	<b>Insurer:</b>	Zurich
<b>Site:</b>	<b>Policyholder:</b>	Mr Stewart-Smith
	<b>Risk Address:</b>	38 Crediton Hill, London, NW6 1HR
<b>Refs:</b>	<b>OCA Ref:</b>	69765
	<b>Client Ref:</b>	6476098
	<b>Insurer Ref:</b>	20-50-118031

<b>Arborist Name:</b>	Adele Devonshire	<b>Date:</b>	12/04/2017
<b>QC:</b>	Thomas Peppiatt	<b>Date:</b>	12/04/2017

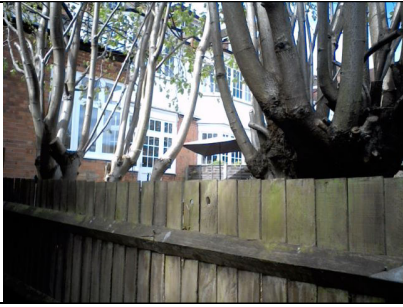
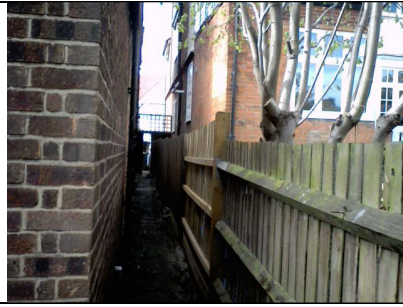
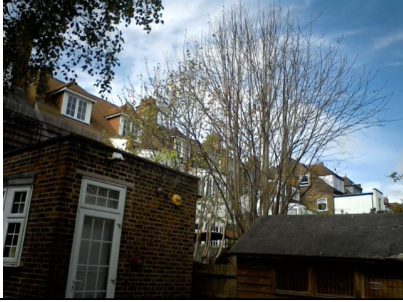
TG1 - Lime

TP1 (USF) 1.5 mm: Tilia spp. 2 roots

BH1 (1.2-1.8m) 1 mm Tilia spp. 2 roots

management. species include rose, conifer & berberous.				1HR	
TG1	Lime	Early Mature	Fair	8.4	6.6	250	1	Pollarded with approximately 5+ years' regrowth.	Fell and treat stump.	Parking restrictions. Heavily parked. Access through side/rear gate.		40 Crediton Hill, London, NW6 1HR	P3P
CG1	Mixed climbers	Mature	Fair	3	3.0	70	0.1	No significant recent management.	No work required.			38 Crediton Hill, London, NW6 1HR	PH

Tree No:	Species	Works Required
TG1	Lime	Fell and treat stump.
