# TECHNICAL REPORT ON A SUBSIDENCE CLAIM

**Crawford Reference: SU1604979**

**157 Gloucester Avenue Ltd  
157 Gloucester Avenue  
London  
NW1 8LA**

**SUBSIDENCE CLAIM**

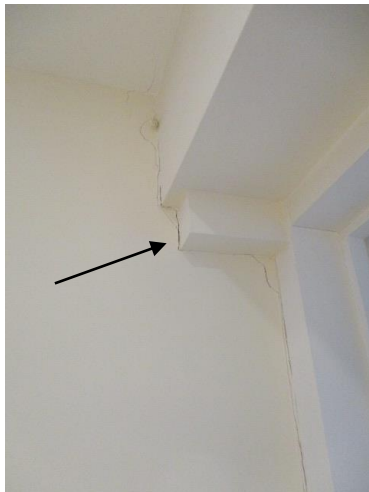
Cracking in upper flat stairway at rear addition junction

**Upper Flat - Stairs and Landing** - 2mm tapering separation at rear addition junction, hairline vertical crack above door to roof terrace, wall / ceiling junction cracking on rear bedroom partition.

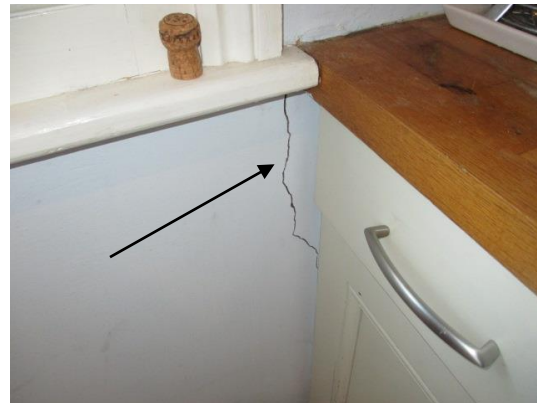
Cracking in ground floor flat kitchen

**Ground Floor Flat - Kitchen** - 3mm diagonal cracking above and below rear window, 1mm horizontal crack in rear left hand corner between windows, 1mm vertical crack below left hand side of flank window.

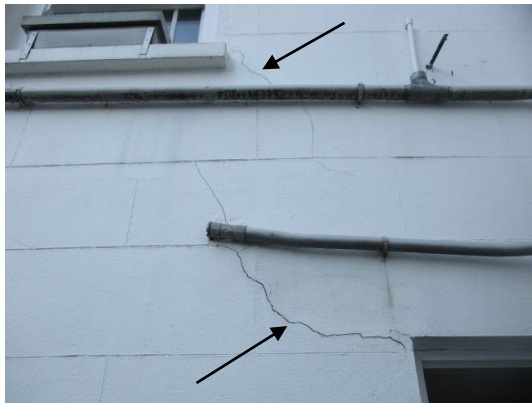
Cracking to rear addition

**Rear Addition** - 3mm diagonal crack above door to kitchen, 3mm horizontal low level crack along rear wall on projecting plinth section, 3mm diagonal cracking above both sides of rear basement window.

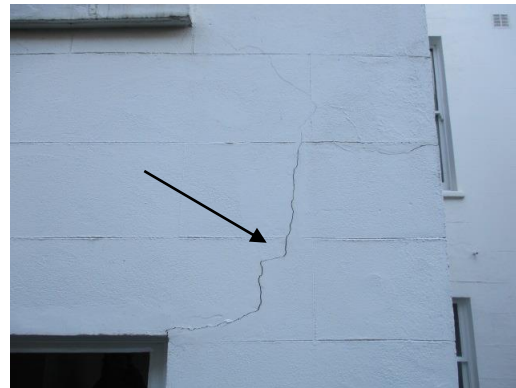
Cracking to rear addition

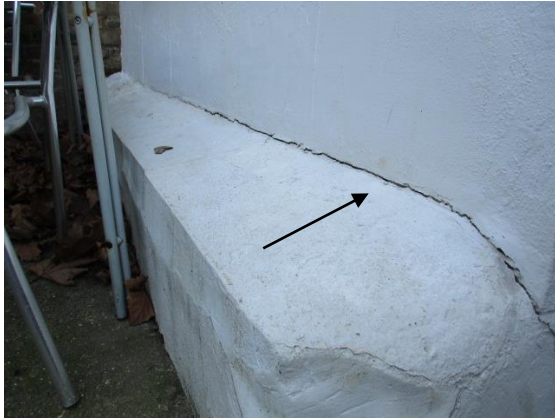
Cracking to rear addition

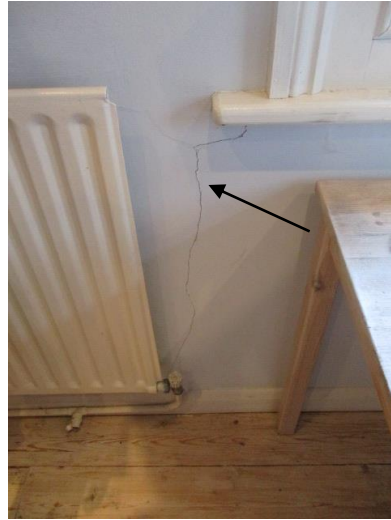
Cracking in ground floor flat kitchen

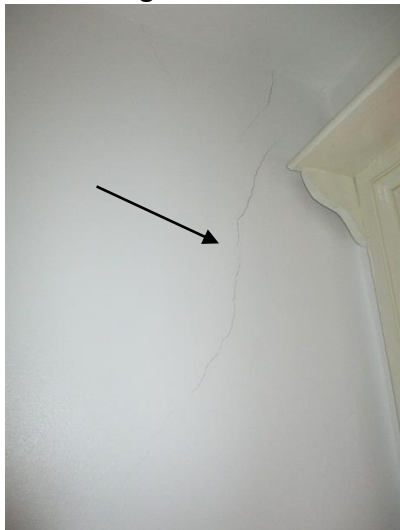
**Hall** - 1mm diagonal crack to bedroom partition, wall / ceiling junction cracking along bedroom partition, 1mm vertical crack above cupboard door.

Cracking in ground floor flat hallway

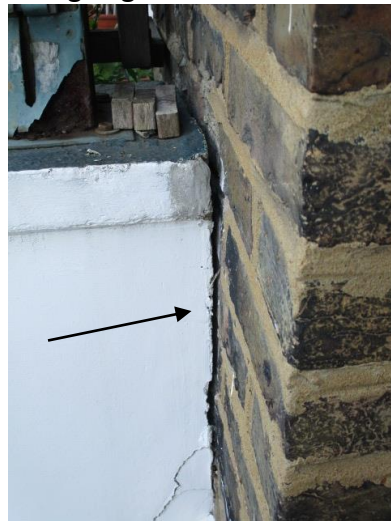
**Upper Flat Roof Terrace** - 10mm tapering separation at rear addition junction on right hand party wall, 1mm stepped cracking above doors, historic bowing noted to high level brickwork to main rear elevation.

Separation at rear addition junction viewed from upper flat roof terrace

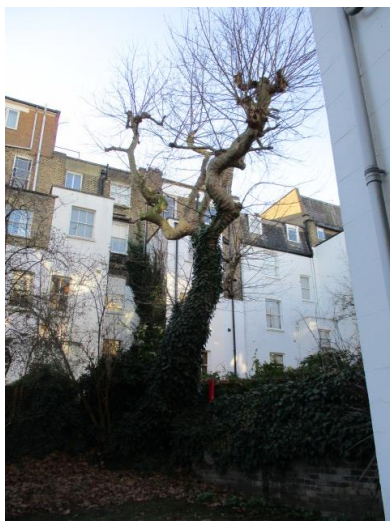
Type	Height	Distance	Ownership
Plane	11 m	7 m	Owners

The timing of the event, the presence of shrinkable clay beneath the foundations and the proximity of vegetation where there is damage indicates the shrinkage to be root induced. This is a commonly encountered problem and probably accounts for around 70% of subsidence claims notified to insurers.

View of insured's tree to rear

Although the cause of the movement needs to be dealt with, we note the vegetation is subject to a Preservation Order. Unfortunately, current legislation requires certain investigations to be carried out to support an application for the tree works.

Typically, these investigations would involve trial pit(s) to determine the depth and type of footings, boreholes to determine the nature of the subsoil/influence of any roots and monitoring to establish the rate and pattern of movement. The monitoring data provided must be sufficient to show a pattern of movement consistent with the influence of the vegetation and therefore it may be necessary to carry out the monitoring for up to a 12 month period.

It will also be necessary to obtain a specialist Arboricultural Report.

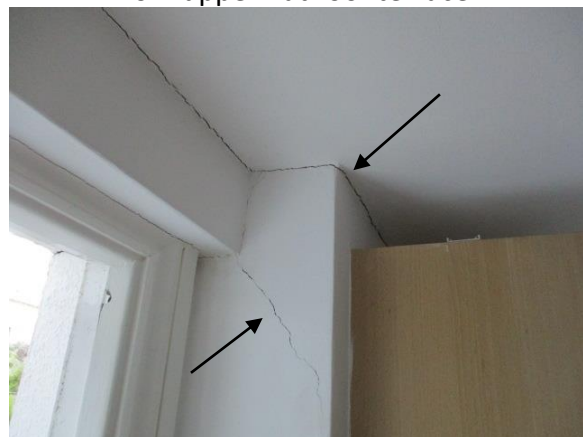
**Kitchen** - 2mm vertical crack on rear addition junction, cracking to ceiling, wall / ceiling junction cracking along left hand flank, 2mm diagonal crack in tiles below rear window, rear door out of alignment, door to hall catching on floor.

Cracking in basement flat kitchen

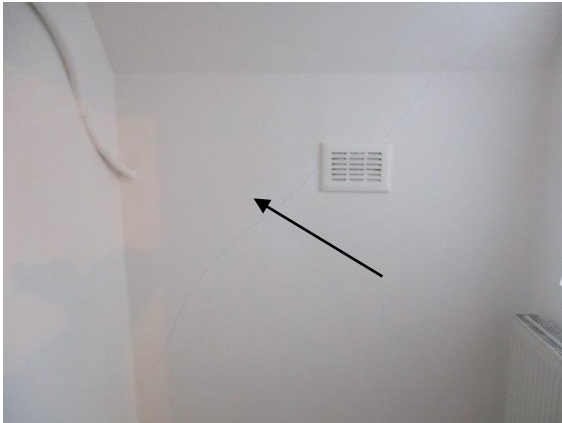
**Basement Flat - Entrance Lobby** - 1mm diagonal crack on front wall continues into ceiling, hairline diagonal crack above door to lounge, front door is sticking.

Cracking in basement flat entrance lobby

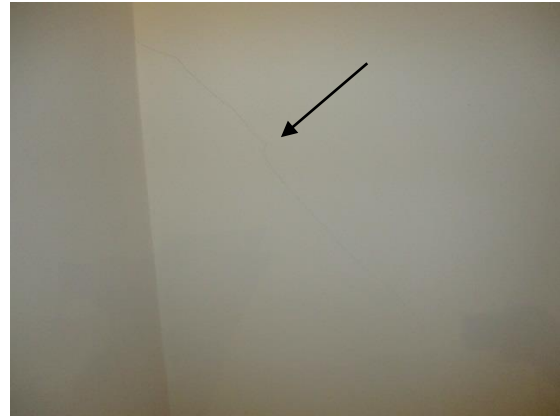
**Lounge** - Hairline diagonal tapering crack to left hand party wall front section, wall / ceiling junction cracking along front wall and right hand party wall, hairline vertical crack to chimney breast, cracking to ceiling, hairline vertical crack above door to lobby.

Cracking in basement flat lounge
