SITE INVESTIGATION FACTUAL REPORT

Report No: 408792
Client: Crawford Claims Management
Site: 157 Gloucester Avenue
Client Ref: SU1604979-157 Gloucester Avenue Ltd
Date of Visit: 02/03/17

Drainage Layout Plan

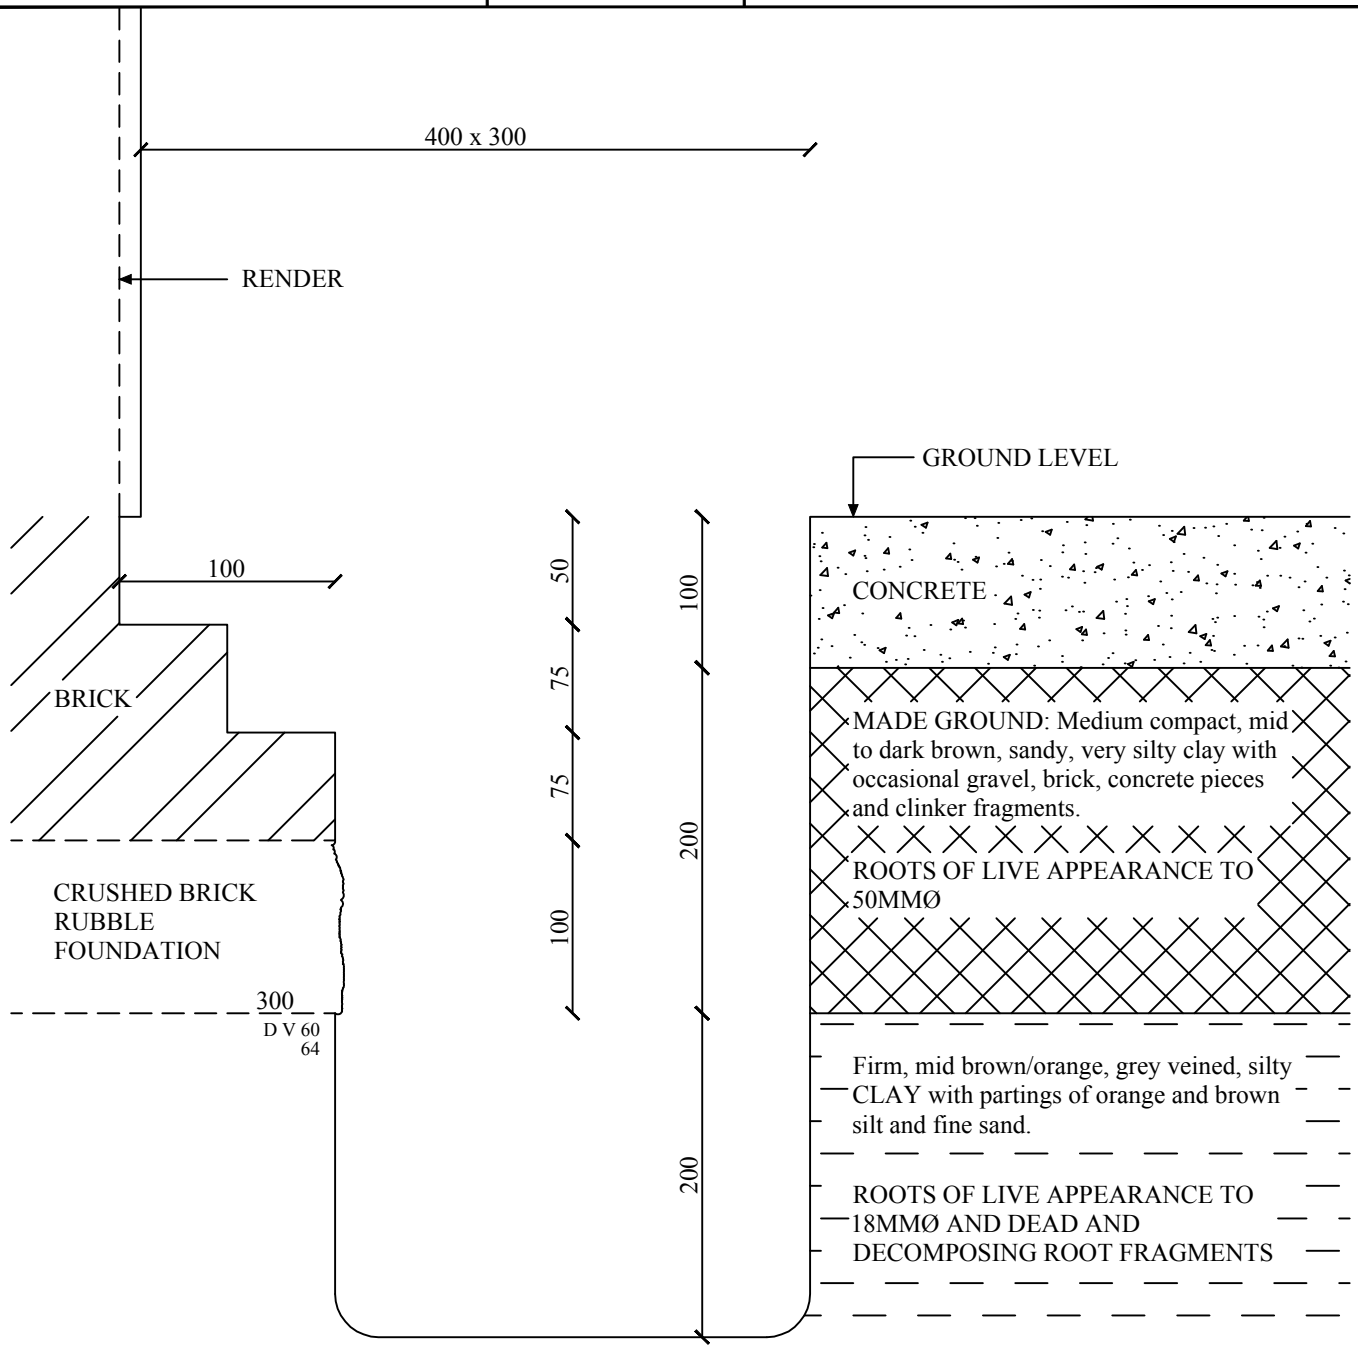
Trial Pit No: 1

FOR STRATA BELOW 500mm SEE BH LOG 1
