# ADDENDUM TECHNICAL REPORT ON A SUBSIDENCE CLAIM

**33 Gloucester Crescent  
London  
NW1 7DL**

Date of Report 14<sup>th</sup> March 2017

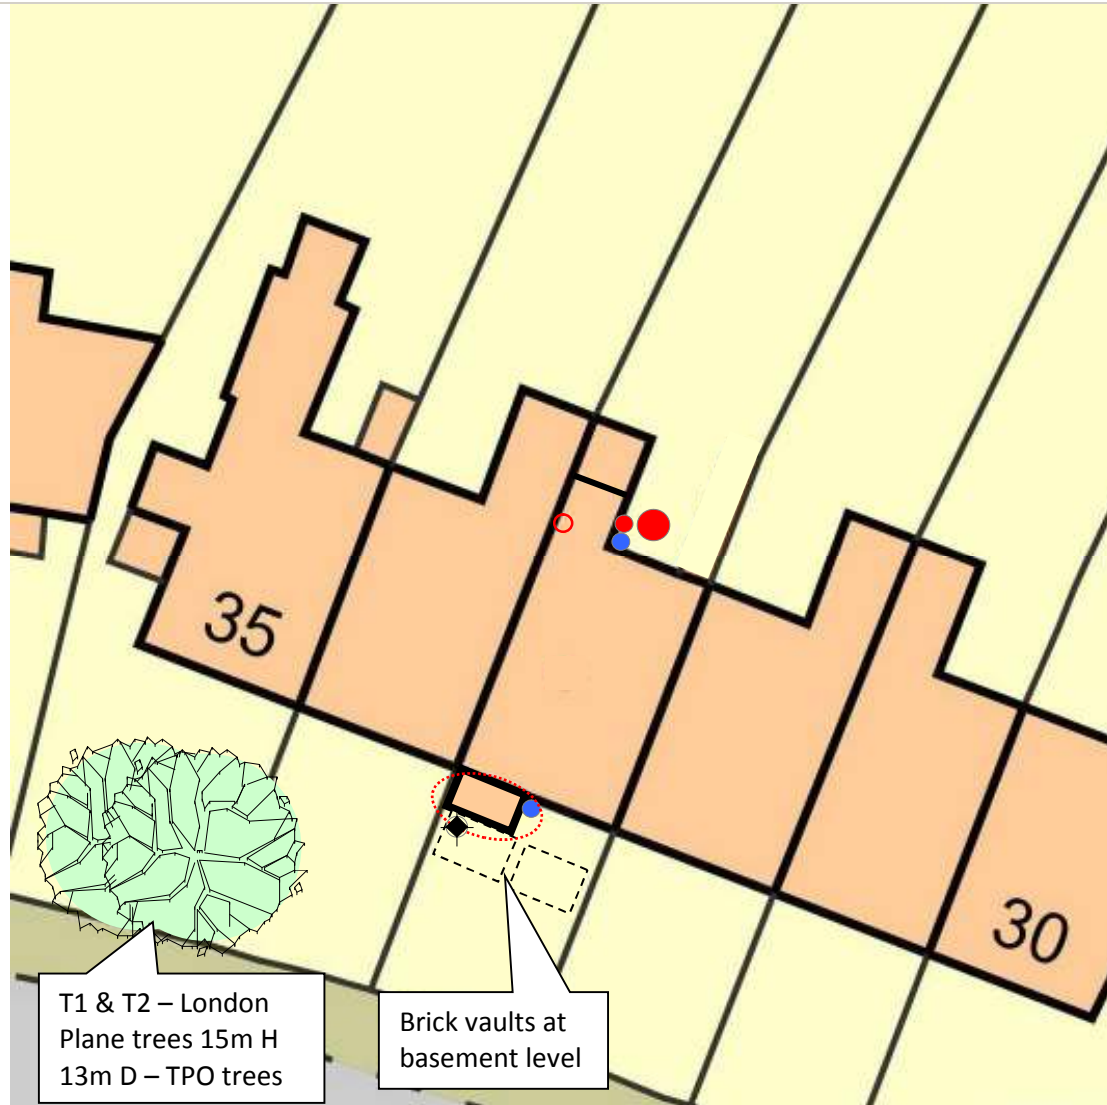
## Site Plan

Referring to the appended CET report, a site investigation found the porch sits on clay, with roots found beneath the foundation. The roots tested were found to be planus from nearby Plane trees.

Referring to their report, MWA implicated two Plane trees as the cause of the claim. The trees have a high level of amenity value attached and, all things considered, have recommended a reduction of the trees. The trees have been reduced in the past, about 12 months ago or so, which may explain why the amount of movement is not severe but sufficient to prevent repairs from proceeding.

We agree with MWA's course of action and are prepared to monitor the effects of the reduction work proposed. As such, MWA shall be instructed to submit an application for tree reduction. They will also look to secure permission for the Plane tree owner to have the means of reducing the trees biennially to curtail the influence of the trees over time.

If stability is observed then repairs will proceed. If ongoing movement is recorded then a further application for tree felling of one or two trees will be considered. Repairs are estimated to be £6,000.00. Underpinning localised to the porch will be needed if tree work is blocked. The cost of this work is estimated to exceed £50,000.00
