TECHNICAL REPORT ON A SUBSIDENCE CLAIM

Crawford Reference: SU1502007

**33 Gloucester Crescent
London
NW1 7DL**

SUBSIDENCE CLAIM

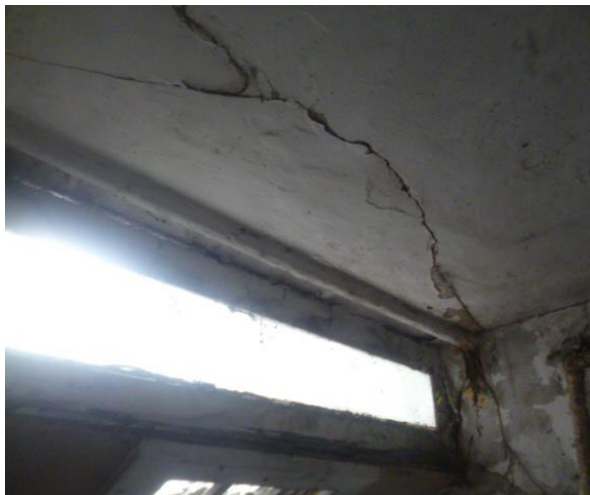
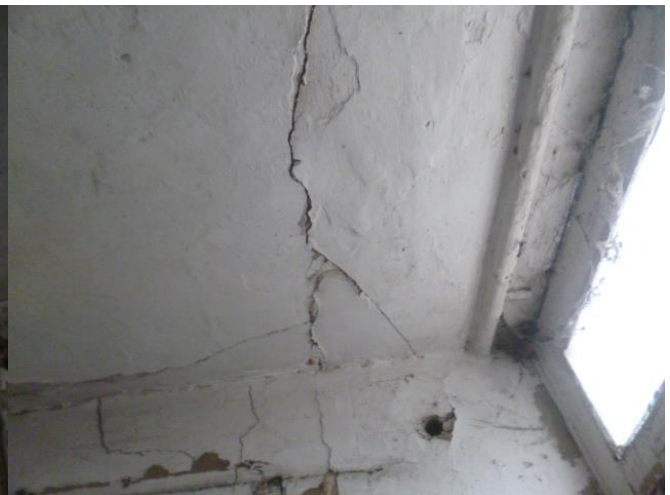
Basement/ Garden Flat

Cracking in garden flat below porch

There is cracking to the ceiling and walls in the front lobby which directly below the storm porch. The crack that measure up to 3 mm appear to be historic.

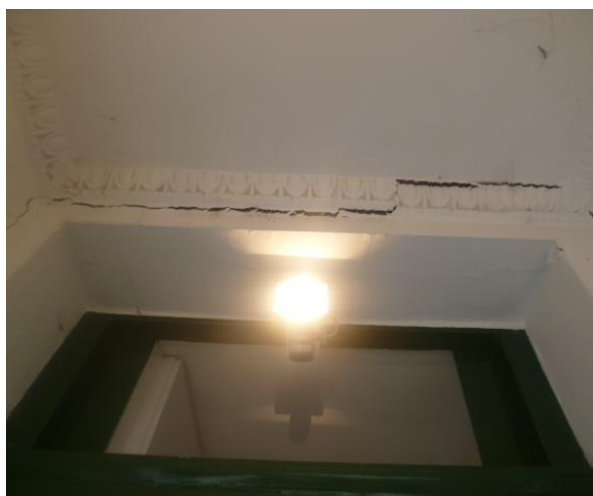
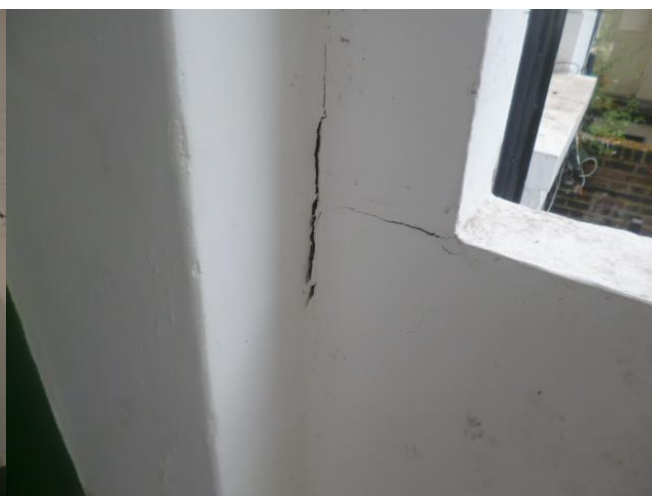
Front Storm Porch

Cracking in storm porch

The front storm porch has rotated outwards at the top. There is 10 mm wide crack running along the ceiling and the ornate run cornice. There are tapered vertical cracks along the right and left hand side where the porch abuts the main property. These cracks range from 10 mm at the top to hairline at the base. The steps leading to the entrance doorway has several horizontal cracks measuring up to 5 mm wide.

In structural terms the damage falls into Category 3 of Table 1, Building Research Establishment⁷ Digest 251, which describes it as “moderate”.

The pattern and nature of the cracks is indicative of an episode of subsidence. The cause of movement appears to be clay shrinkage.

The timing of the event, the presence of shrinkable clay beneath the foundations and the proximity of vegetation where there is damage indicates the shrinkage to be root induced. This is a commonly encountered problem and probably accounts for around 70% of subsidence claims notified to insurers.

The cause of the movement needs to be dealt with first. We have completed a soil risk analysis (VISCAT Assessment) and we are satisfied that your neighbour's London Plane trees can be removed. We will liaise with your neighbour in this respect.

Following completion of the tree management works, we will undertake a suitable period of monitoring to confirm stability has been achieved before undertaking repairs to the property.

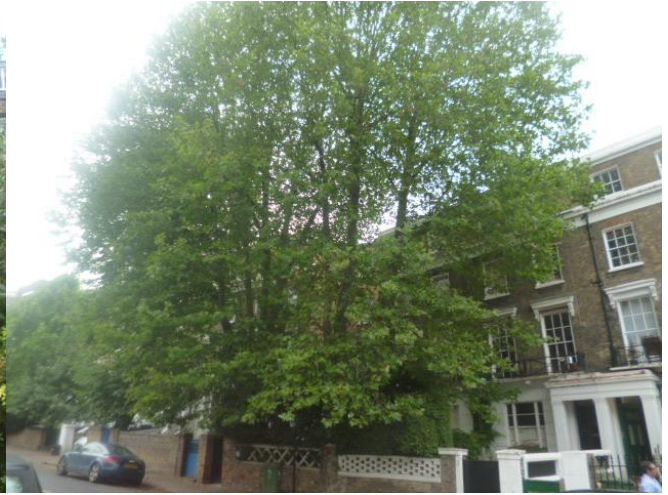
Type	Height	Distance	Ownership
T1 Plane	15 m	12 m	Neighbour 1
T2 Plane	15 m	12 m	Neighbour 1
T3 Cherry	5 m	9 m	Owners
T4 Plum	m	4 m	Neighbour 2

London Plane trees at front

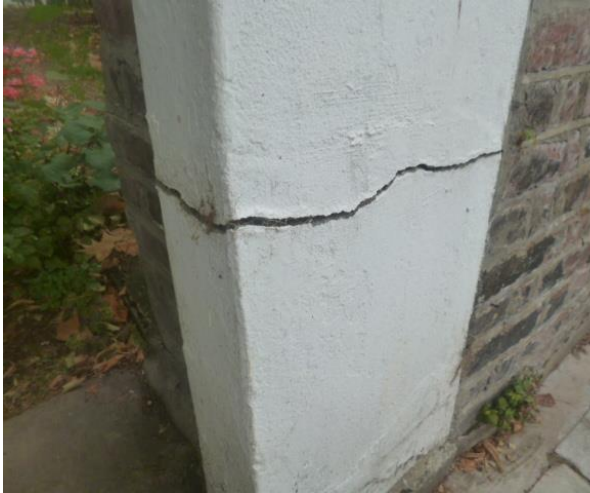
Stone paving slabs are uneven and cracked. There is cracking to the front garden wall and there is historic distortion the garden wall separating No. 33 and 34 Gloucester Crescent.

Cracking to front gate pier

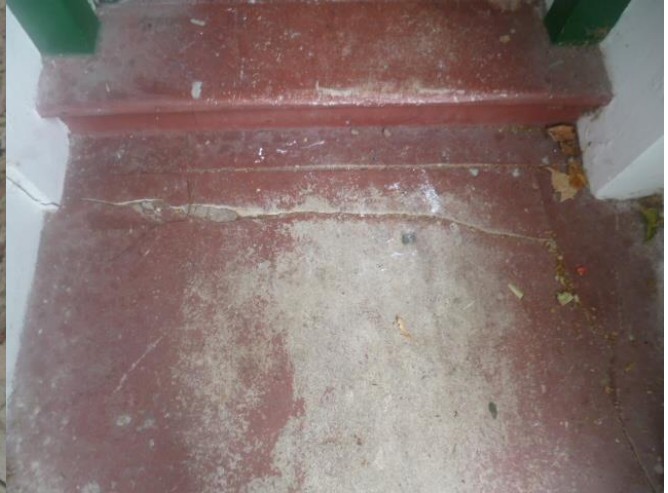
Cracking to storm porch floor

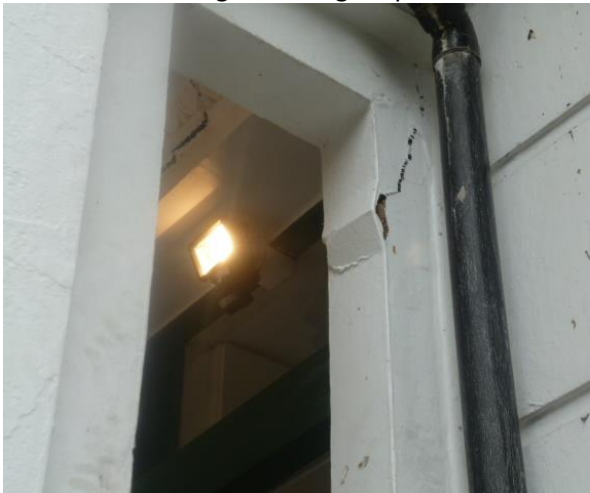
Rotation cracking to storm porch

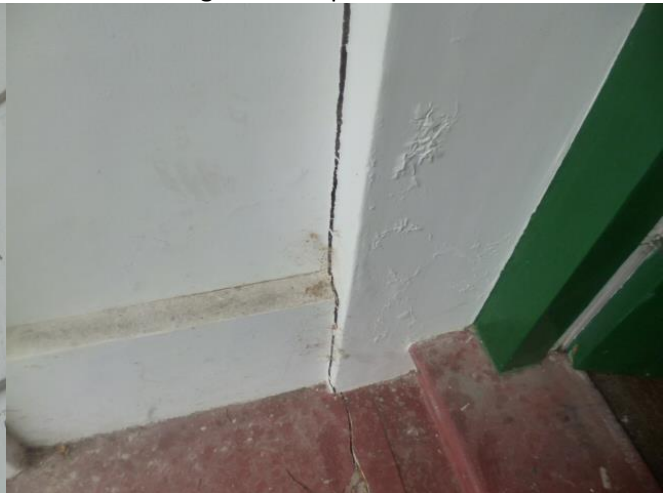
Cracking to left wall in storm porch

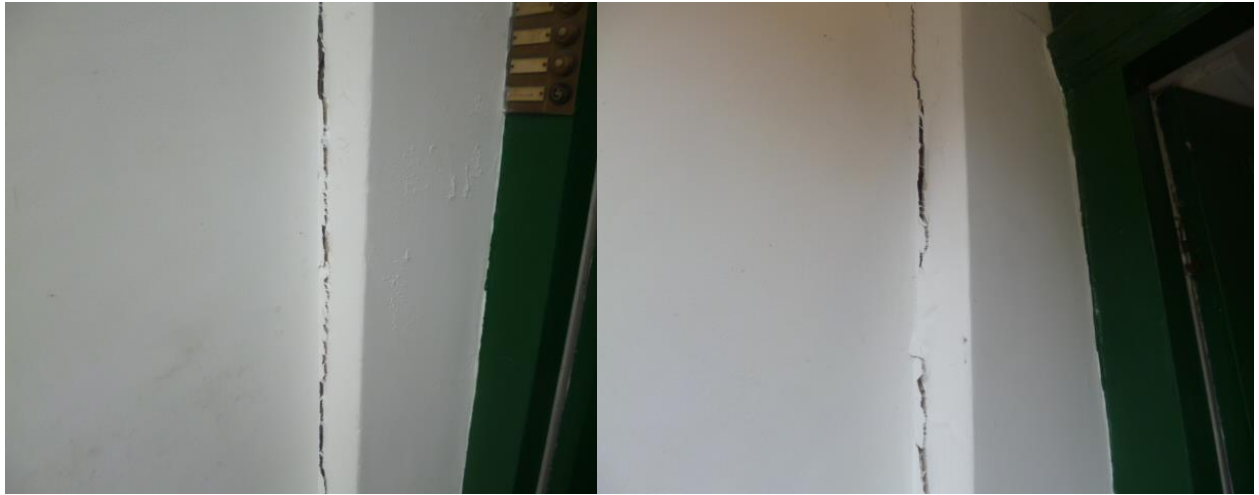
Cracking in storm porch
