# Arboricultural Appraisal Report

## Subsidence Damage Investigation at:

33 Gloucester Crescent  
London  
NW1 7DL

CLIENT:	Crawford & Company
CLIENT REF:	SU1502007
MWA REF:	SUB170221-1127
MWA CONSULTANT:	David Williams (N.D.Arb MArborA)
REPORT DATE:	03-03-2017

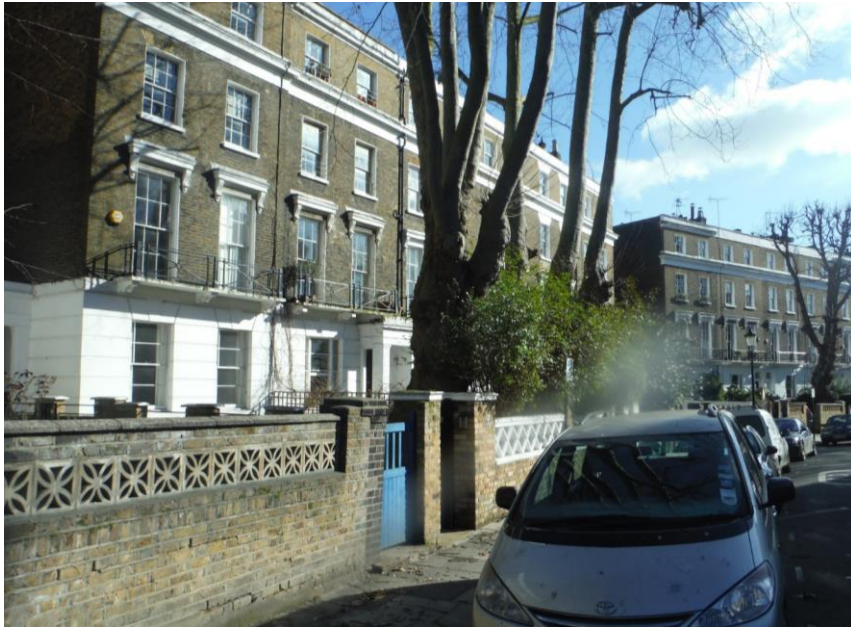
Tree No.	Species	Ht (m)	Dia (cm)	Crown Spread (m)	Dist. to building (m)	Age Classification	Ownership
G1	London Plane x 2	17.0	M/S Av75*	13.0	10.0-13.5	Younger than property	3 <sup>rd</sup> Party:- No. 35
Management history		Evidence of past management involving reduction of the upper/outer crown periphery. Around 12 months re growth visible and with vertical scaffolds indicating previous pruning was more severe.					
Recommendation		Reduce both trees by pollarding at c.12.0m in height removing all secondary growth from upper crown. Repeat pruning biennially ensuring all new secondary re growth is removed.  If pruning does not promote a return to stability, the merits of removal of one or both trees should be assessed further.

View of G1

Level monitoring since late October 2016 records modest amplitudes of movement and for this reason we suggest that pruning may be sufficient to promote a restoration of stability. However, should movement persist after the proposed reduction of the trees crown volume has been completed, the merits of complete removal (one or both trees) should be considered further.

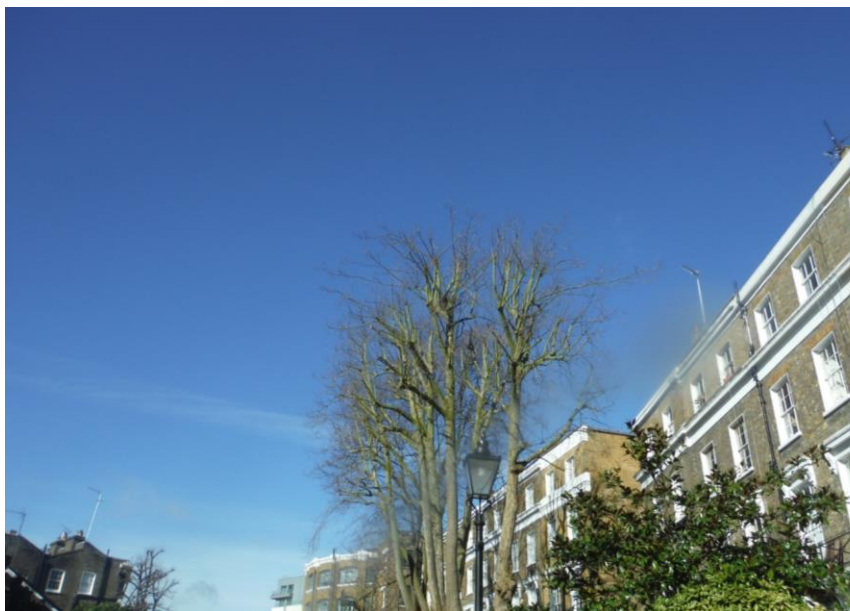
View of upper crowns – G1
