ARBORICULTURAL ASSESSMENT REPORT

For:	Client:	Oriel Services Limited
	Insurer:	
Site:	Policyholder:	
	Risk Address:	40 Elsworthy Road, London, NW3 3DL
Refs:	OCA Ref:	60189
	Client Ref:	7964115
	Insurer Ref:

Arborist Name:	Matthew Gardiner	Date:	16/02/2017
QC:	Margaret MacQueen	Date:	28/02/2017

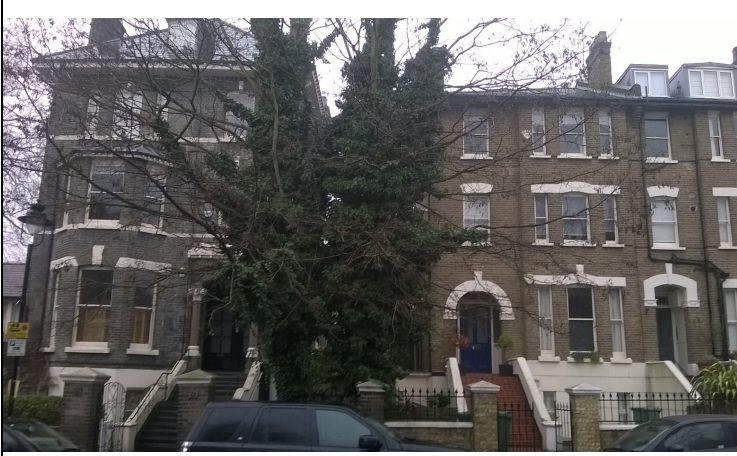
T1 &T2 False Acacia

Tree No	Common Name	Age Class	Condition	Height (m)	Crown Spread (m)	Stem diam. (mm)	Dist to bldg. (m)	Pruning history	Recommendation	Tree work constraints	Notes	Owner address	Owner
T1	False Acacia	Mature	Fair	19	11.0	500	3	No significant past management	Fell and treat stump	Parking restrictions. Heavily parked.	Estimated stem diameter	42 Elsworthy Road, London, NW3 3DL	P3P
T2	False Acacia	Mature	Fair	19	11.0	490	4	No significant past management	Fell and treat stump	Parking restrictions. Heavily parked.	Estimated stem diameter	42 Elsworthy Road, London, NW3 3DL	P3P
S1	Spotted Laurel	Semi-Mature	Fair	2	2	40	2	No significant past management	No work required	Parking restrictions. Heavily parked.	Estimated stem diameter	42 Elsworthy Road, London, NW3 3DL	P3P

Tree No:	Species	Works Required
T1	False Acacia	Fell and treat stump
T2	False Acacia	Fell and treat stump
