**34 John Street, London**

**Decorative Plaster Survey**

February 2017

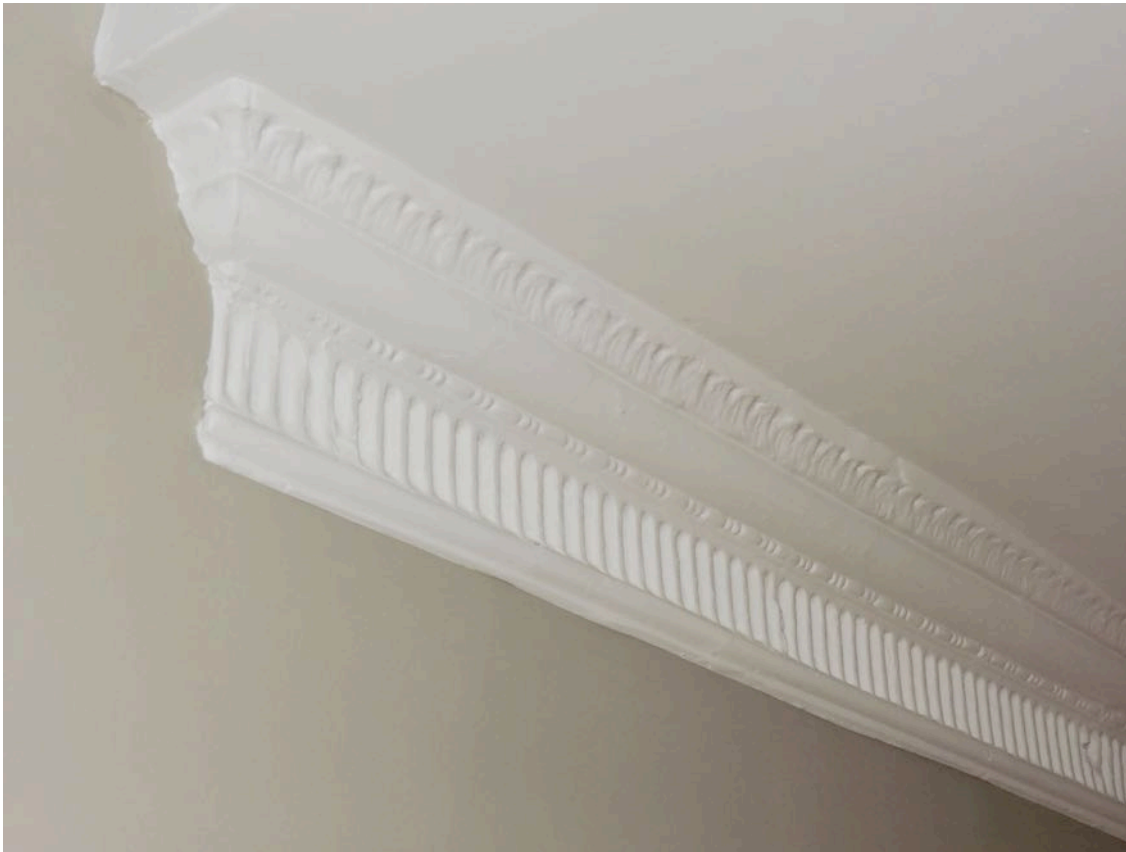
3.4 Entrance hall

This fluted, enriched cornice is 6 inches high x 2 inches deep. It frames the entrance hall well, and stops as seen in the photo to the left as the cantelivered stairway begins.

3.5 The cornice is original and in good order, except the internal mitre above the front door. Possibly a section has fallen, and the repair has not re-aligned the mitre detail.

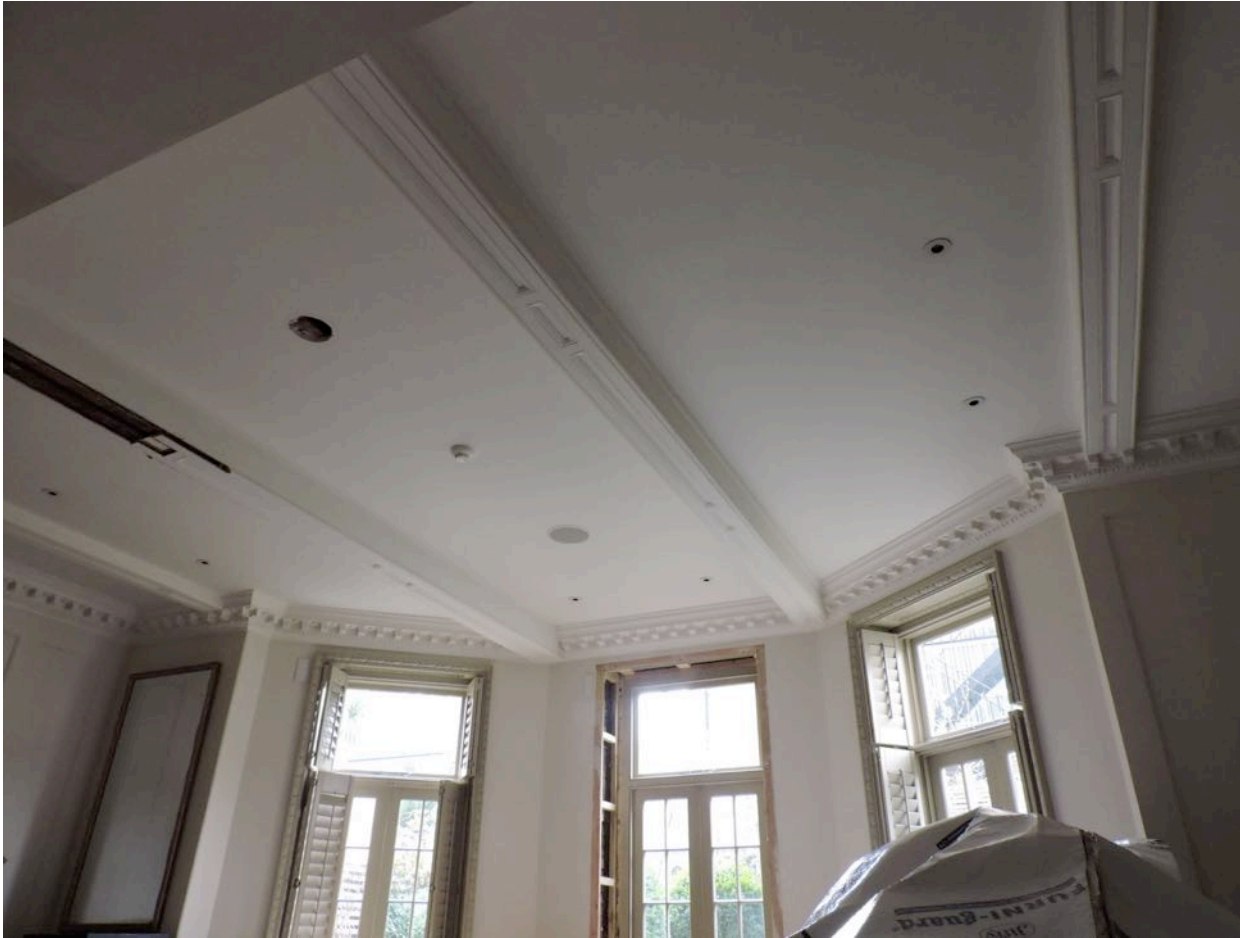
3.7 This photo shows the flitch beams, West facing bay windows and corning.

3.8 The cornice is 9 inches high by 9 inches deep. It is a classic Georgian cornice with enriched modillion blocks, egg and dart and water leaf designs.

3.9 The flitch beams sit at 2 different heights. The 2 central beams are lower and the 2 outer beams are higher in the ceiling.

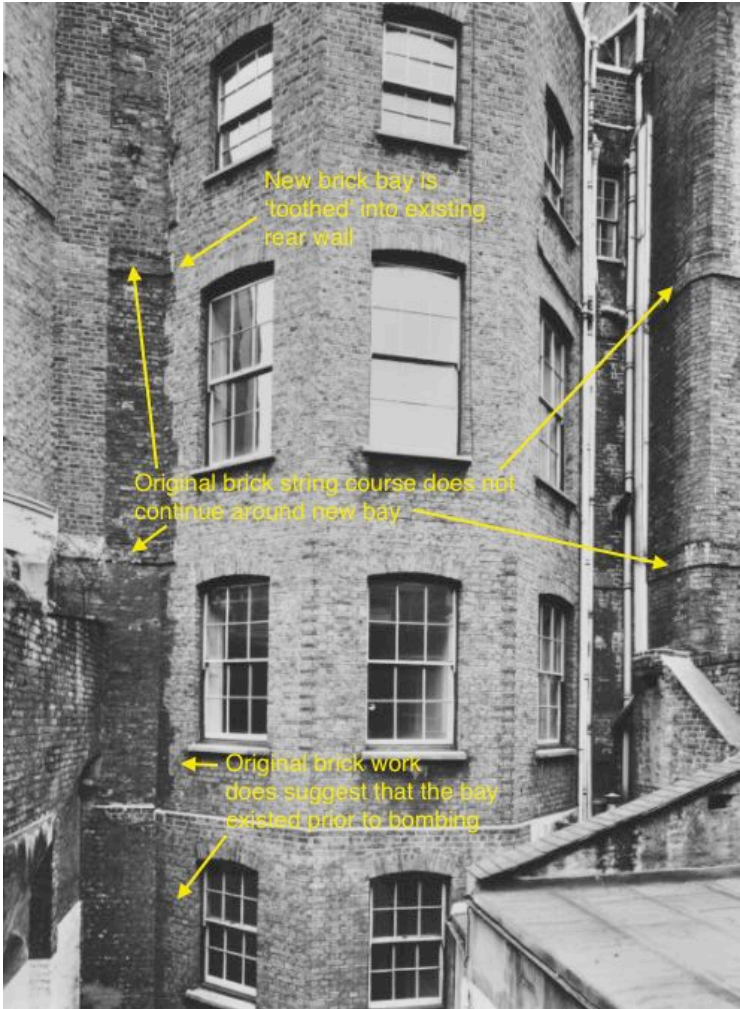
3.10 This rear room is a reconstruction of the original design. The rear brick bay was re-built in the 1950's, as shown in the left-hand image. There does however appear to be evidence that suggests the bay did exist prior to the bomb damage, so is not a new design.

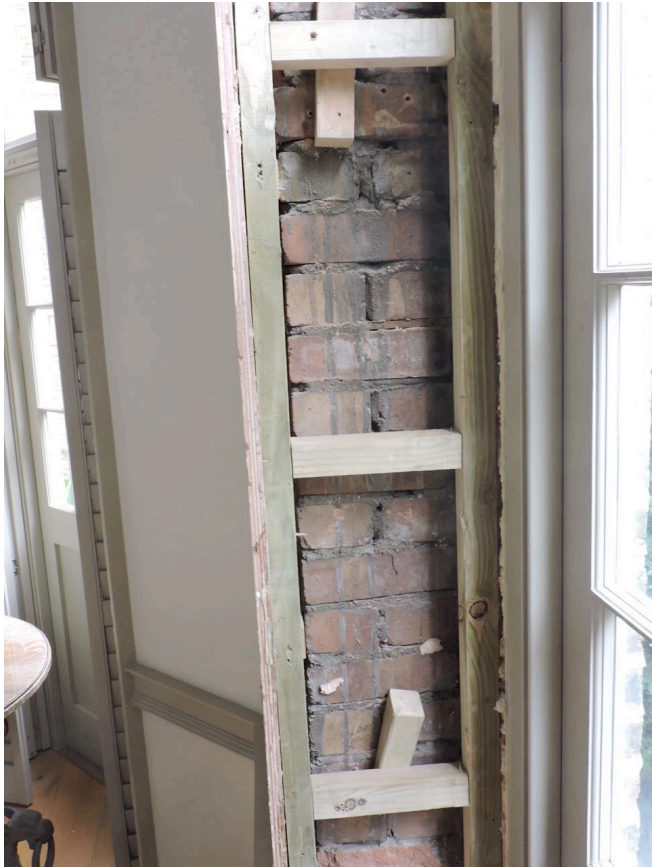
3.11 The image to the right shows the internal brickwork in the bay is laid in a cement based mortar, rather than a lime mortar. This helps to date the repair to the 1950's. The bricks are also machine-made, rather than hand-made, clamp fired london stock bricks of the front and rear external elevations.

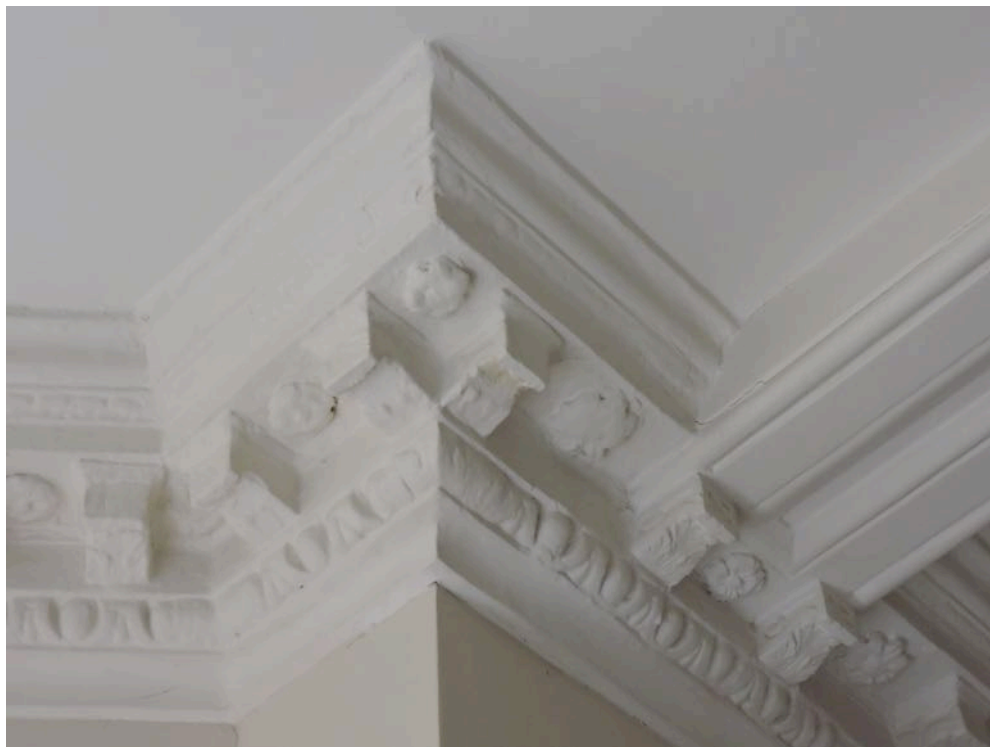
3.13 The 4 flitch beams are covered with timber paneling, forming small framed divisions along their length. This attempt to disguise the structural work distracts from the decorative cornice, and is at odds with any other moulding or detail within the house. There are also awkward junctions where the beams meet the cornice, as seen in the image below.

The 2 modillions have been lowered to allow the beams to continue into the wall.

3.14 We would recommend that a more honest aesthetic approach is required for these beams, and the decorative cladding is removed and a plain plastered surface is applied.

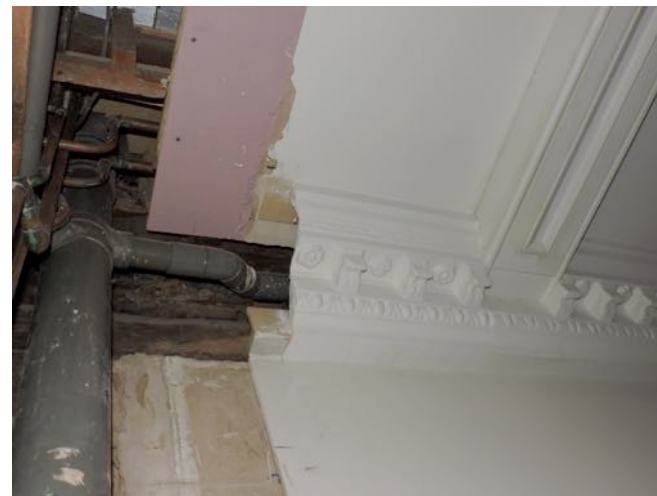
3.15 Image (on right) showing fibrous cornice, rather than solid 18th century plasterwork.

3.16 The ceilings are also new, constructed of 2 layers of 12mm plasterboard.

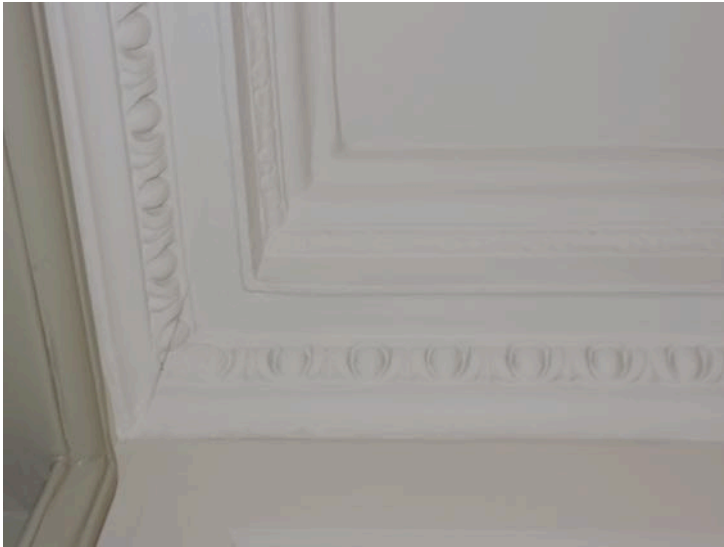
### Front room

3.17 The small front room has an egg and dart cornice approximately 7 inches high x 7 inches deep, with a large prominent drip detail and water leaf design. This cornice is original to the room.

3.18 This room seems to have been unaffected by the bomb damage and subsequent office and residential conversions. It is well proportioned, although it feels small due to the space required for the cantilevered stairway and hall.

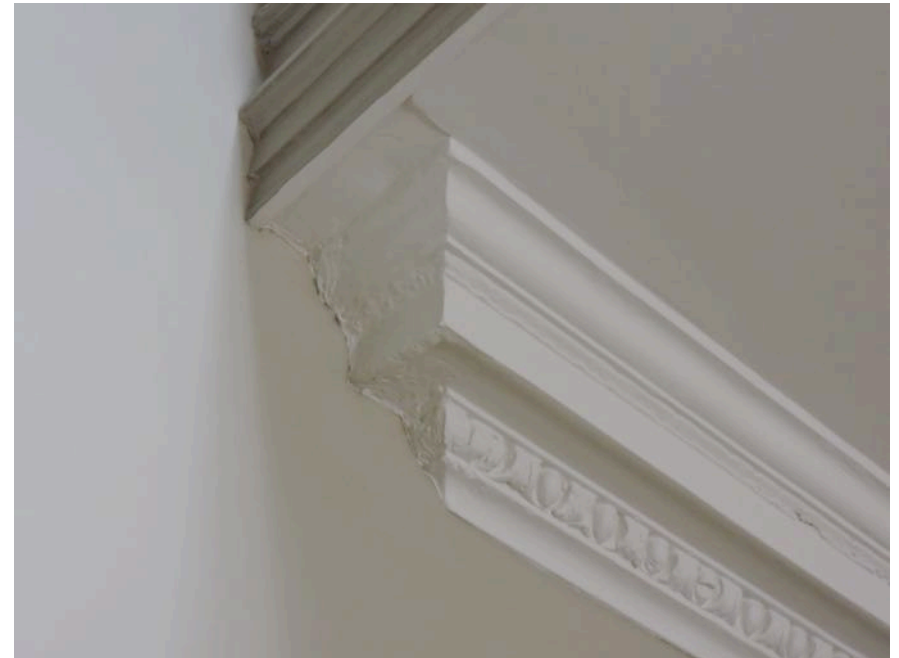
3.19 The cornice here matches the ground-floor front room.

3.20 The image on the right shows the landing cornice, and a small mitred repair that possibly used to extend to the timber work.

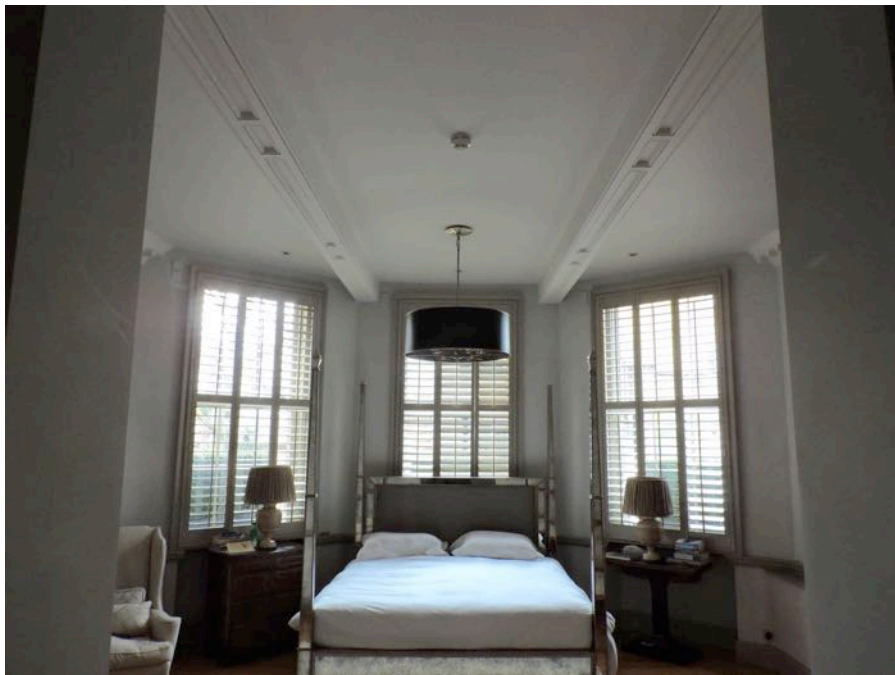
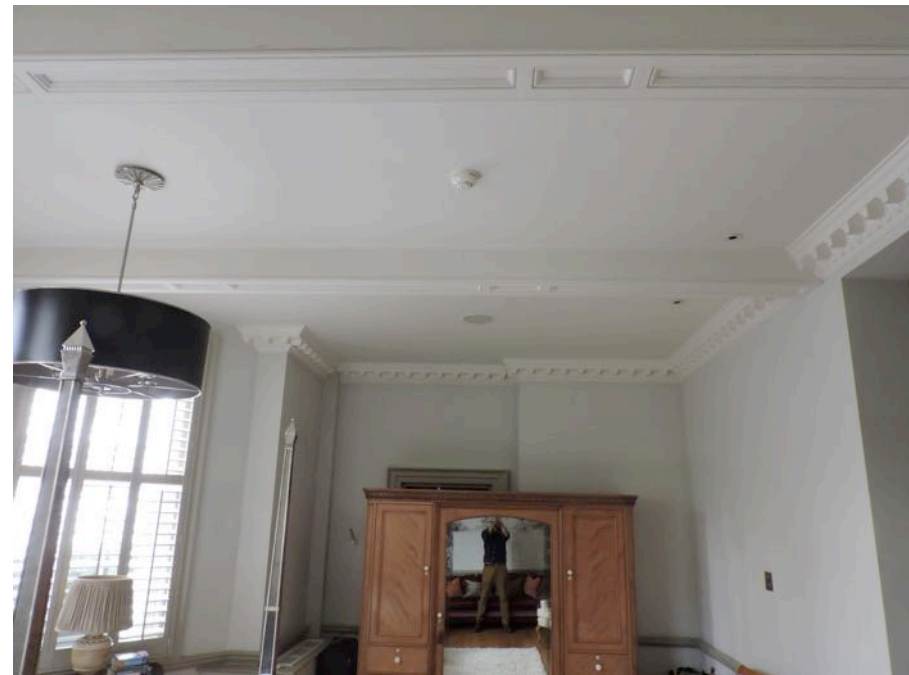
3.23 The 2 images below show the room with the 2 new structural beams, and no cornice present in the bay.

3.24 The window heights do not allow the cornice to continue onto the bay walls. Possibly the new bay allowed for larger windows on this floor, or the cornice was never continued onto these walls.

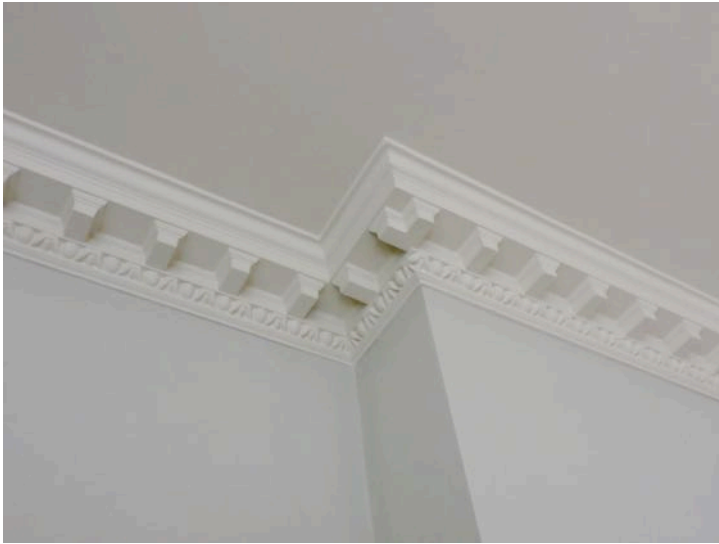
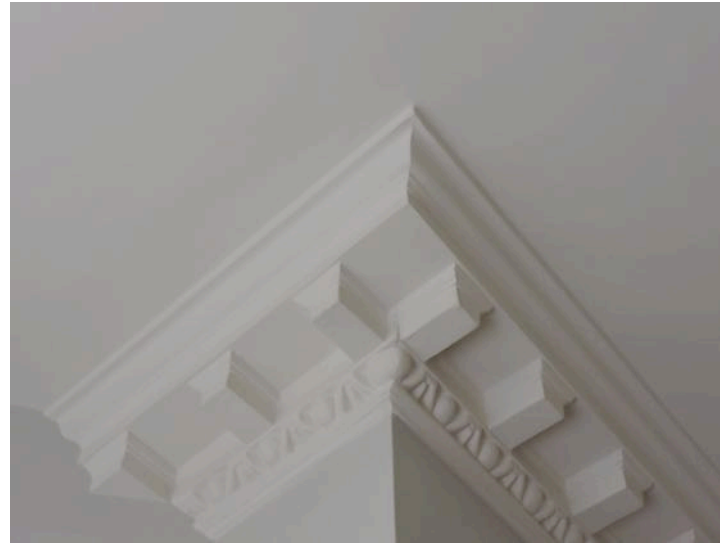
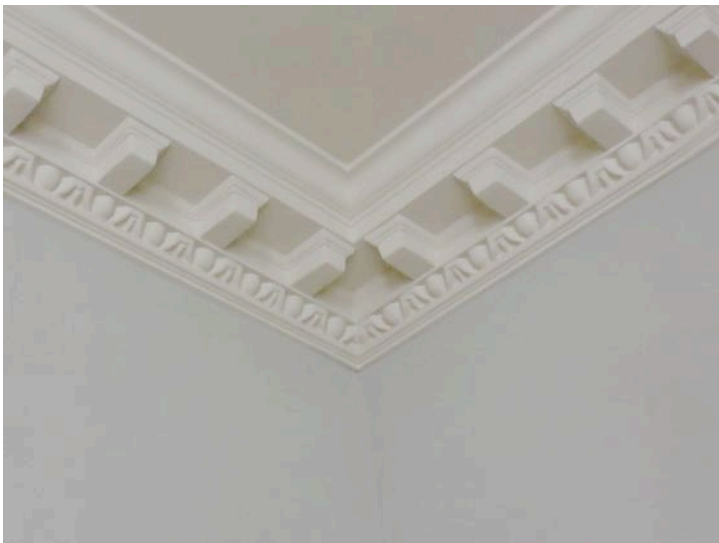
3.25 The cornice has been applied without much thought for the mitred details. These 3 photos show how the positioning of the plain modillion blocks have not been planned, and the free-hand modeled egg and dart corner detail is crudely done:

3.26 These odd details are indicative of a newly added scheme, rather than the original cornice.

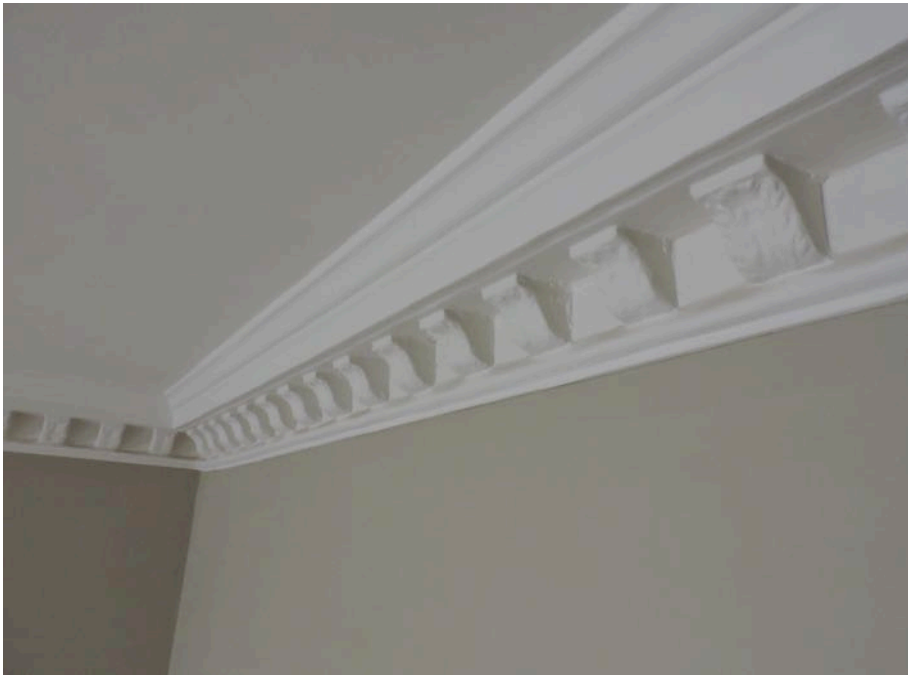
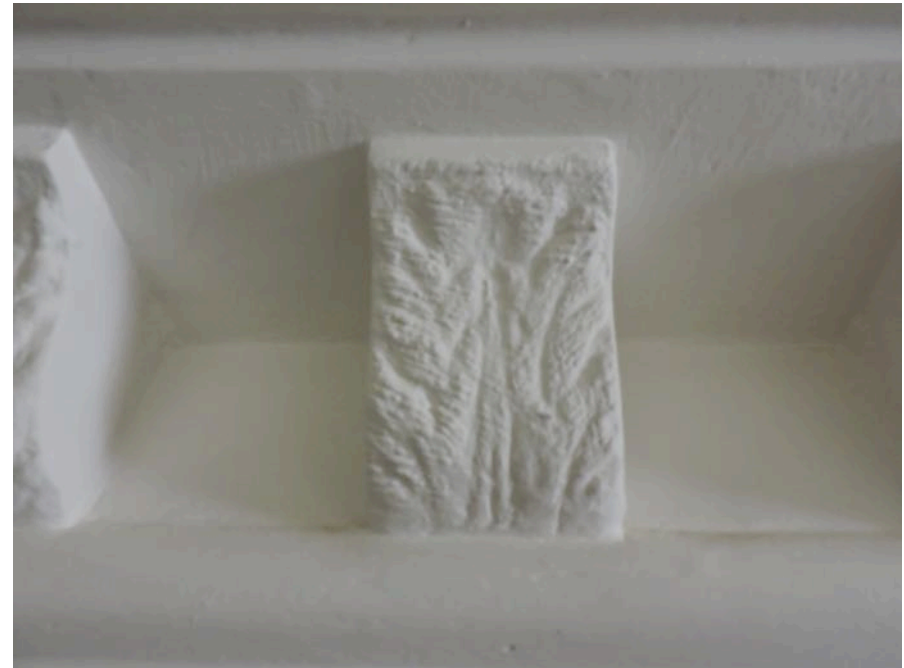
3.30 This is the top of the original main staircase. It has much lower ceilings, so the cornice is more visible. It is original, though may have been reapplied on the front elevation wall, as this was re-built in the 1950's.

3.31 It is a plain cornice with enriched modillion blocks. 7 inches high x 7 inches deep.

3.32 The image on the right shows an area where a detail has been damaged by cleaning with a wire brush to remove layers paint and limewash.
