Simon Pryce Arboriculture

Site: 40 Camden Square, London, NW1 9XA

Subject: Tree survey

Reference: 15/140/2

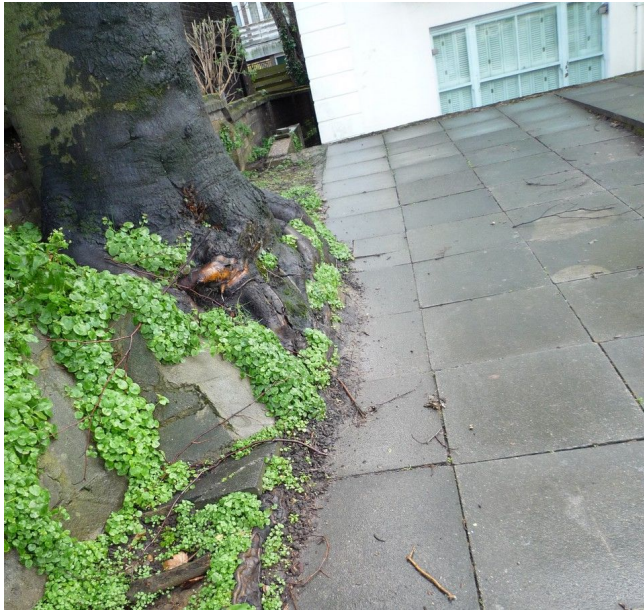
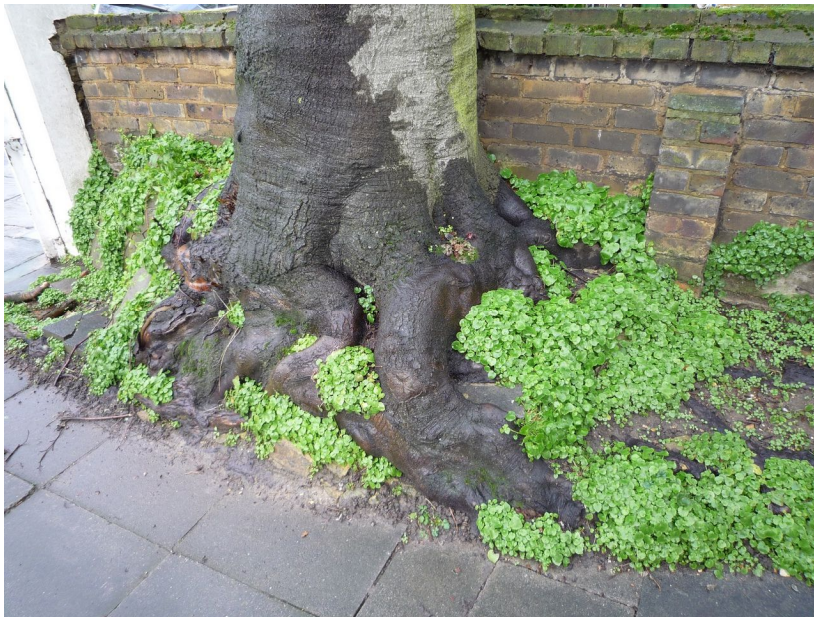
- 4.4 It is not clear how the left hand side of the front garden was landscaped before the drive was laid, but the roots at the base of the copper beech spread parallel with the drive, which suggests that they had been contained until then by a retaining wall or planting bed edge, which restricted their spread while they were developing. There are some minor superficial wounds caused by vehicle wheels on the roots, but no signs that any major roots were cut in order to lay the drive, which also suggests that there were no large ones where the drive now is. This was done almost fifty years ago, there are no signs of decay and the tree is in good physiological condition, so it has evidently recovered from any damage that occurred. Also the drive is flat with no signs of any subsequent major root development underneath.

Views of the base of the copper beech, showing where roots were contained and directed parallel with the drive early in the tree's life. The surface has remained flat and level suggesting that no large roots have spread under the drive since it was laid.

- 4.5 This area is well within the tree's potential root zone, as indicated by the RPA circle, so the work here will need to take that into account. However the points outlined above indicate that it will be possible to replace the existing drive, possibly keeping the existing sub base, and carry out some low key landscaping in the front garden without harming the tree. Some protective measures and work methods will be needed, but this is a small scale project and the tree is not unduly vulnerable.
