ARBORICULTURAL ASSESSMENT REPORT

For:	Client:	Cunningham Lindsey (Leeds)
	Insurer:	
Site:	Policyholder:	
	Risk Address:	Flats 1&2, 108 Greencroft Gardens, London,NW6 3PH
Refs:	OCA Ref:	69755
	Client Ref:	6332780
	Insurer Ref:	TBC

Arborist Name:	Sorrel Kiamil	Date:	10/04/2017
QC:	William Argent	Date:	10/04/2017

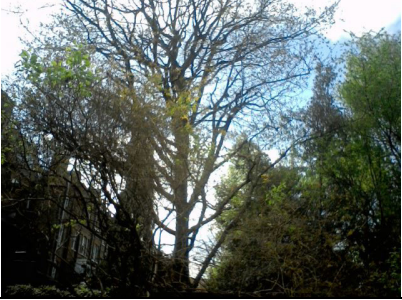
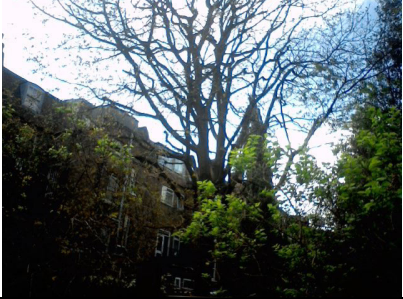
1m Quercus roots in TP1

T6	Oak	Mature	Fair	9.1	10	500	6	management. Subject to past management.	Fell and treat stump.	London, NW6 3PH 110 Greencroft Gardens, London, NW6 3PH	P3P
SG1	Mixed species group	Semi-Mature	Fair	1.5	1.0	80	1	Subject to recent management. Managed Shrub group. includes rose, acer, yacca	No work required.	Flats 1 and 2, 108 Greencroft Gardens, London, NW6 3PH	PH
SG2	Mixed species shrubs	Semi-Mature	Fair	4	2	80	1	Subject to past management.	No work required.	110 Greencroft Gardens, London, NW6 3PH	P3P

<p>SG1 - Mixed species group</p>	<p>T6 - Oak</p>

<p>T6 - Oak</p>	<p>SG2 - Mixed species shrubs</p>

Tree No:	Species	Works Required
T6	Oak	Fell and treat stump.
