Building Services Report

**Melia White House Hotel
Albany Street London NW1 3UP**

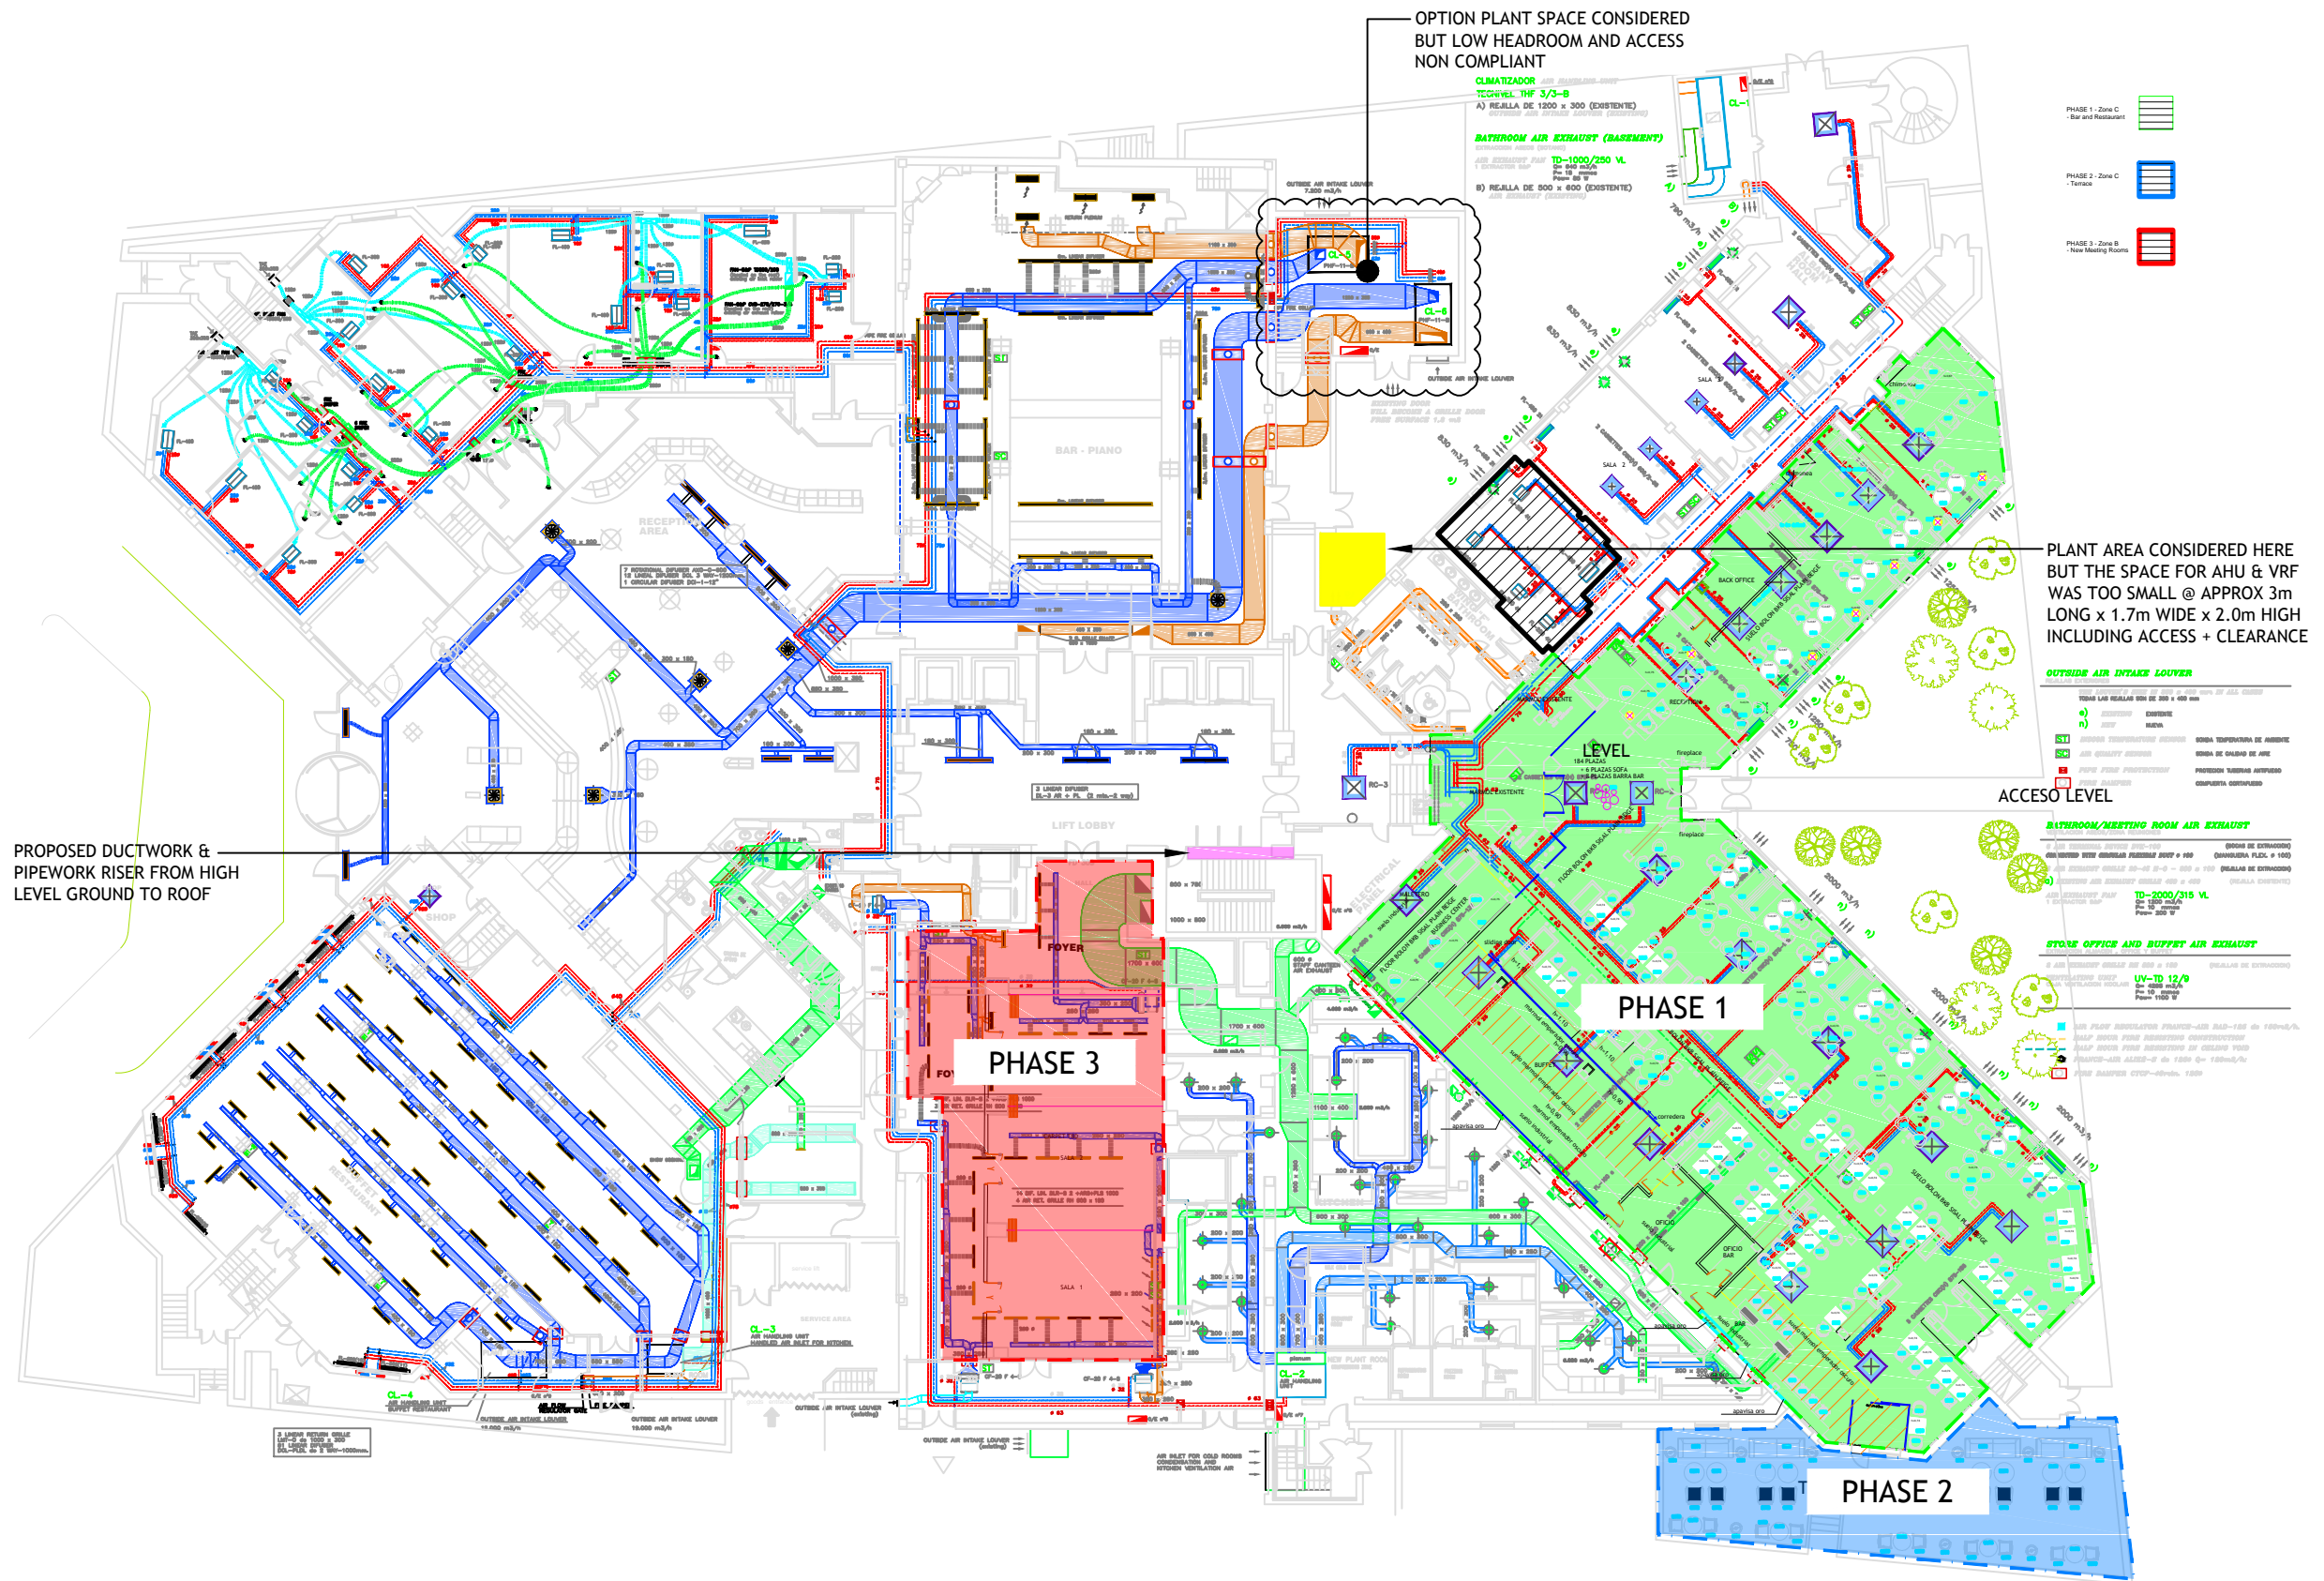
OPTION PLANT SPACE CONSIDERED BUT LOW HEADROOM AND ACCESS NON COMPLIANT

PLANT AREA CONSIDERED HERE BUT THE SPACE FOR AHU & VRF WAS TOO SMALL @ APPROX 3m LONG x 1.7m WIDE x 2.0m HIGH INCLUDING ACCESS + CLEARANCE

PROPOSED DUCTWORK & PIPEWORK RISER FROM HIGH LEVEL GROUND TO ROOF

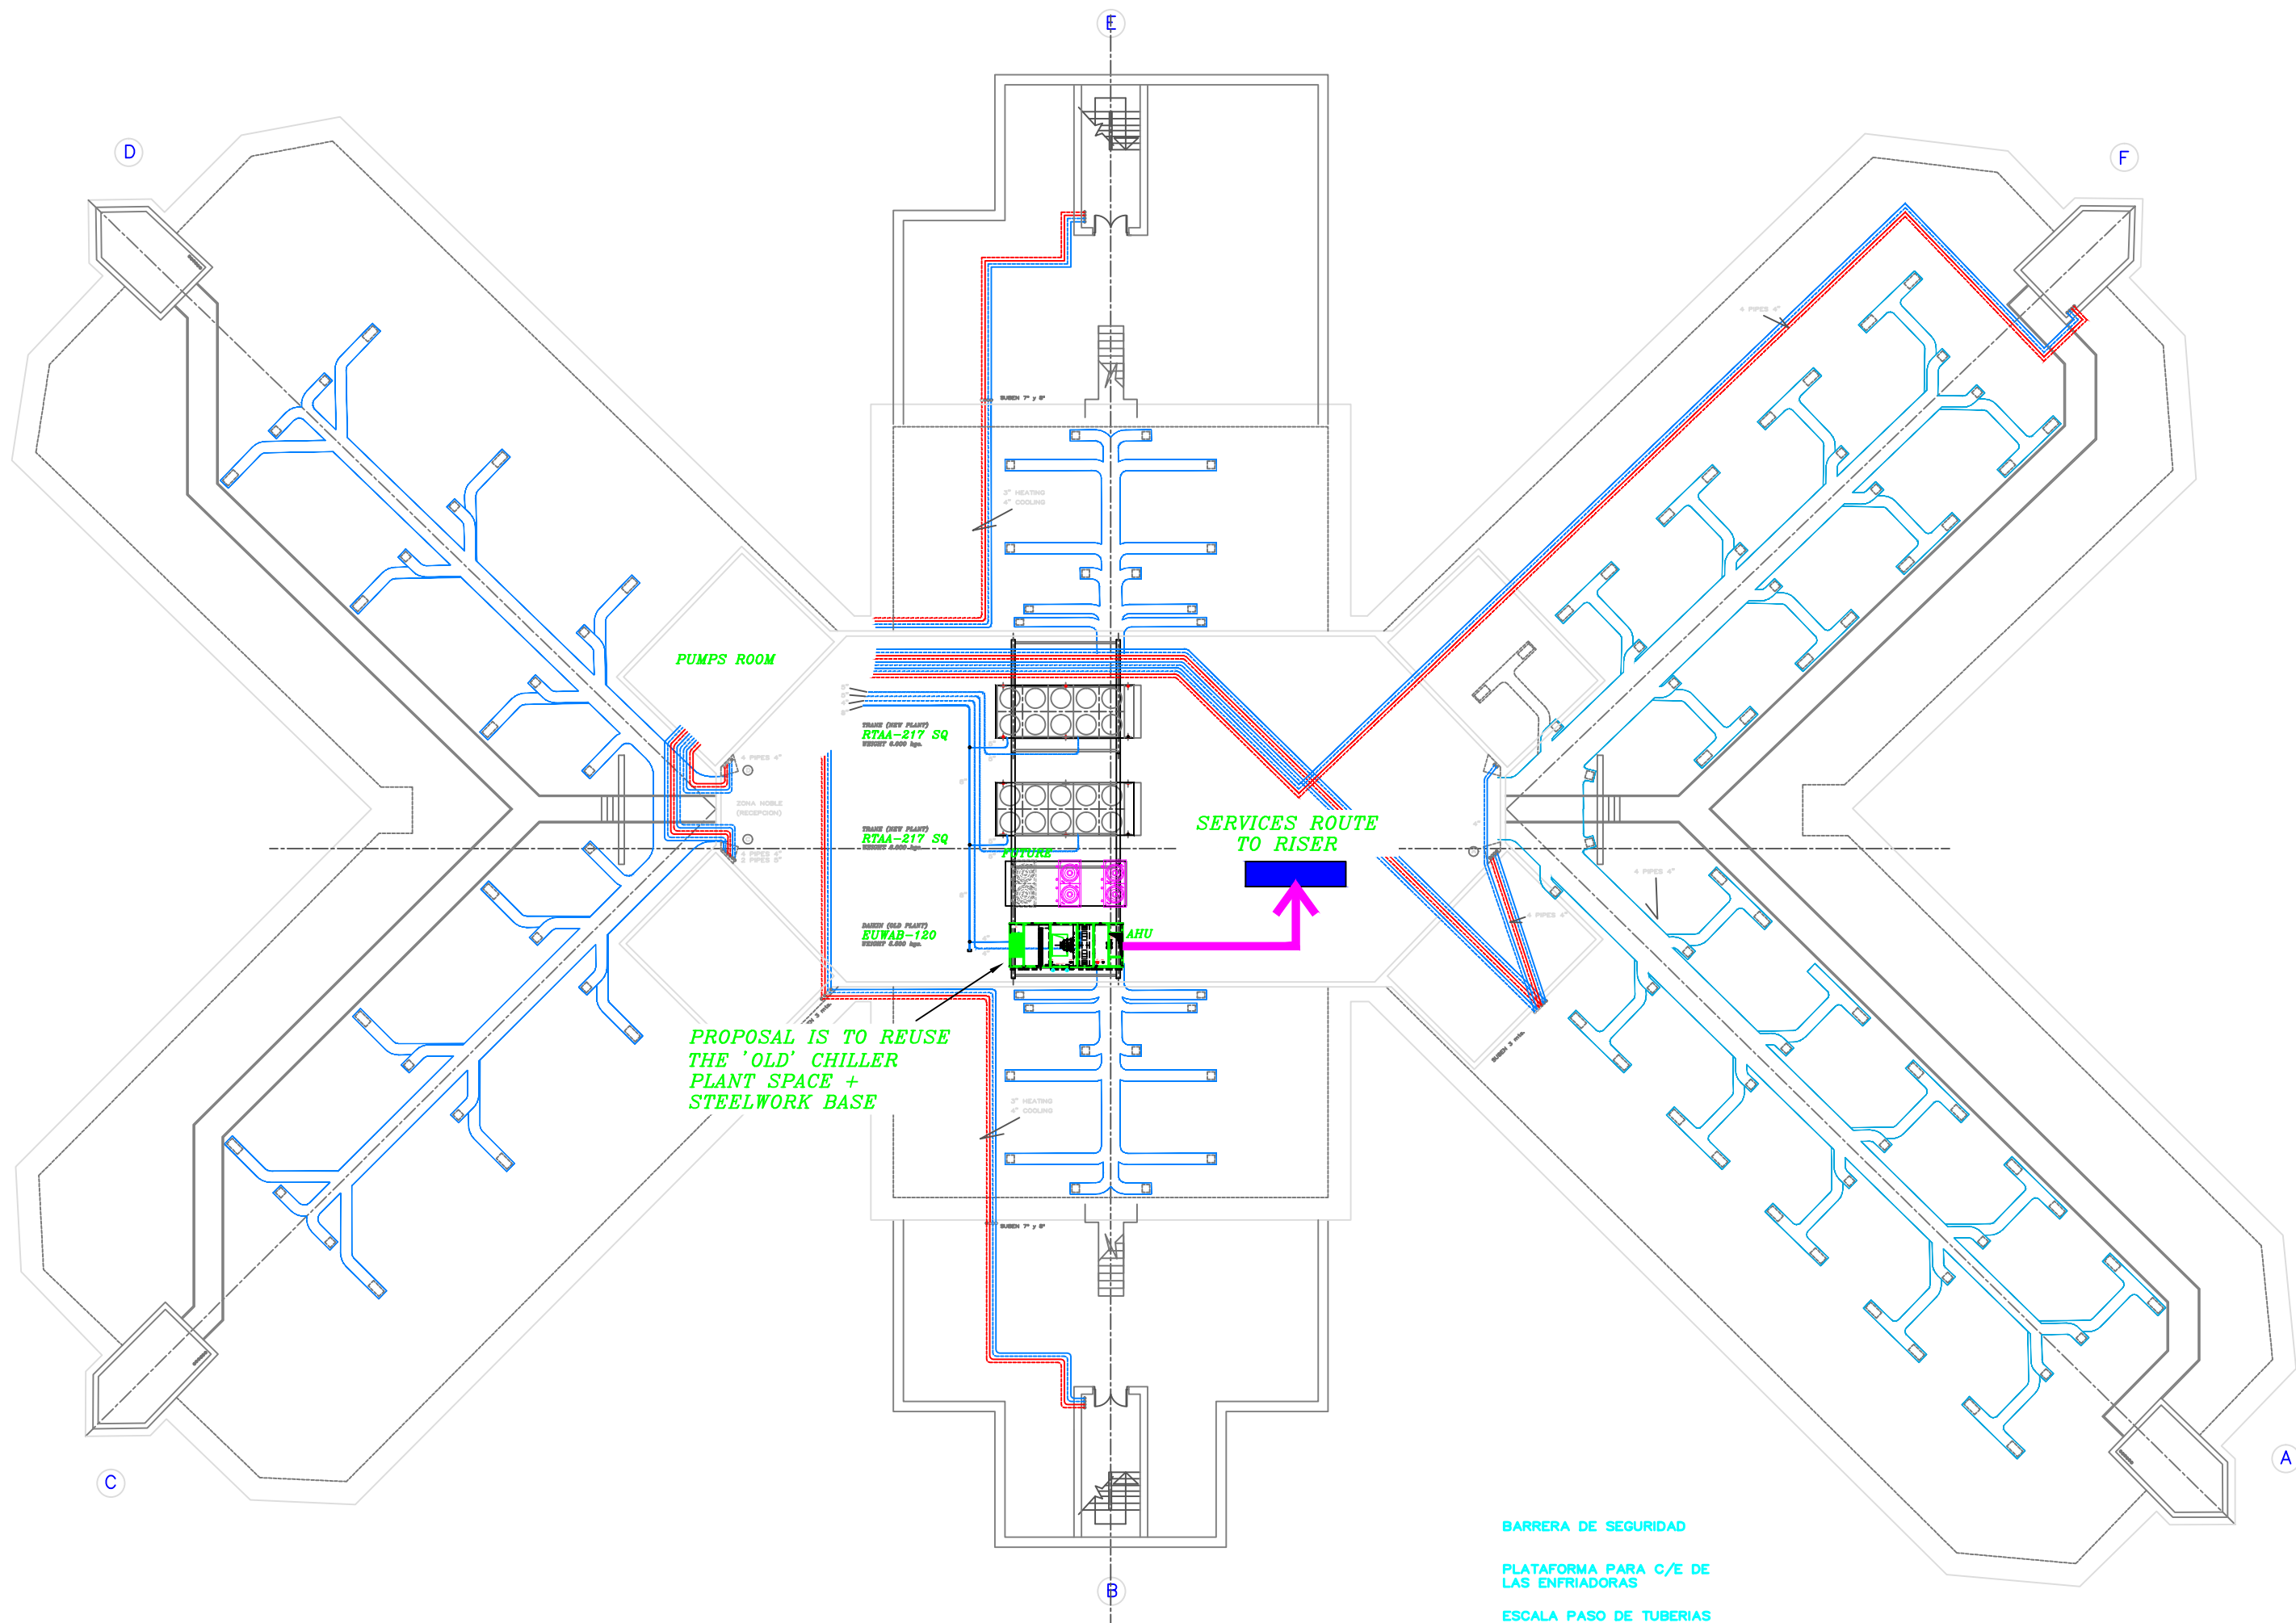
SERVICES ROUTE
TO RISER

PROPOSAL IS TO REUSE
THE 'OLD' CHILLER
PLANT SPACE +
STEELWORK BASE

- New VRF heat pumps providing simultaneous heating and cooling to be located at roof level (see drawings) utilising slimline Fan Coil Units.
- New Eco ventilation plant with Heat recovery to be located at roof level
- Reuse the existing steelwork at roof level to locate the plant
- Riser interconnection as shown on the drawings as discussed on site with Miguel using the “sacrificial” store.

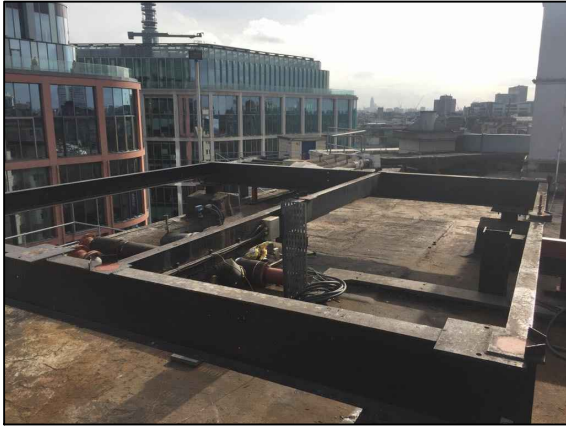
IMG001 EXISTING STEELWORK; PREVIOUS CHILLER

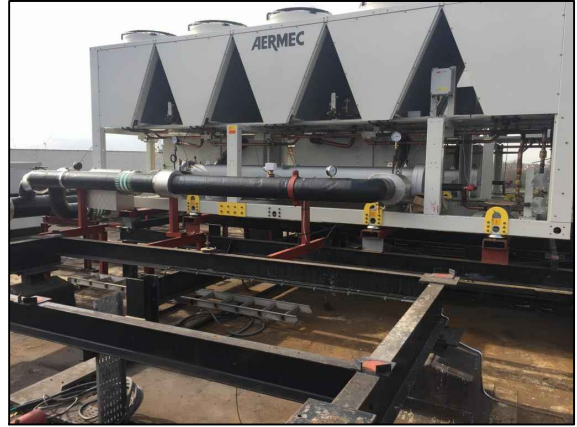
IMG002 NEW CHILLER; SPARE PLANT SPACE

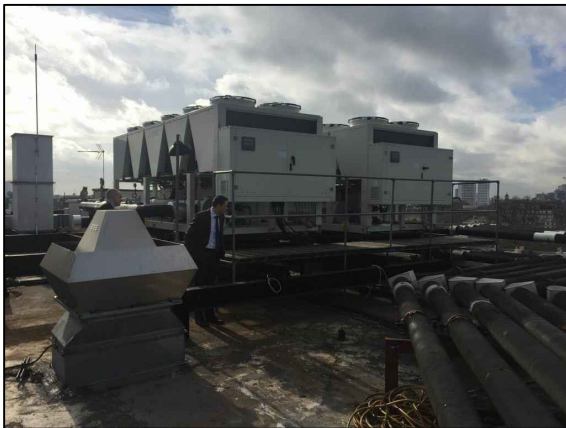
IMG003 VIEW OF CHILLERS + ADJACENT PLANT SPACE

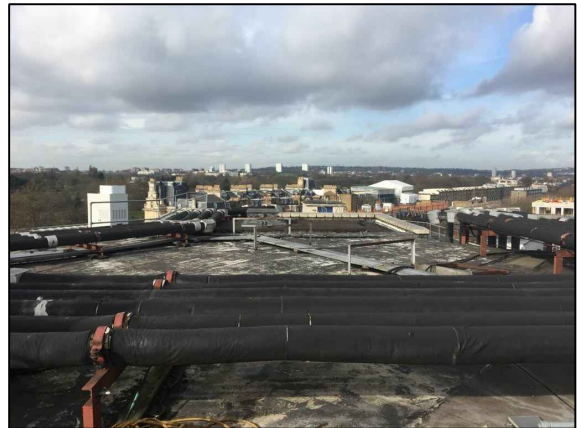
IMG004 PIPEWORK + VIEW ACROSS ROOF

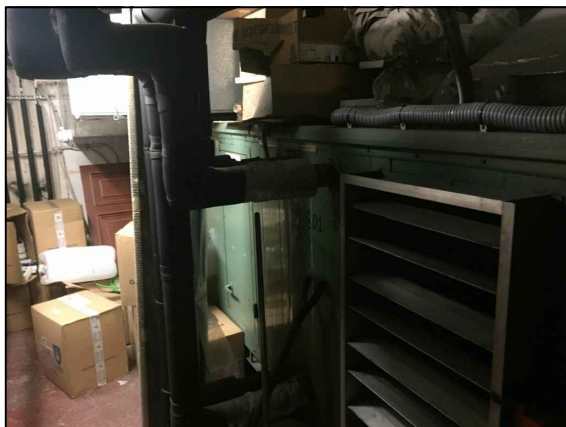
IMG005 EXISTING AHU PLANTROOM – NO SPARE SPACE

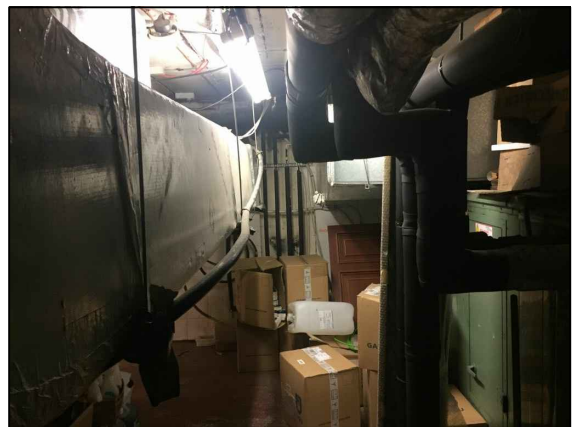
IMG006 EXISTING AHU PLANTROOM – REDUCED HEADROOM

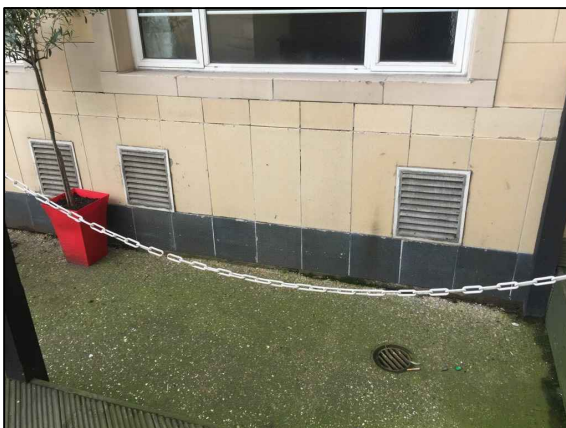
The original outside air solution is via holes through the façade at low level to the back of the perimeter fancoils. This method would no longer be efficient or compliant. A new ventilation plant is required to serve the restaurant and hospitality areas. This will provide better quality of air from the roof rather than from ground floor level.

IMG007 OUTSIDE AIR LOUVRES TO RESTAURANT PERIMETER FAN COILS

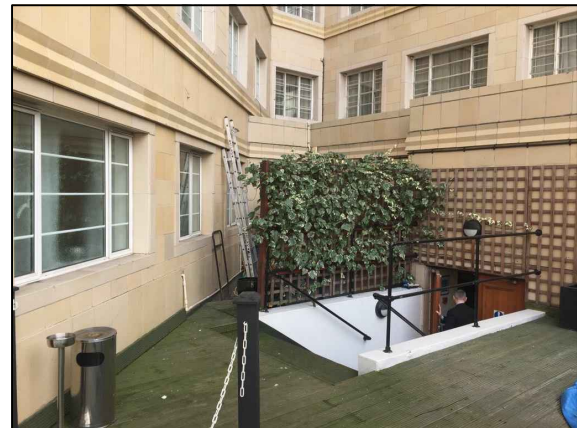
IMG008 POTENTIAL PLANT SPACE BEHIND SCREEN

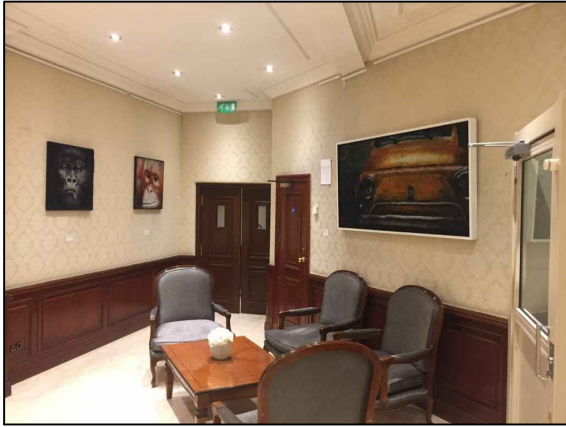
IMG009 POTENTIAL PLANT SPACE (AS DISCUSSED ON SITE)

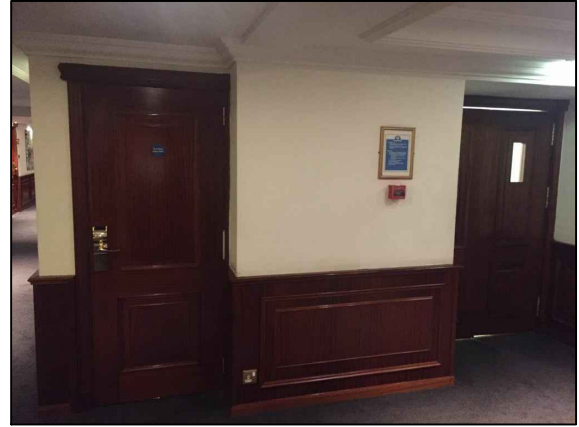
IMG010 DOOR TO LONG STORAGE 'SACRIFICIAL' FOR NEW PROPOSED RISER LOCATION

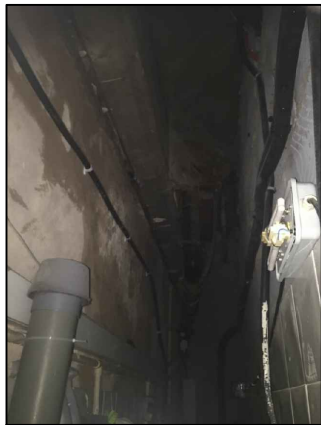
IMG011 SERVICES AT BACK OF PROPOSED RISER CUPBOARD

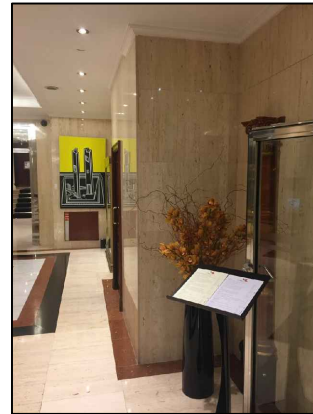
IMG012 GROUND FLOOR VIEW OF RISER (ABOVE) LOCATION

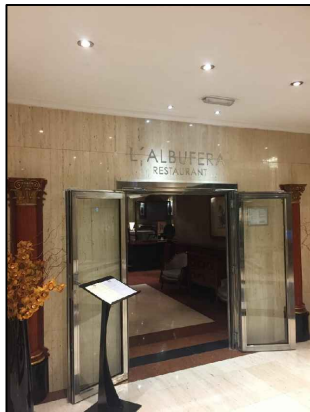
IMG013 REDUCED HEADROOM IN ALBUFERA RESTAURANT

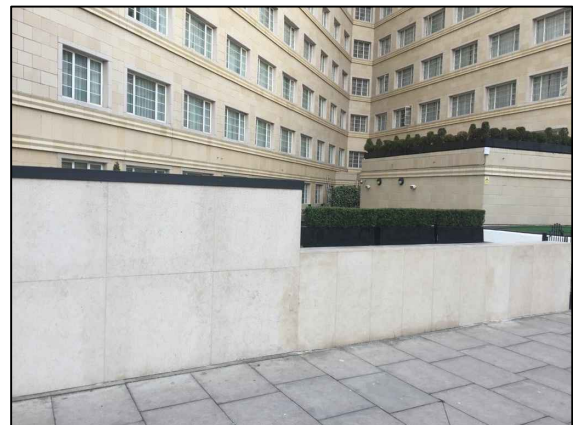
IMG014 REVIEW OF LINES OF SIGHT FROM STREET PERIMETER FOR 'CORNER' OPTION
