DR. FRANK HOPE

Forensic & Planning Arboricultural Consultant

ARBORICULTURAL IMPACT ASSESSMENT REPORT RELATING TO THE PROPOSED DEVELOPMENT AT NUMBER 15 LYNDHURST TERRACE, LONDON, NW3 5QA – REVISION 1: FEBRUARY 2017.

FH-Mond-15-Lyndhurst-Terrace-London-NW3-5QA

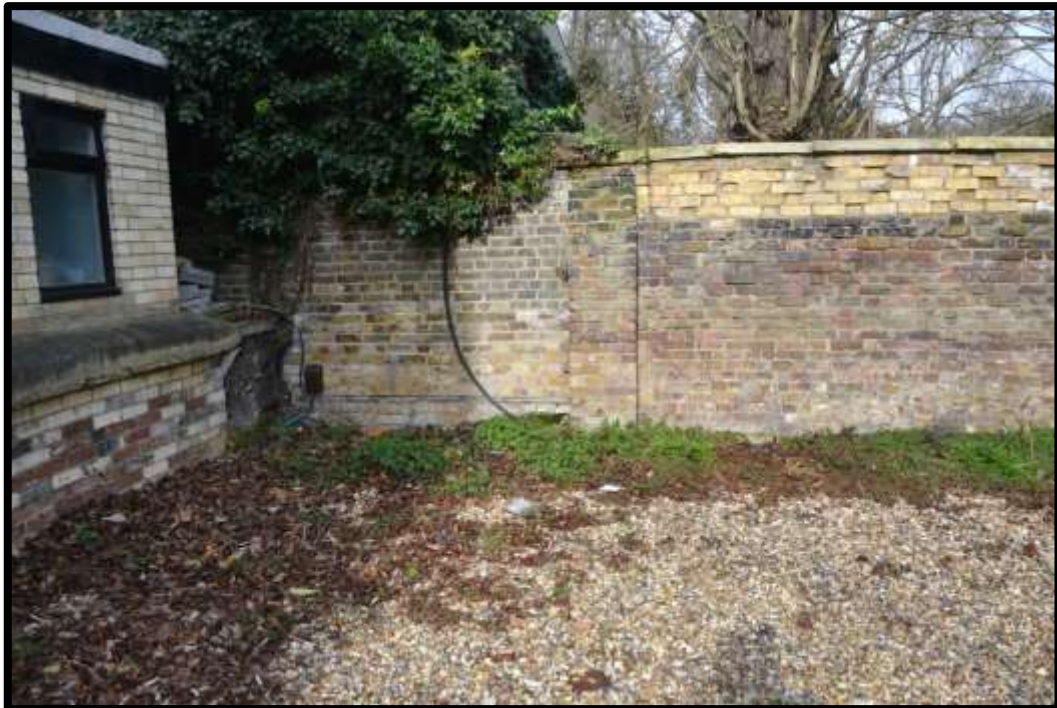
Picture taken on the 26th of February 2016, showing the section of the gravel hard-standing area at the front of number 15 Lyndhurst Terrace, and the poor quality brick-built wall along the boundary.

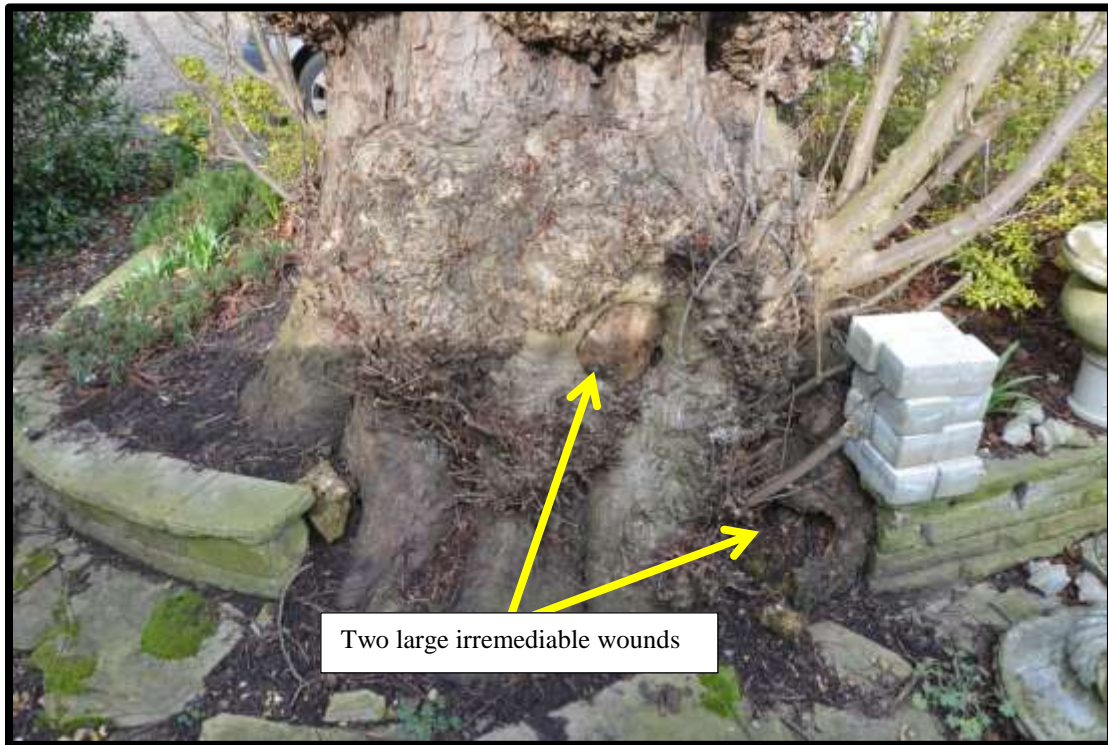
Picture taken on the 26th of February 2016, showing two large, open, irremediable decaying wounds on the main trunk on the Chestnut.

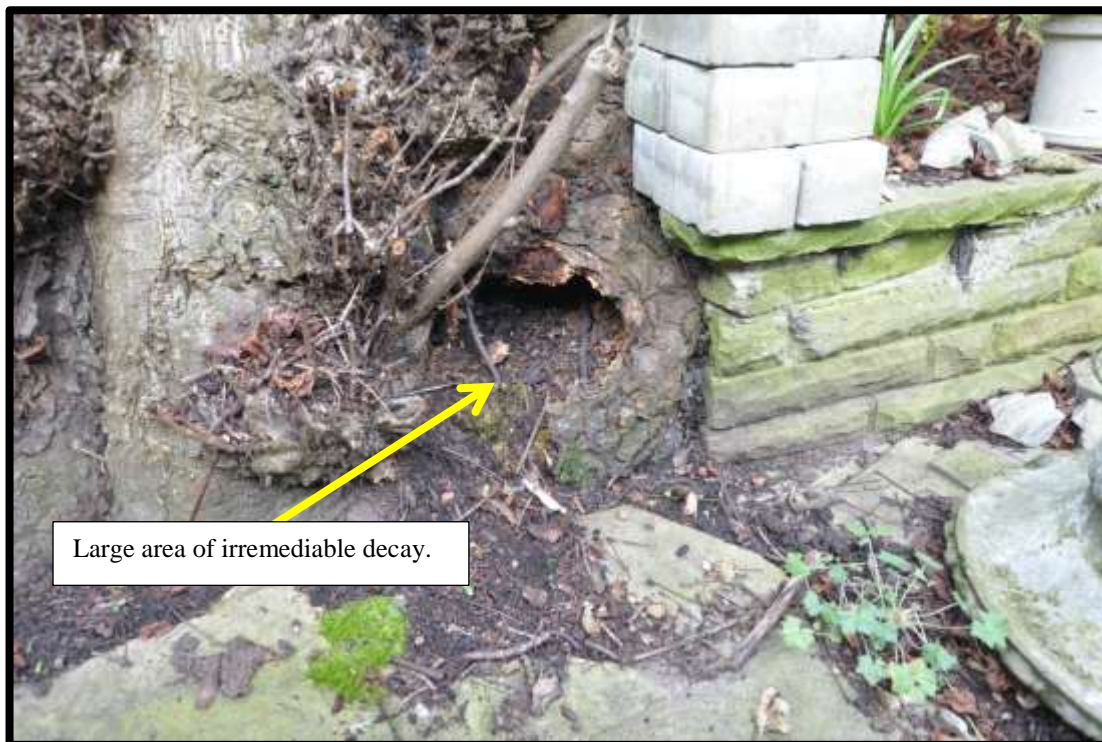
Close-up picture taken on the 26th of February 2016 showing one of the large, irremediable decaying wounds on the main trunk.

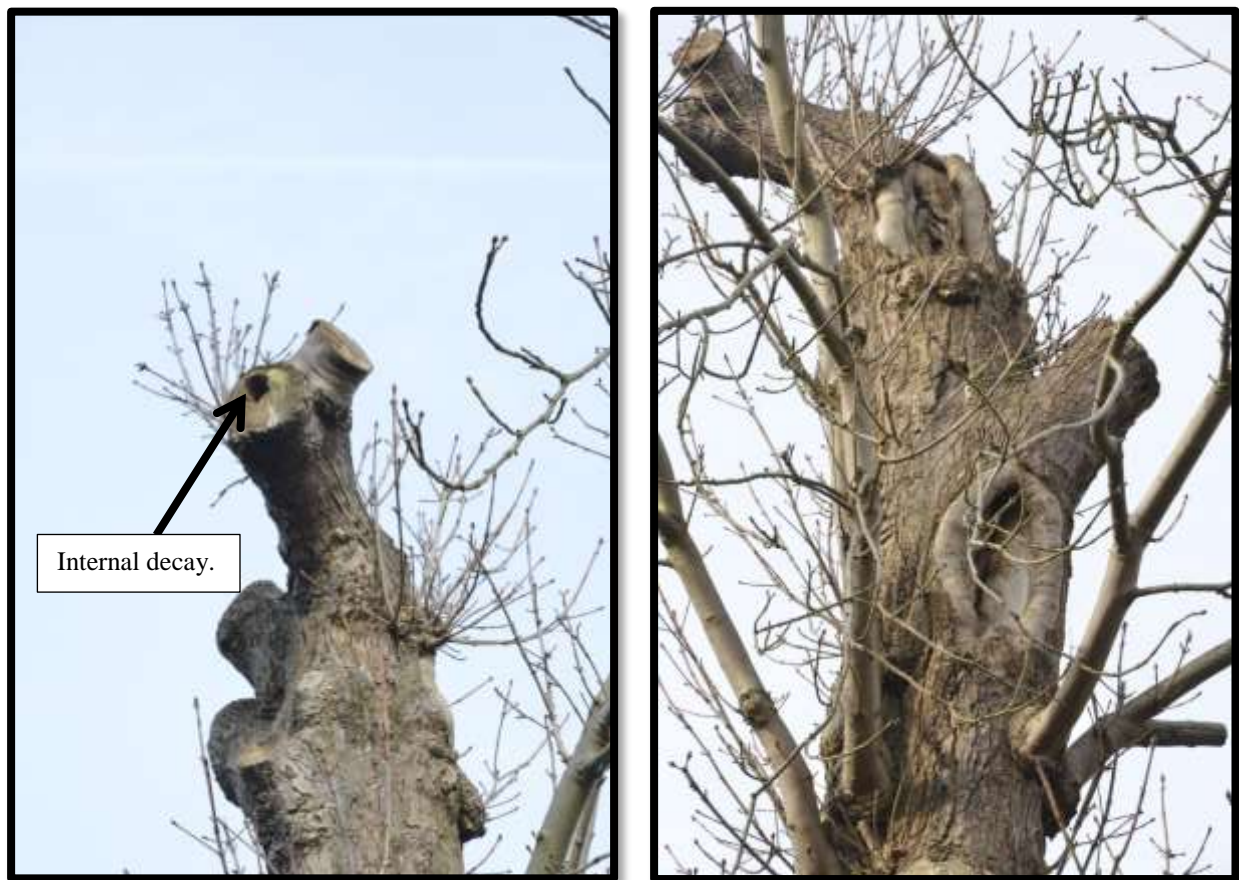
Pictures taken on the 26th of February 2016, showing large areas of irreparable internal decay in the Chestnut main trunk.

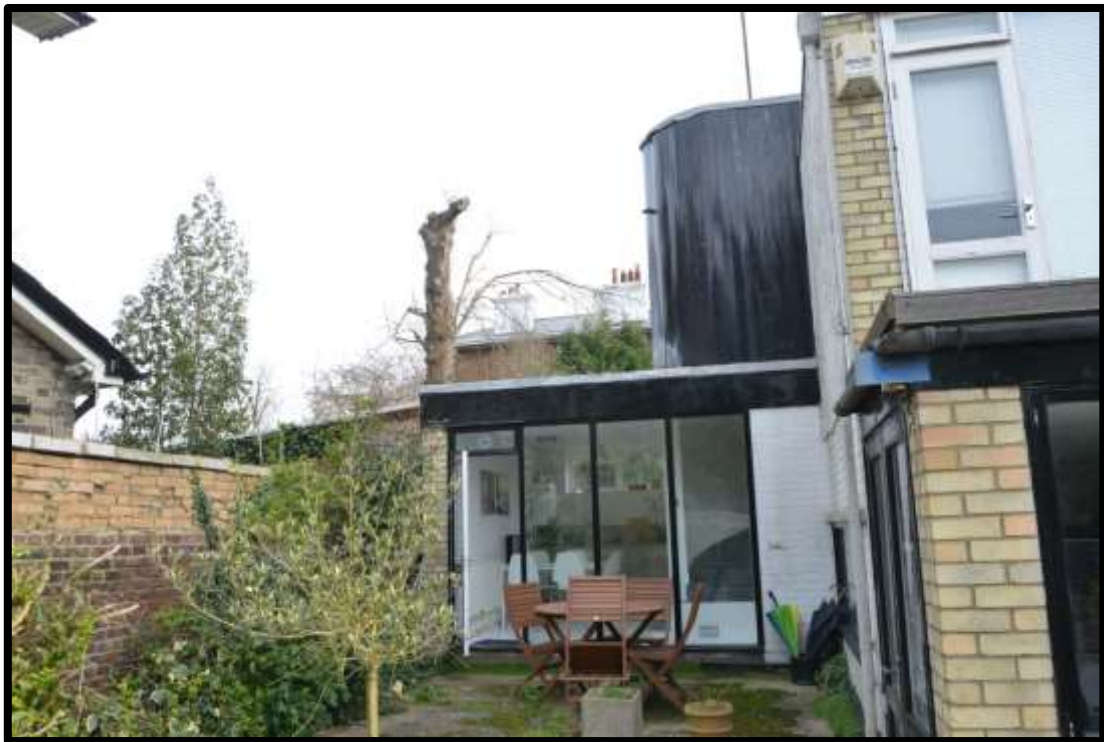
Picture taken on the 26th of February 2016 showing the extreme poor quality of the Horse Chestnut (T1), with all of its crown removed.

Tree T1: This is an over-mature Horse Chestnut (*Aesculus hippocastanum*) located in the grounds of number 17/19 Lyndhurst Terrace, approximately 3.0 metres away from the brick-built boundary wall with number 15 Lyndhurst Terrace. The tree is in an extremely poor condition, and it is in terminal decline (See the picture above).

9.14 The Horse Chestnut is in an appalling condition, and is in terminal decline. The tree’s crown has had to be totally removed on safety grounds, as it has previously shed large structural branches. It does not have the typical visual characteristics of an average tree of the species. The only growths on the trunk are epicormic shoots, which will never form an attractive new crown. There is significant internal decay of the basal trunk, which is irremediable, and the tree is making almost no new annual extension growth.

9.17 In my opinion, the Horse Chestnut has a British Standard 5837 category rating of “U”. It can be left in situ, and be allowed to deteriorate naturally, but should not be used to attempt to prevent the proposed development at number 15 Lyndhurst Terrace.

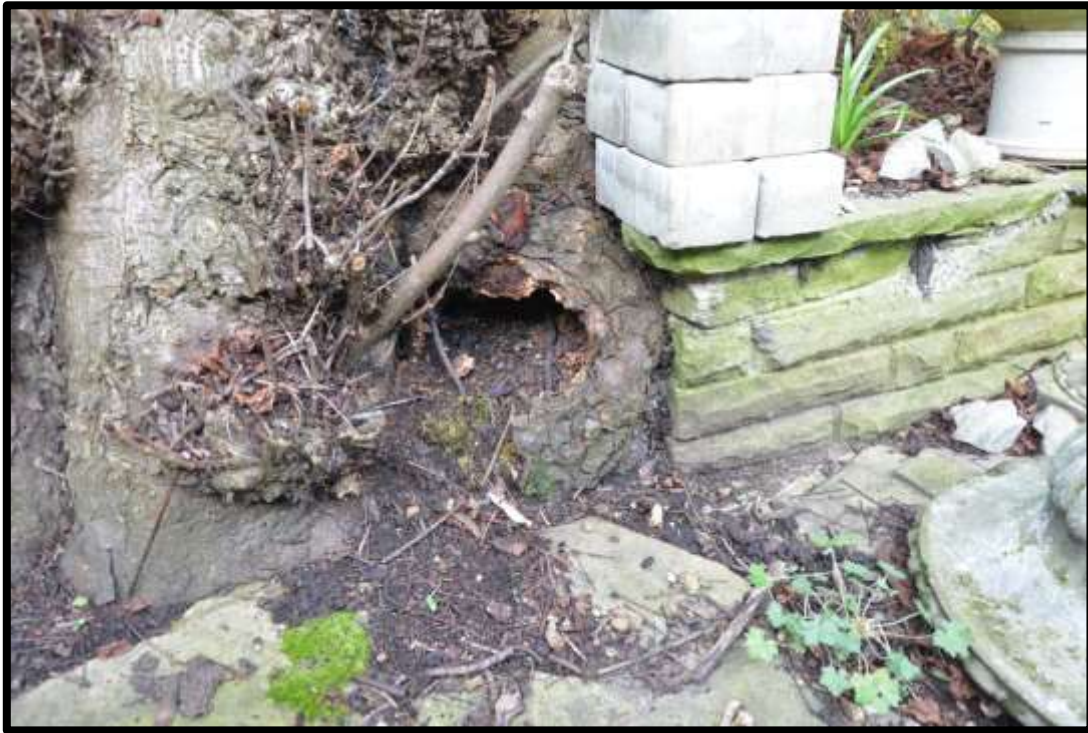
The basal trunk of the tree contains a large, decaying, open cavity, which is irremediable, and will continue to develop for the remainder of the tree's life. However, there are no current signs to indicate that the tree is potentially unstable at the present time.

Picture taken on the 26th of February 2016 showing the large, open decaying cavity at the base of the Horse Chestnut (T1).

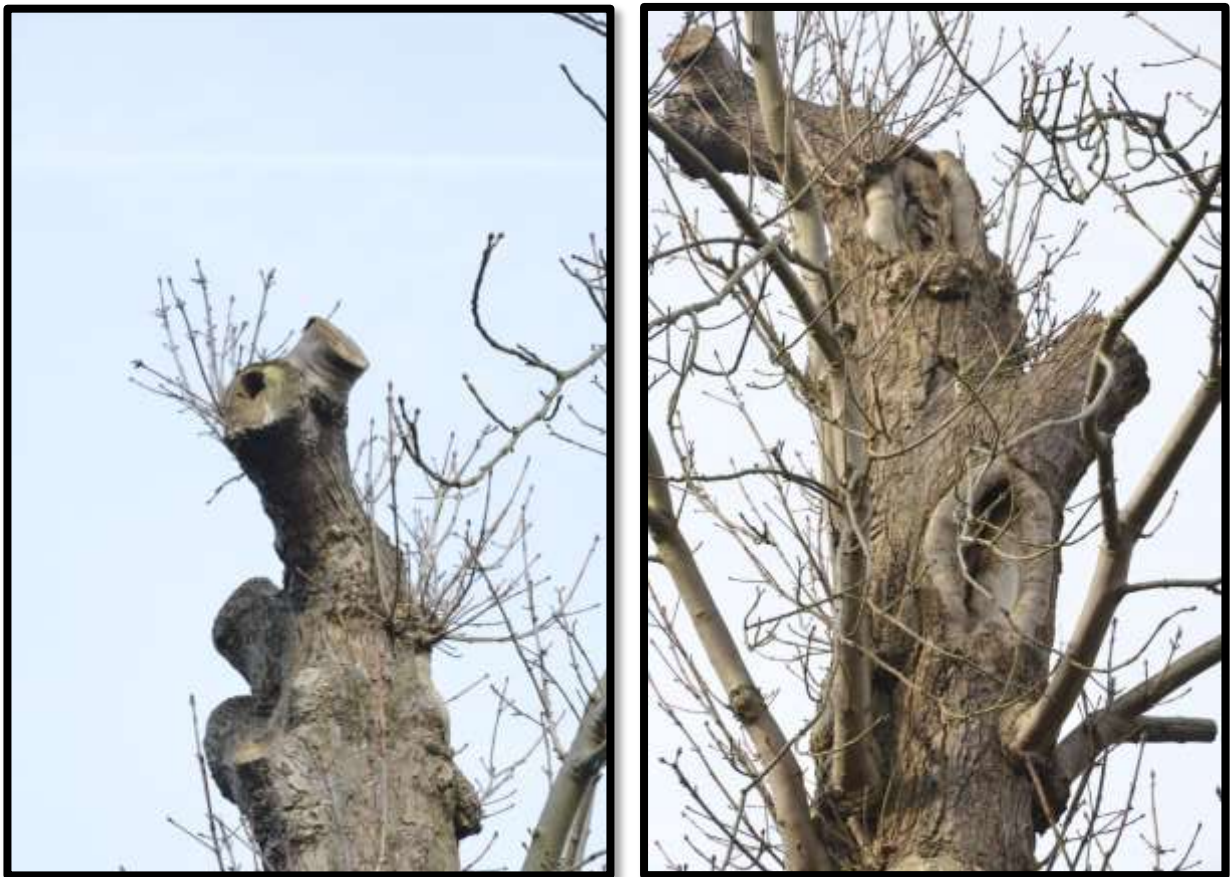
There is a series of very large, open, decaying wounds located along the main trunk of the tree, i.e. from within 500mm of ground level, to almost all the way up to the point where the tree has recently been topped. The largest wounds are long-standing, and have occurred through limb loss which commenced when the tree canopy started to naturally disintegrate. The wounds contain some callus growth around their open surfaces, although the wounds are so large, and have deteriorated to such an extent, that they will never fully occlude, and the internal tissues will continue to decay

Pictures taken on the 26th of February 2016, showing the large, open, decaying cavities, with some callus growth around the old exposed surfaces.

The left-hand picture above clearly identifies a large open decaying wound, with almost no callus growth present. This decay is long-standing, and confirms that the internal tissues of the structural branch would have been decaying, and rotten, for an extended period of time. The internal decay is irremediable, and will continue to extend throughout the tree's remaining life.

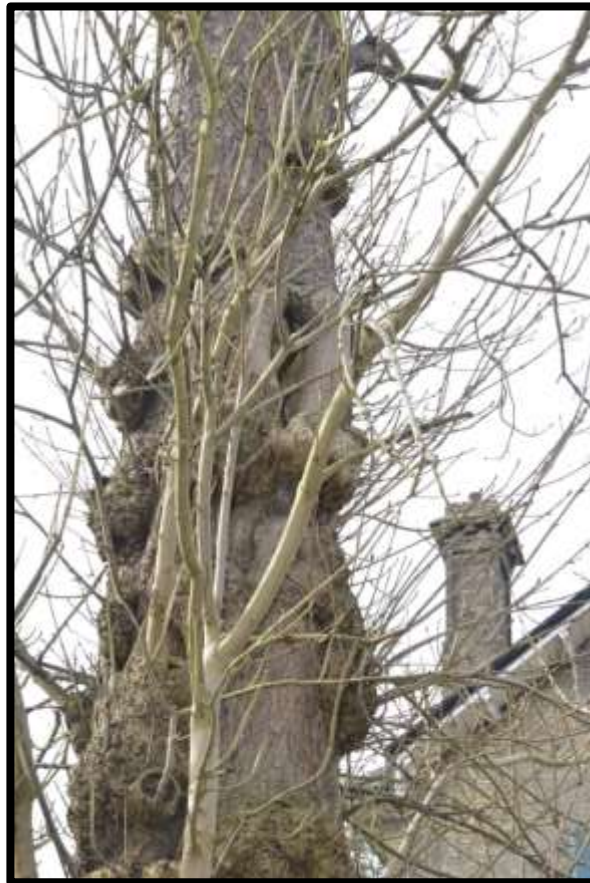
Picture taken on the 26th of February 2016, showing the mass of epicormic shoots that have developed on the main trunk, close to previous wounds.

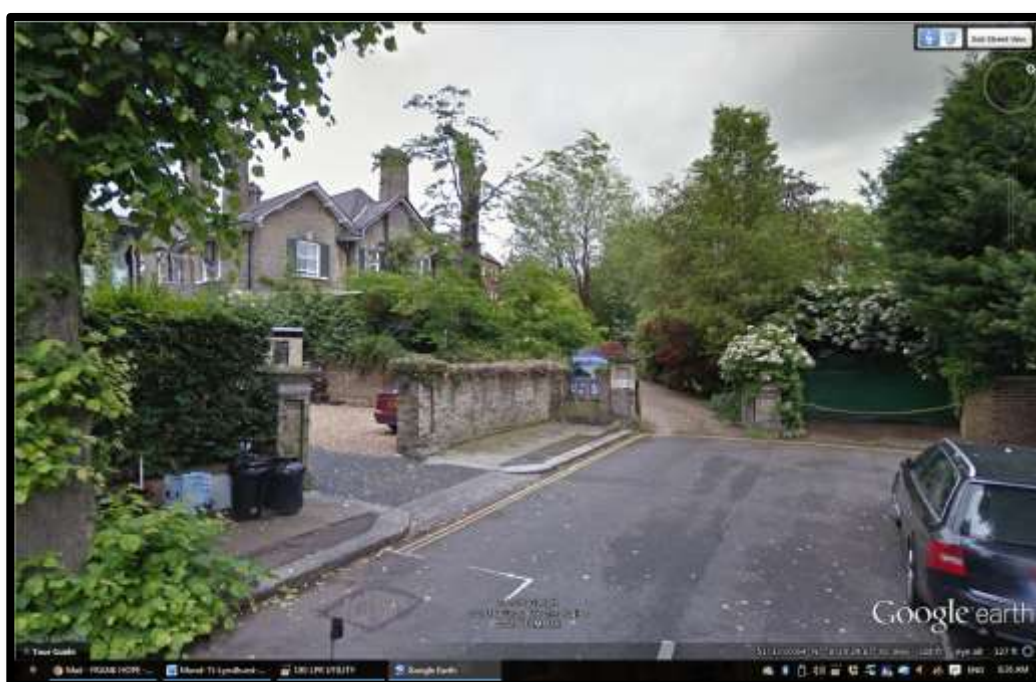
In item 3.1 of Mr Pryce's report he confirms that the tree was pruned approximately three years ago. It was actually pruned prior to June 2012 (See the Google Street Scene image below). The left-hand photograph on page 16 above indicates that the tree is making almost no new re-growth following the topping. The shoots from around the exposed wound at the top of the tree are only in the region of 500mm in length after at least three years of growth, not 1.0 metre as asserted by Mr Pryce. The regrowth is minimal, and shows the lack of vigour in the tree – it is in terminal decline.

Google Street Scene image showing the Chestnut tree (T1) in June 2012.

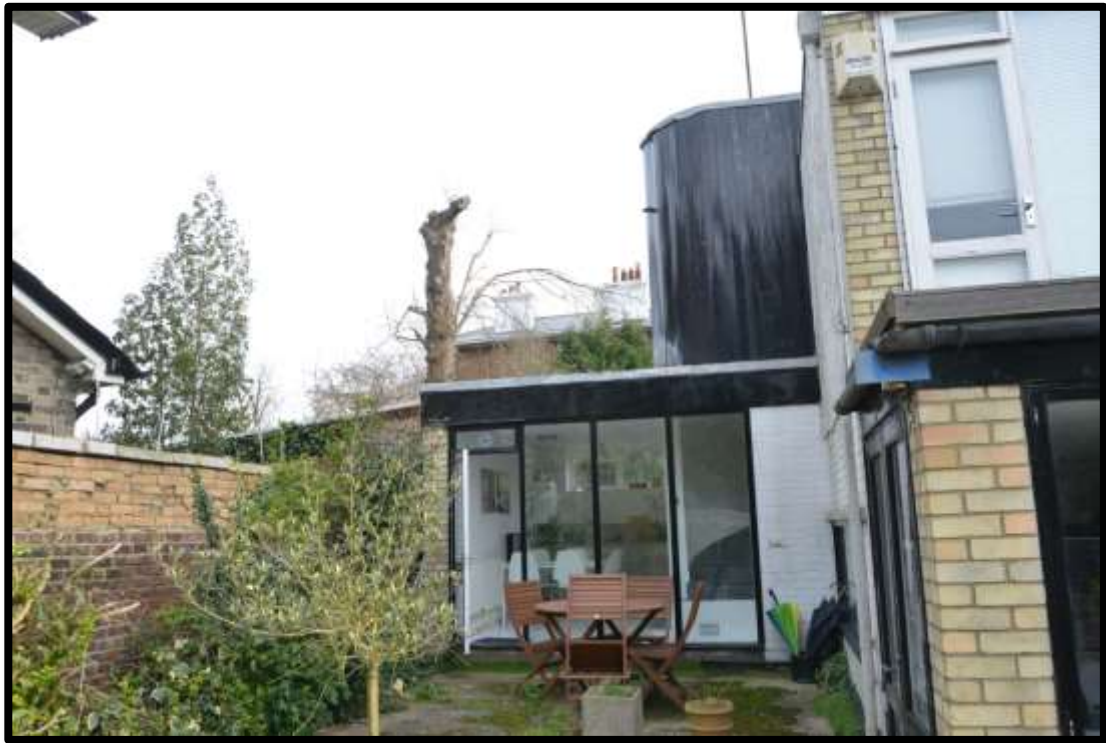
Picture taken on the 26th of February 2016 showing the total loss of canopy of the Horse Chestnut (T1).

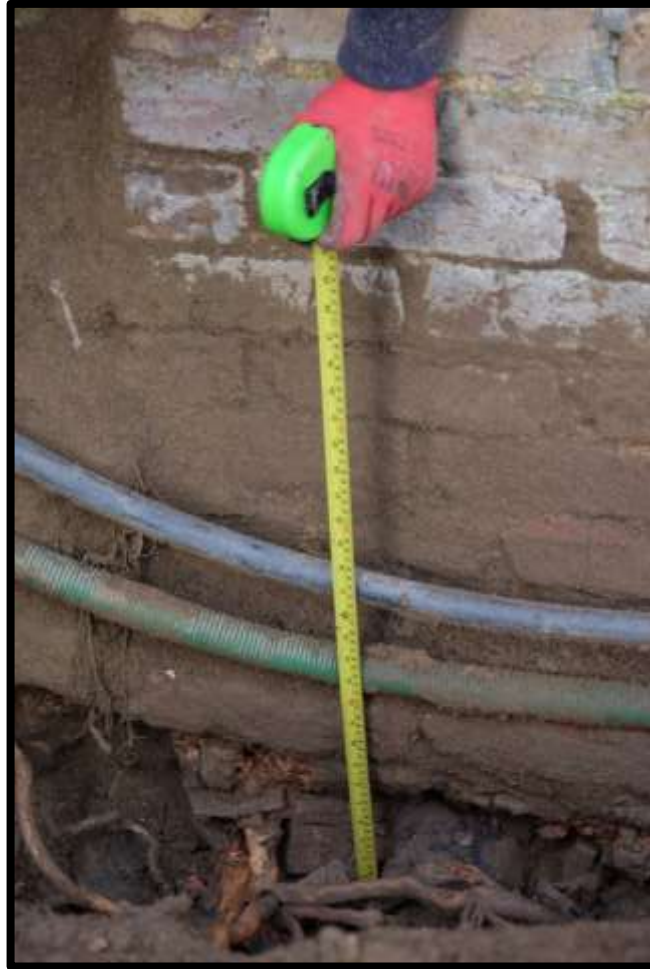
Picture taken on the 29th of February 2016, showing the depth of the foundations of the boundary wall.

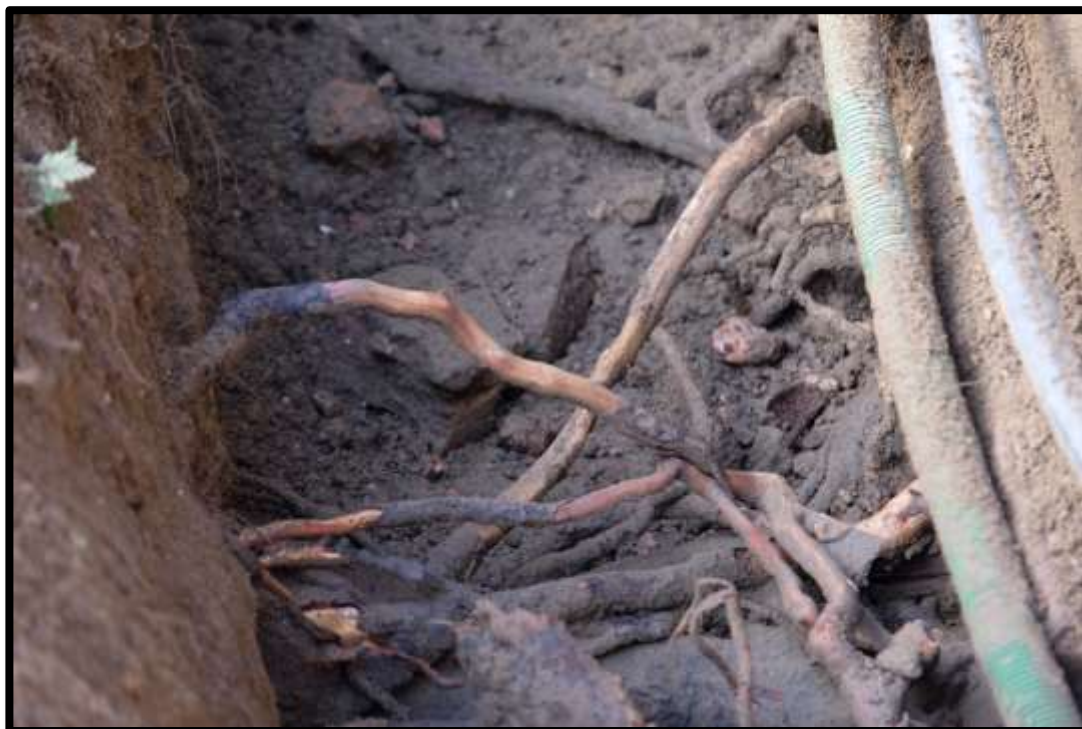
- 14.3 The Air-Spade investigations confirmed the presence of a number of roots beneath the foundations of the boundary wall.
- 14.4 The exposed roots were inspected visually, and it was confirmed that only one live root with a diameter in excess of 25mm was present within the trench. This root was 100mm in diameter, but exhibited signs of deterioration.
- 14.5 Other than the one 100mm diameter root all of the other roots were dead, and were significantly decayed. The dead roots are evident in the photographs as the Air-Spade removed the bark. The decay was long-standing.

Picture showing the extensive dead roots within the Trench.

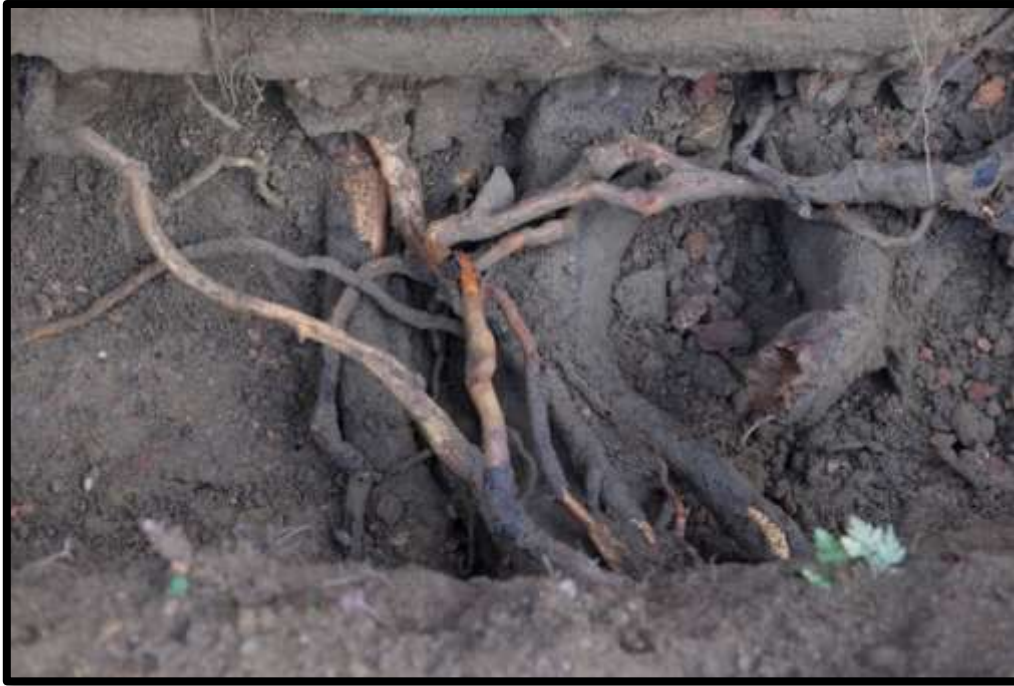
Picture showing the mass of dead and decaying roots.

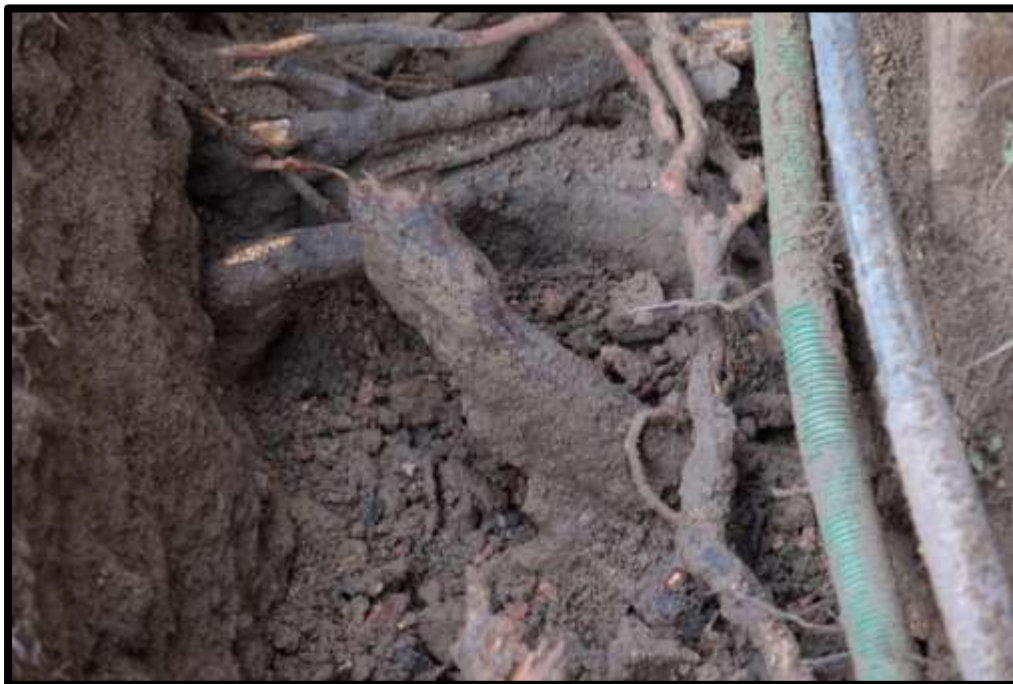
Picture showing one of the large decaying roots, and smaller roots dead and decaying roots.

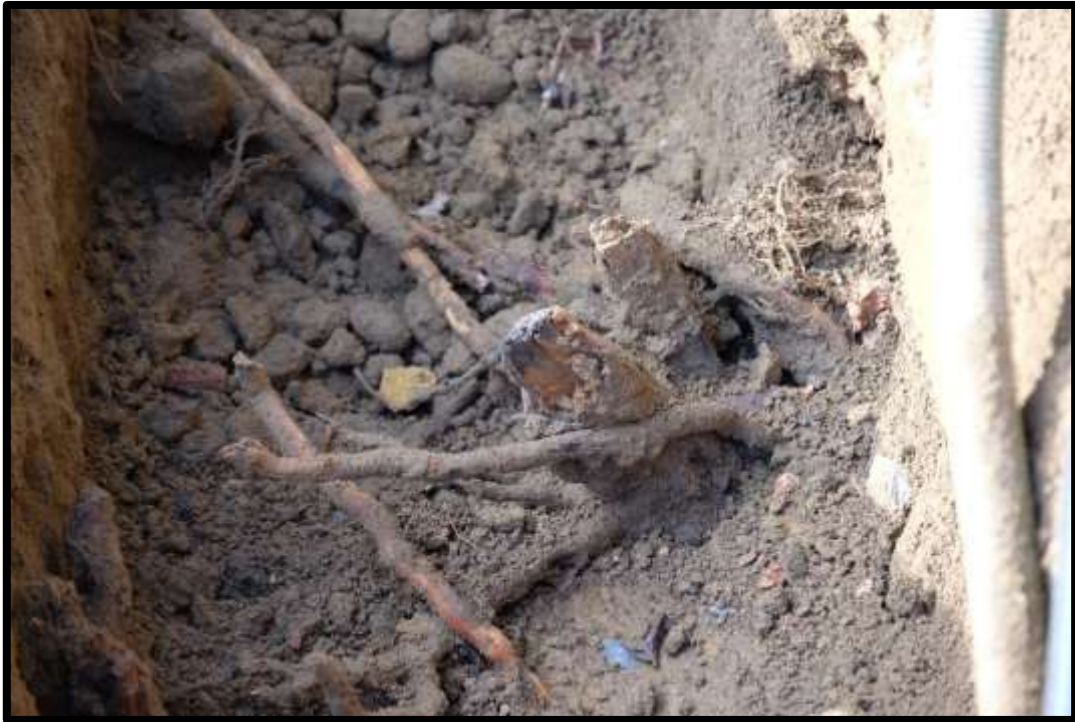
Picture showing large, long-standing decaying roots.

14.9 The results of the Air-Spade investigation confirm that the roots within the grounds of number 15 Lyndhurst Terrace have been dead for a considerable number of years, and contain extensive decay.
