**04 LISTED BUILDING
EXISTING CONDITION**

**EXISTING EXTERNAL
CONDITION**

**8-10 SOUTHAMPTON ROW
& 1 FISHER ST**

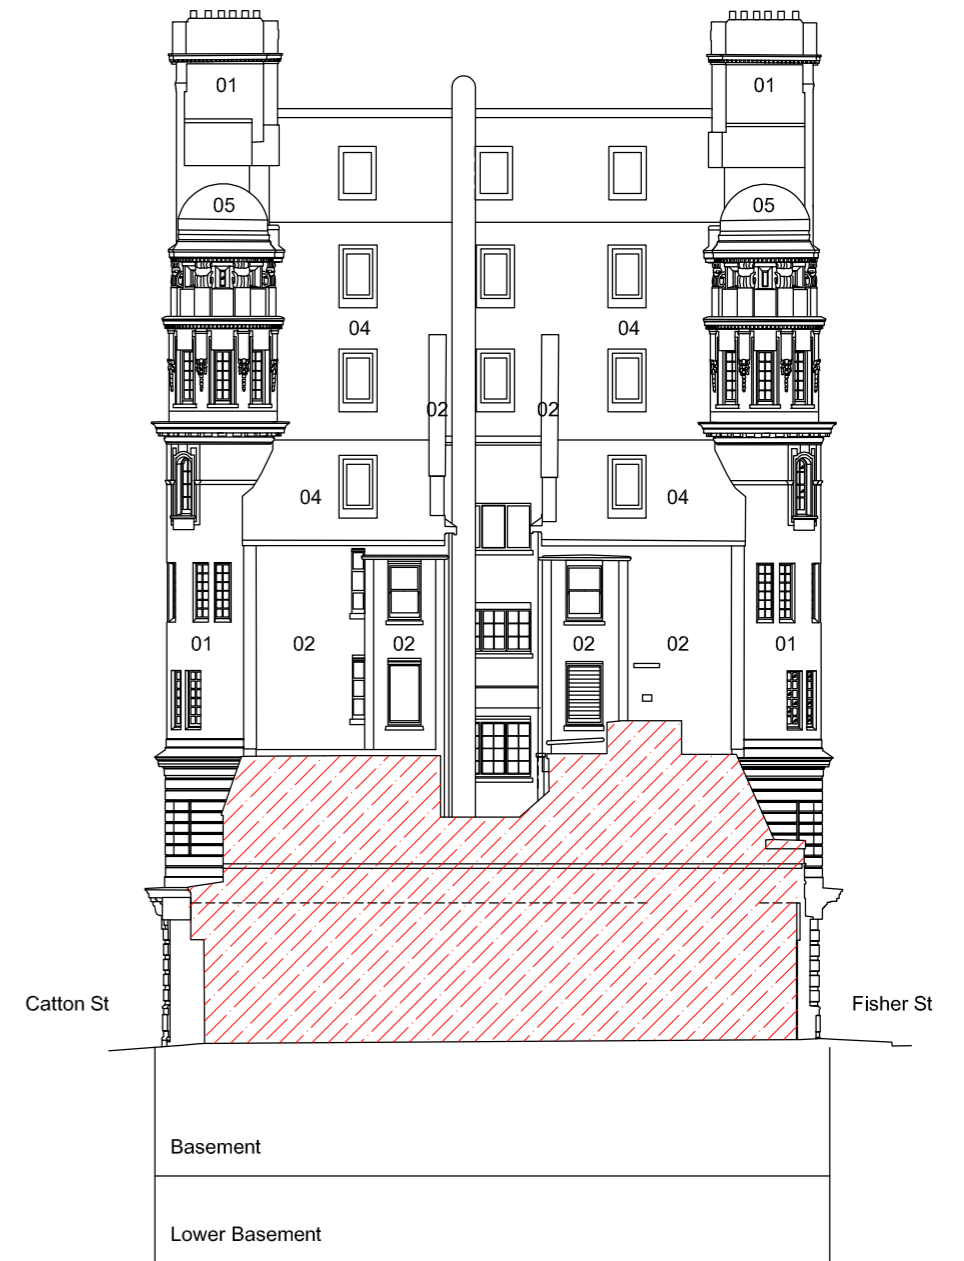
Area demolishes by Crossrail

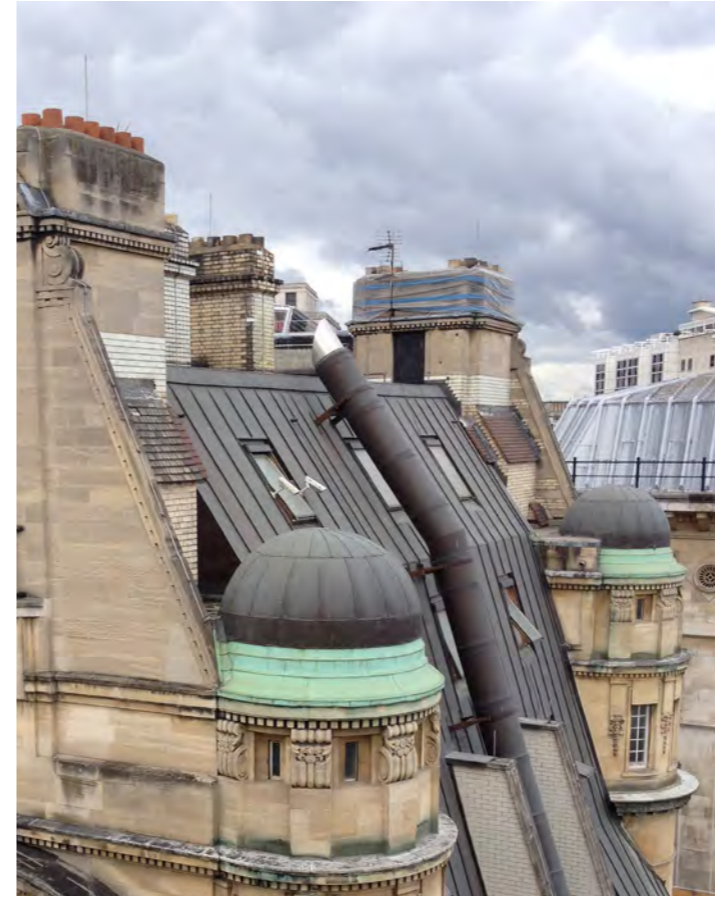
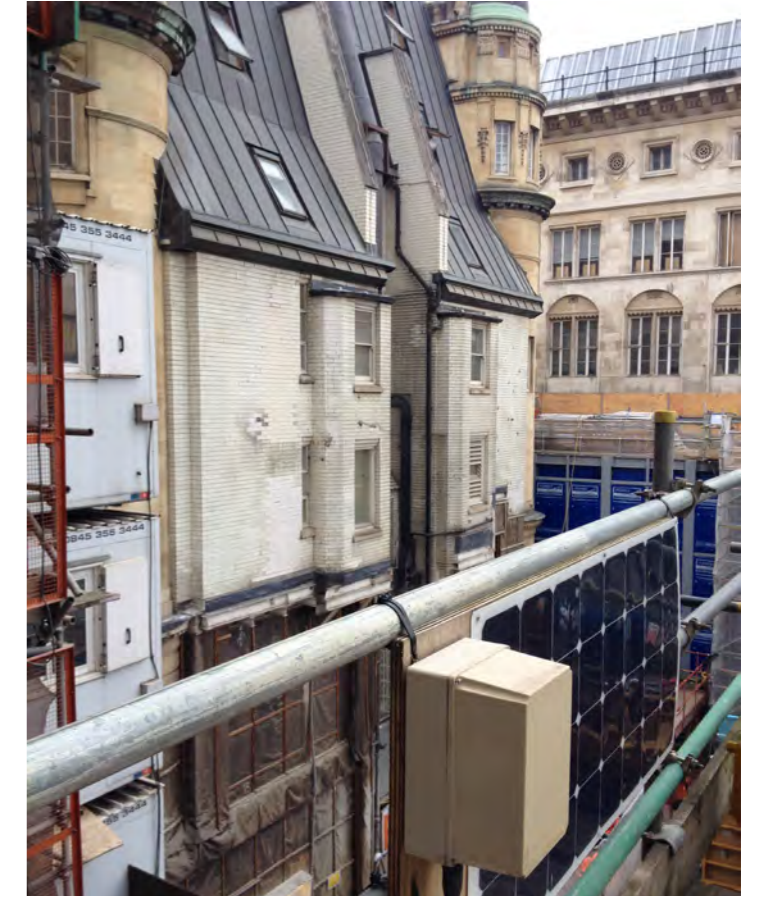
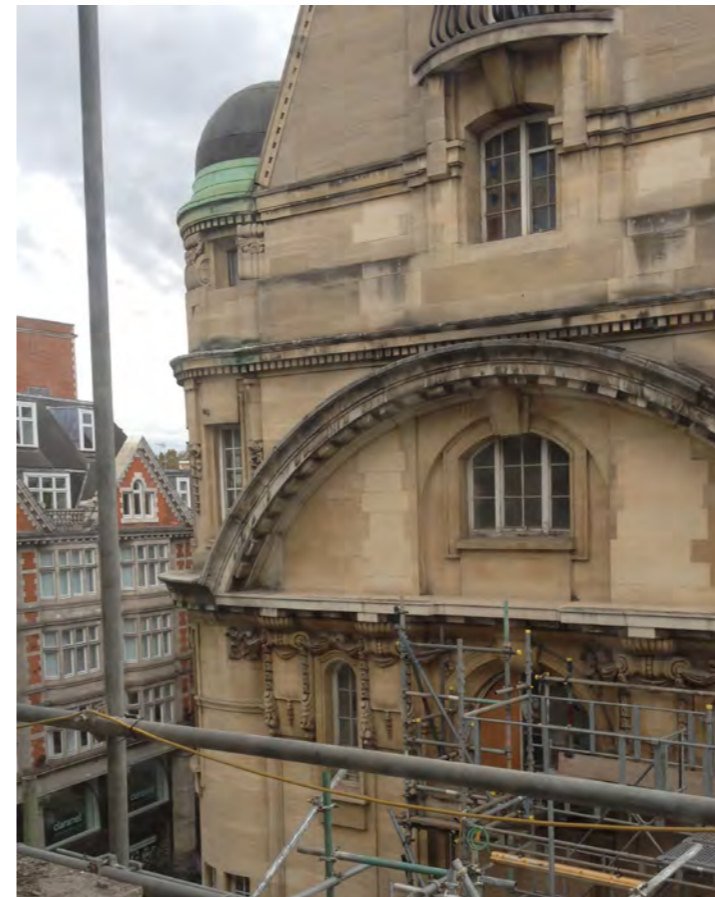
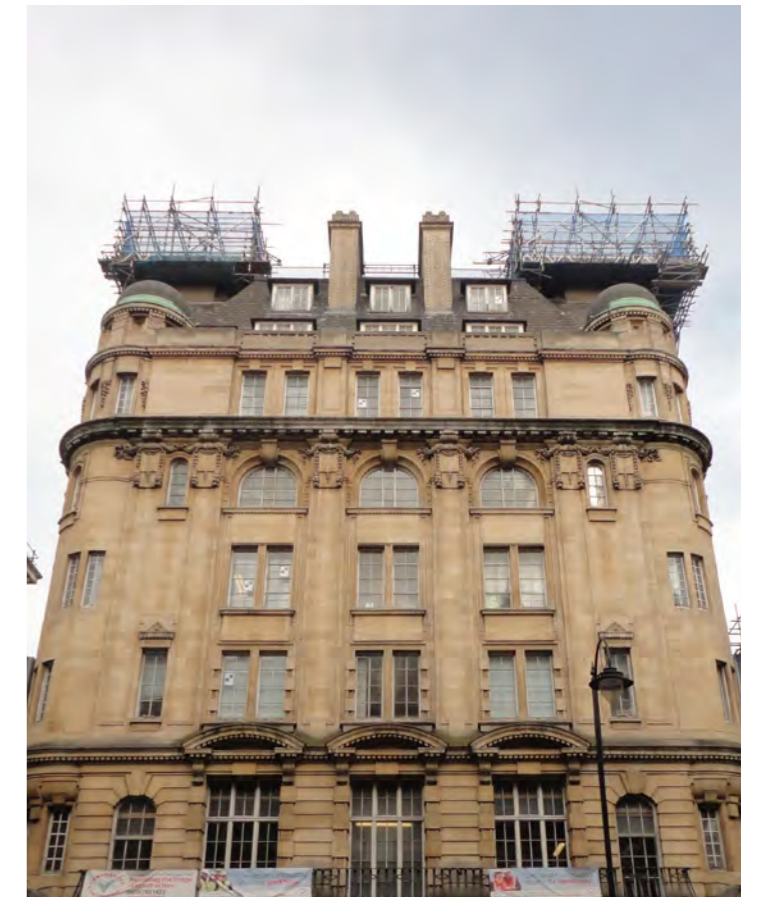
- Significant cracks to the stone were noted to each of the elevations indicating that corrosion is likely to be occurring to the steel frame of the building. If left, the stone will eventually start to fall away from the building.

- The slated roofs have reached the end of their economic life. A number of the slates have slipped, and others are held in place with temporary lead tingle repairs.

- The leadwork to the dormer windows and copper to the turrets is in need of renewal.
- The metal framed windows are in poor condition. Many of them have become distorted and corroded. They will require a major overhaul or complete renewal.

- The rear of the building at lower levels will require substantial work to either make good the fabric of the building where structure has been removed, or integrated into a new building to the rear.

- Access was not available to the crown of the mansard roof. However, it is likely to be in poor condition and should be renewed as part of the extensive repair works that will be required to the roofs and elevations.

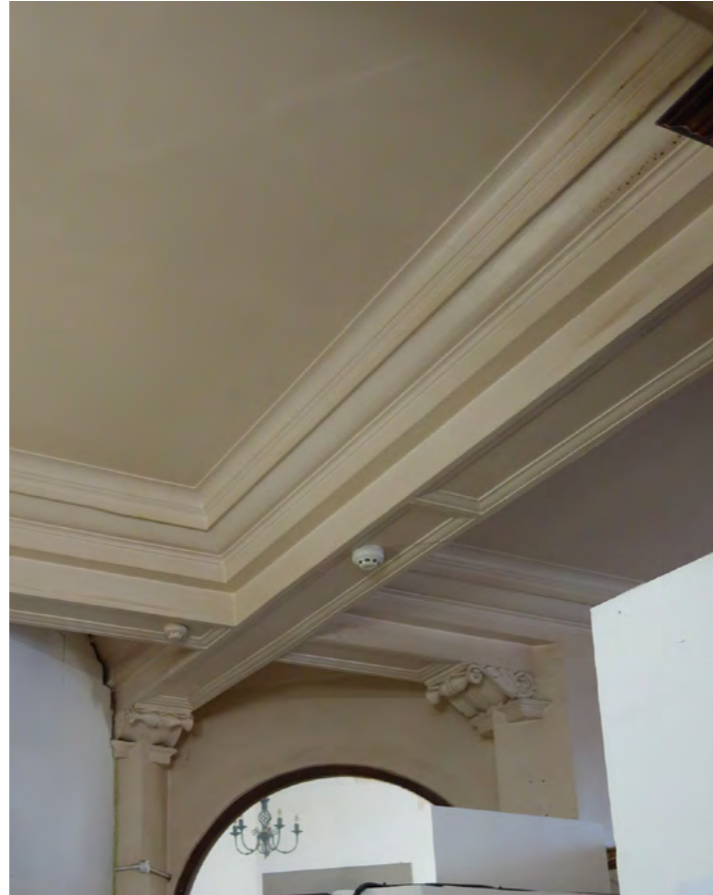
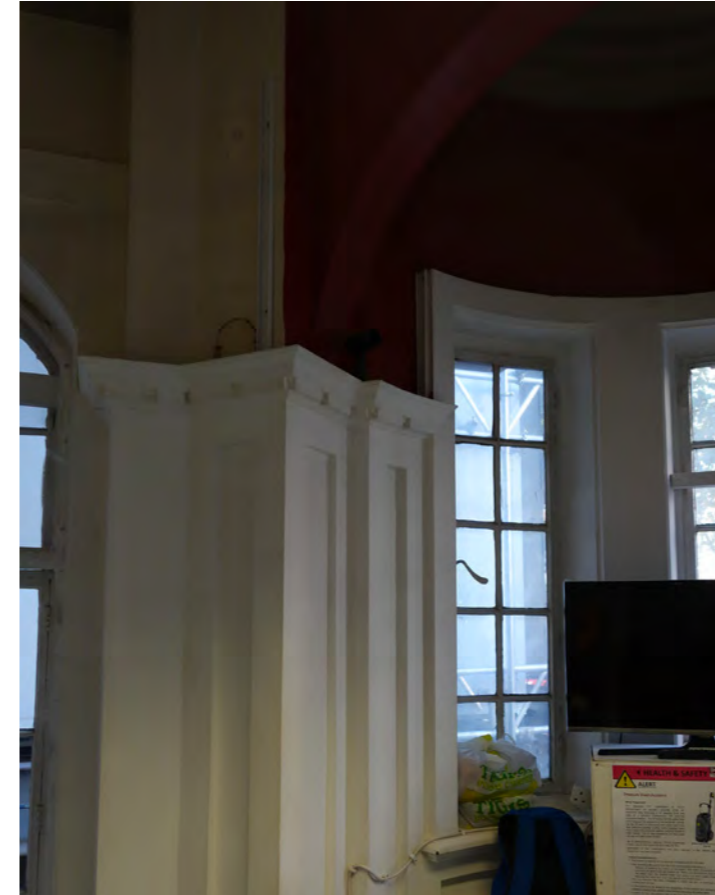
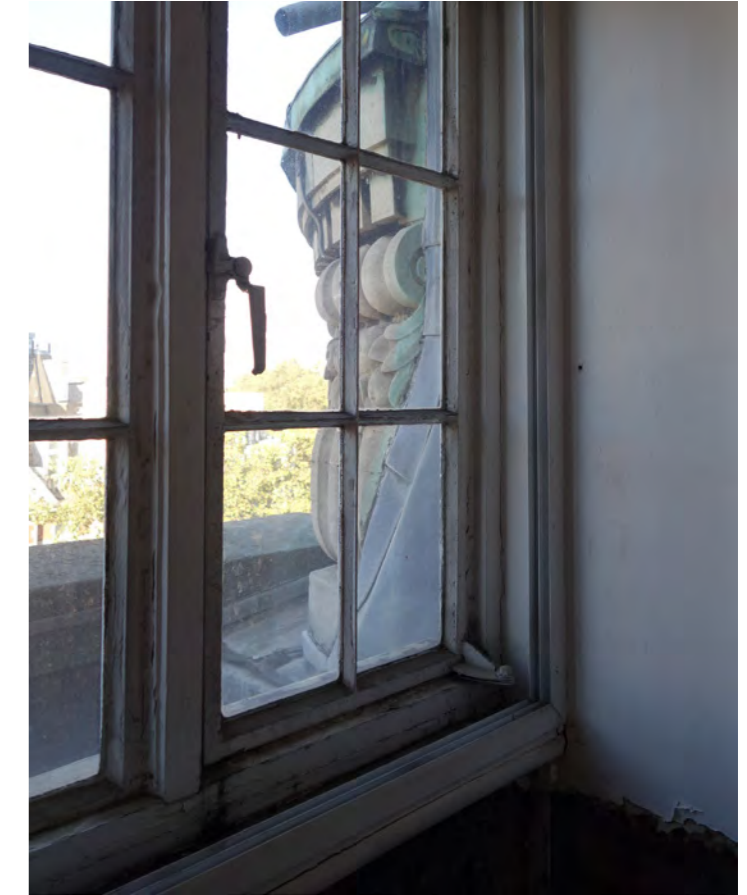
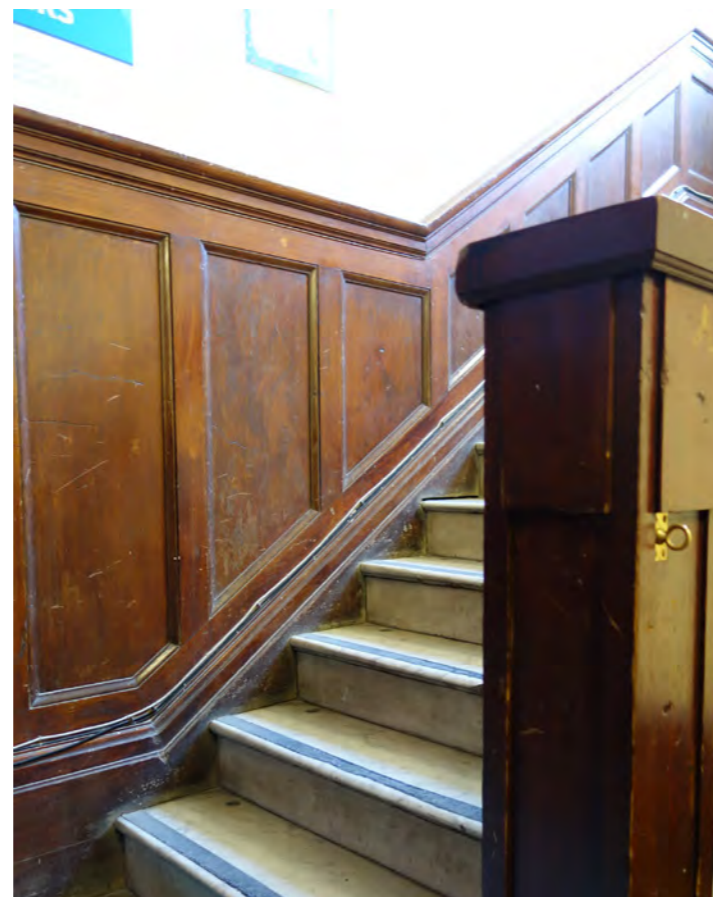
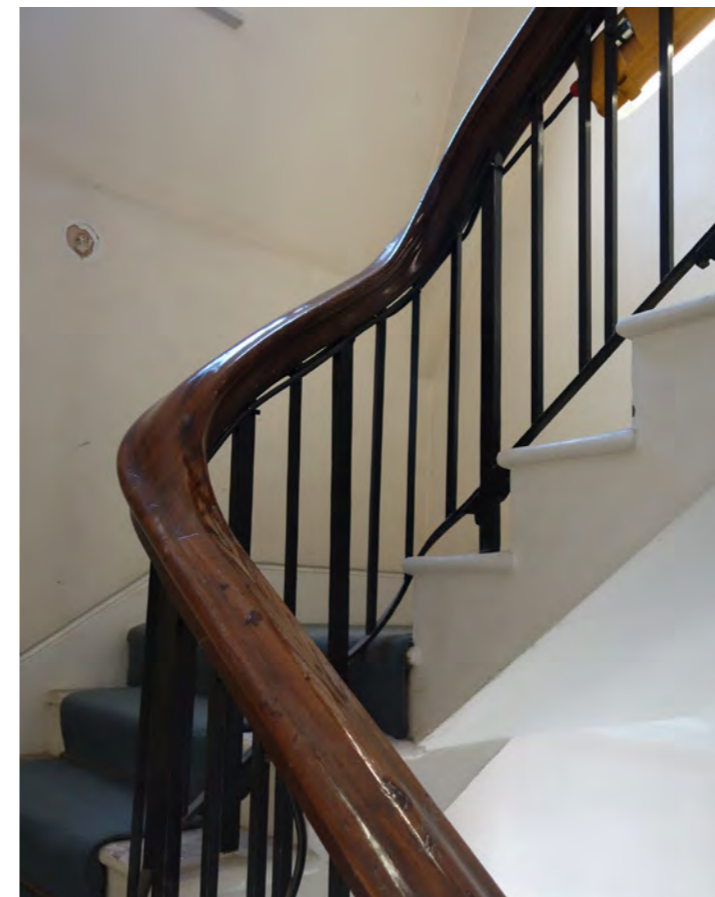
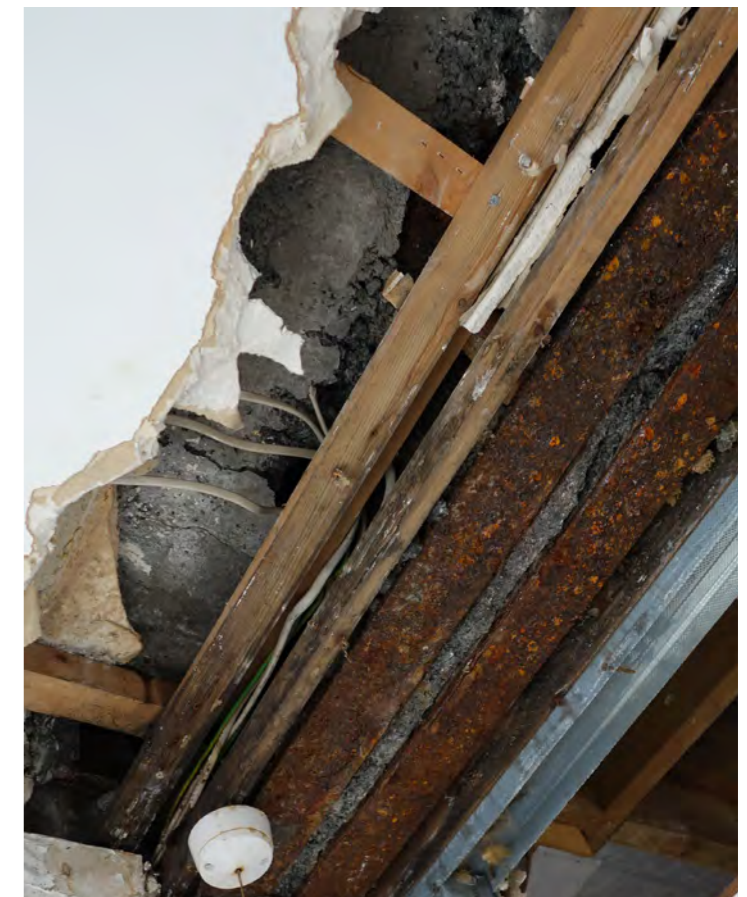
- Water penetration was noted in numerous locations throughout the building suggesting that the external roofing elements require a thorough overhaul and partial renewal.

- The extensive water penetration noted has in turn caused damage to the steel frame structure where corrosion has taken place, delaminating the surround concrete, render and plaster finishes.

- Fire places and chimney breast have been generally enclosed
- Crittall windows are poor showing of significant corrosion and will require either an extensive overhaul or replacement.

- Areas of the ground floor are affected by significant water ingress resulting in significant corrosion of steel beams. .
- The disabled access within the residential areas is also poor. The lift core serving the upper floors is too small to accommodate a wheelchair. There are also considerable constraints imposed by the existing layout of the building in respect of door sizes within the historic fabric of the Listed building.
-
