**REPORT ON  
DESK STUDY AND CONTAMINATION ASSESSMENT  
AT  
248 KILBURN HIGH ROAD  
LONDON NW6 2BS**

**CLIENT:** INSIDE-OUT ARCHITECTURE

**DATE:** 21 JANUARY 2013

**REF:** G/121224/002

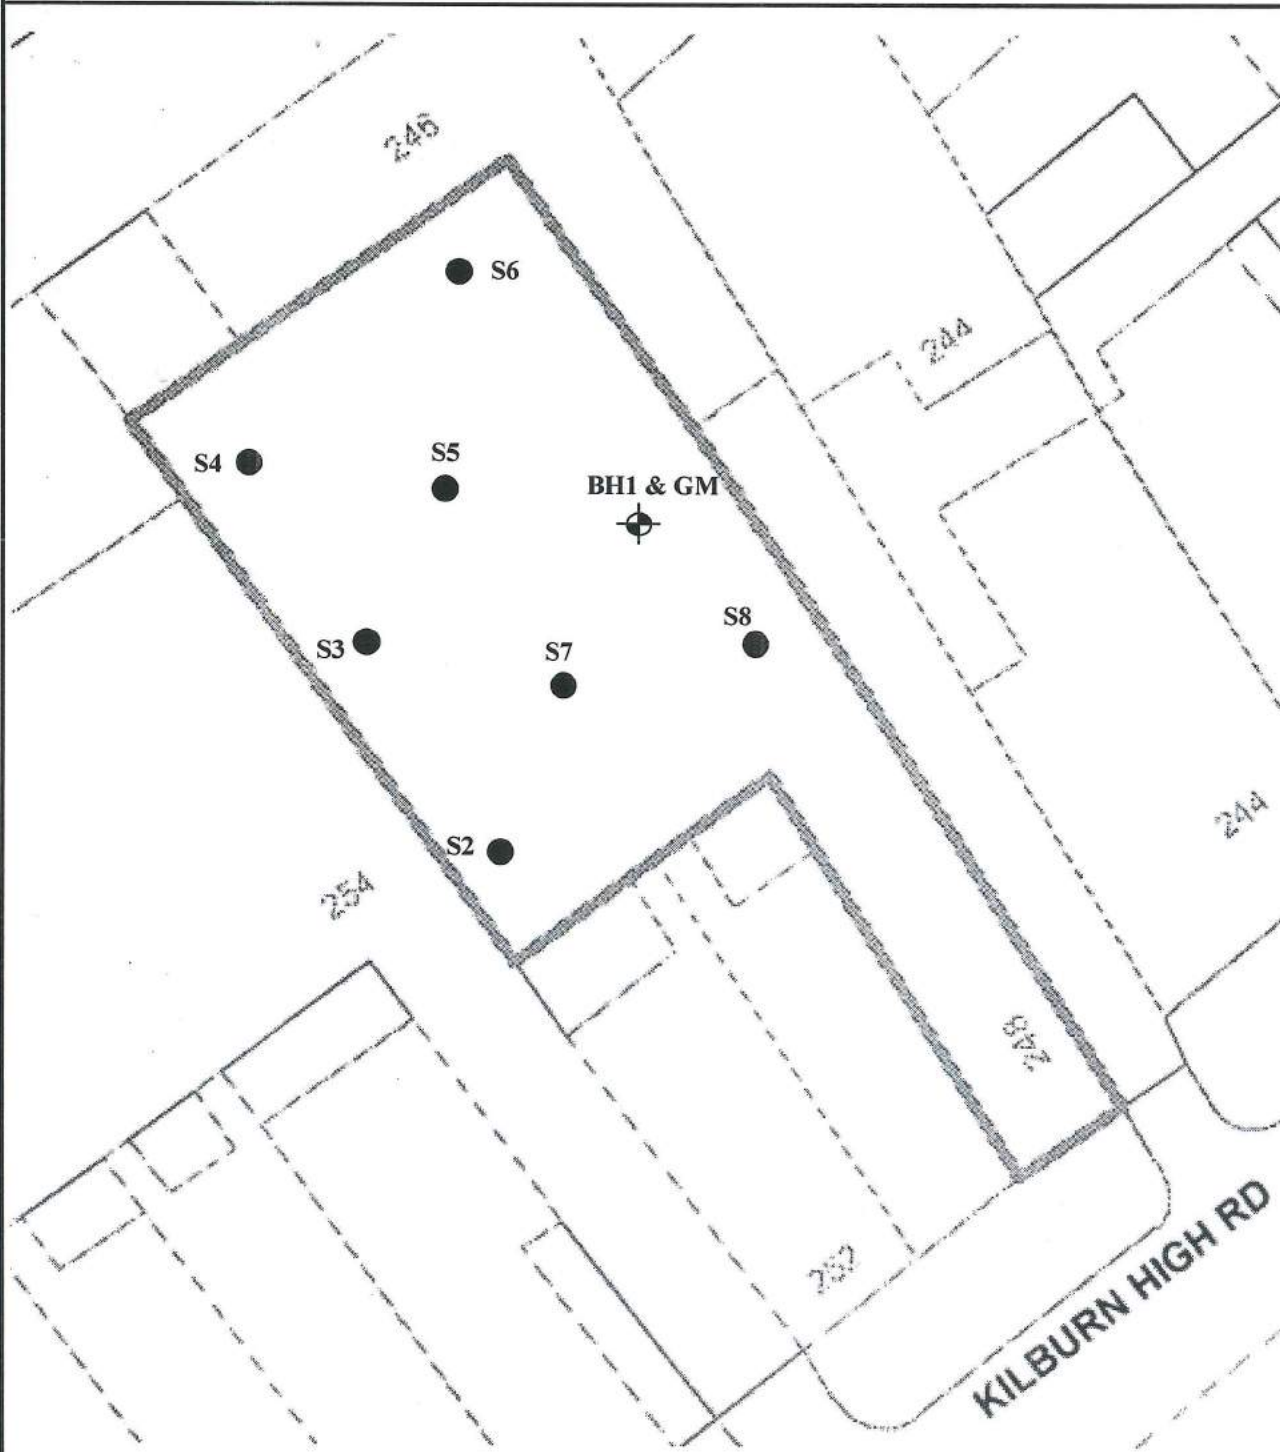
## SITE LOCATION PLAN

- 4.1 The layout of the site and the location of our eight sampling points together with the 3.0m deep hand augered borehole and gas monitoring is indicated on our Location Plan G/121224/101.
- 4.2 The borehole revealed 100mm of loose broken tarmac over hardcore to 300mm. Below this is made ground consisting of a soft silty sandy clay with gravel and brick. The natural ground encountered at 1.2m consists of a firm silty sandy clay becoming a firm silty clay at 1.7m and proved to the base of the borehole at 3.0m.
- 4.3 Gas monitoring was carried out within the borehole and no traces of methane or carbon dioxide were measured and there was no measurable flow.
- 4.4 Each of the eight samples for contamination testing were taken from the top 300mm and these were placed in suitable sealed containers and sent via cool box to our specialist laboratories for contamination analysis.

6.1 Apart from the sample S8 close to the entrance of the site and in an area which will be car parking, there are relatively low levels of contamination across the site consistent with the fill material found in our borehole and in-line with expectations based on our conceptual model.
