Subsidence Damage at: 159 Gloucester Avenue, London, NW1 8LA

# Arboricultural Consultancy for Ecclesiastical Insurance Group

Insured	Mr A Billand	Address	159 Gloucester Avenue, London, NW1 8LA		
Client	Subsidence Management Services	Contact	Nicola Shaw	Claim No.	IFS-EIG-SUB-16-0065046
ES Ref	SA-73134	Consultant	Giles Mercer	Contact No.	0330 380 1036
Report Date	11/04/2017

## 9. Tree Works Reserve - Does not include recommendations for future risk

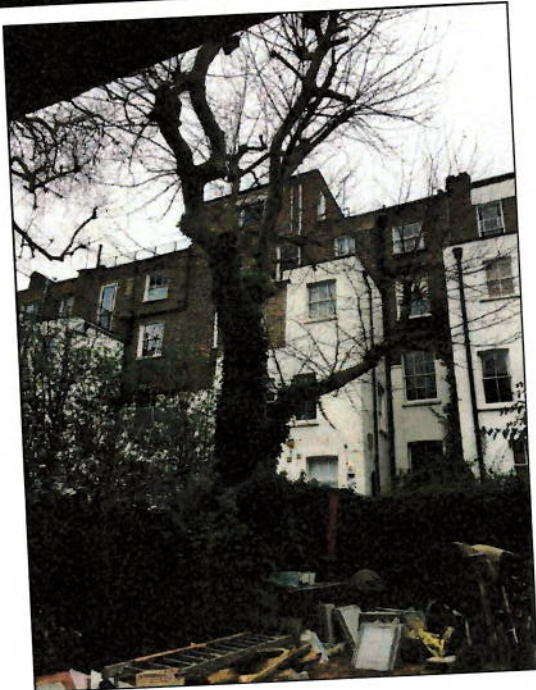
Based on our observations on site and with due regards to species profile, T1 (Plane (London)) is considered the dominant feature and accordingly we have identified it as the principal cause of the subsidence damage.

With due regards to species profile, the size and proximity of this tree is consistent with the location of damage and mechanism of movement.

Tree No.	Species	Age Cat	Approx. Height (m)	Distance to Building (m)	Ownership	Action	Requirement
S1	Privet	1	4	3	C - Insured	Action to avoid future risk	Do not allow to exceed current dimensions by way of regular pruning.
T1	Plane (London)	2	14	9	A - Third Party 157 Gloucester Avenue London NW1 8LA	Action to avoid future risk	Re-pollard back to point of previous reduction and maintain thereafter on a strict 2-3 year cycle.
T2	Plane (London)	2	22.5	18	A - Third Party 151 Gloucester Avenue London NW1 8LA	Action to avoid future risk	Re-pollard back to point of previous reduction and maintain thereafter on a strict 2-3 year cycle.
T3	Willow	1	11	15.3	A - Third Party 25 Chalcot Square London NW1 8YA	Action to avoid future risk	Do not allow to exceed current dimensions by way of regular pruning.
T4	Laurel (Bay)	1	3.8	3.8	A - Third Party 161 Gloucester Avenue London NW1 8LA	Action to avoid future risk	Do not allow to exceed current dimensions by way of regular pruning.

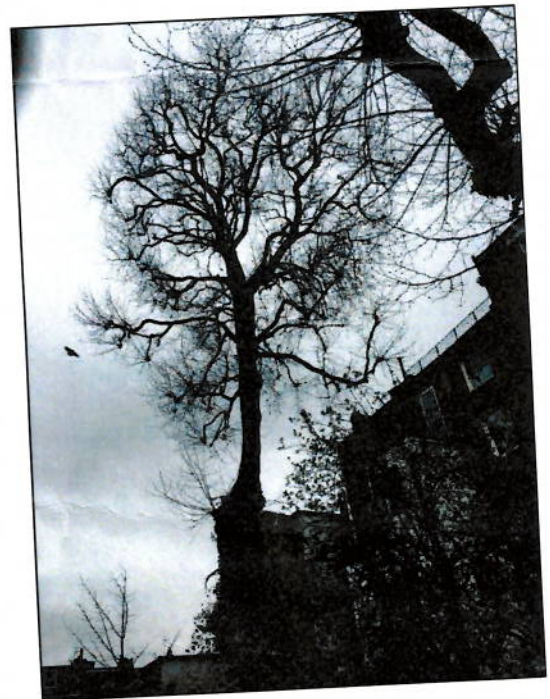
We enclose an arboricultural report which states future risk recommendations. please note that vegetation within the boundary of your property is not implicated in the current damage, however has the potential to influence the property in the future should the recommended action not be undertaken.

T2 Plane (London) tree re-pollard back to point of previous reduction and maintain thereafter on a strict 2 to 3 year cycle.
