Building Survey Report

**Rose Cottage
Vale of Health
London
NW3 1AX**

**Warmans Surveying
(Warmans Cube Ltd)
2nd Floor
13 Swan Yard
London
N1 1SD**

21st December 2016

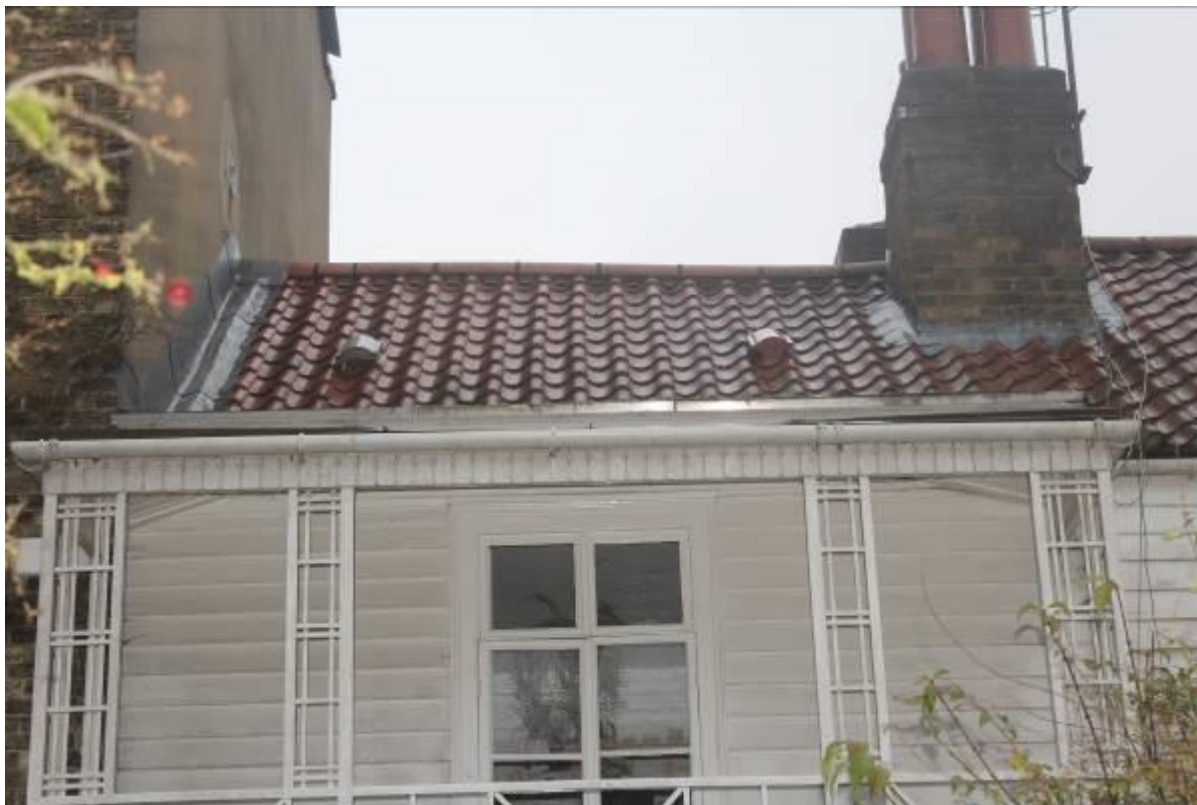
1. Inspect what appears to be a zinc roof to the balcony.

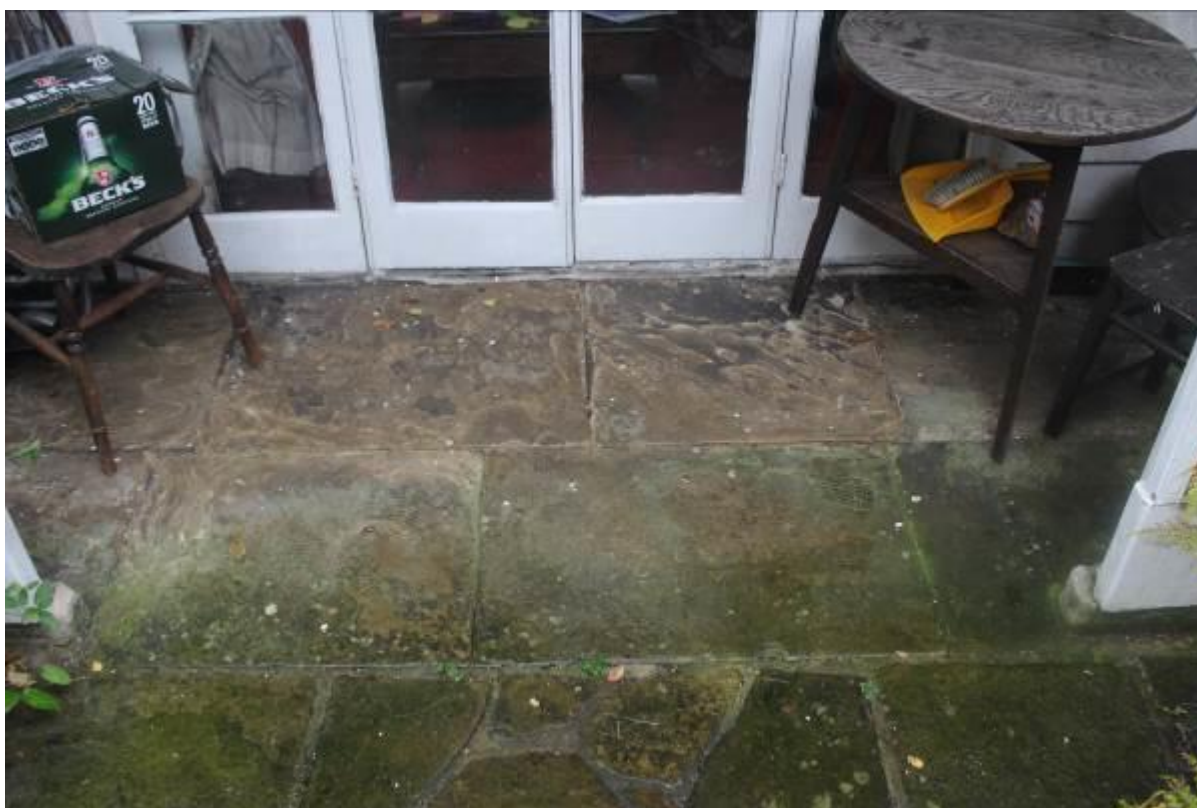
2. Sub floor ventilation required and a gap between door sill and external surfaces, also inspection of the condition of the timber sill, currently under ground level.

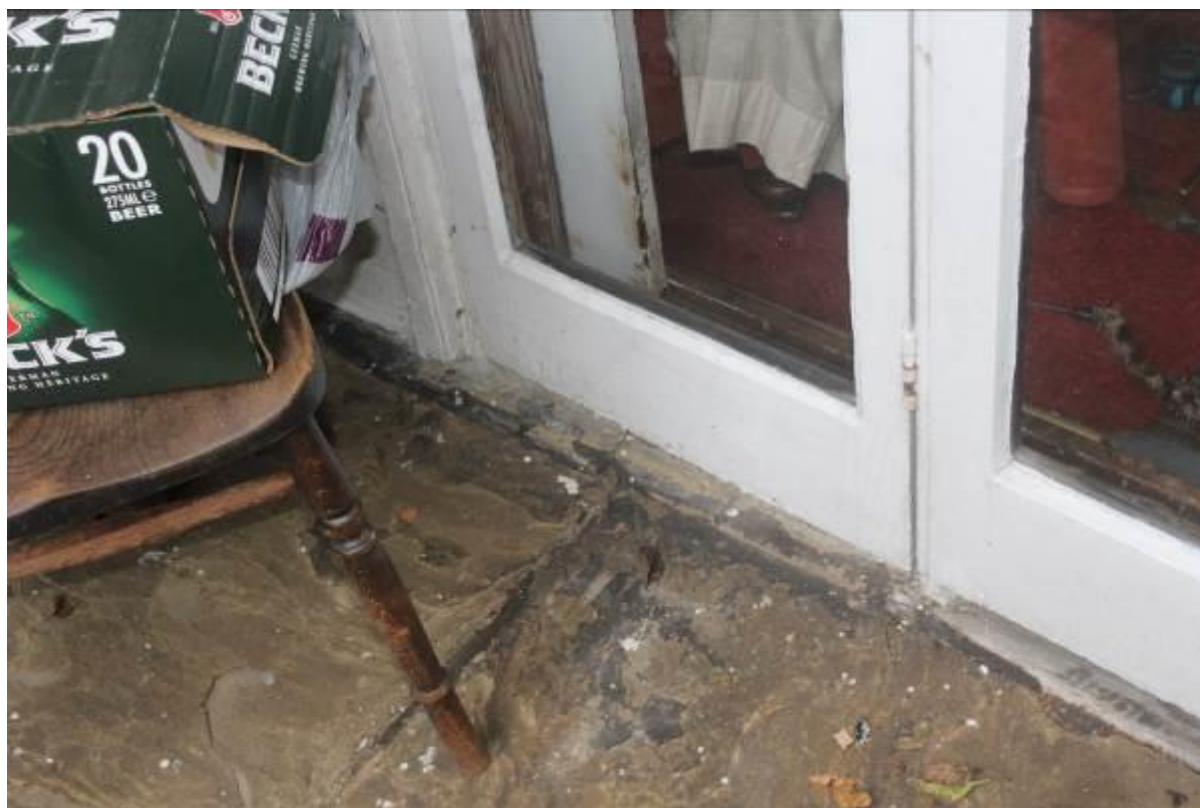
3. As above.

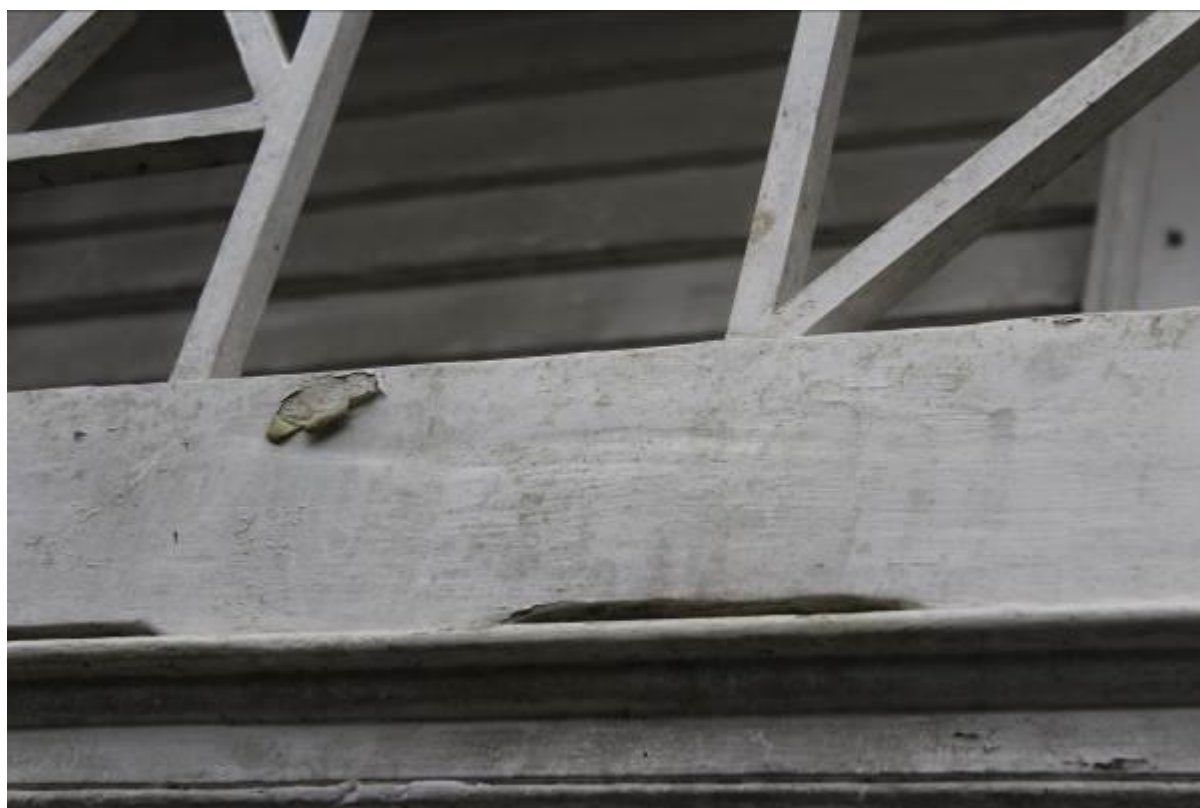
4. Timber decay evident to balcony structure.

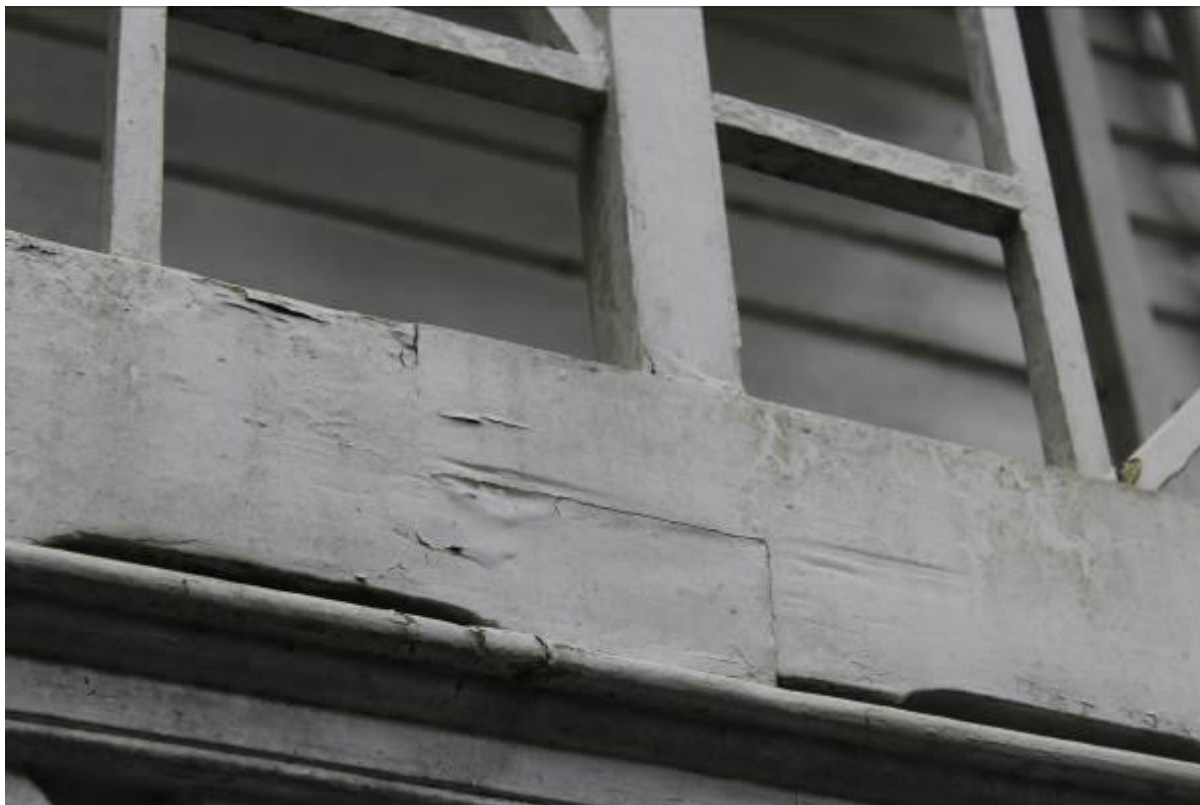
5. As above.

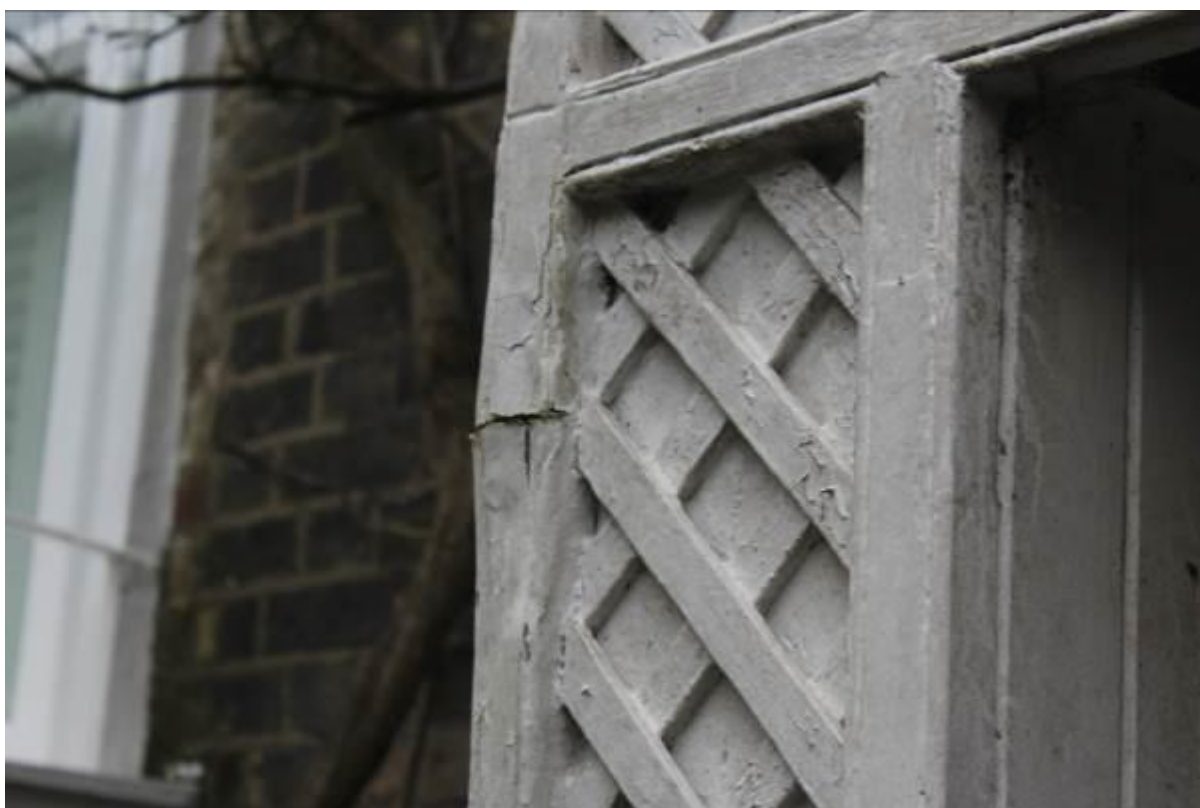
6. Window care repair required.

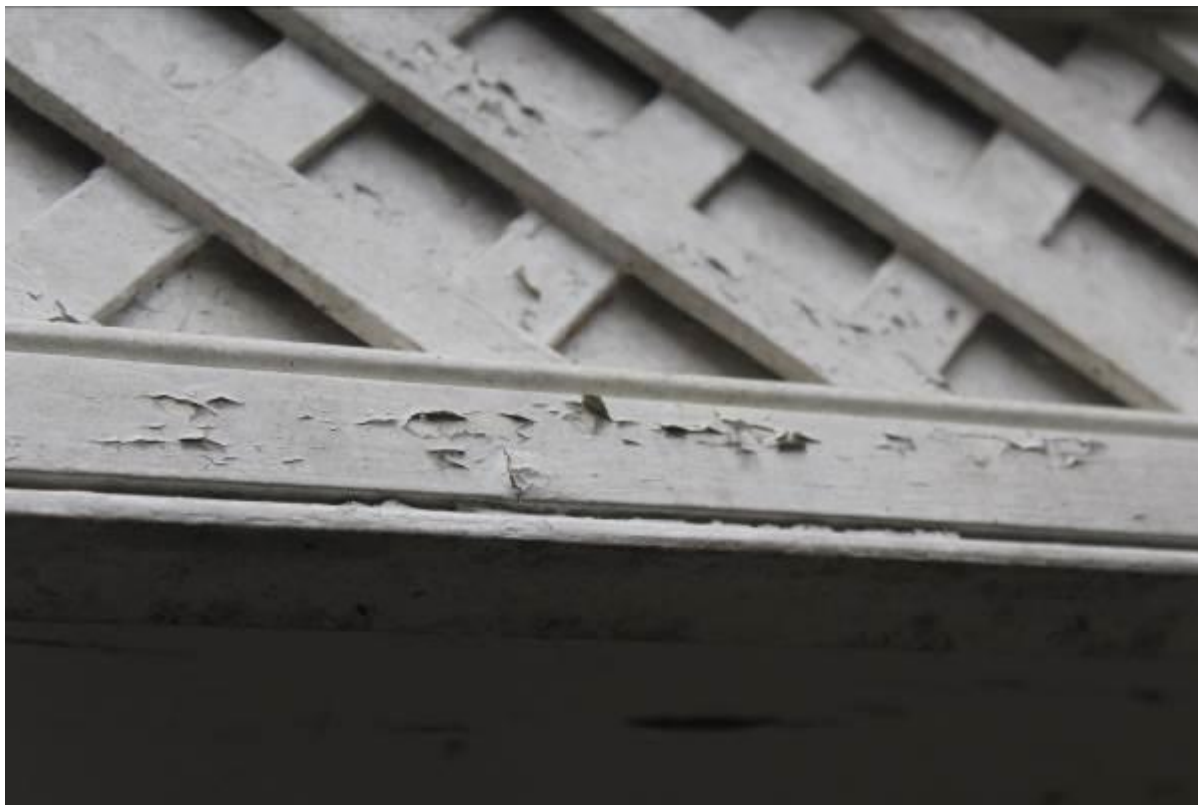
7. Paint coatings require redecoration.

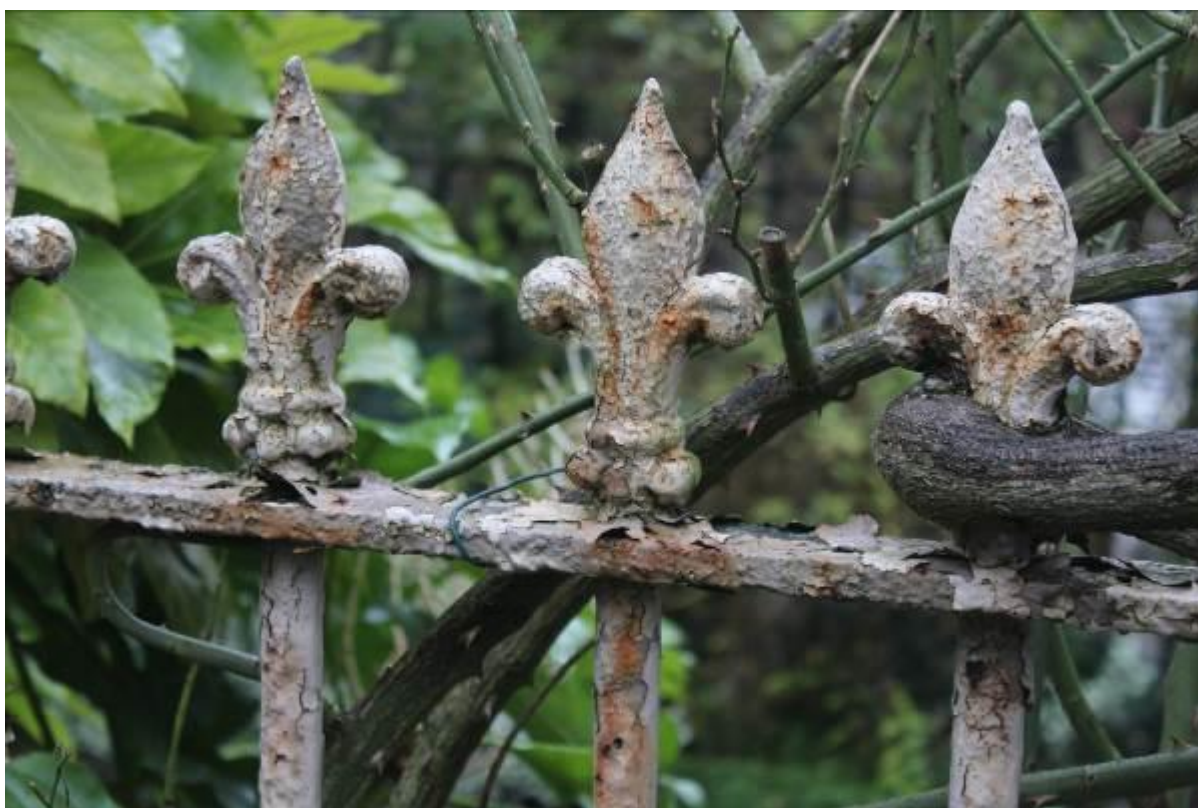
8. Redecoration required in conjunction with careful removal of corrosion to boundary railings.

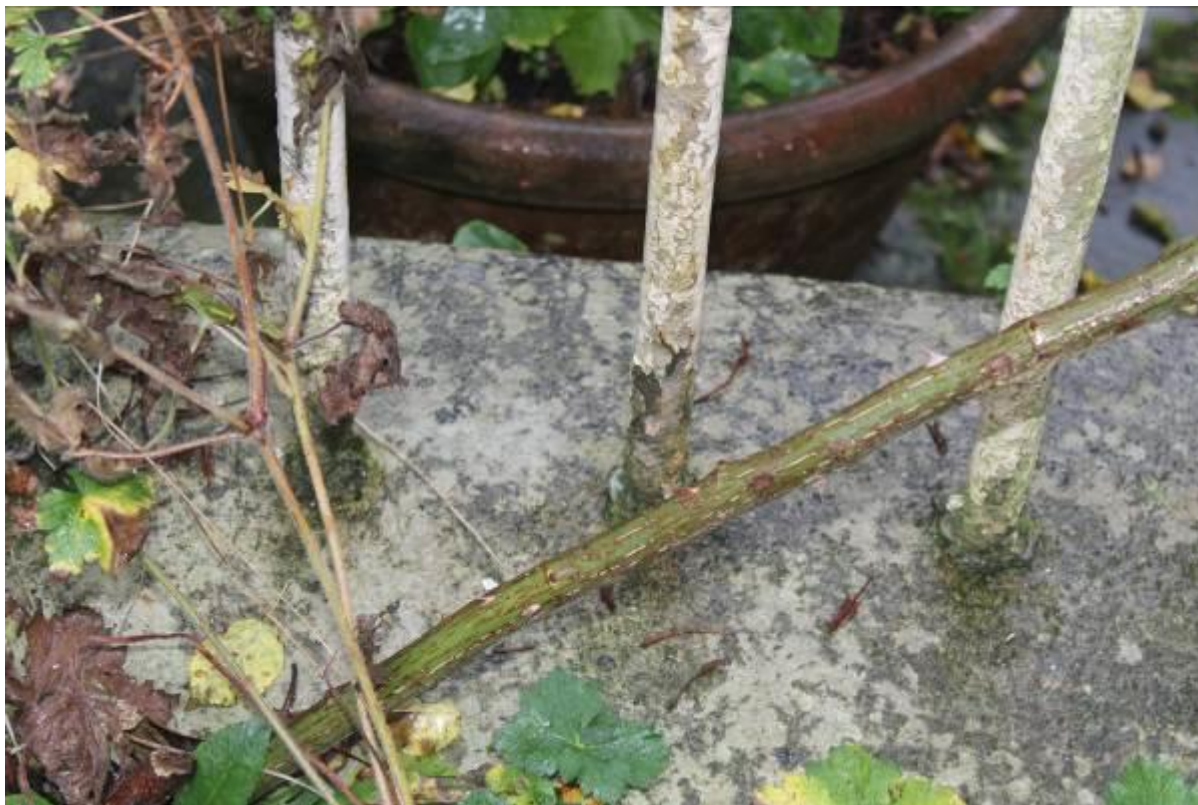
9. As above.

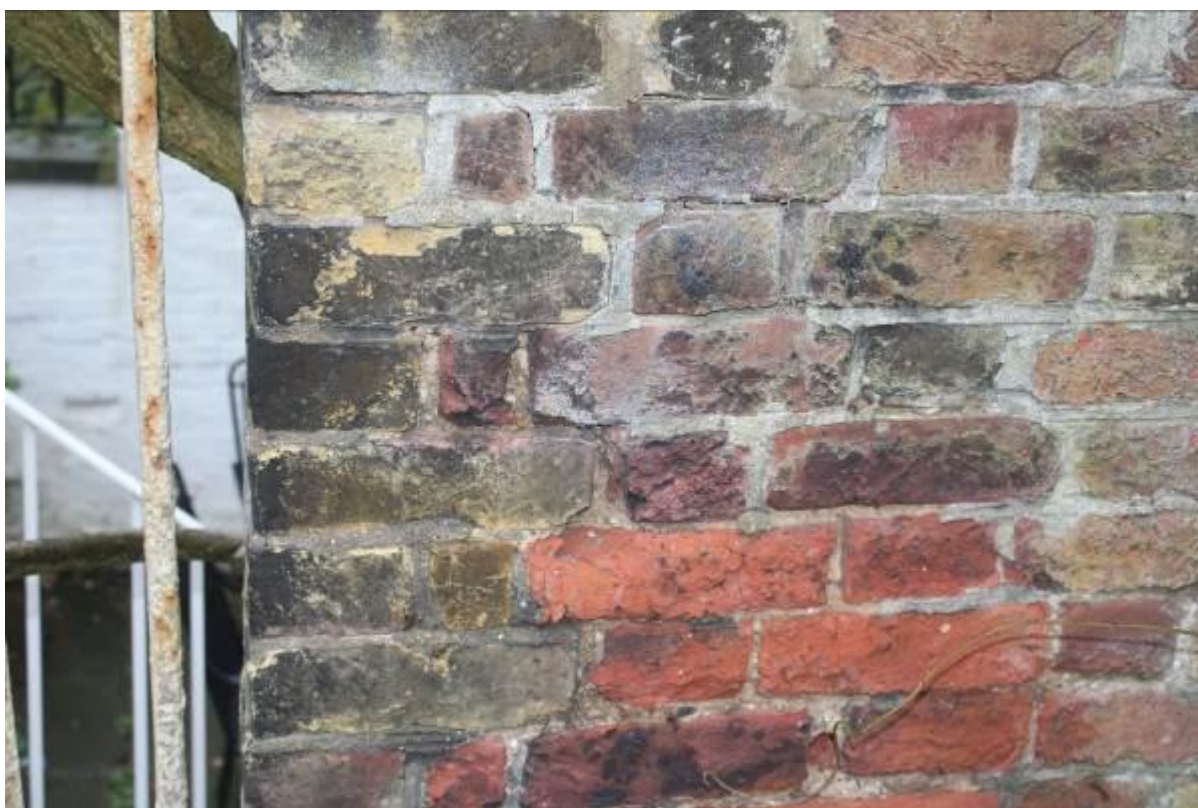
10. Some minor brick boundary repairs also required.

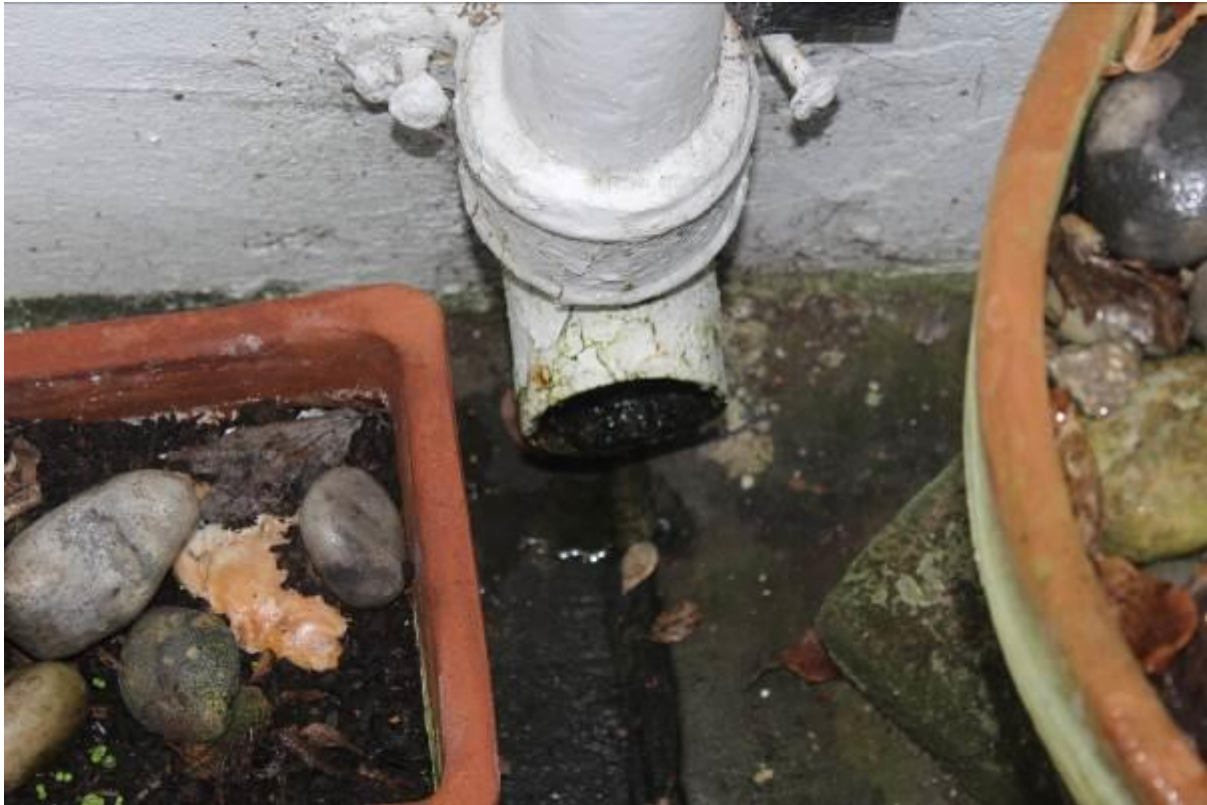
As can be seen in the attached photographs, the rainwater downpipe serving the main rear elevation roof slope, simply discharges over the ground. This rainwater over the years will have gradually washed away the fine particles of soil from the underside of the foundations in addition to the rainwater that naturally falls over the courtyard stones.

- 11. This is the rainwater downpipe to the east courtyard that requires a drainage system taking the rainwater away from the building.**

The simple solution would be to lift up the paving slabs create a waterproof barrier preventing rainwater from passing through the slabs and washing away the fine particles of soil from underneath the existing foundations of the side wall of the rear addition, creating a gully for the rainwater goods to the rear elevation of the main building and then running that into the inspection chamber located at the very front end towards the end boundary of the main building. There may be some very minor movement between now and in the next twelve months but this is likely to be extremely minor in nature and once this has been carried out we would not expect any more settlement type movement of this rear addition.

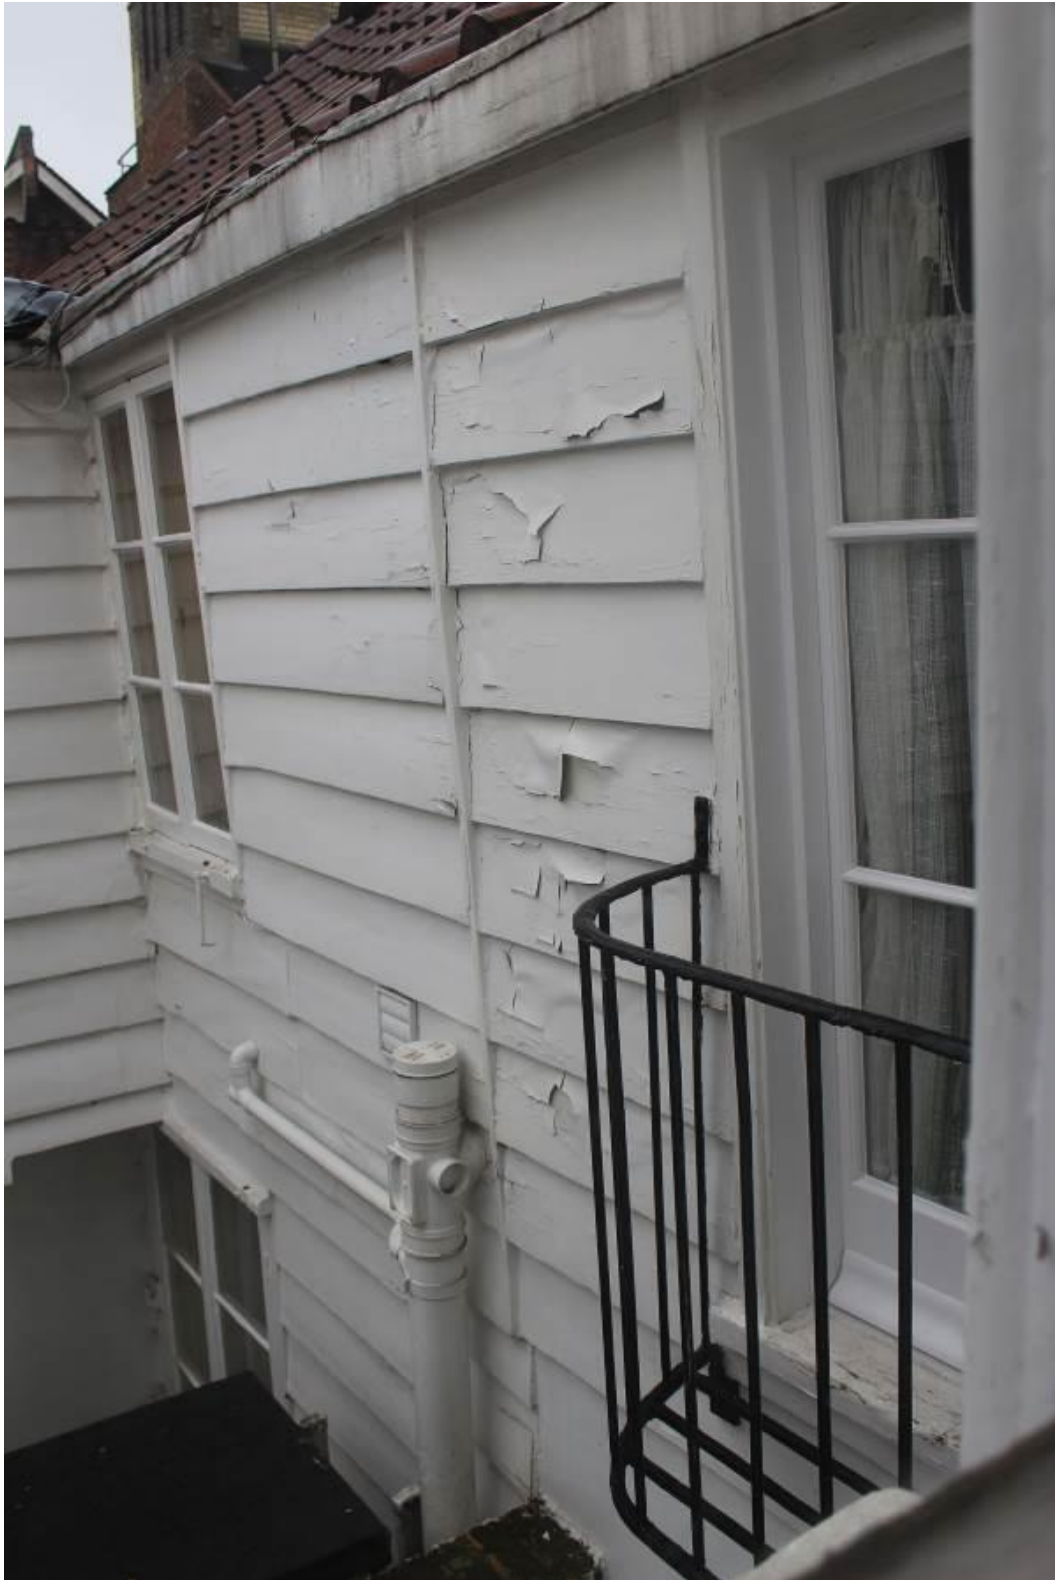
As can be seen in the attached photograph there is some lateral movement at first floor level in the rear elevation of the main wall at the party wall junction with the adjoining property. This lateral movement is caused by lack of lateral restraint of the roof structure. This has occurred because in normal roof structures the ceiling joists of first floor rooms rest on the outside wall and the rafters are connected to these ceiling joists which triangulates the roof structure and provides its strength. However, in this instance the ceiling joists are connected to the roof rafters, which creates a sloped ceiling before the ends of the roof rafters are connected to the top of the outside wall. This type of structural construction causes stress on the lower, sloped section of the rafters and this causes the rafter ends to push out, this is called spread and this has caused the distortion at the top of the outside wall. The extent of the "spread" depends upon the load imposed on the roof by the roof covering. The building is likely to have originally comprised a slate weathering, which is about half of the weight of the clay tiles now applied. There is no evidence of any current movement of the structure in this regard and therefore we believe it has stabilised and not of significant structural concern although should always be monitored.

12. Deviation in the external rear wall caused as a result of roof spread.

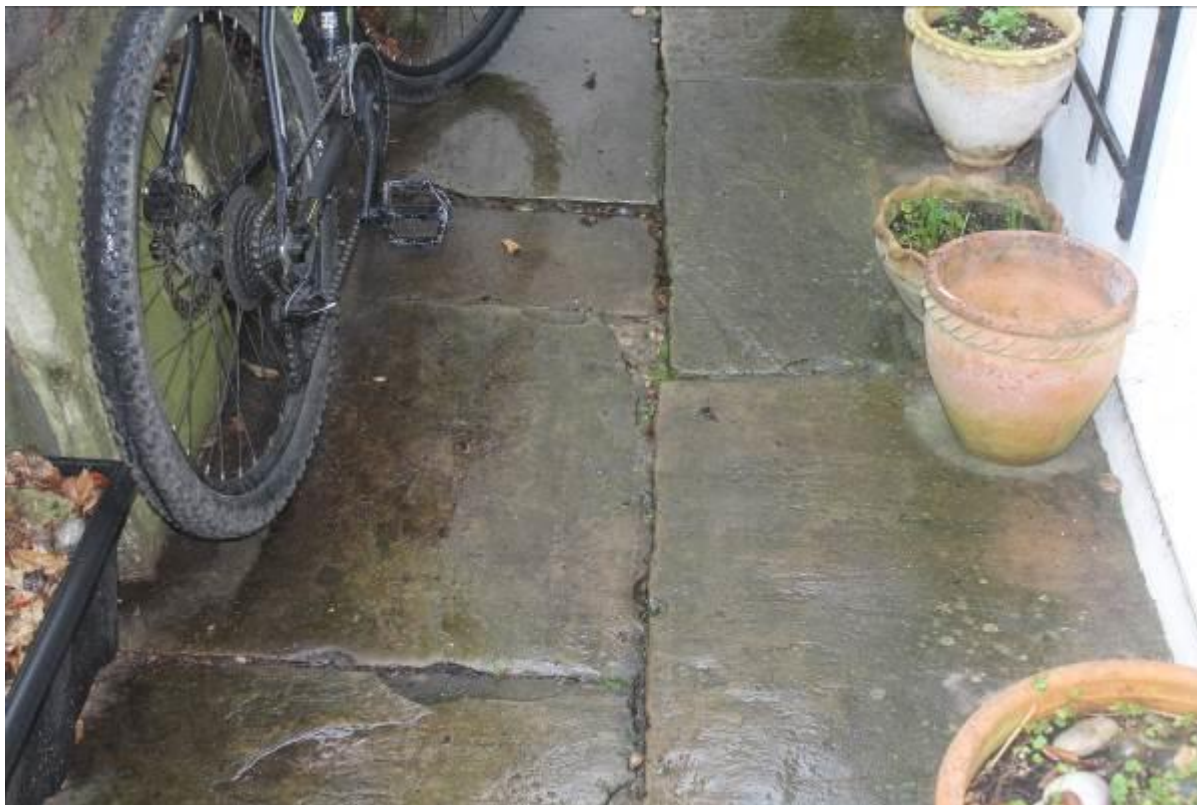
When you observe the condition of the York stone flagstones to the side yard it is apparent that they undulate and they have no sealed joints and some of the slabs, particularly adjacent to the brick buttress, have dropped more significantly, so much so that a trip hazard has formed between adjacent slabs, this indicates that water has washed away the particles of soil from underneath these slabs so if this event has occurred to the slabs then it would have happened to the adjacent foundations as well.

13. Rainwater percolates through the paving gaps causing them to settle unevenly and contributes to the movement to the flank wall, this is why we recommend a damp membrane is located under these slabs.

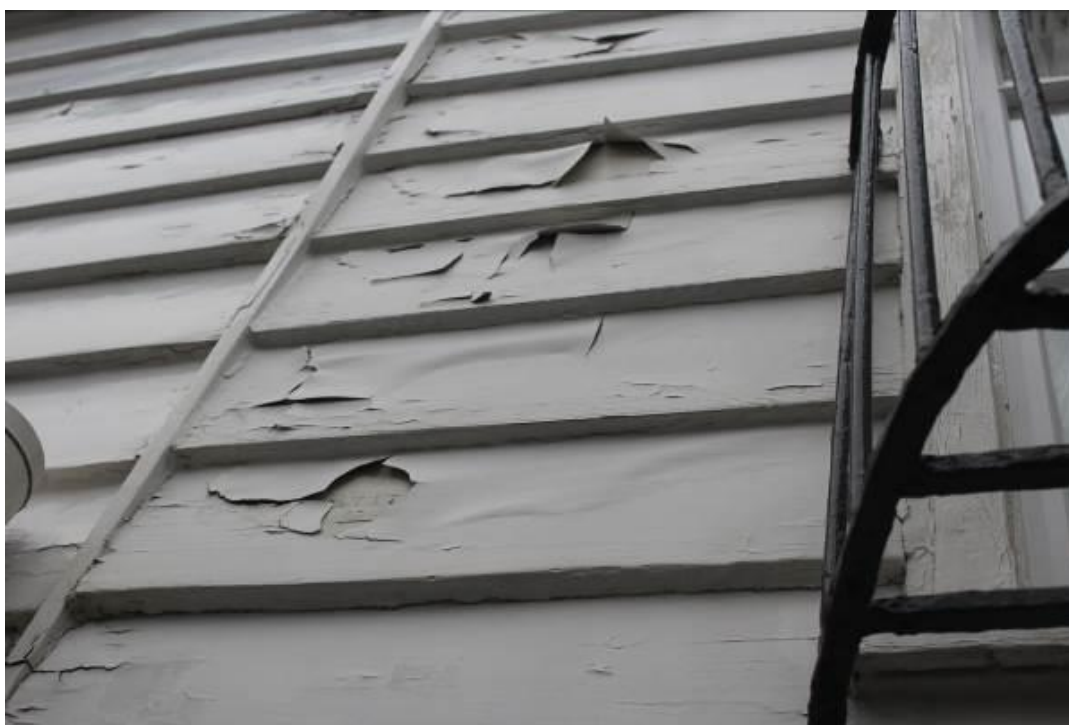
14. Redecoration required.

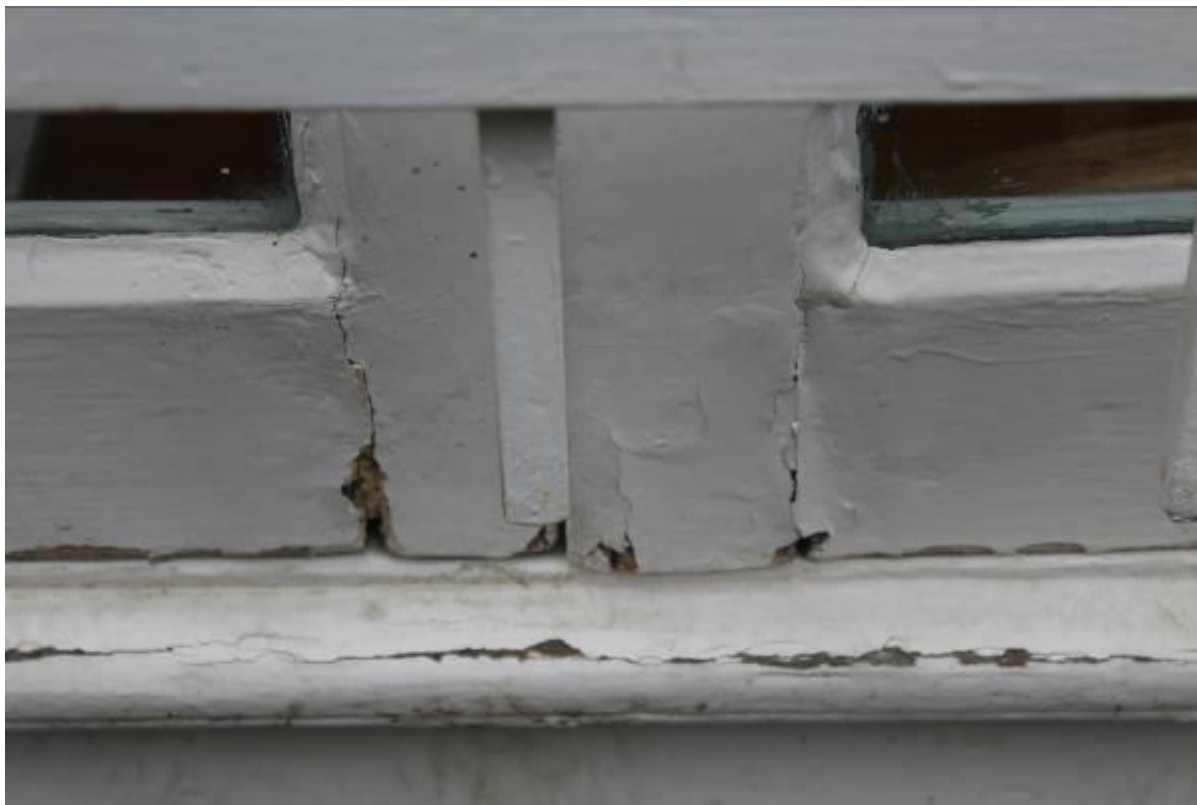
15. Joinery window care repairs required to some rear addition windows.

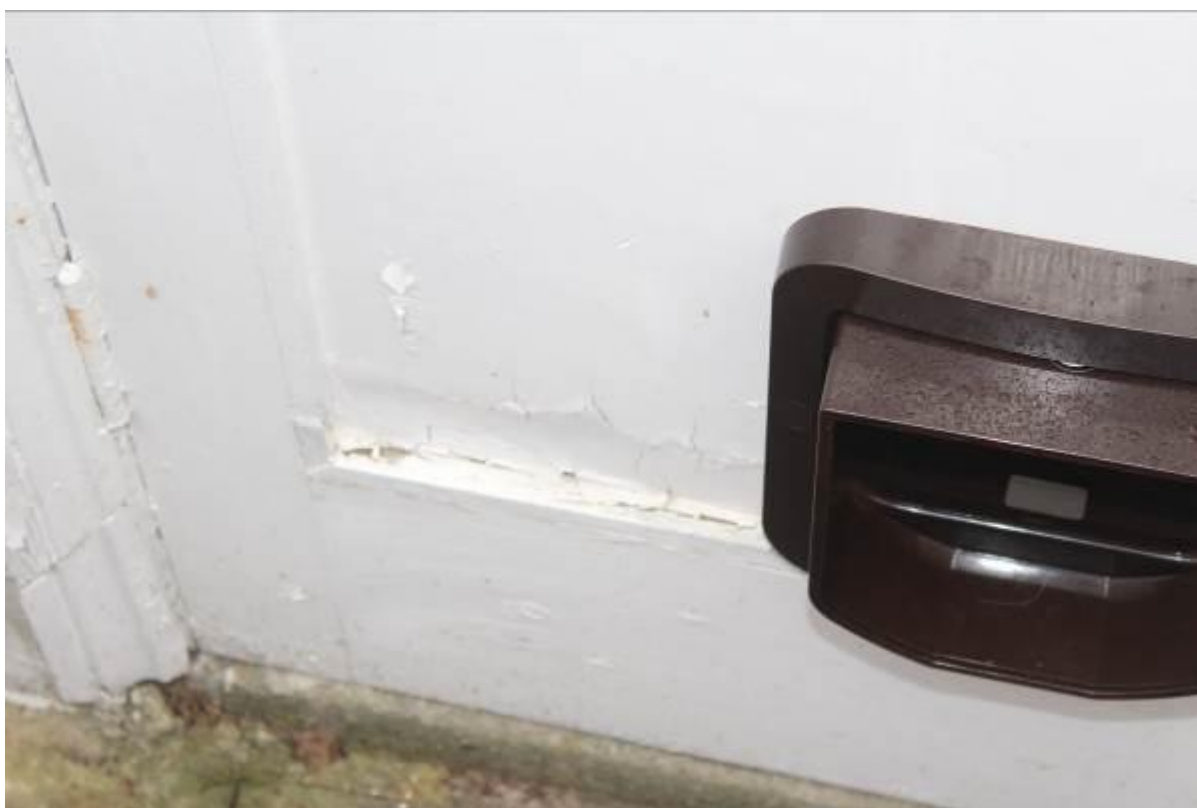
16. As above.

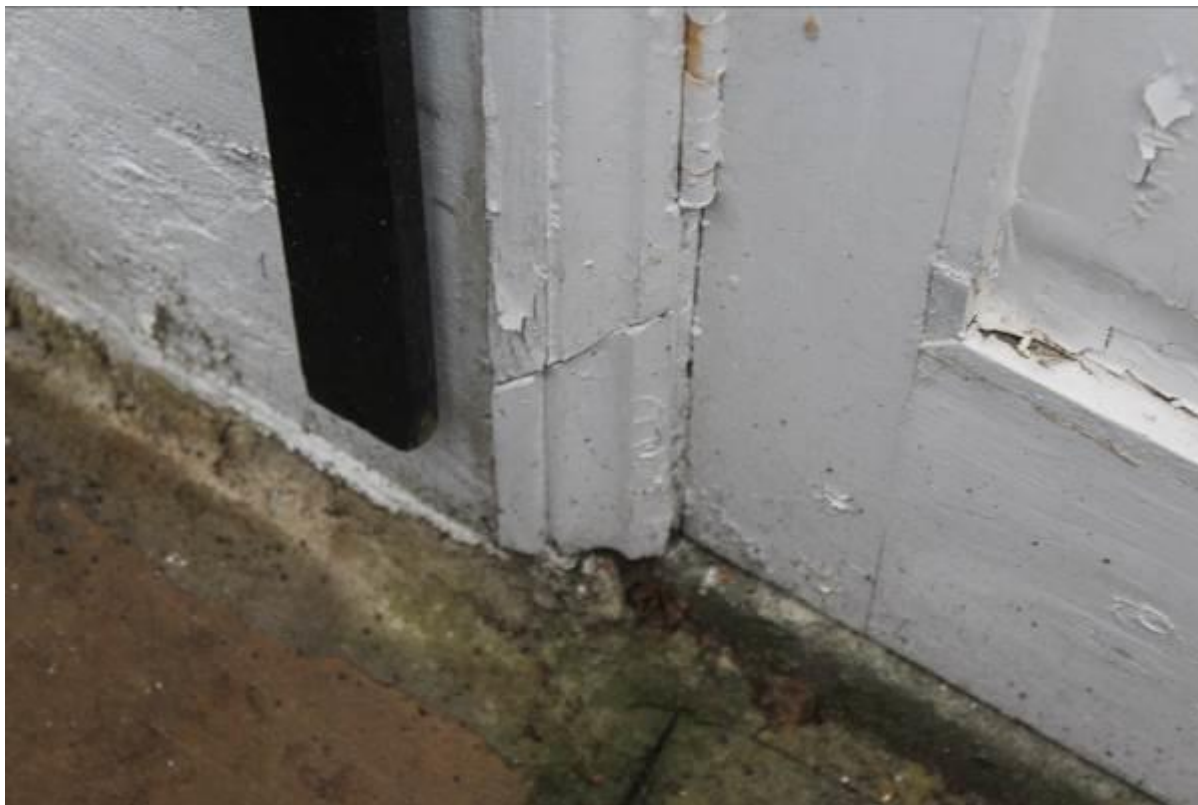
Repair has been carried out at low level to the left hand architrave this will only fail again in the relatively near future because the timber is not treated or of external quality and cracks have already developed in the paint finish and water penetration will occur into this and decay will occur this is inevitable as a result we would recommend the door is replaced in its entirety and completely redetailed.

17. Poor internal quality architrave timber used, this should all be redtailed.

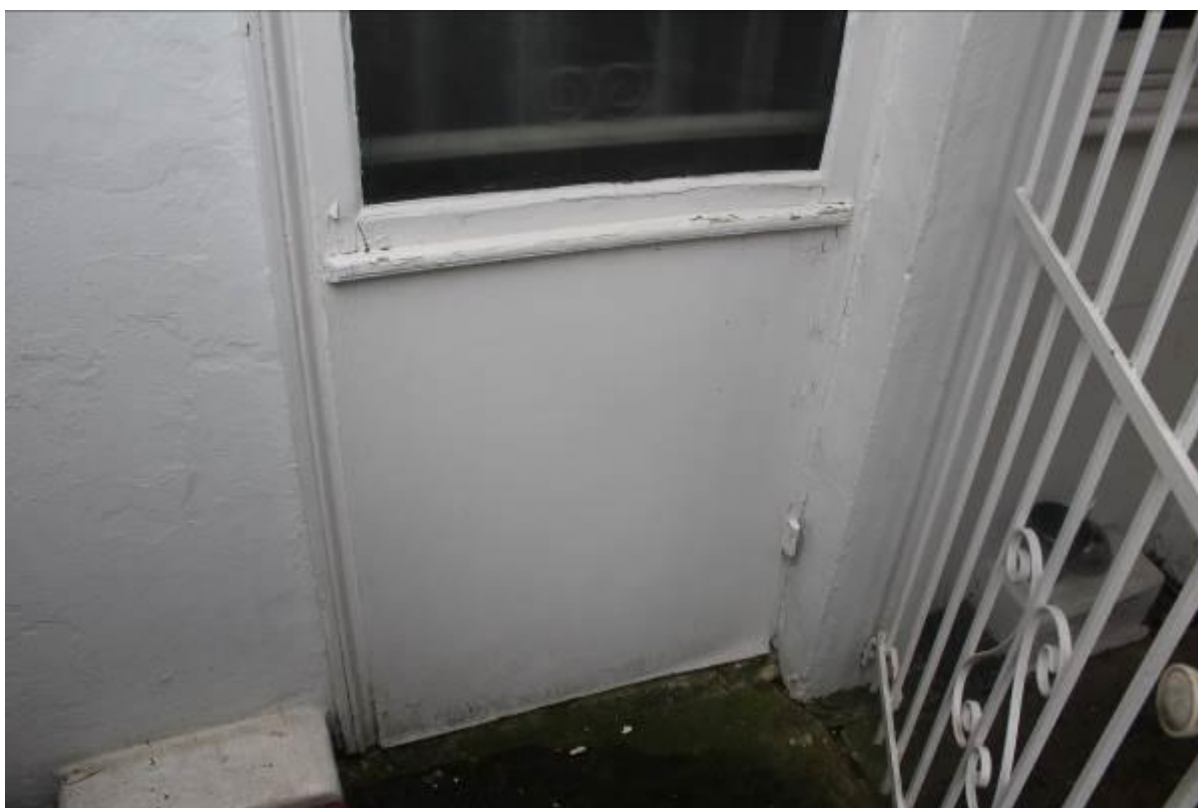
Similarly there is a door which has been blanked over which leads to the rear of the ground floor reception room which has all been painted shut the door is completely unusable and listed building consent will be required in order to replace this.

18. Rear reception room door fixed shut.

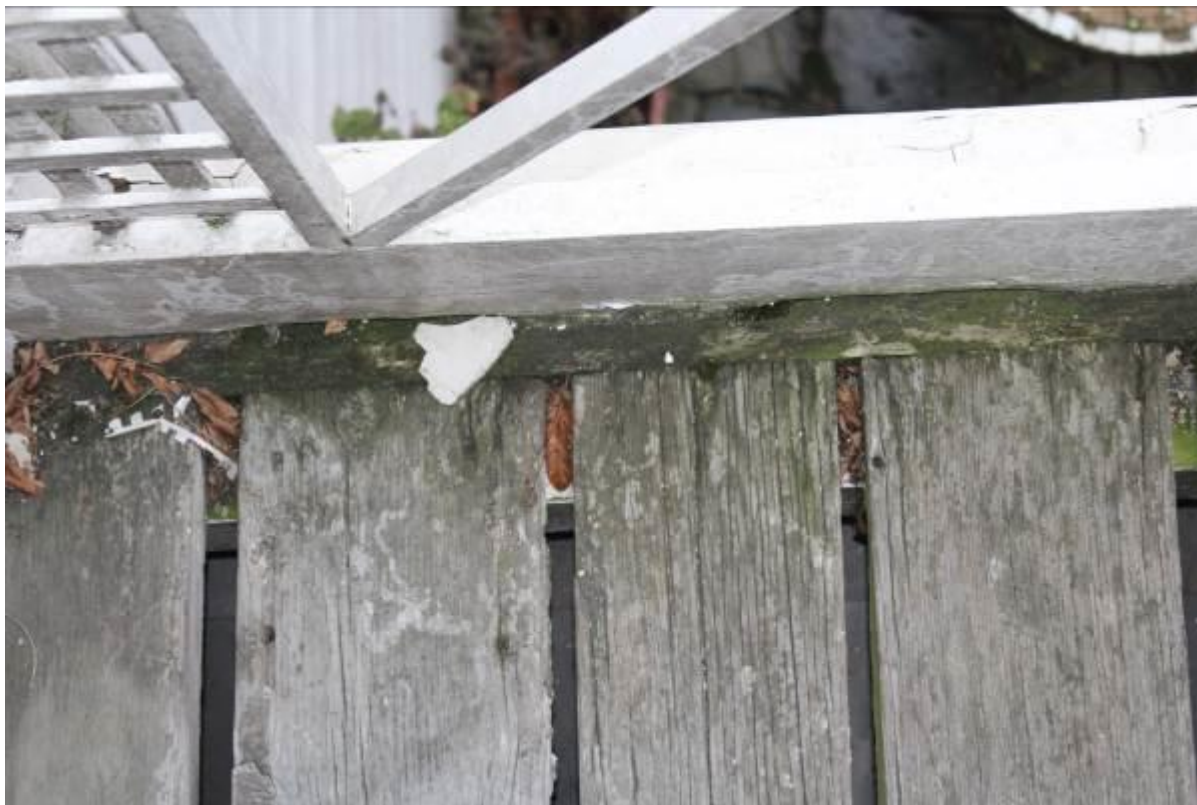
19. Ends of balcony decking showing signs of decay.

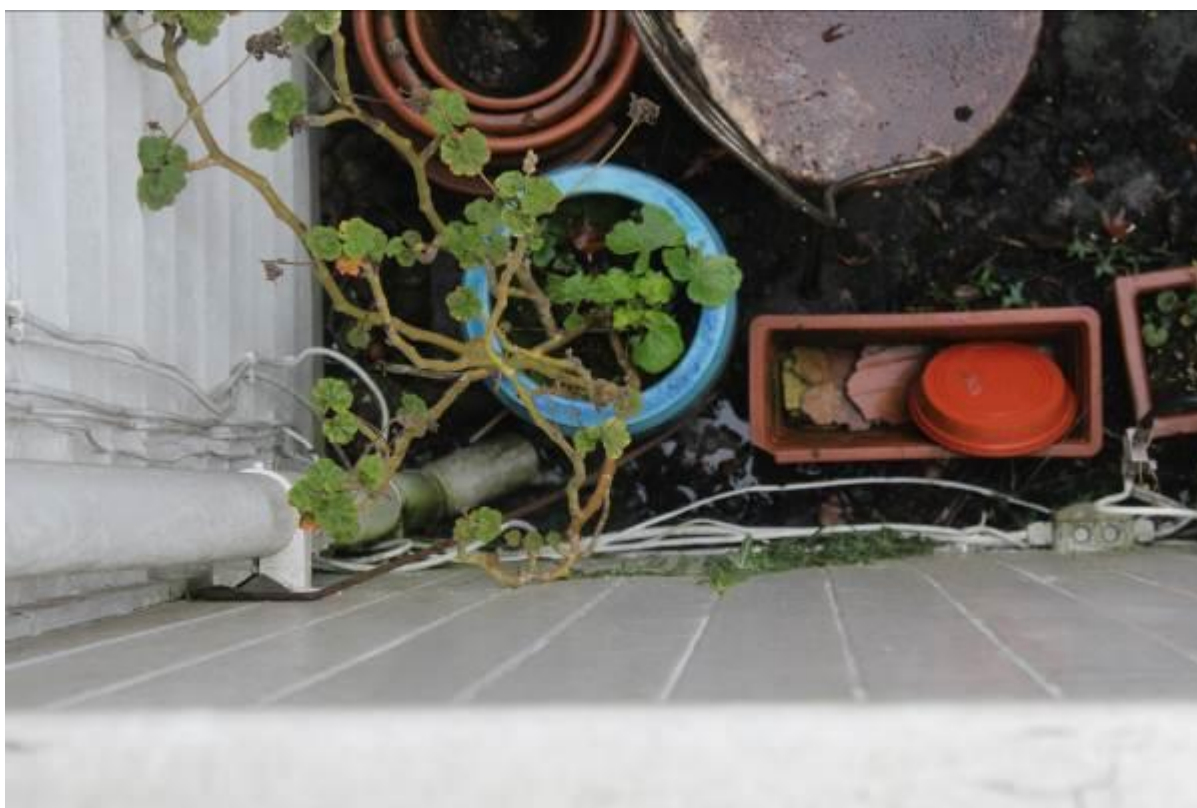
20. Rainwater build up noted in adjoining property to downpipe serving west elevation roof. Further investigation and repair/unblocking is required.

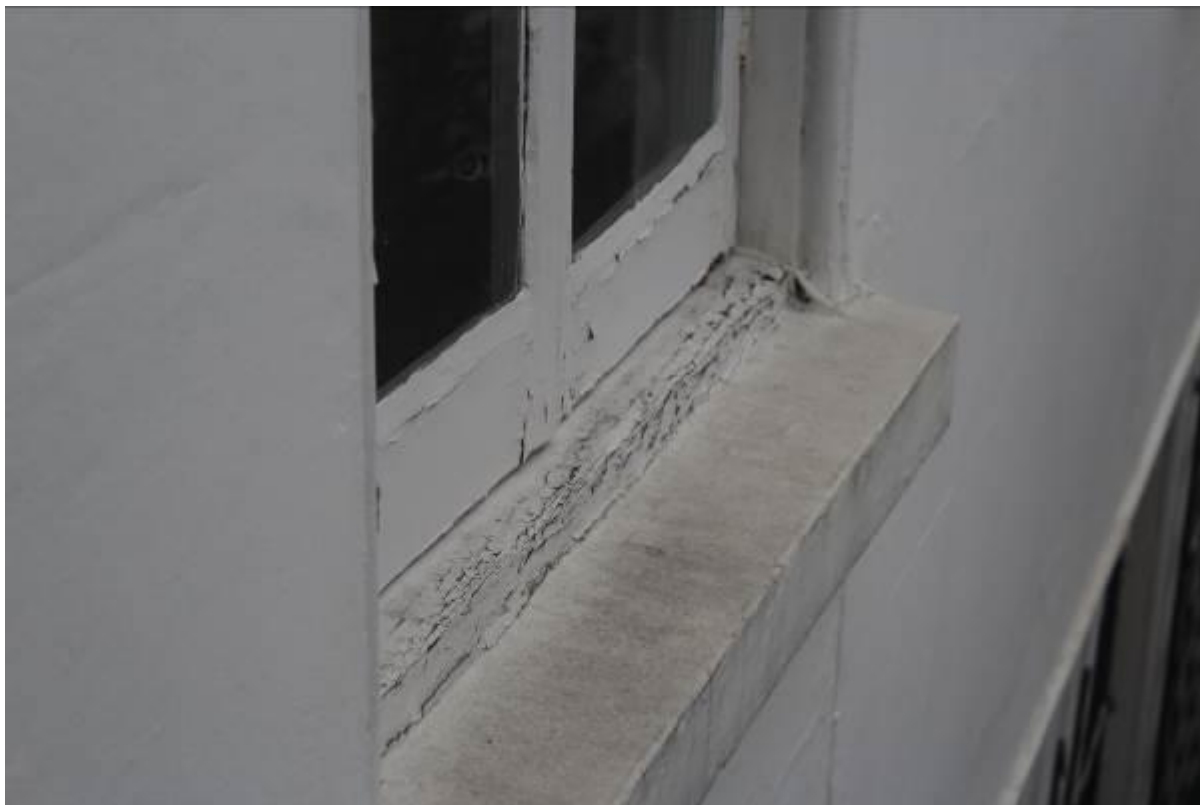
21. Redecoration and repair required to external joinery to rear addition.

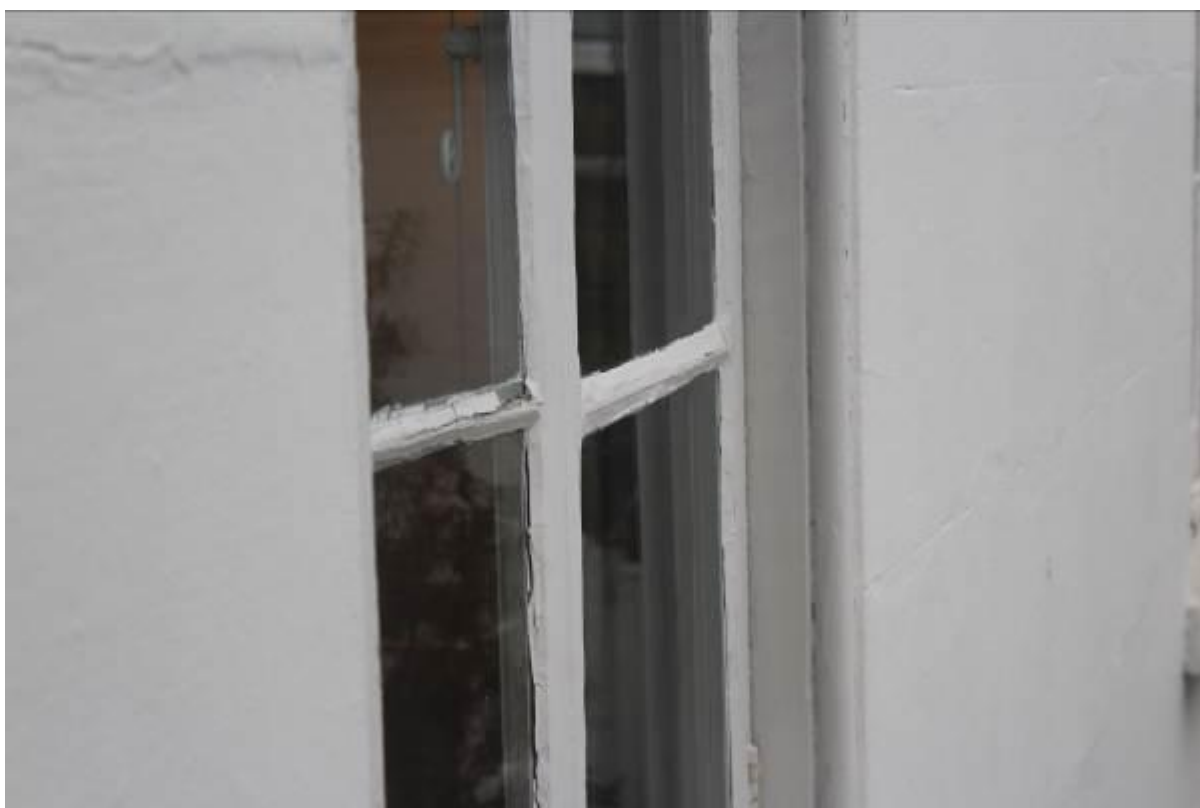
22. As above.
