Building Survey Report

**Rose Cottage
Vale of Health
London
NW3 1AX**

**Warmans Surveying
(Warmans Cube Ltd)
2nd Floor
13 Swan Yard
London
N1 1SD**

21st December 2016

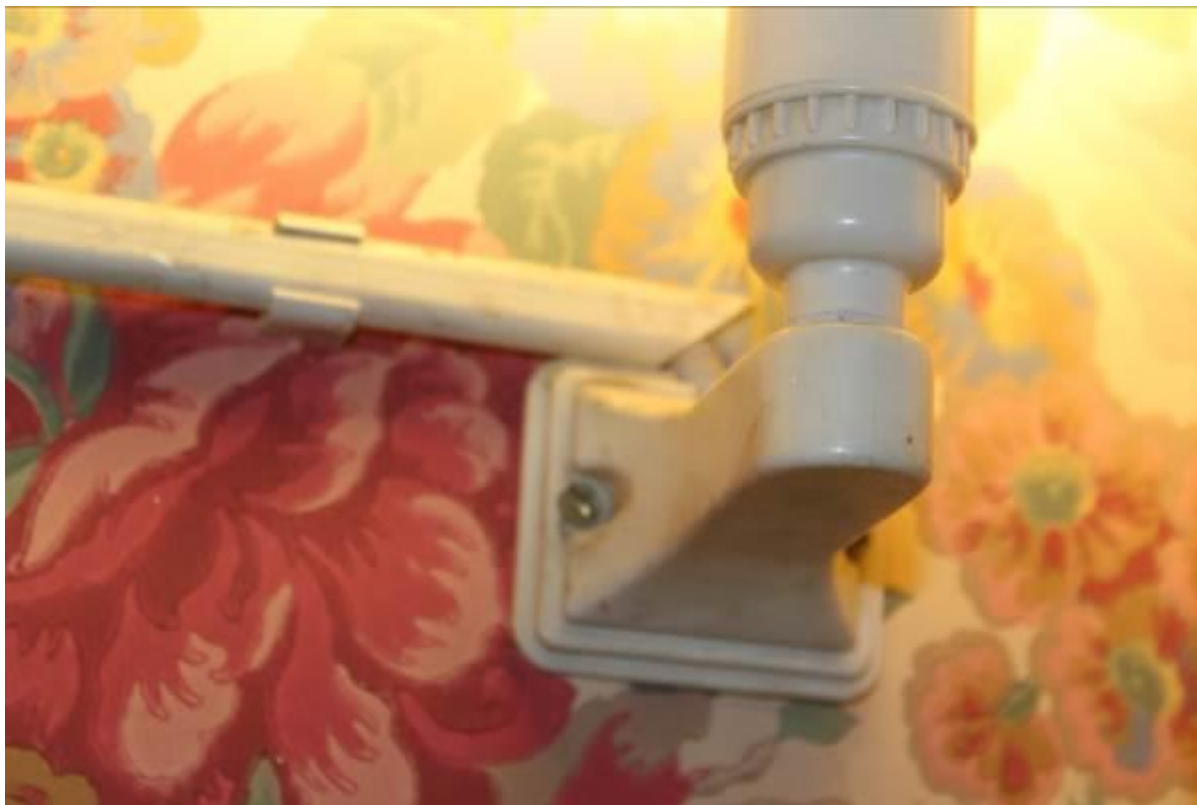
23. Poorly formed surface run conduit.

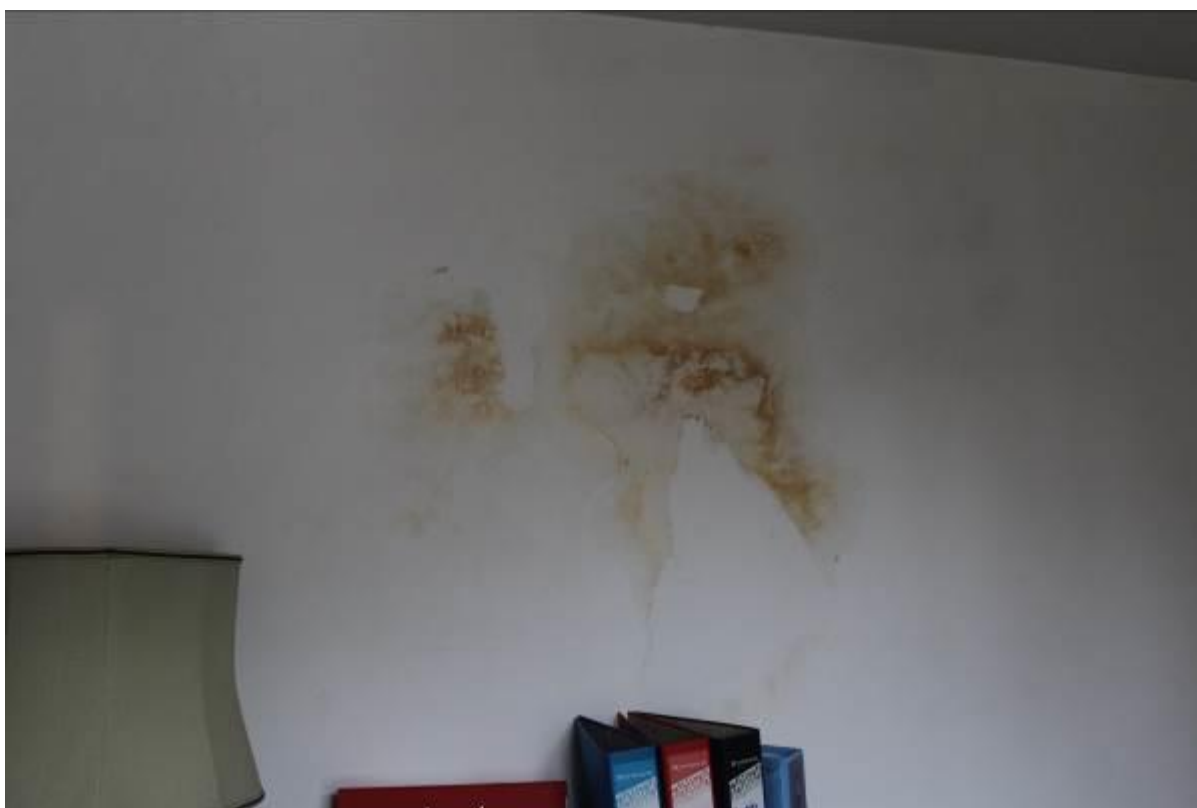
24. Plaster repairs required to first floor bedroom where water damage has occurred.

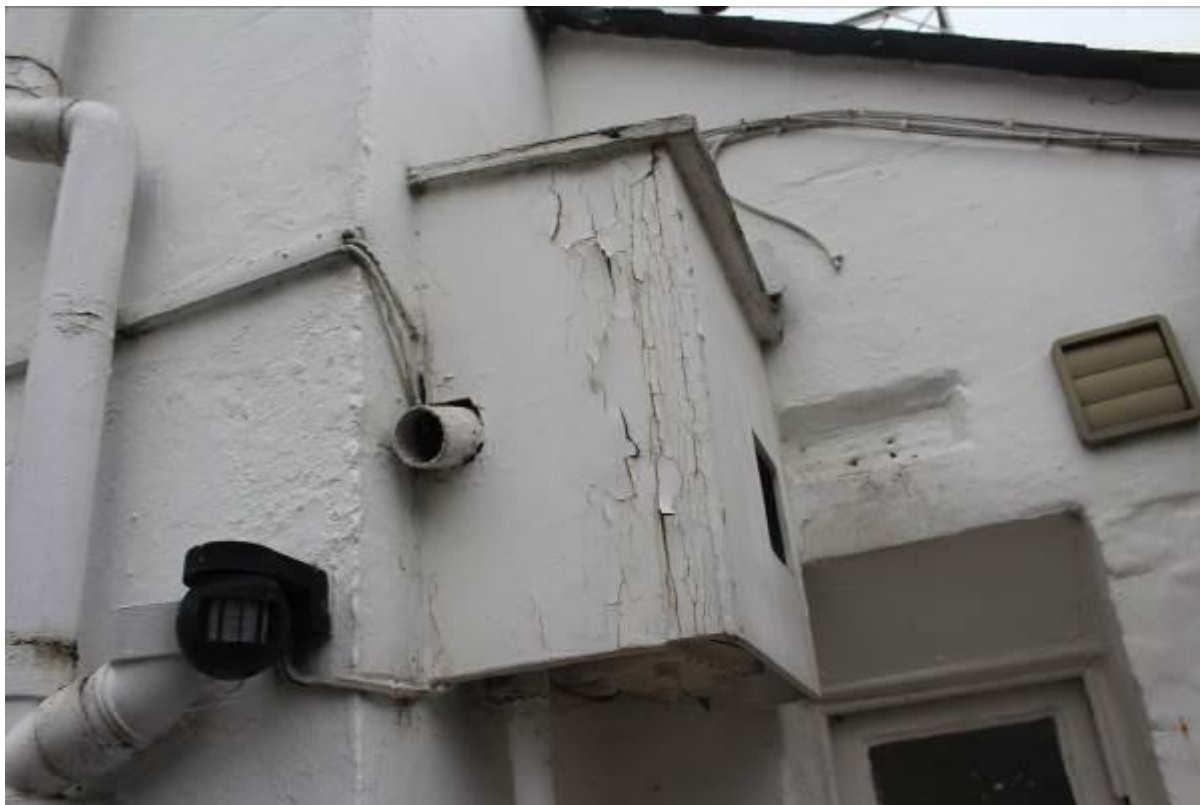
26. Repair and redecoration of gas meter box is required.

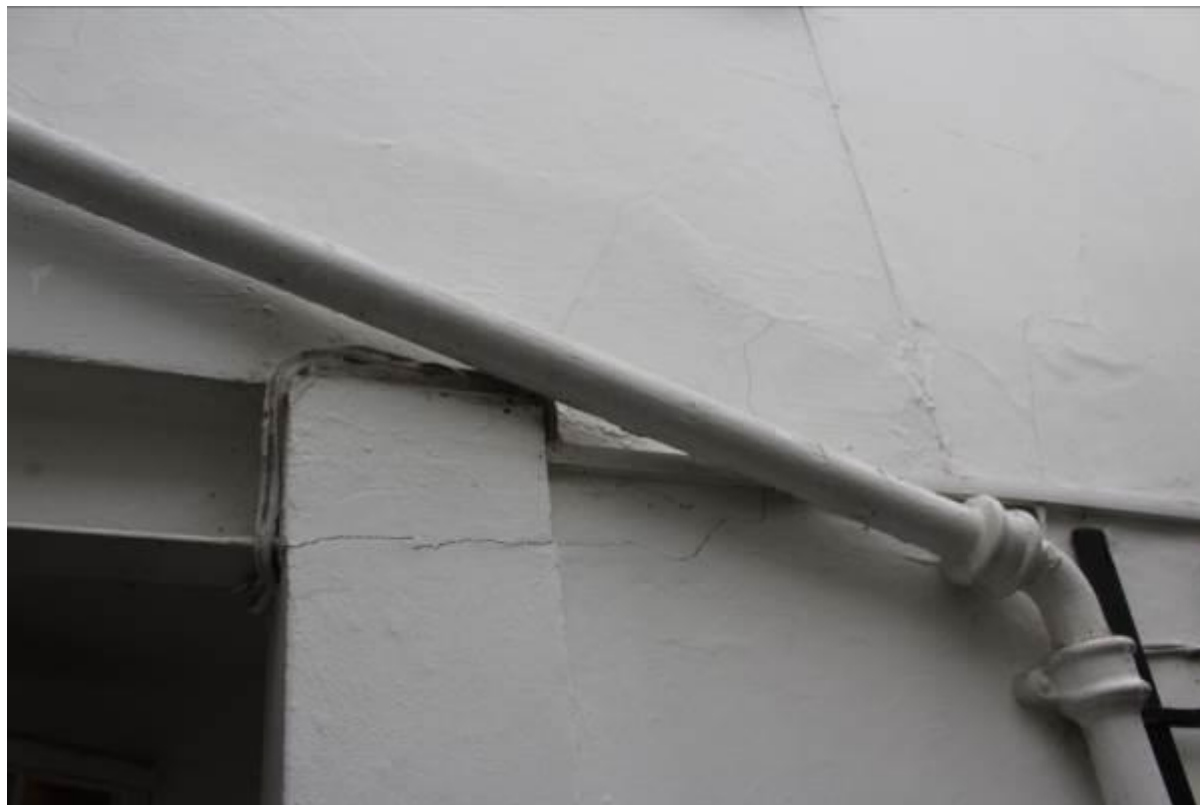
Whilst this hairline cracking as can be seen in the attached photograph it illustrates that movement is minimal but possibly ongoing.

28. Some cracking observed to rear addition masonry indicating the movement is slowly ongoing.

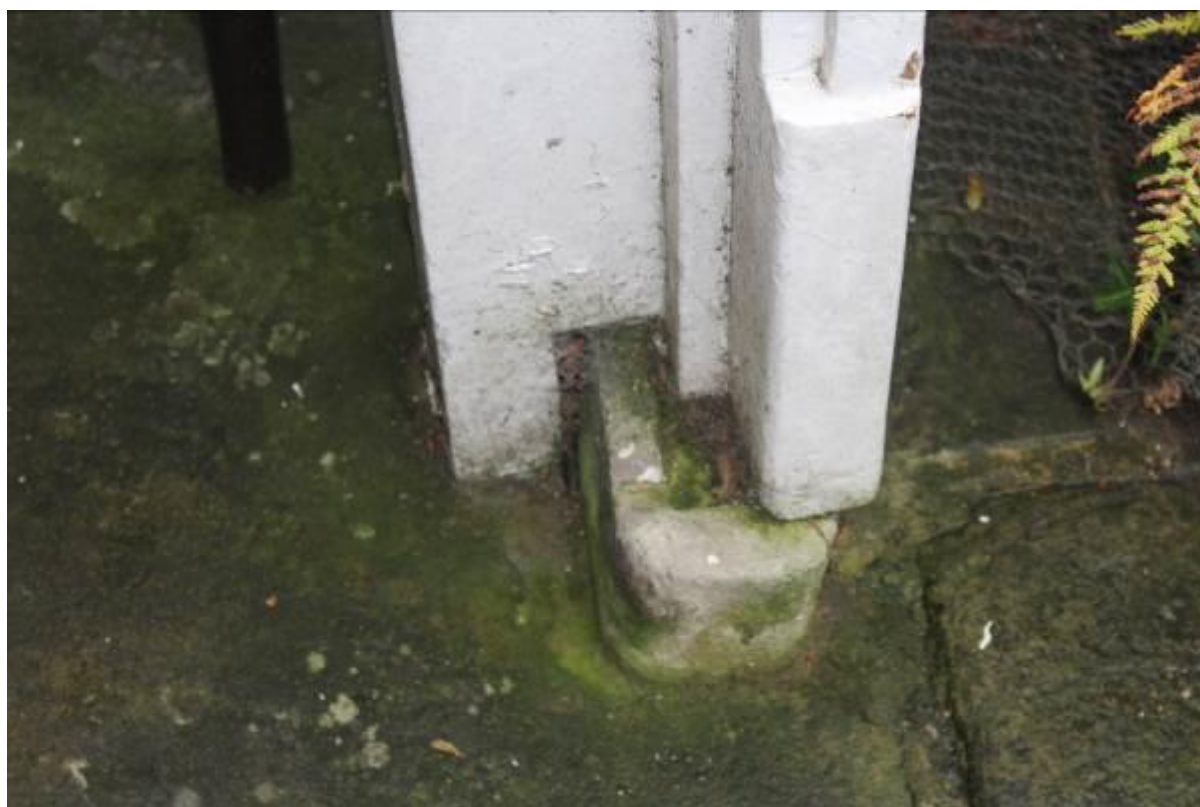
In addition, the base to the two main front posts comprises a stone, which appears to be just resting on a flagstone and the timber frame has begun to move away from these supporting structural support "stones" and as a result we recommend that the structure is temporarily propped and a new support base is provided for the timber structure. It may be possible to retain the existing stone blocks but this does need to be readjusted because eccentric loading on these blocks is likely to cause them to fail at some stage in the future. (See attached photographs)

29. Front balcony support base now out of alignment and in need of re-seating.

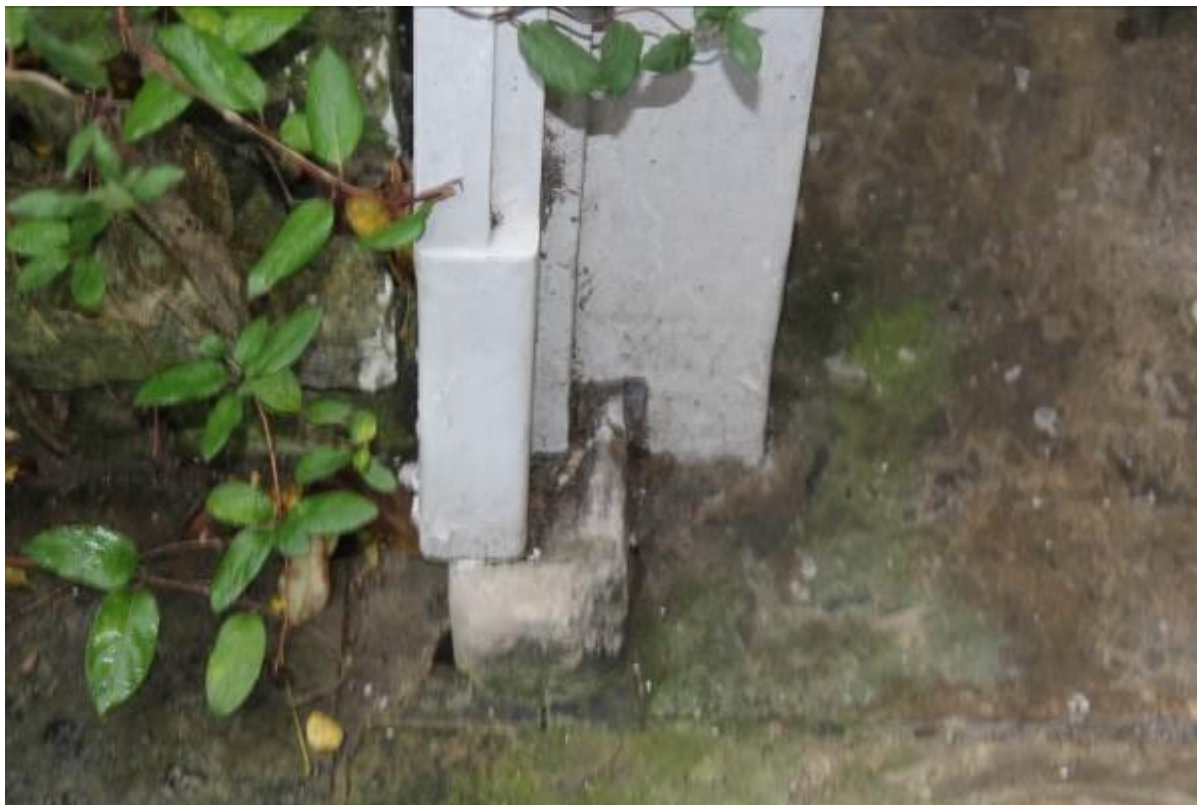
30. As above.

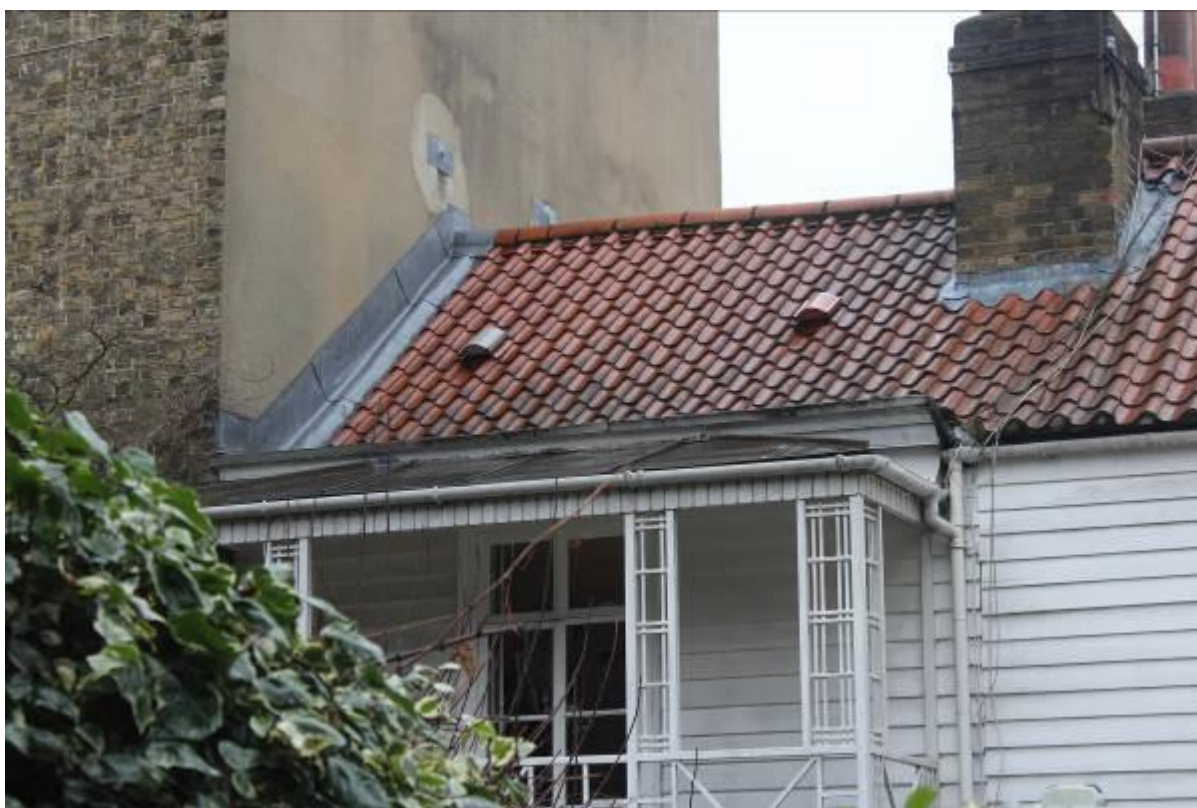
31. The balcony roof can be seen here to be zinc or lead, further investigation recommended.

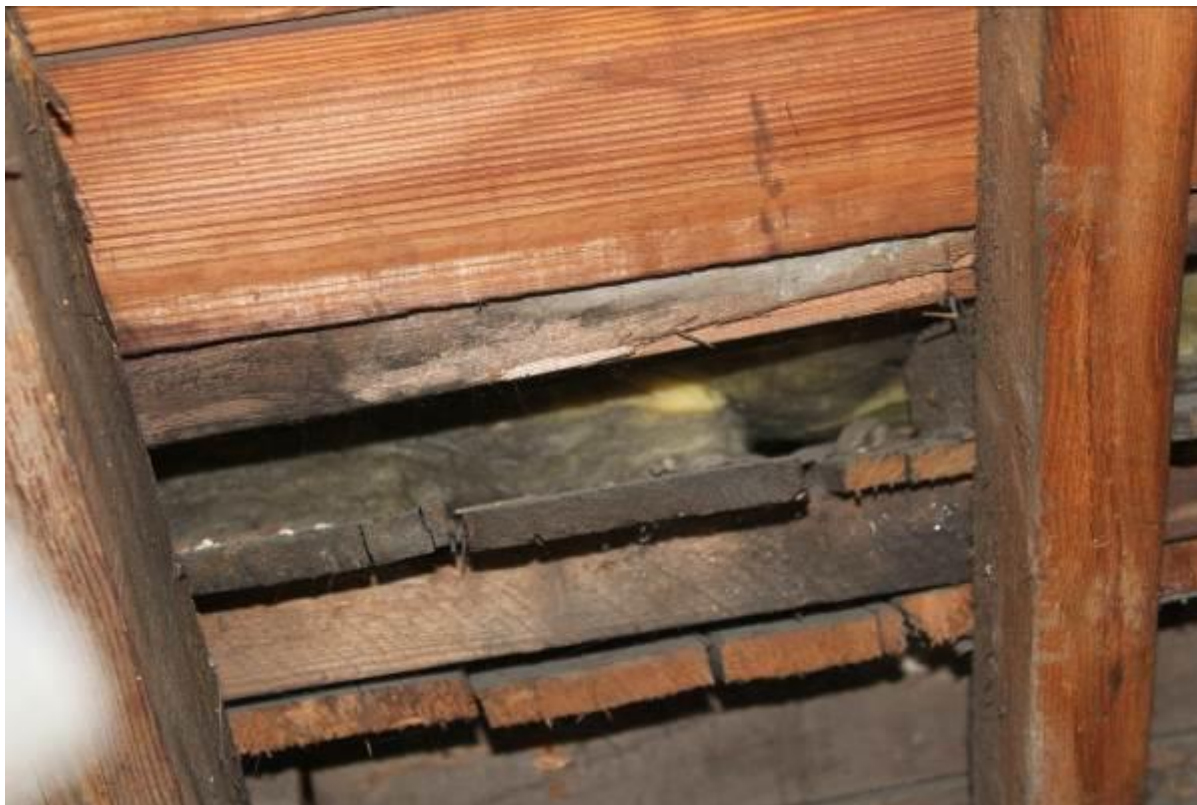
Evidence of insulation in the rear addition roof was apparent although no visual inspection of this area was possible as there is no roof access hatch, ideally one should be installed. Overall we consider the roof space to be in good condition, there are no significant issues or concerns that we have in relation to this area.

32. Evidence of some insulation in back addition roof space as viewed from the front roof space. An access hatch in this roof space is recommended.

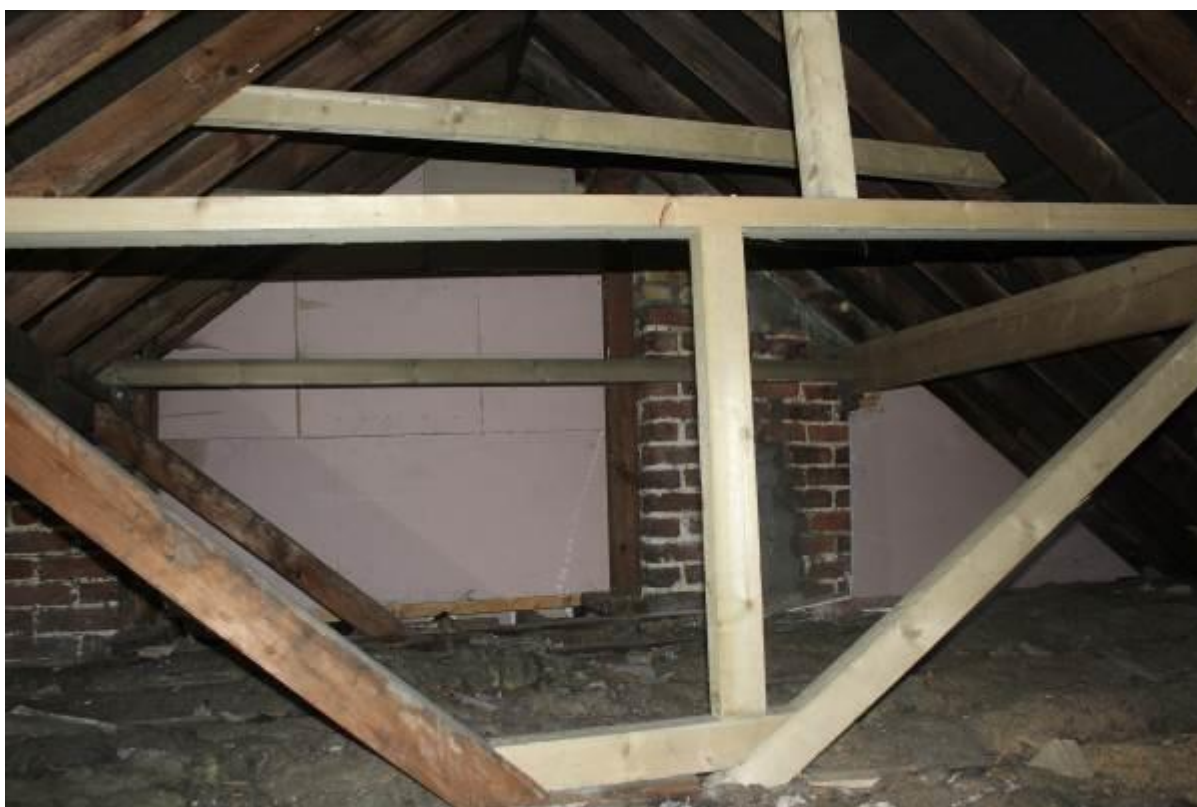
33. Additional roof supports and fireproofing of party wall to main roof space.

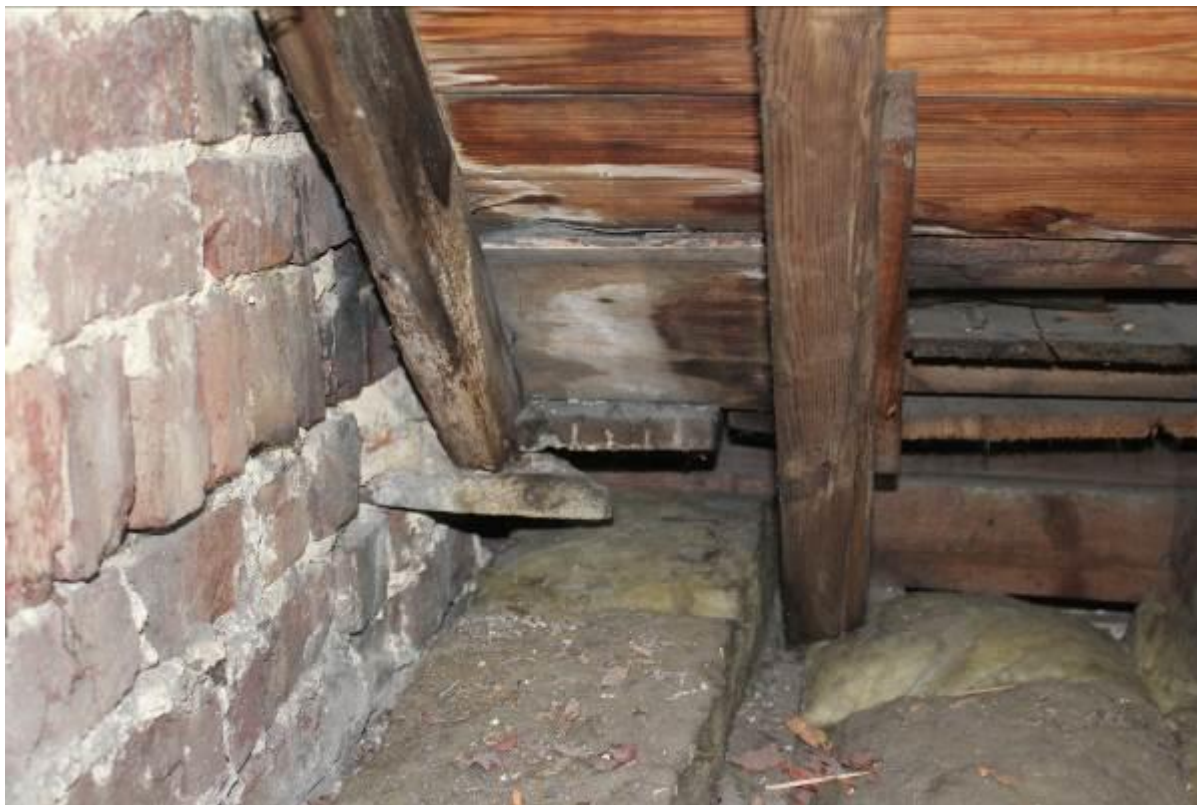
34. Support to base of rafter not ideal but currently satisfactory, this needs to be monitored or strengthened in some way.

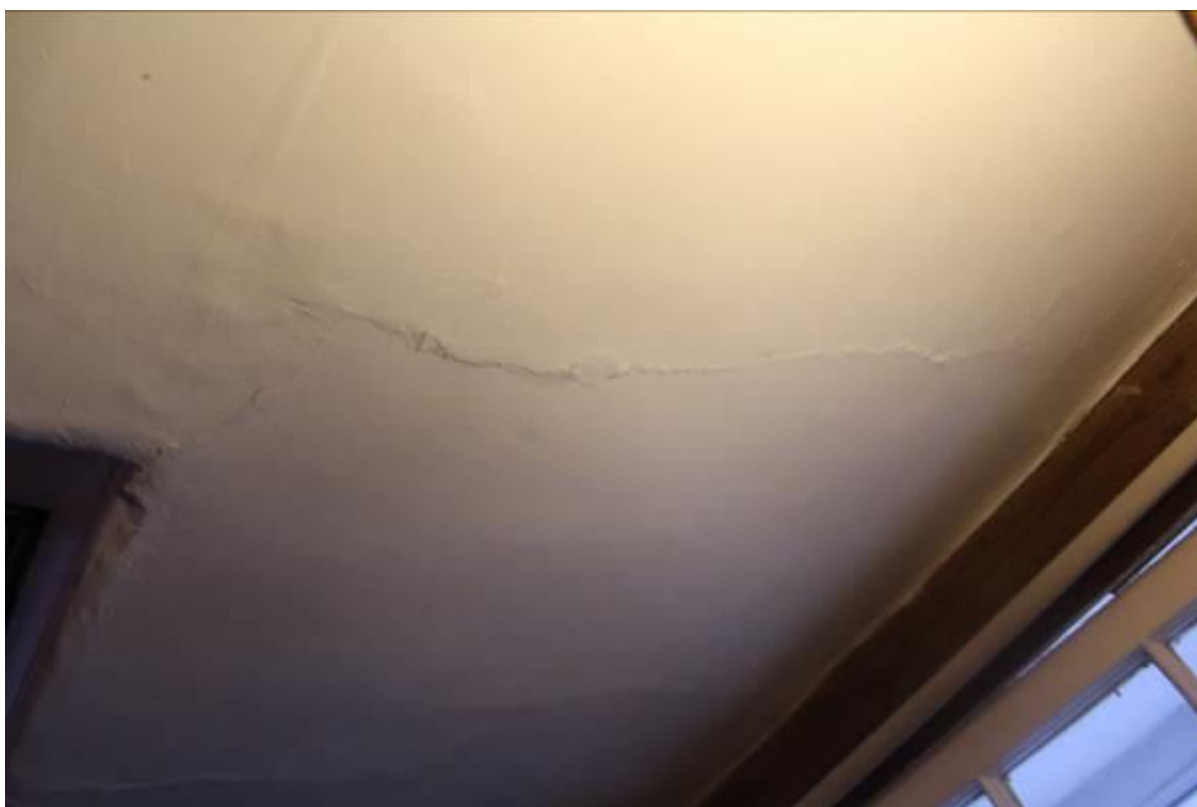
35. Ceilings would benefit from overboarding.

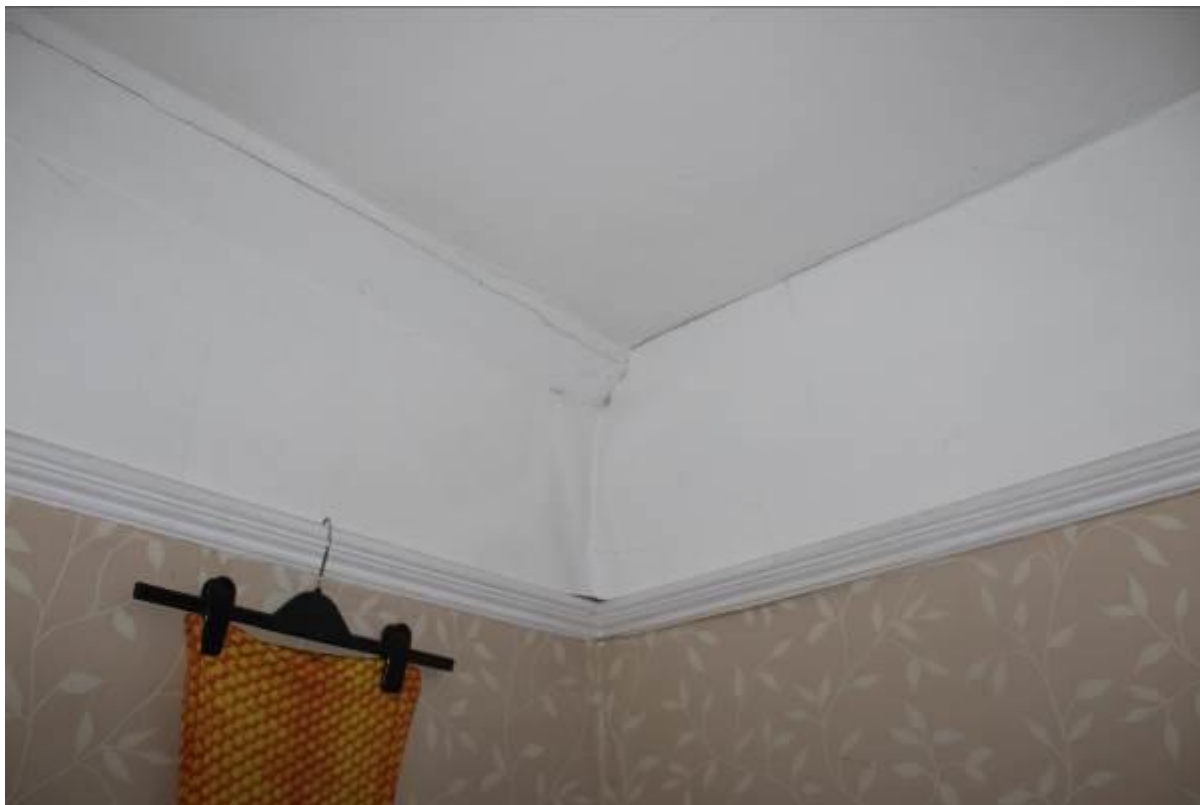
36. Some minor movement evident in first floor bedroom.

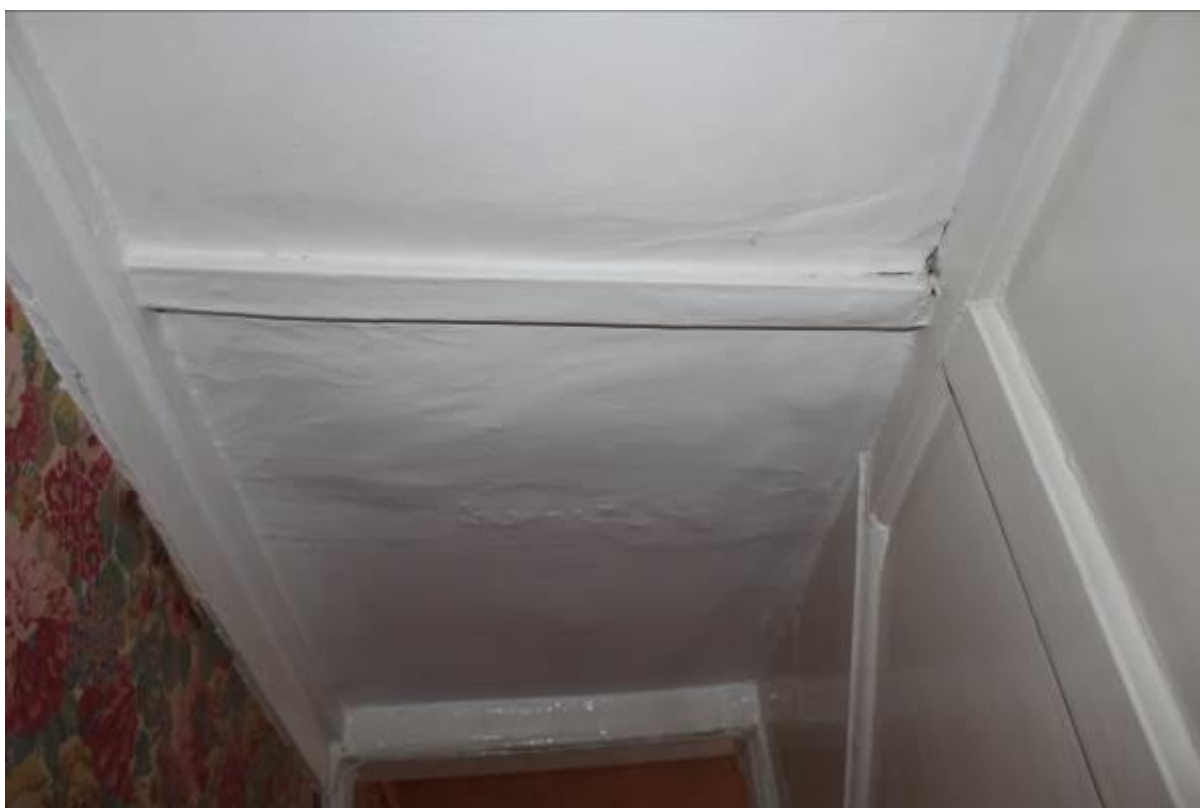
37. Overboarding recommended to first floor ceilings

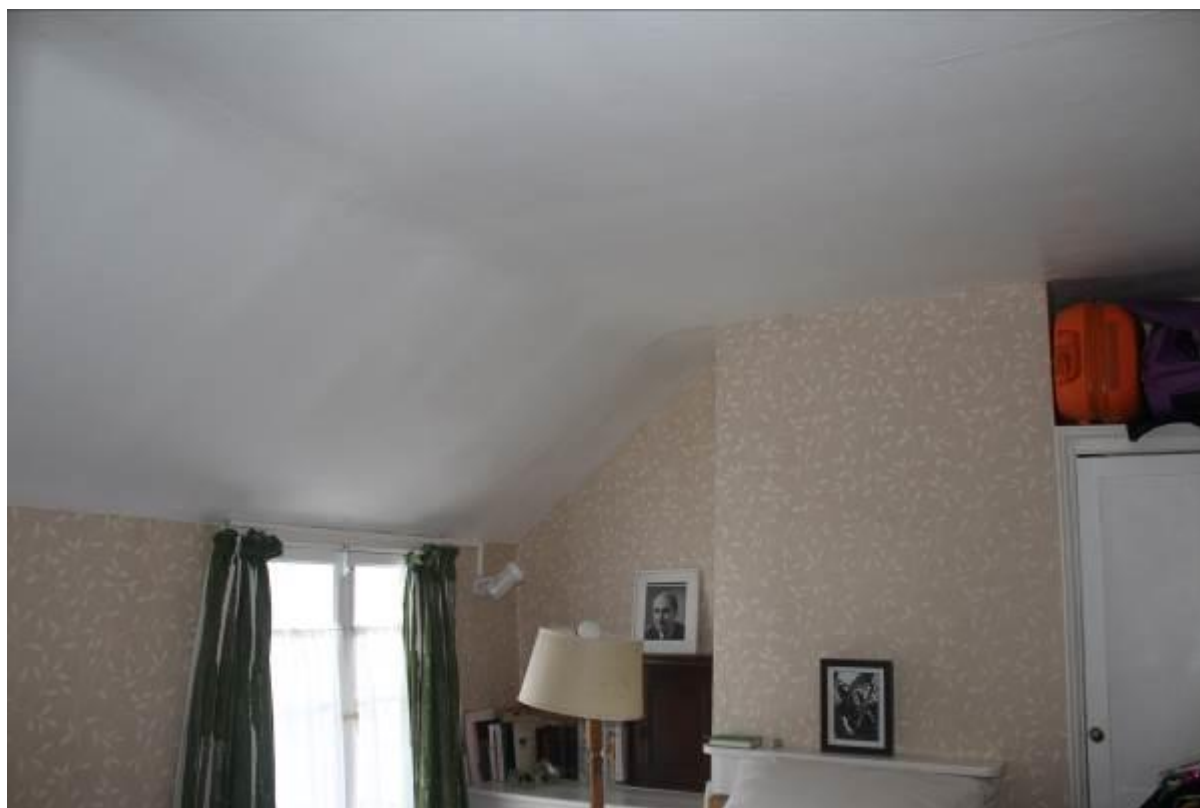
38. The roof construction has caused the rear wall to spread as demonstrated in photograph 12, but there is no significant evidence of this being ongoing.

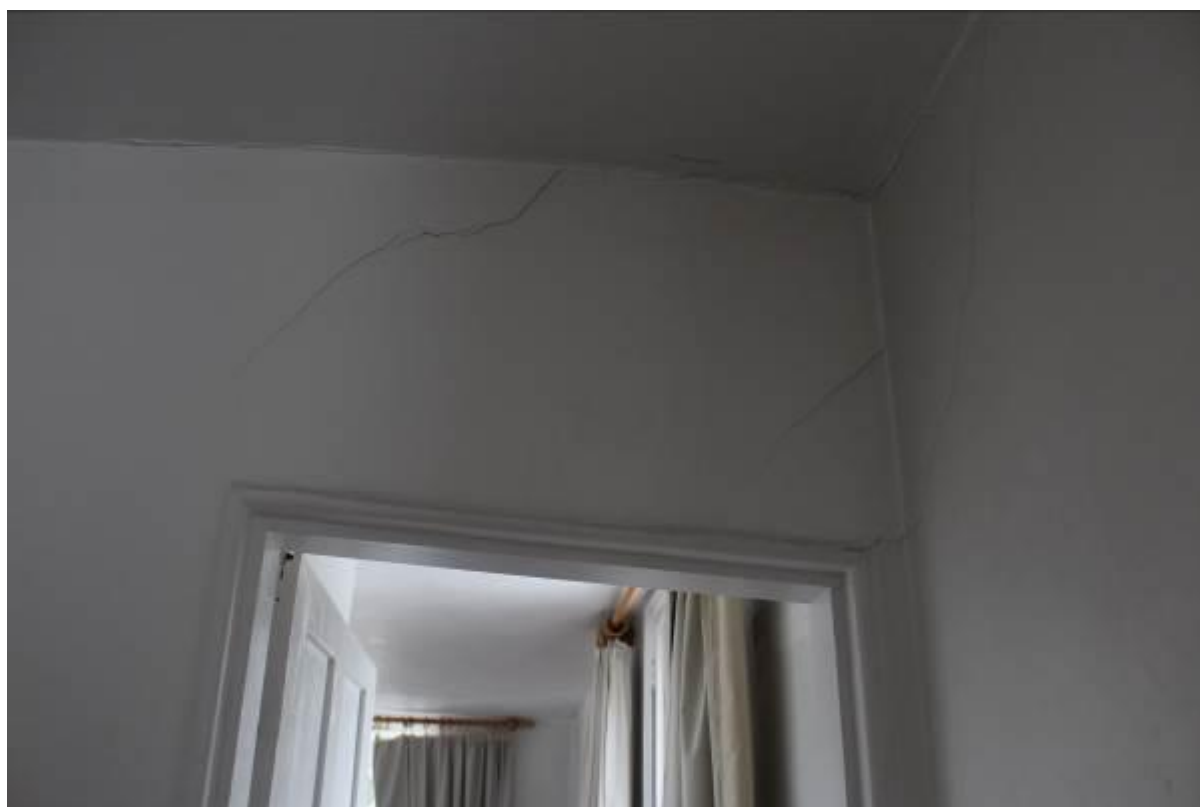
39. Slight cracking above first floor door opening indicating movement is ongoing.

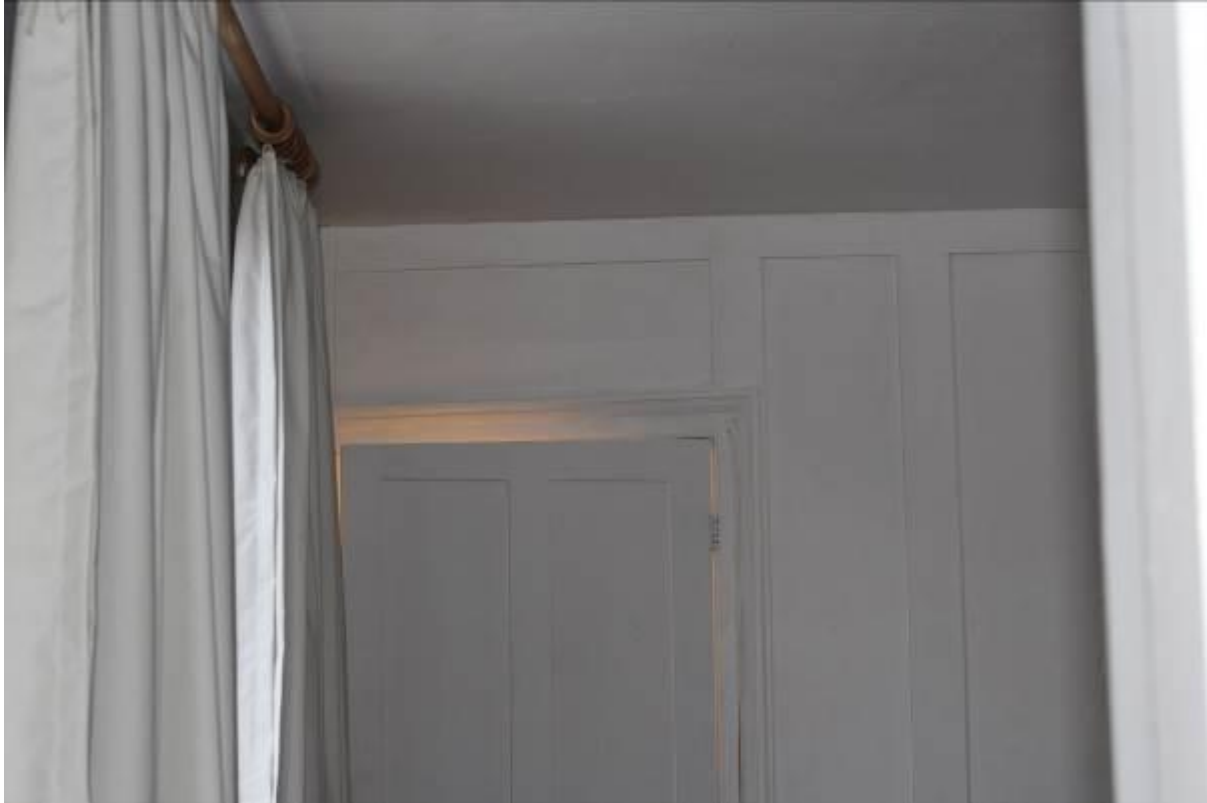
The heads to the internal door openings along the side of the rear addition, particularly at ground floor level are observed to be deflecting and there is an indication that significant movement has occurred over a long period of time slowly in a vertical plane to this side wall. This movement is generally in a downward direction caused by settlement but this does appear mainly to be historic.

40. Door openings to the rear addition are out of alignment.

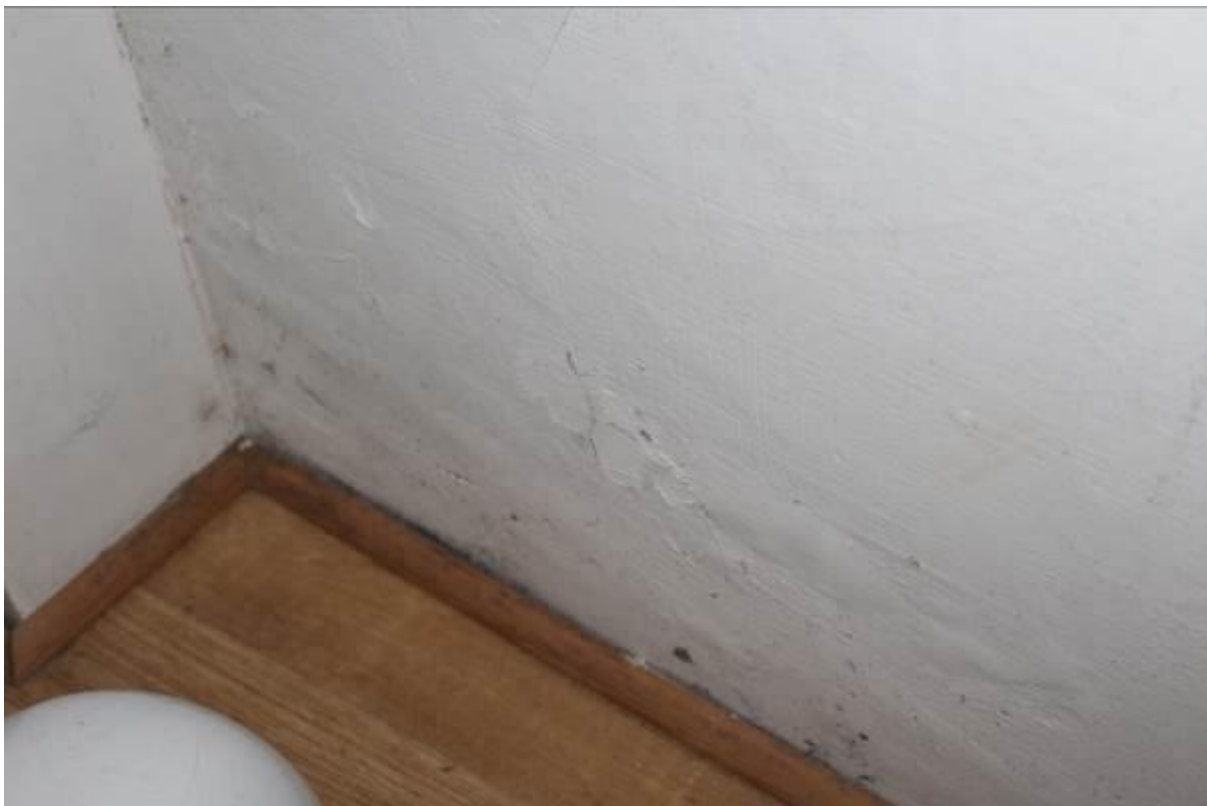
41. High damp readings noted.

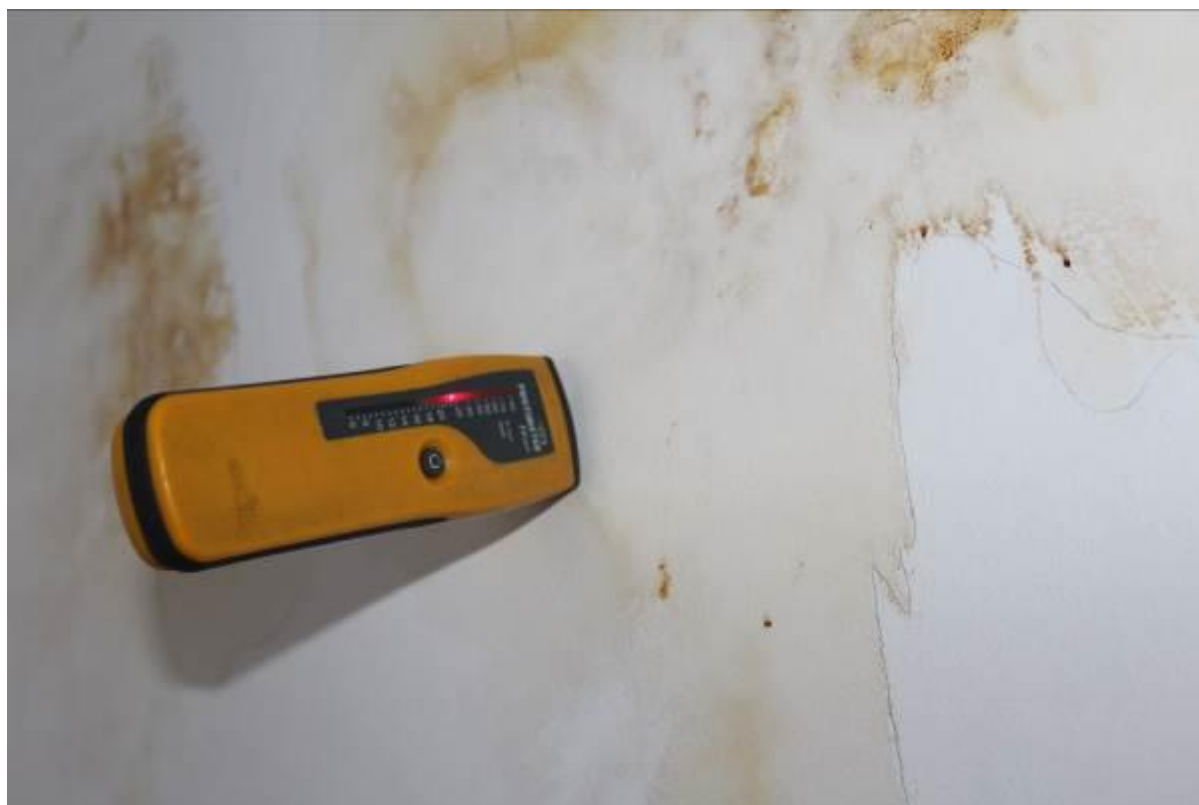
42. High reading noted in first floor bedroom, this could be caused by salt contamination, replastering required and further investigate by inspecting roof above.

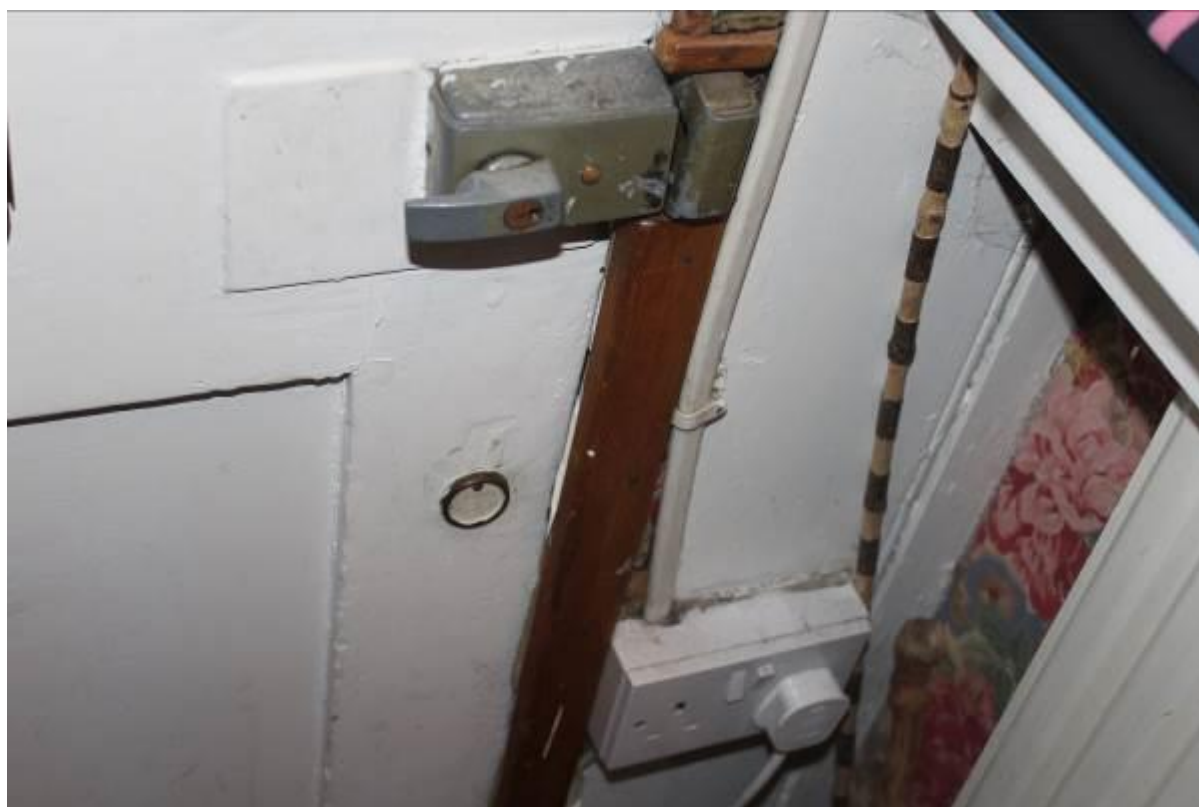
43. Air gap between door and frame.

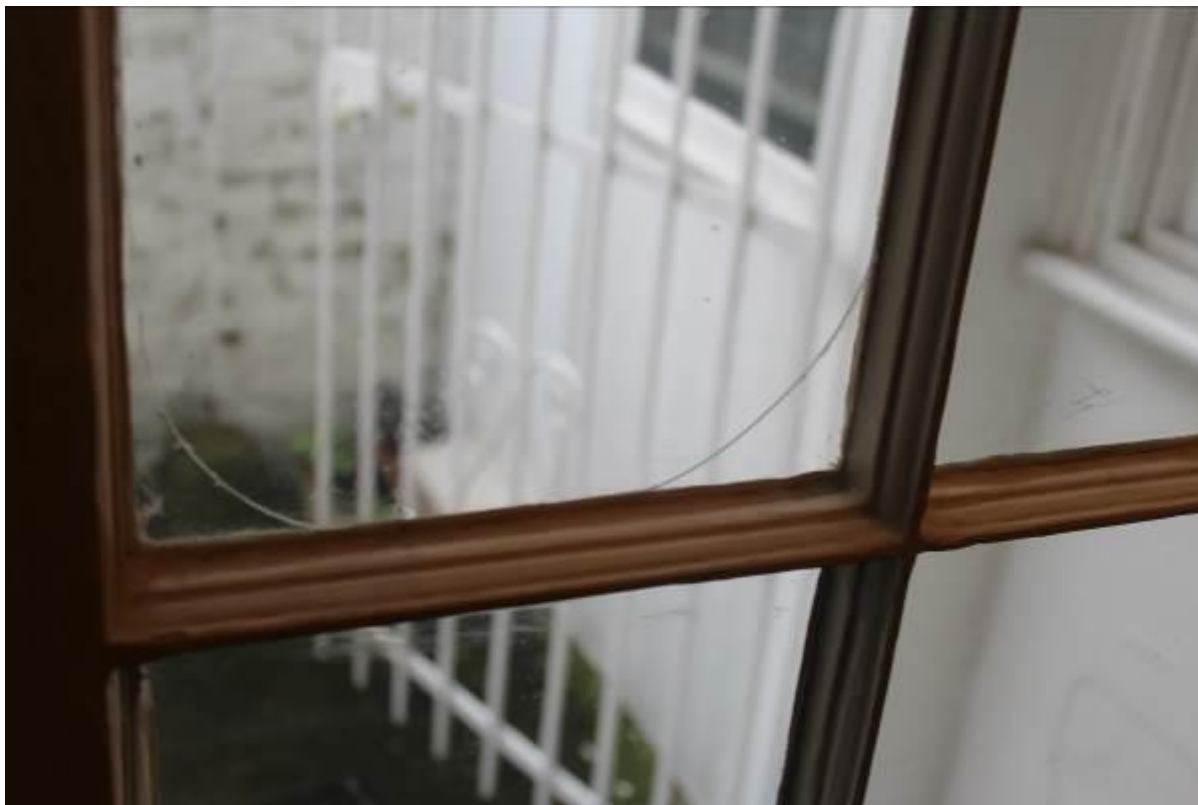
44. Replace broken glass pane.

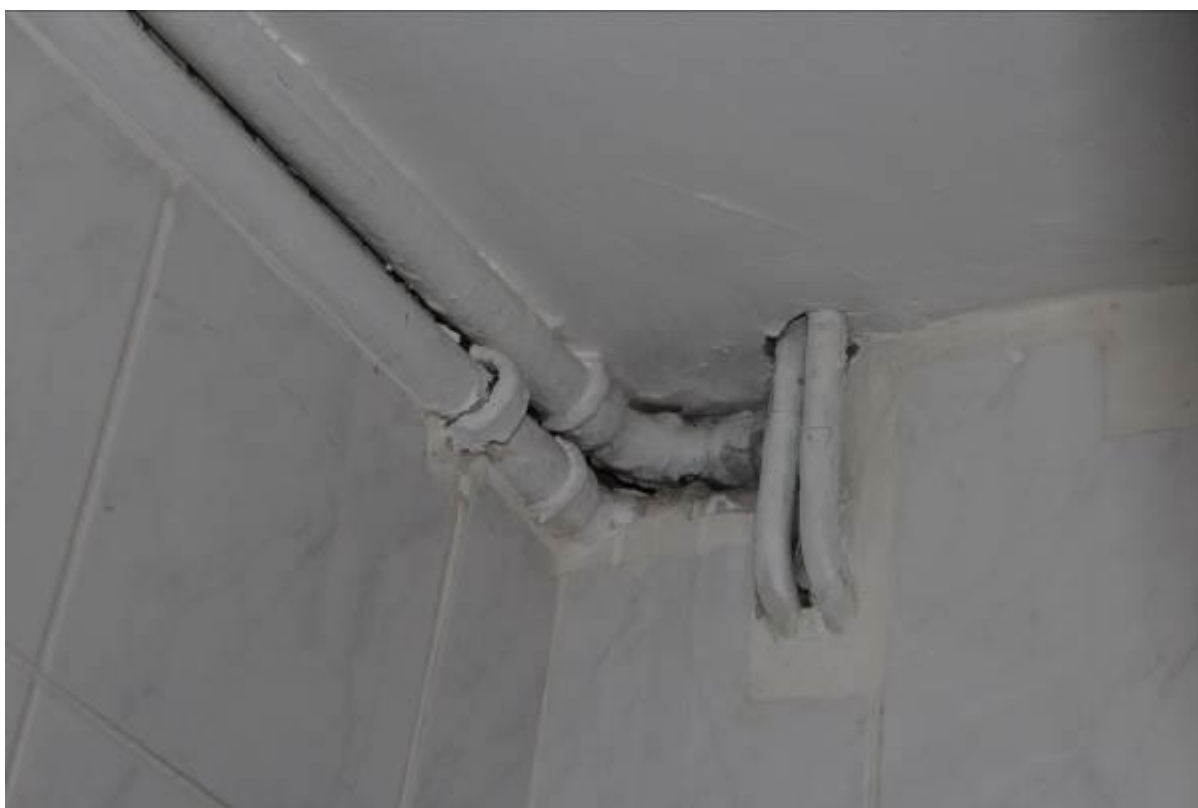
45. Surface run ground floor pipework, unsightly, recommend concealment if not redundant.

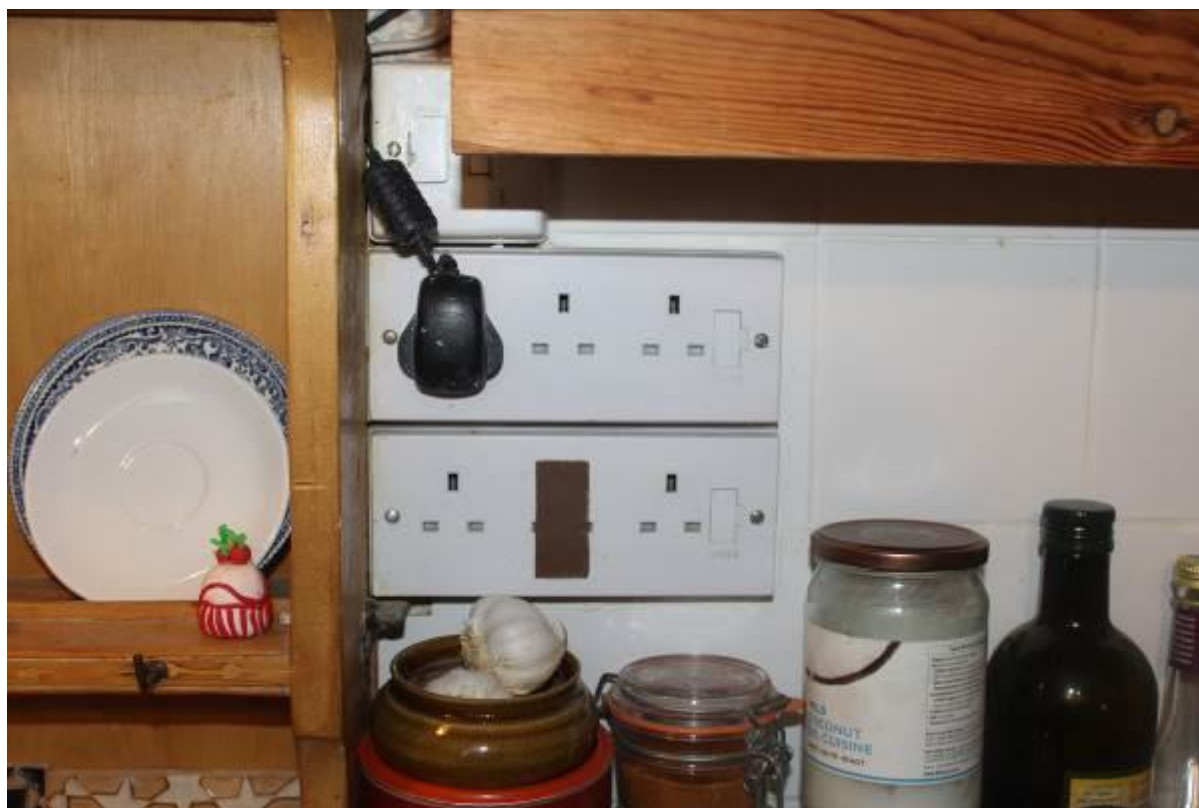
46. Poorly designed electrical socket facilities, also note one of the positions has been blanked off with tape. Further investigation or rewiring required.

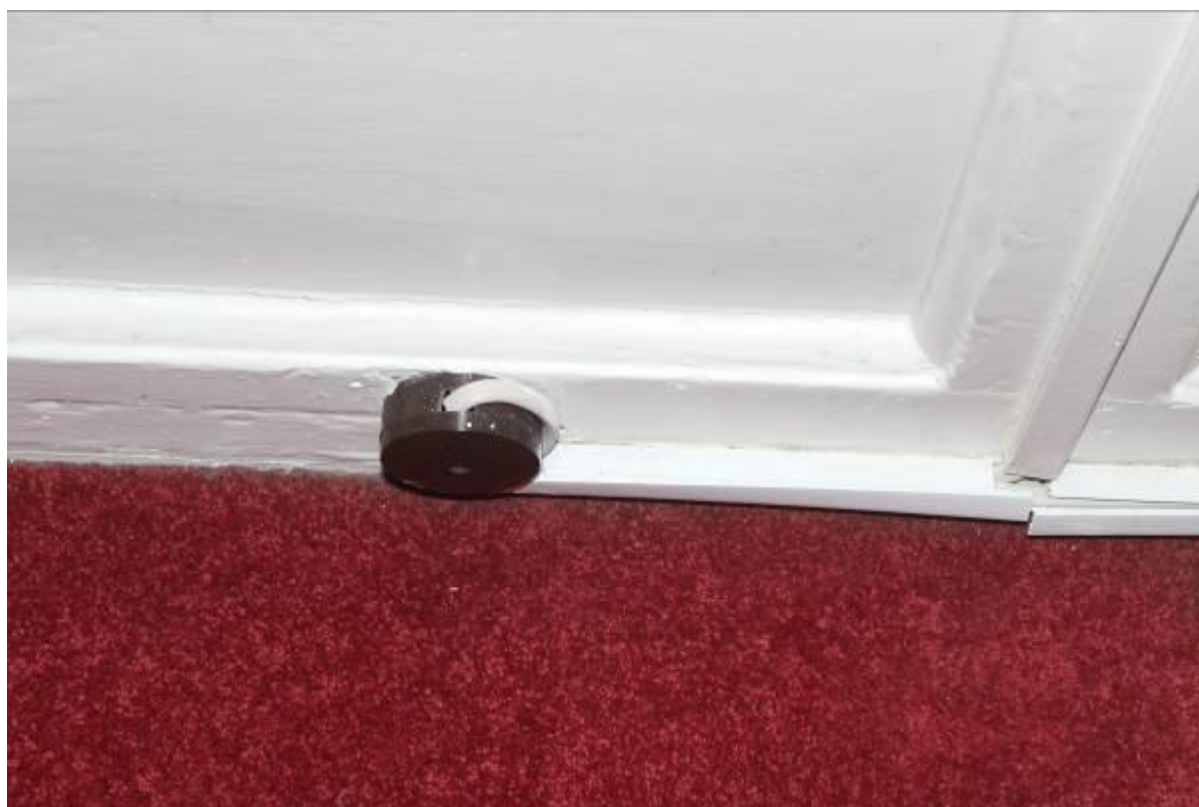
47. Poor electrical detailing.
