Building Survey Report

**Rose Cottage
Vale of Health
London
NW3 1AX**

**Warmans Surveying
(Warmans Cube Ltd)
2nd Floor
13 Swan Yard
London
N1 1SD**

21st December 2016

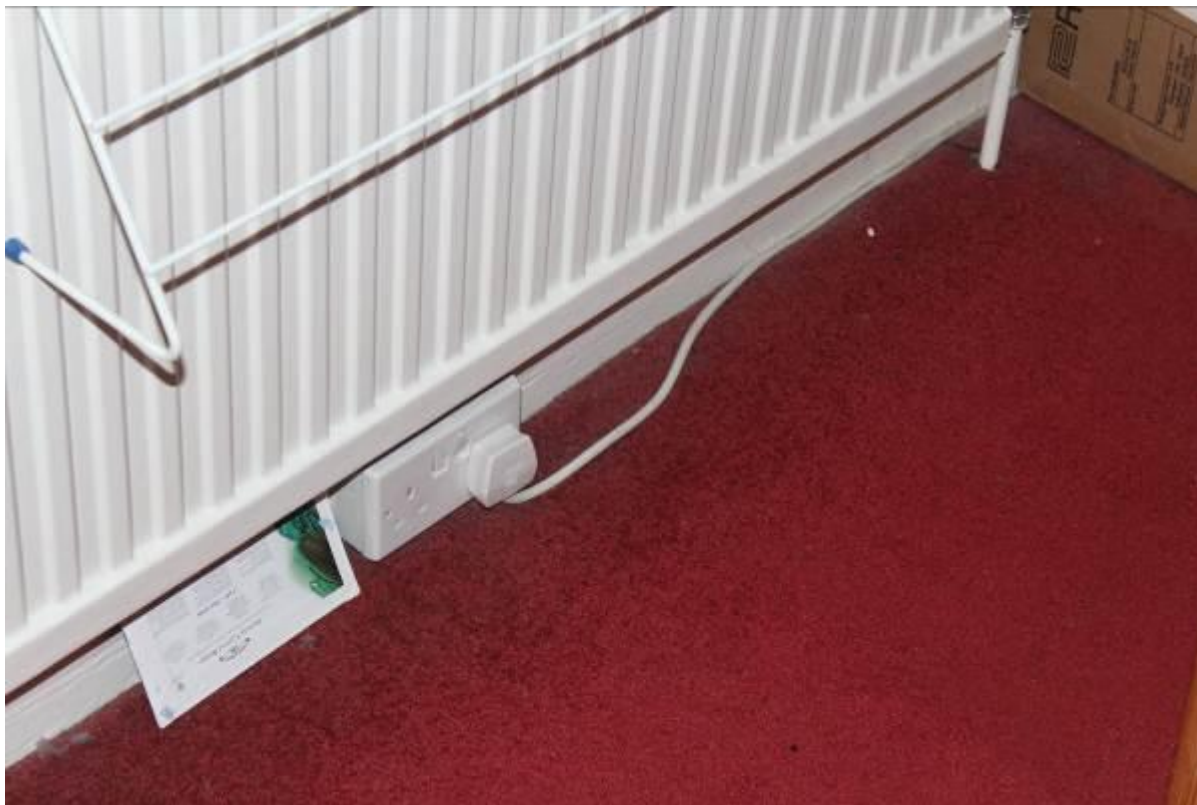
48. As above.

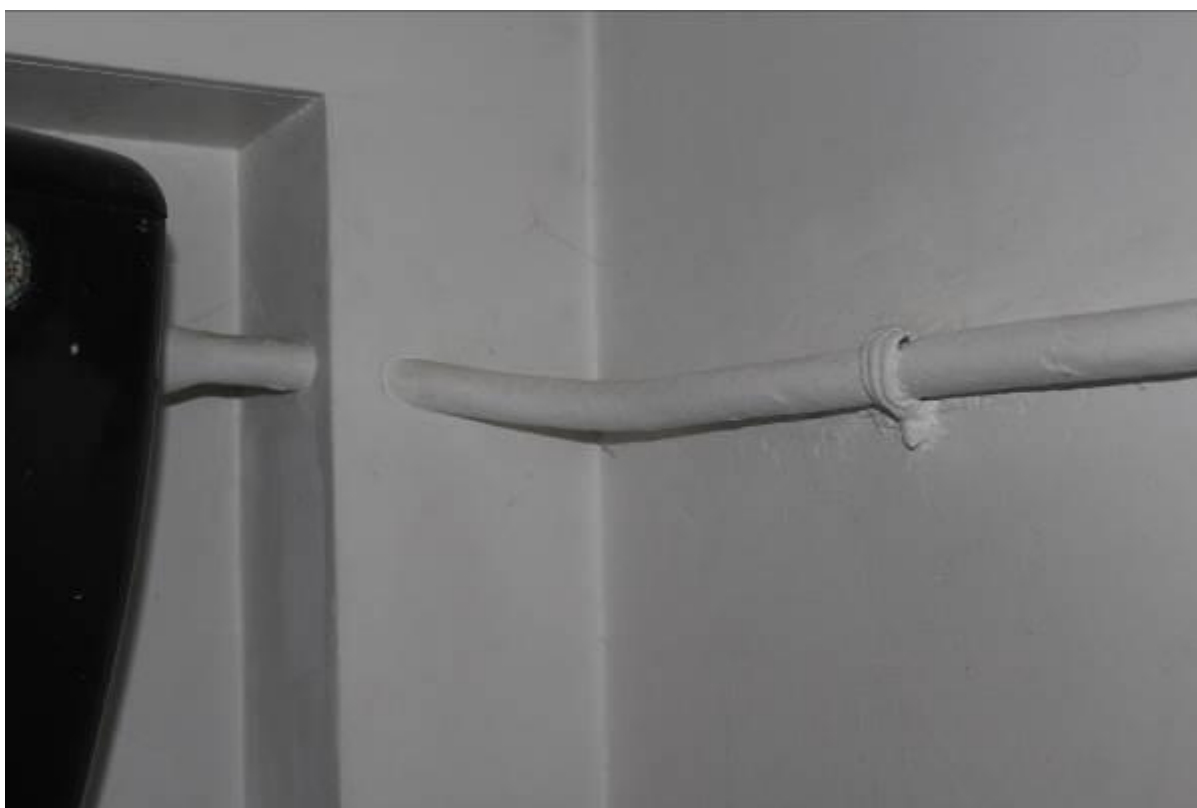
49. Lead main cold water pipework.

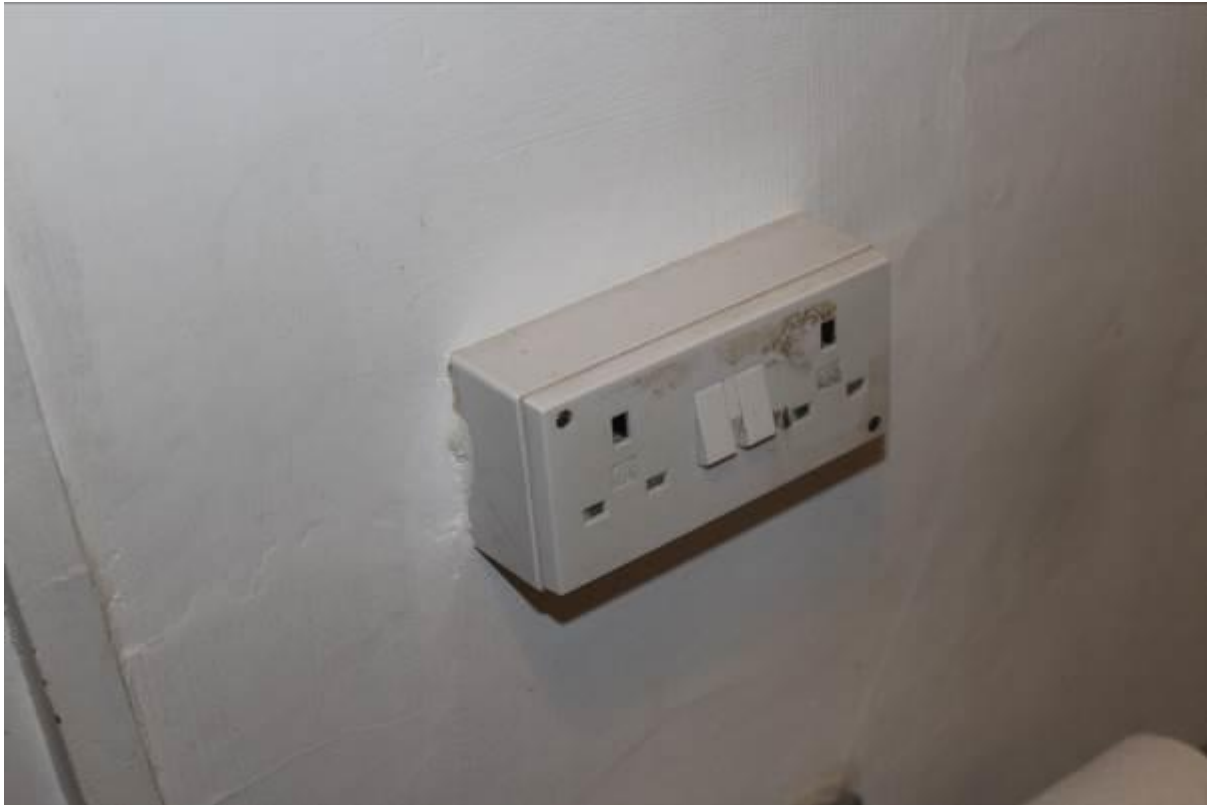
50. Socket outlet in cloakroom contravenes the IEE wiring regulations.
