**Rose Cottage, Vale of Health, Hampstead , London.**

### **Structural Overview**

On May 8 2017 I visited this cottage and, together with the help of a builder, I was able to determine the sizes of most of the main structural elements, and see some of the defects.

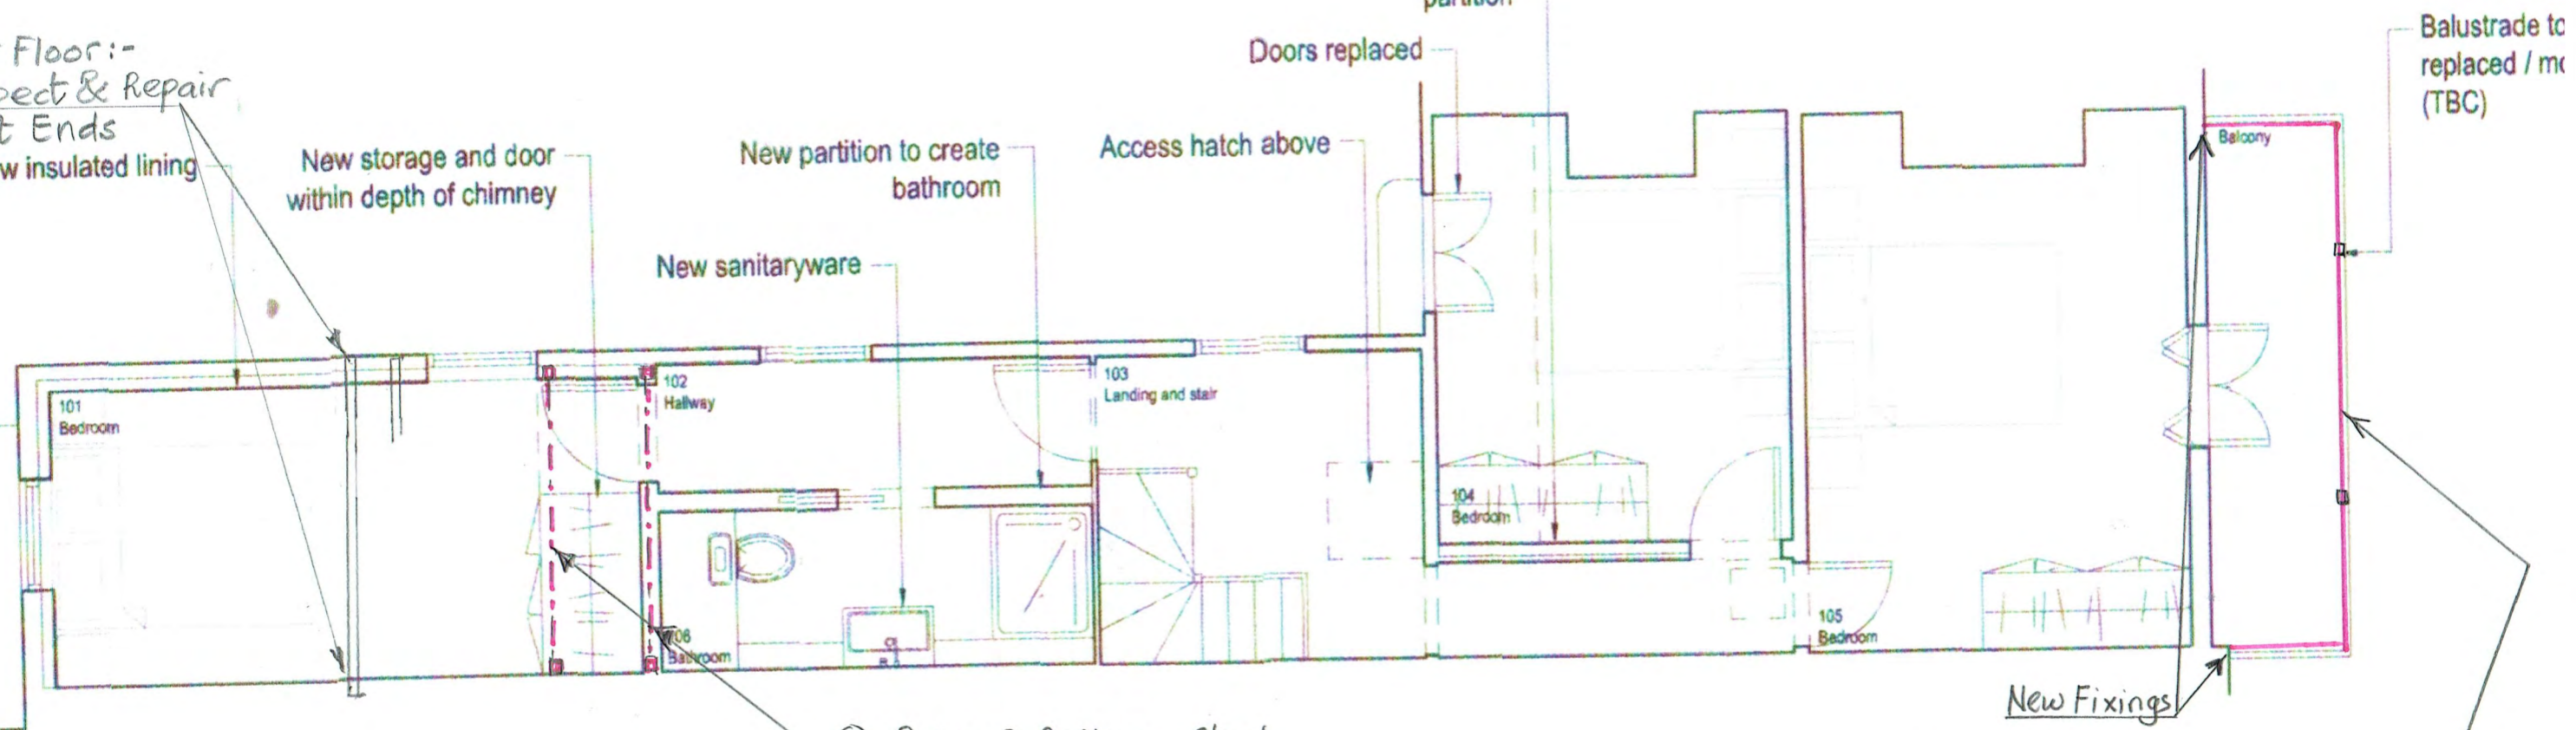
**First Floor.** For the main part of the house the joists run from front to back, and must be carried by a beam in the centre, visible in the ceiling of the ground floor room. For the extension, joists (125x 50) run from party wall to the external side wall (span 2.4m). Some joists have been weakened by deep notches where pipes have been threaded, and the joist ends bearing on the thin outside wall were hardly adequate, so all these need inspection and may need repair.

First Floor :-  
 ① Inspect & Repair Joist Ends  
 New insulated lining

1. The first floor joist ends where they bear on the outside wall of the should all be inspected, and if there is rot or less than 75mm of bearing, then repair work should be done. Likewise, the buried horizontal timber bond beams within the external walls should be located, inspected and probably cut out and replaced with masonry. Since the wall is only 112mm thick, this will affect internal plaster and external render.

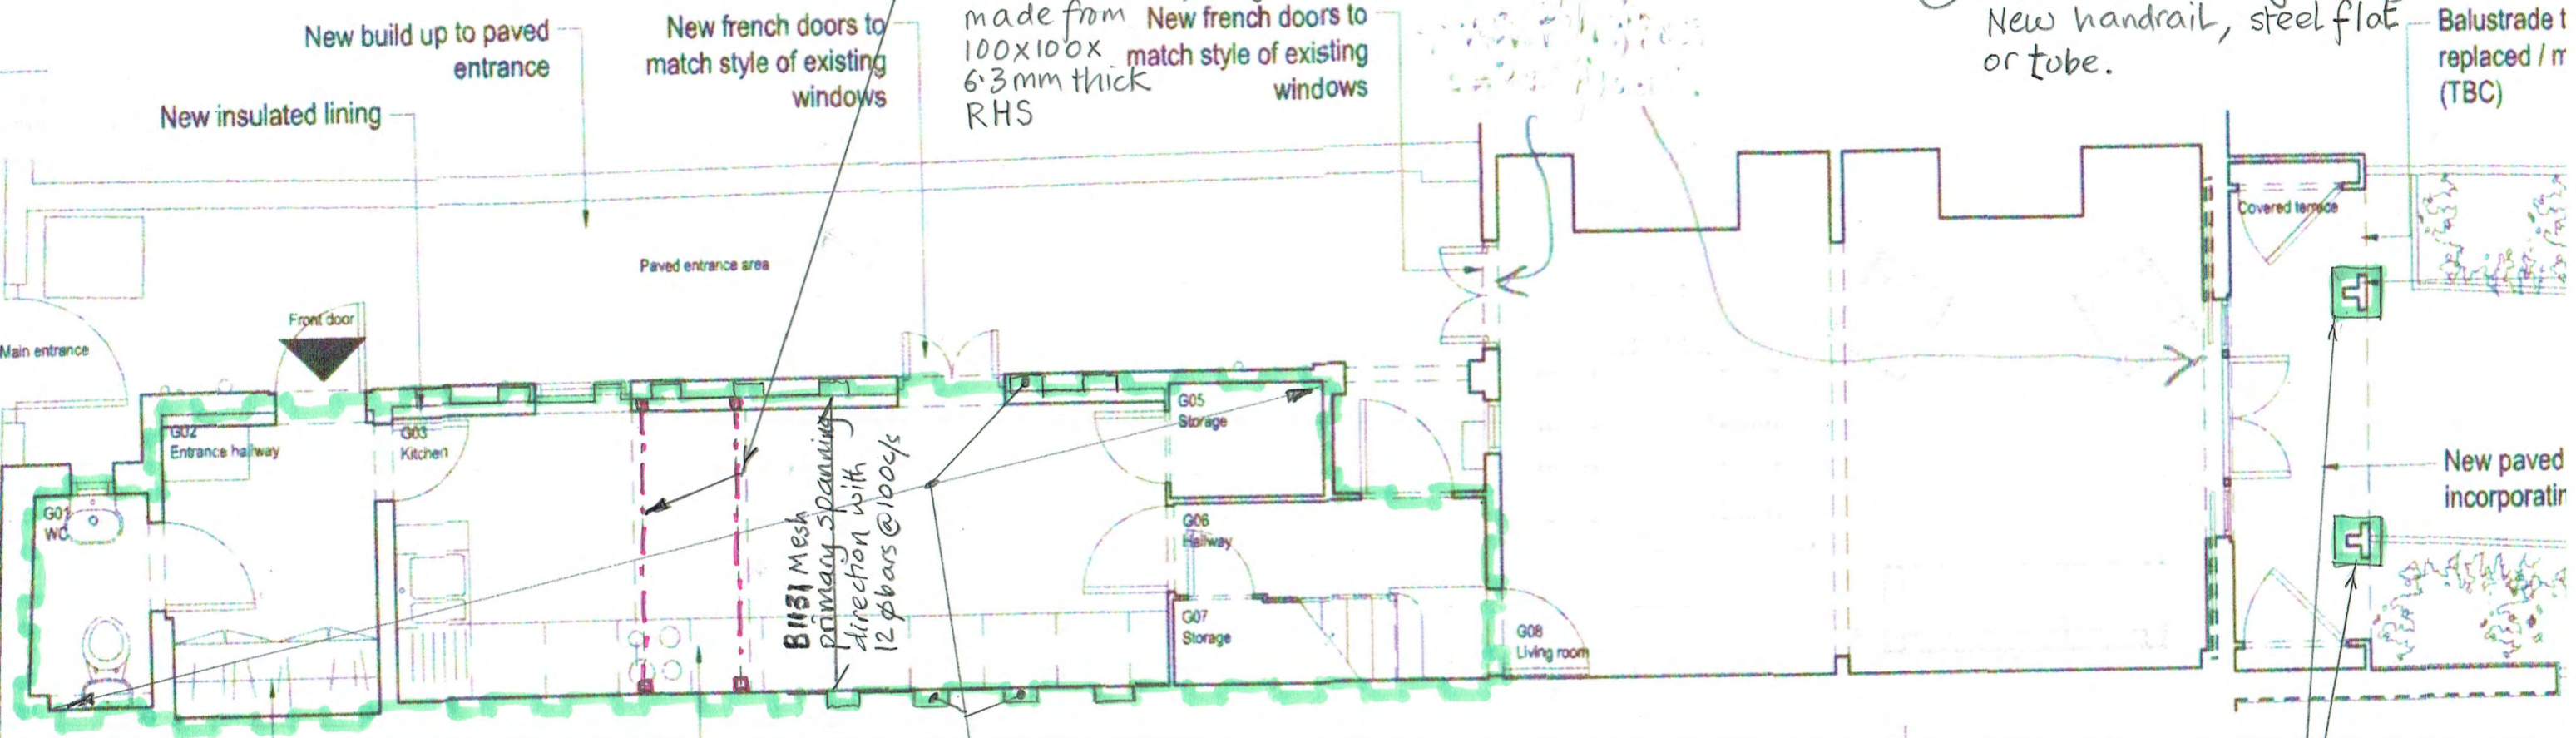
**Balcony.** This timber structure seems to have settled slightly, since it is pulling away from the front wall. The handrail of the balustrade is rather lower, and the open apertures do not comply with modern building regulations.

③ Pair of 2 Storey Steel Portal Frames, rigid joints, made from New french doors to 100x100x 6.3mm thick RHS match style of existing windows

⑤ Balustrade Strengthening New handrail, steel flat or tube. Balustrade to be replaced / m/c (TBC)

3. The chimney stack in the rear extension provides lateral stability, so new slender steel portal frames are needed when the masonry stack is removed. This steel frame could carry the weight of the top part of the chimney as it passes through the roof.

4. Larger deeper foundations are needed under the 2 posts which hold up the balcony. This will reduce the likelihood of further settlement.
5. Because the balcony posts are not strong enough to resist accidental outward load, the balustrade of the balcony needs to be strengthened, and a higher handrail ought to be added. The slender diagonal balusters are also too weak, and small steel flats could be added almost invisibly in order to make them stronger

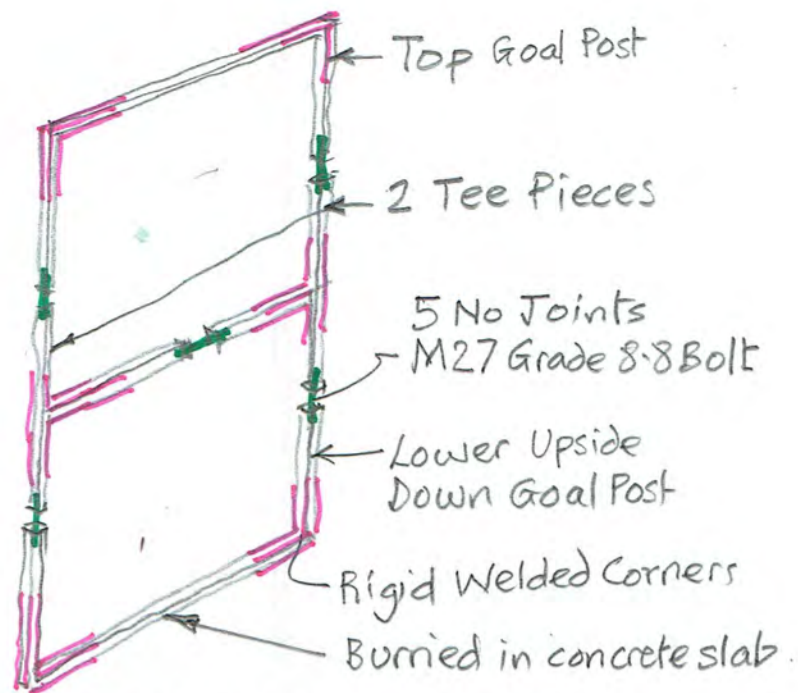
2 No Portal Frames Like This  
 All members 100x100x6.3 RHS

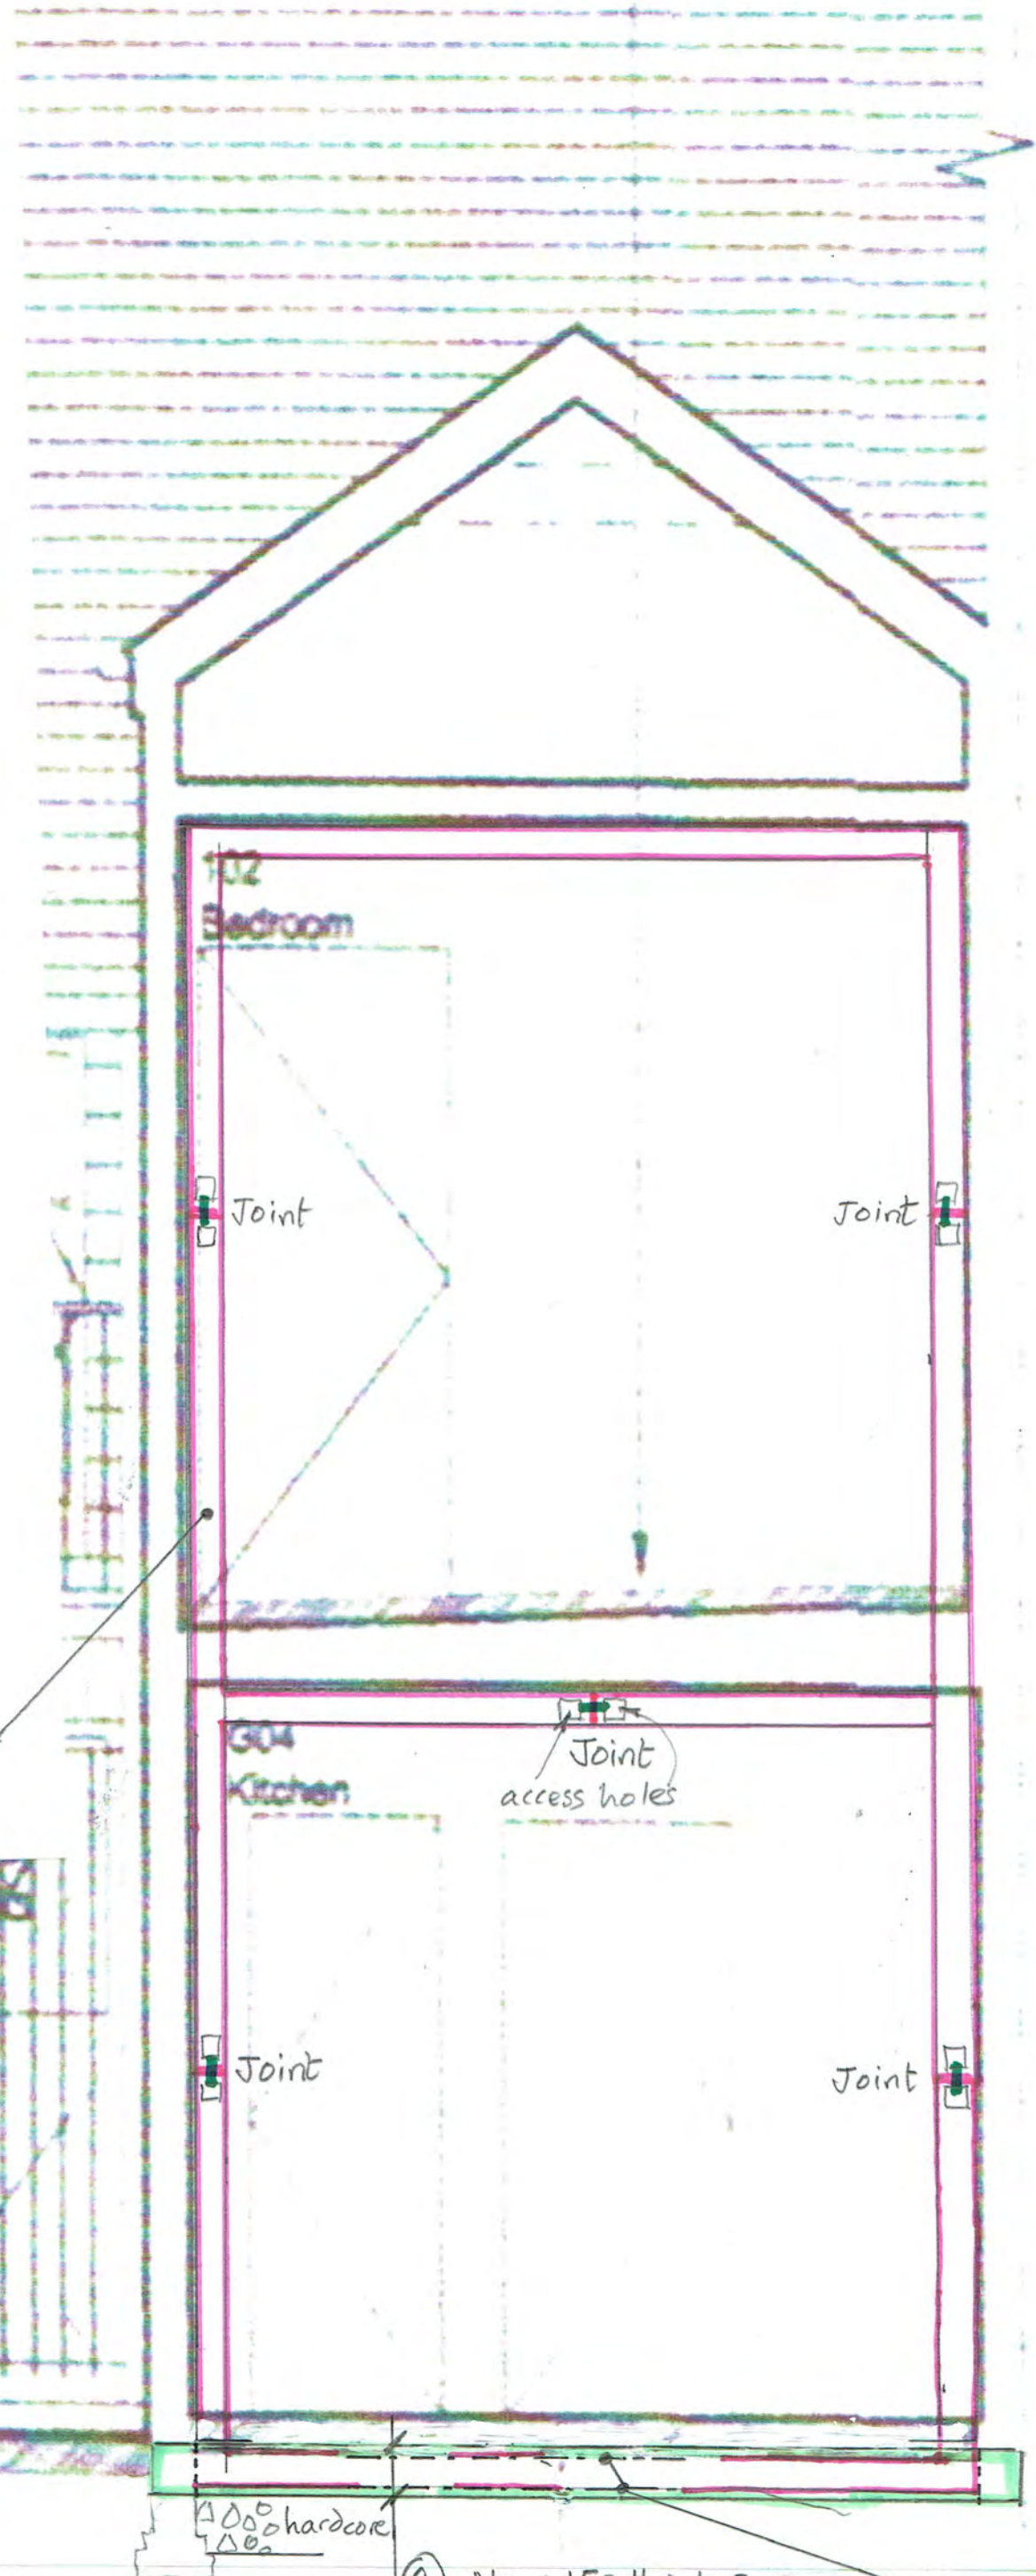
③ Pair of steel Portals

② New 150 thick RC slab 2 layers B1131 mesh reinforcement with 225x102 hit & miss reinforced tongues @ 675c/s around perimeter

② New 150thick R.C. Slab. 2 layers B1131 mesh

2. A new ground floor slab made of reinforced concrete should be introduced to form a raft foundation, with the ends tucked into the masonry walls on all 4 sides. This raft will reduce the risk of further settlement.

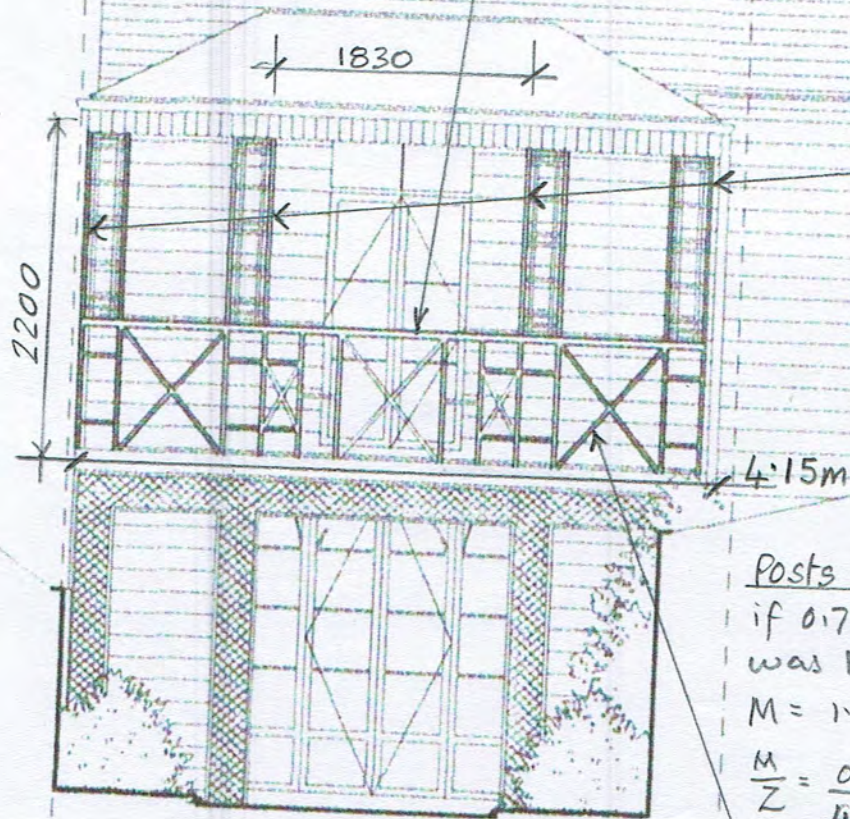
existing handrail 60x45  
wide deep

existing 4 posts 62x45 mm

Handrail span 1.83m  
if 0.75 kN/m applied  
 $W = 0.75 \times 1.83 = 1.37 \text{ kN}$   
 $M = 1.37 \times 1.83 / 8 = 0.314 \text{ kNm}$   
 $\frac{M}{Z} = \frac{0.314 \times 10^6 \times 6}{45 \times 60^2} = 11.6 \text{ N/mm}^2$

allowable short term if c24 wood,  
 $= 7.5 \times 1.5 = 11.25 \text{ N/mm}^2$  just under  
11.6, but probably OK since margin  
of safety.

Look at Joints. will handrail to post take  
 $1.37/2 = 0.685 \text{ kN}$ . I think it will since  
I gave it a sharp tug, and no sign of  
weakness.

So, handrail is just strong enough based  
on calcs but should be load tested with  
Horiz load to check. Put horiz load  
of  $1.37/2 = 0.685 \text{ kN} = 68.5 \text{ kg}$  as point  
load centre span to verify

NB. Handrail only 900 high  
Not 1100 high as Building Regs

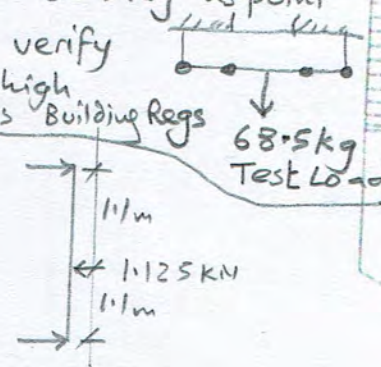
Posts height 2.2m.

if 0.75 kN/m applied to handrail, and if handrail  
was 1.5m high; then  $W = 1.5 \times 0.75 = 1.125 \text{ kN}$

$$M = 1.125 \times \frac{2.2}{4} = 0.618 \text{ kNm}$$

$$\frac{M}{Z} = \frac{0.618 \times 10^6 \times 6}{45 \times 62^2} = 21.4 \text{ N/mm}^2 \text{ Fails}$$

Small Baluster 22x33mm (wood)

diagonal spans 1.1m what point load would overload?

if max stress = 11.25  $\sigma Z = 11.25 \times \frac{22 \times 33^2}{6} = 44921 \text{ Nmm}$

$$\frac{P \times 1100}{4} = 44921$$

$P = 163 \text{ N} = 16 \text{ kg}$  very low - Not strong enough - Balusters  
should be swapped for steel.

New 25x25 steel  
handrail white  
at 1100 above deck

Extra 45x45 timber  
(taper if desired)  
glued & screwed to  
inside (back face) of  
2 vertical posts at  
both ground to 1st  
and 1st to Roof.
